WBA11FY000FR29303

Zustandsbericht

Inspection date: 16 Jan 2025
Protocol number: 37988176

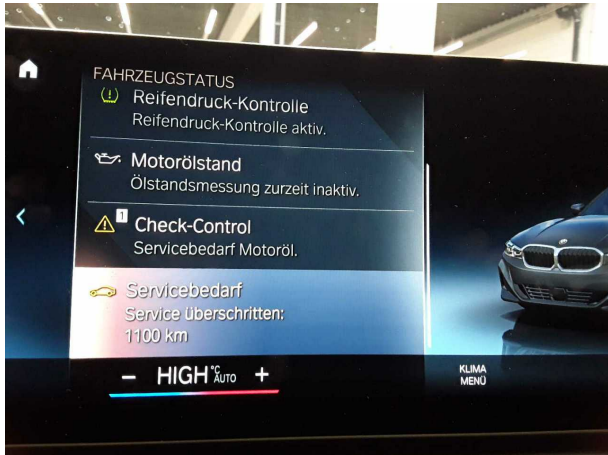
Damage #1: Misc.: Inspection / maintenance - Due - Replace

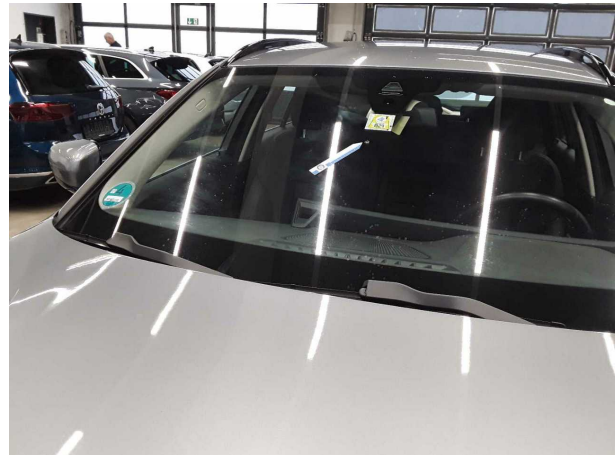
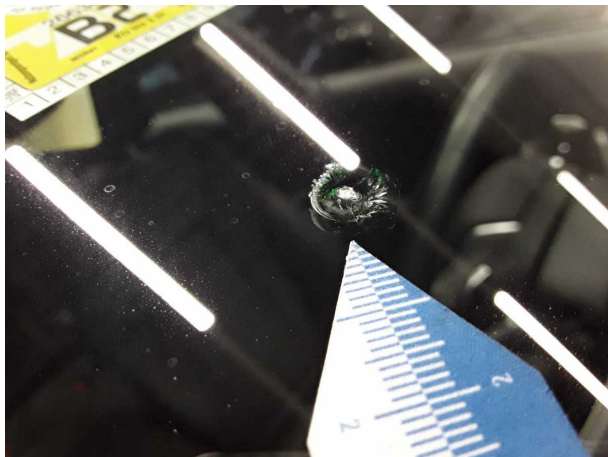
Damage #2: Vehicle glazing: Windscreen with lane departure assistant - Broken / torn - Replace

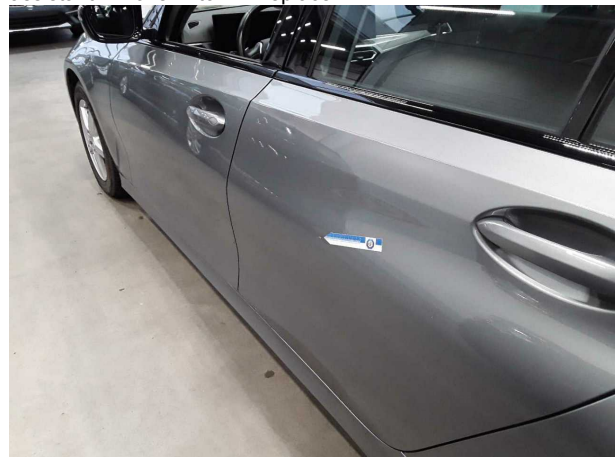
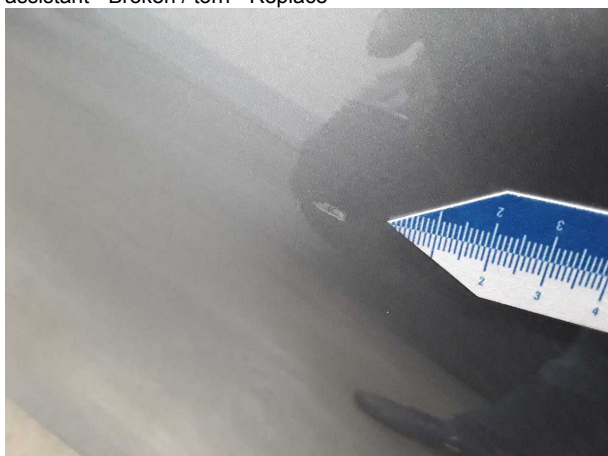
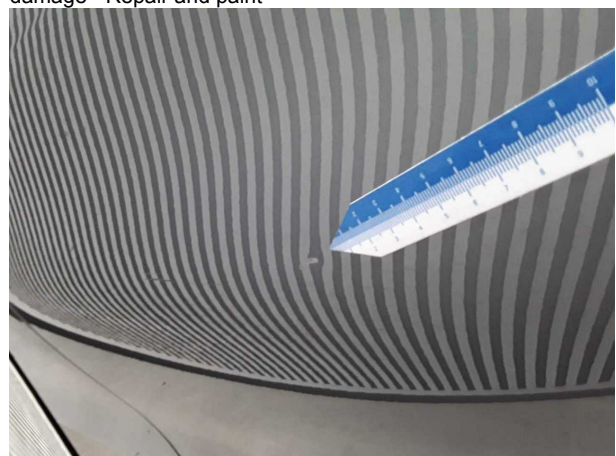
Damage #3: Door - rear left side: Door - Dent / paintcoat damage - Repair and paint

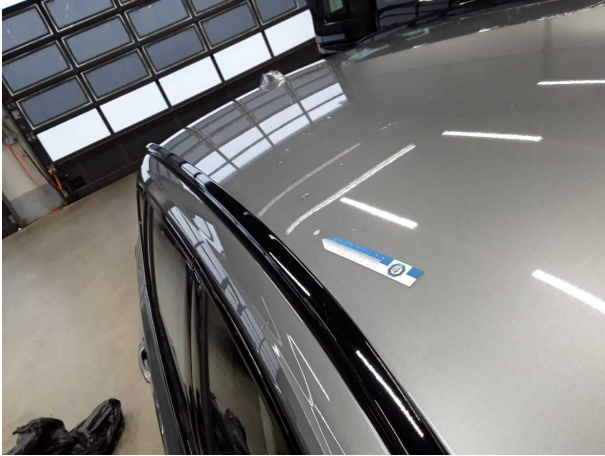
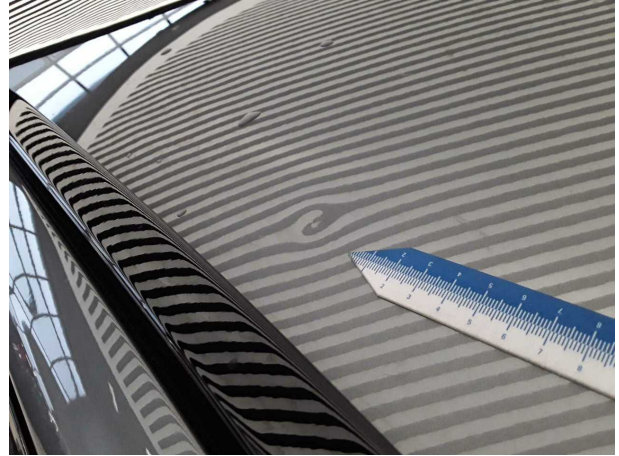
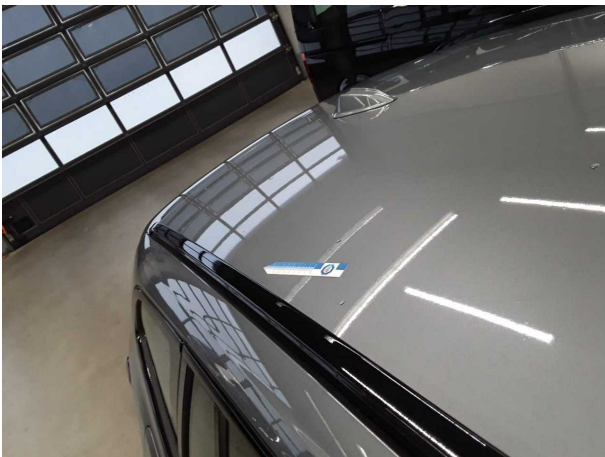
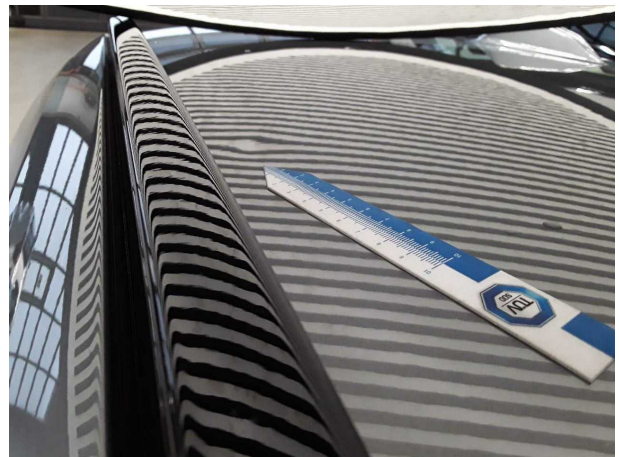
Damage #4: Roof: Roof - Dent(s) - Repair and paint
