WAUZZZF24MN031011

Zustandsbericht

Inspection date: 27 Feb 2025
Protocol number: 38607635
Delivery date: 27 Feb 2025

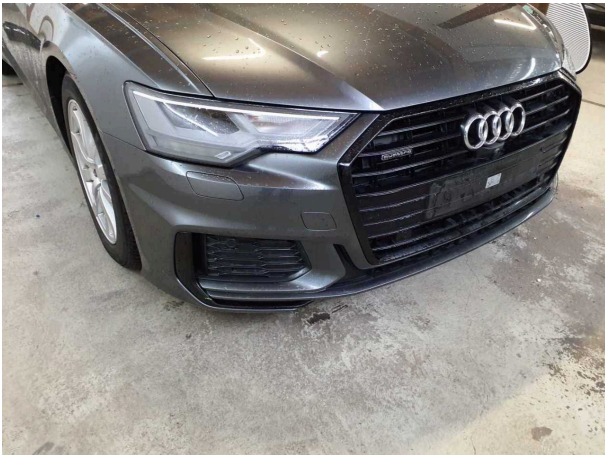
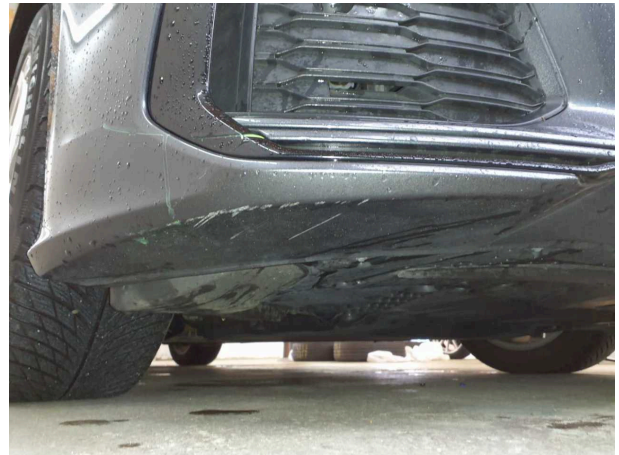
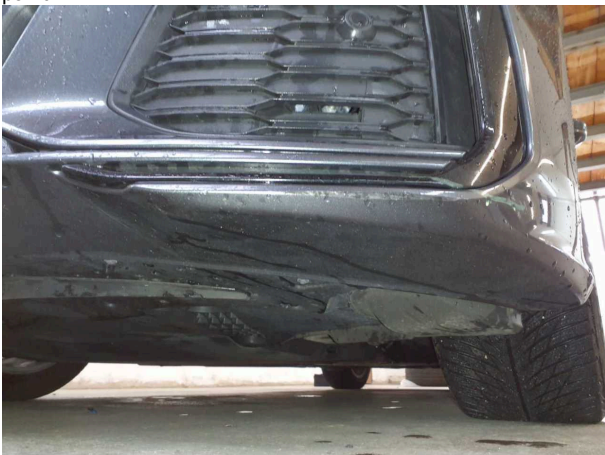
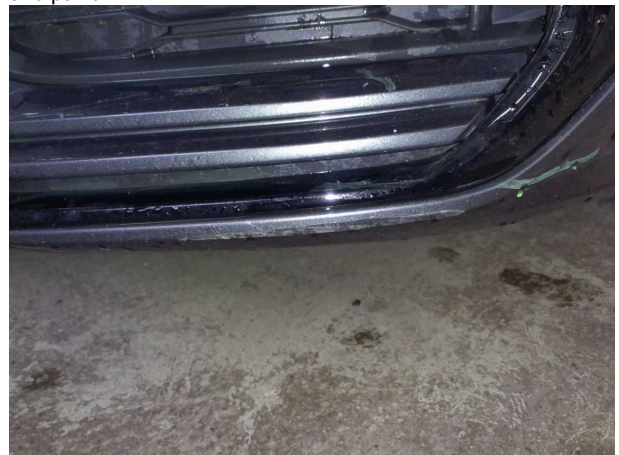
| No. | Component group | Description |
|---|---|---|
| 3 | Front bumper | Front bumper - Scratched - Repair and paint |

Damage #3: Front bumper: Front bumper - Scratched - Repair and paint
