WBA6N31020FK87718

## Zustandsbericht

Inspection date: 11 Feb 2025

**Protocol number:** 38364846

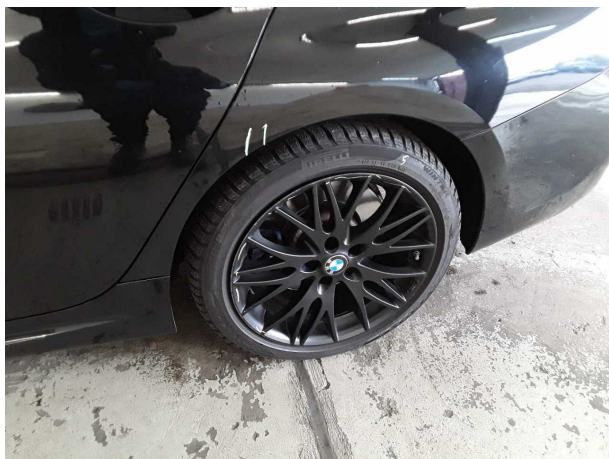
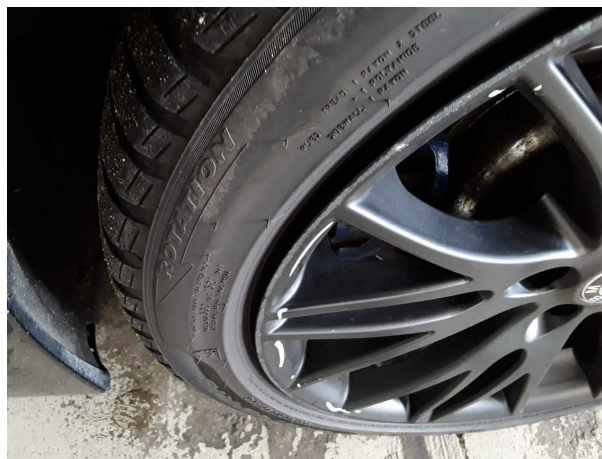
| No. | Component group | Description |
|---|---|---|
| 2 | Wheel / tyres | Alloy rim - rear left side - Scratched - No deduction |

**Damage #2:** Wheel / tyres: Alloy rim - rear left side - Scratched - ... deduction

**Damage #2:** Wheel / tyres: Alloy rim - rear left side - Scratched - No deduction

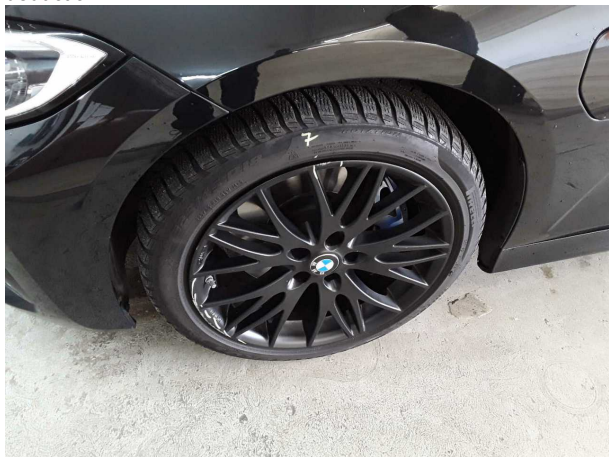
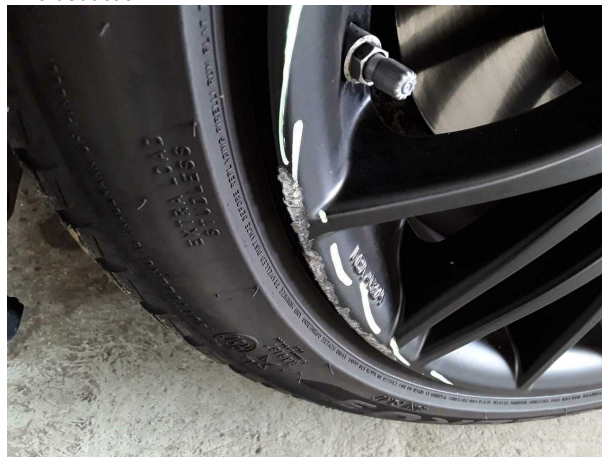
| No. | Component group | Description |
|---|---|---|
| 3 | Wheel / tyres | Alloy rim - front left side - Scratched - No deduction |

**Damage #3:** Wheel / tyres: Alloy rim - front left side - Scratched - No deduction

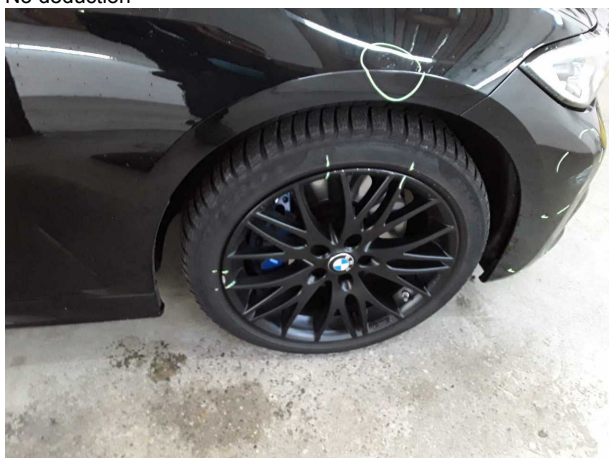
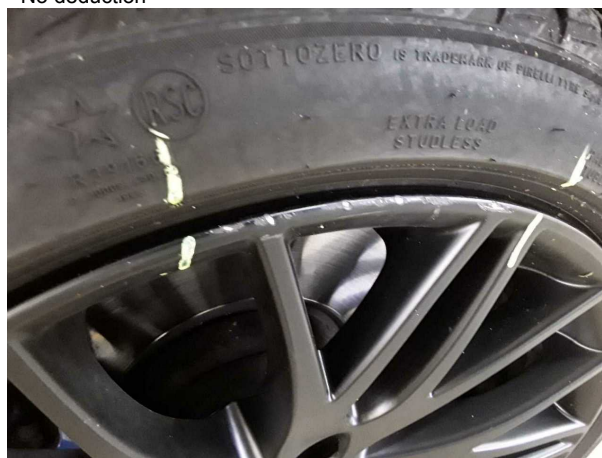
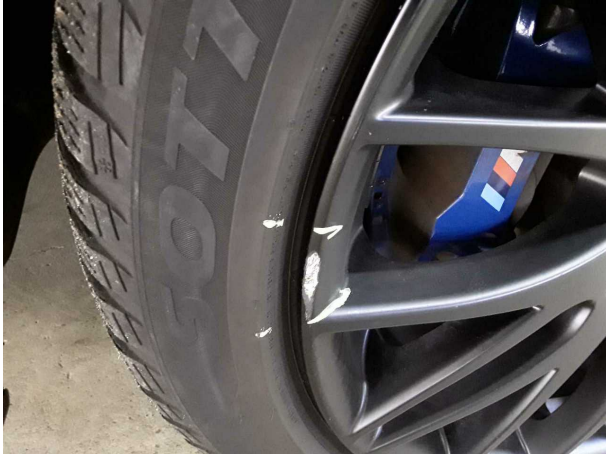
| No. | Component group | Description |
|---|---|---|
| 4 | Wheel / tyres | Alloy rim - front right side - Scratched - No deduction |

**Damage #4:** Wheel / tyres: Alloy rim - front right side - Scratched - No deduction

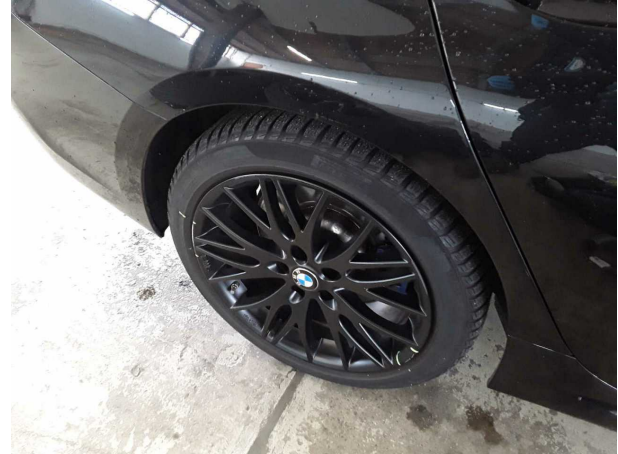
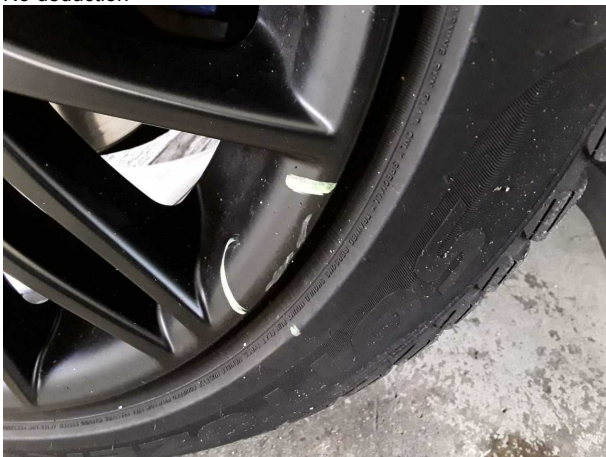
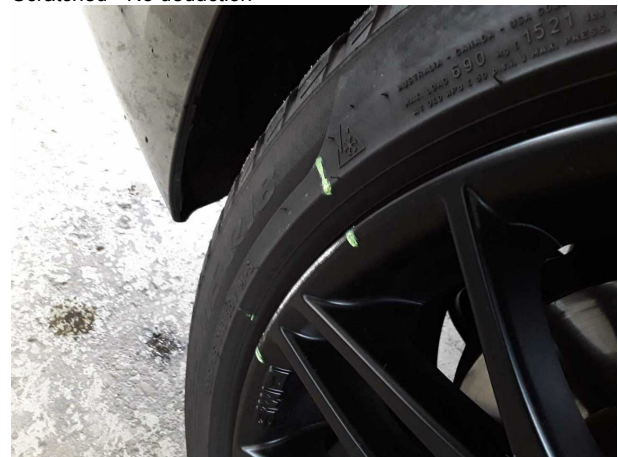
| No. | Component group | Description |
|---|---|---|
| 5 | Wheel / tyres | Alloy rim - rear right side - Scratched - No deduction |

**Damage #5:** Wheel / tyres: Alloy rim - rear right side - Scratched - No deduction

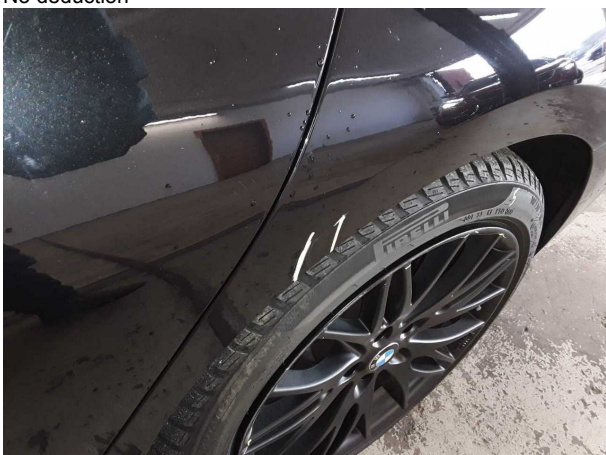
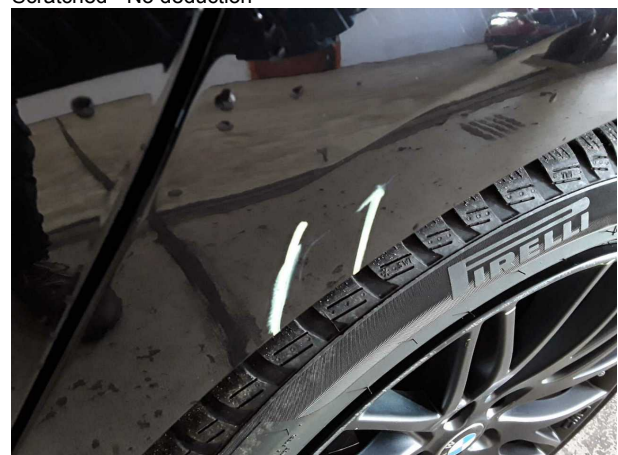
| No. | Component group | Description |
|---|---|---|
| 6 | Side panel - rear left side | Side panel - Scratch(es) - Cover / polish |

**Damage #6:** Side panel - rear left side: Side panel - Scratch(es) - Cover / polish

**Damage #6:** Side panel - rear left side: Side panel - Scratch(... - Cover / polish

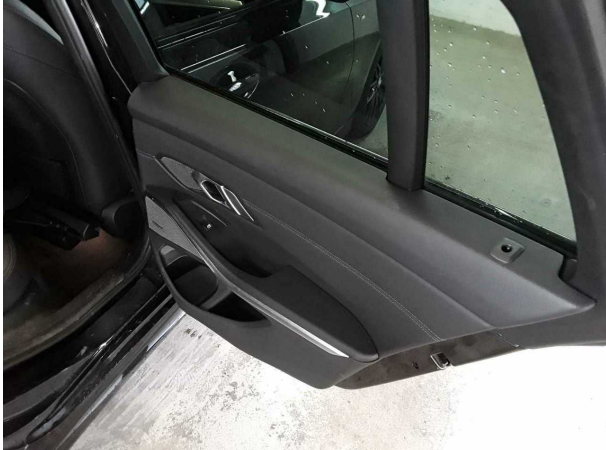
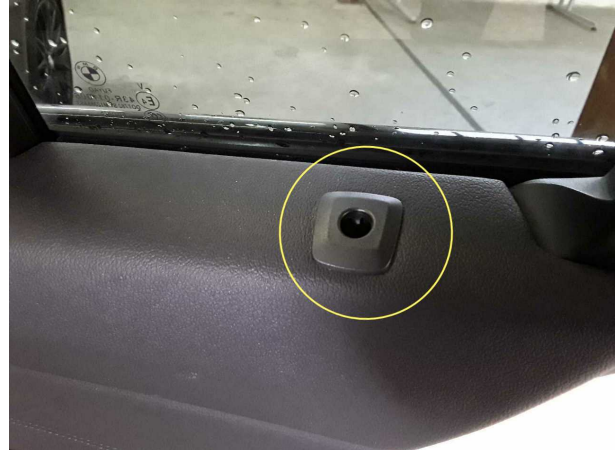
| No. | Component group | Description |
|---|---|---|
| 7 | Trim / covers | Trim / covers (Stift Fehlt Tür hi re.) - Un- / install |

**Damage #7:** Trim / covers: Trim / covers (Stift Fehlt Tür hi re.) - Un- / install

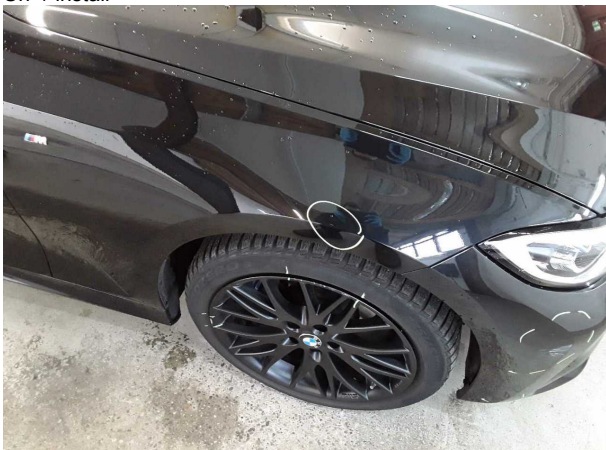
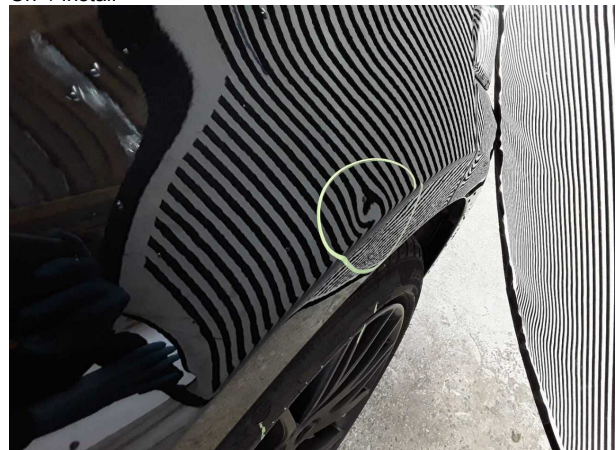
| No. | Component group | Description |
|---|---|---|
| 8 | Mudguard - right side | Mudguard - right side - Dent(s) - Smooth repair work |

**Damage #8:** Mudguard - right side: Mudguard - right side - Dent(... Smooth repair work

**Damage #8:** Mudguard - right side: Mudguard - right side - Dent(s) - Smooth repair work

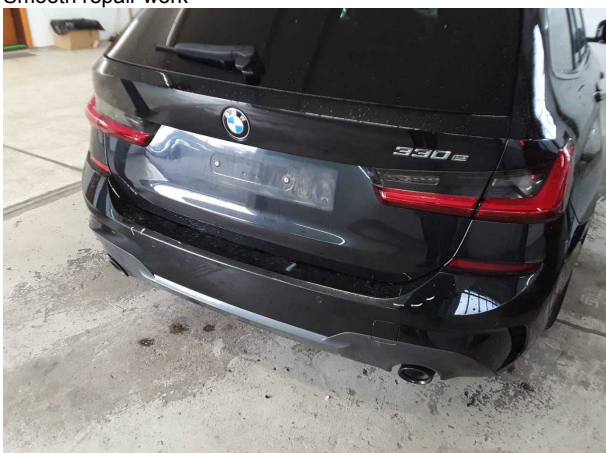
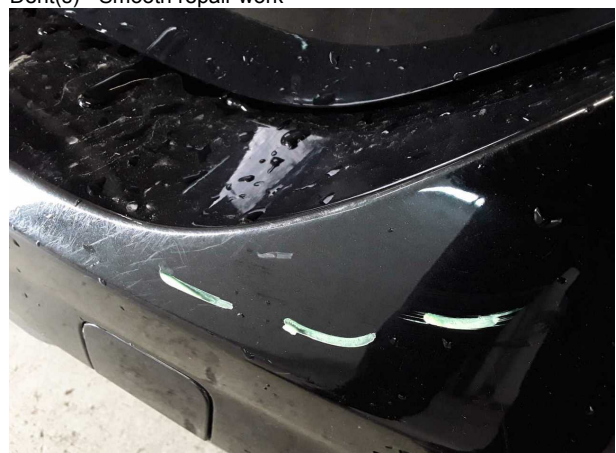
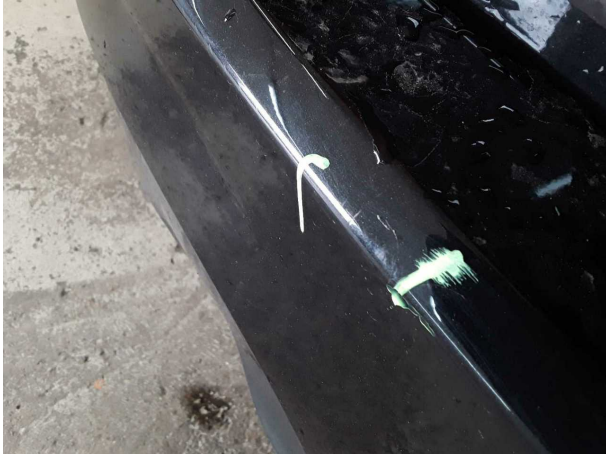
| No. | Component group | Description |
|---|---|---|
| 9 | Rear bumper | Rear bumper - Scratched - Smart repair |

**Damage #9:** Rear bumper: Rear bumper - Scratched - Smart repair

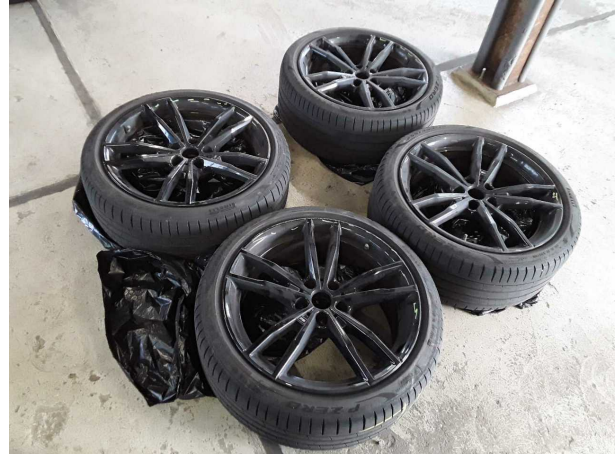
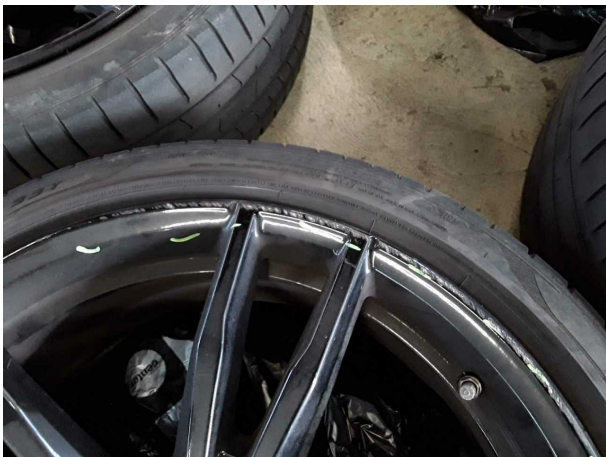
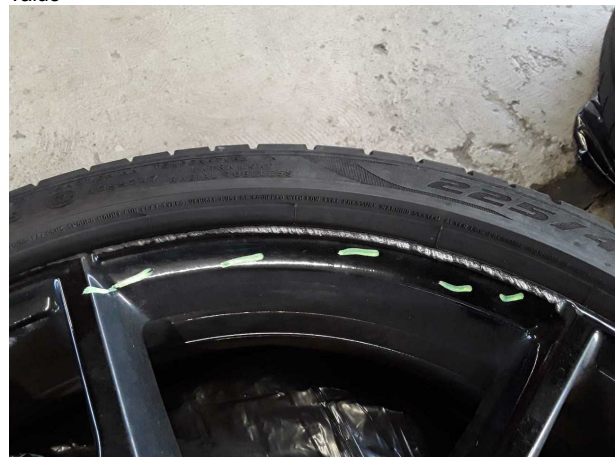
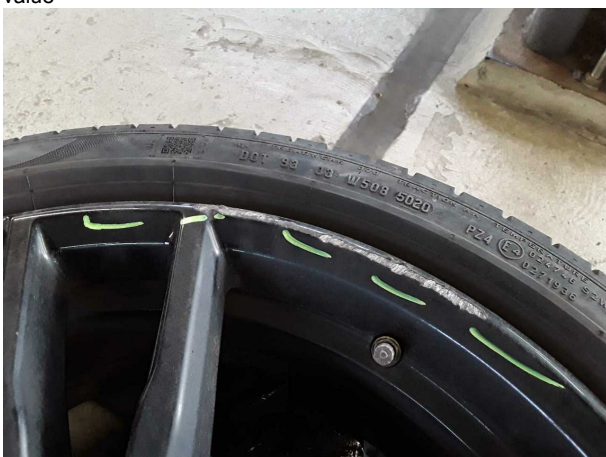
| No. | Component group | Description |
|---|---|---|
| 10 | 2nd wheel set | 3 alloy rims - Scratched - Loss in value |

**Damage #10:** 2nd wheel set: 3 alloy rims - Scratched - Loss in value

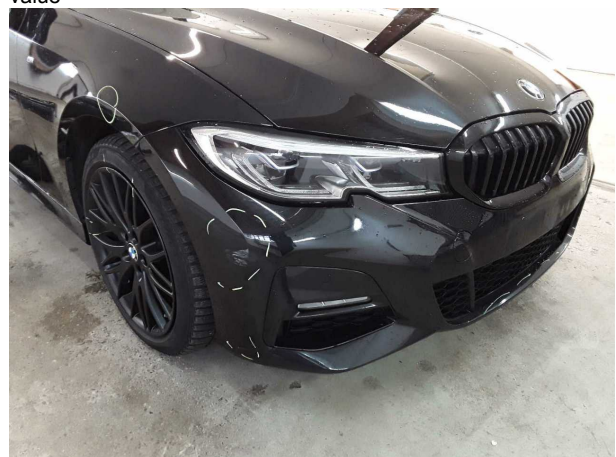
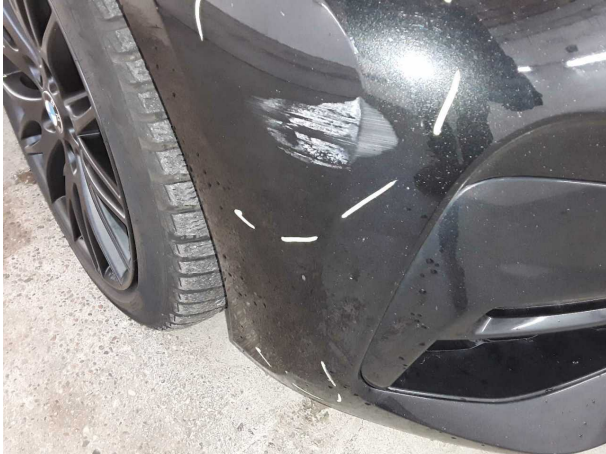
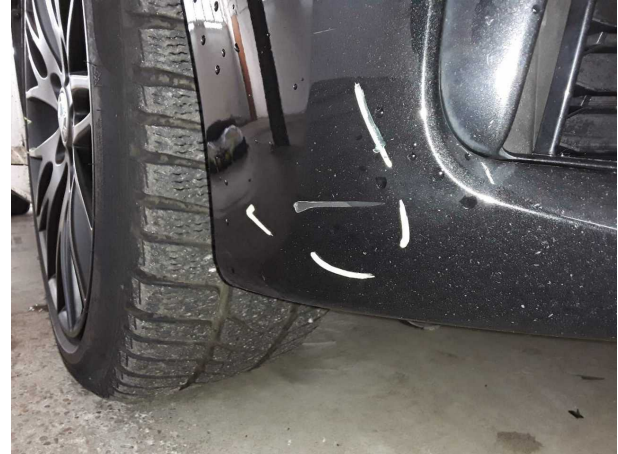
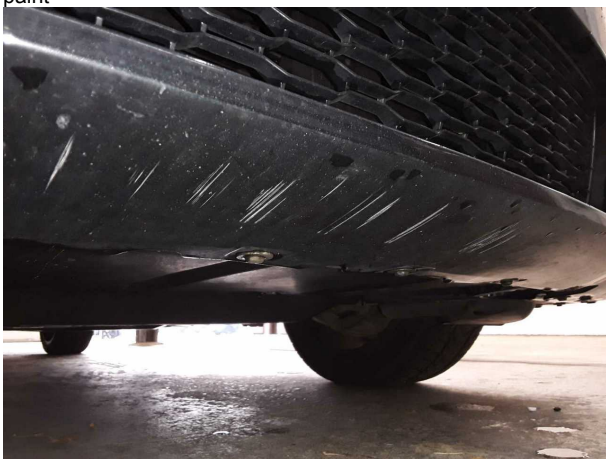
| No. | Component group | Description |
|---|---|---|
| 11 | Front bumper | Front bumper - Scratched - Repair and paint |

**Damage #11:** Front bumper: Front bumper - Scratched - Rep... and paint

**Damage #11:** Front bumper: Front bumper - Scratched - Repair a...  
paint

**Damage #11:** Front bumper: Front bumper - Scratched - Rep...  
and paint

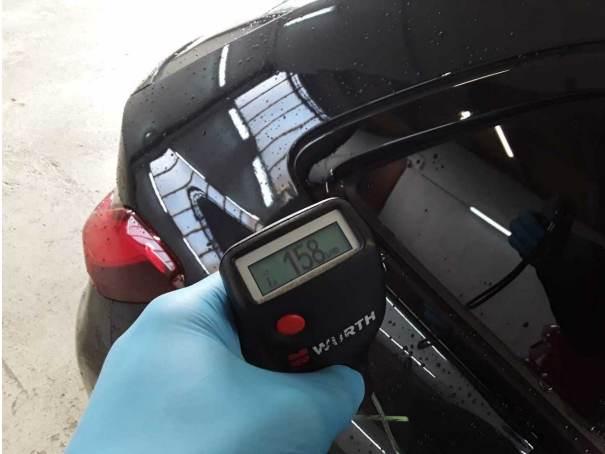
| No. | Location |
|---|---|
| 1 | Mudguard - left side, Side panel - rear right side, Door - front left side, Professionally carried out |

**Repainting 1:** Mudguard - left side, Side panel - rear right side,  
Door - front left side
