WBA6N71020FL27089

Operator		Inspection condition	conditional: light/moisture/dirt
License number		Mileage (Read)	88,268 km
Manufacturer	BMW	Next maintenance in	10,000 km
Type / Model	330e xDrive	Main inspection (Report not on hand)	05/2026
Vehicle Identification number	WBA6N71020FL27089	Power / Engine displacement	135 kW / 1,998 ccm
First registration	11 May 2021	Upholstery/Colour	/
Last maintenance	05/2024, 64,728 km	Paintwork	
Fuel type	Hybr.B/E ext. edition	Gearbox	Automatic

Zustandsbericht

Inspection date: 28 Feb 2025
Protocol number: 38641725
Delivery date: 28 Feb 2025

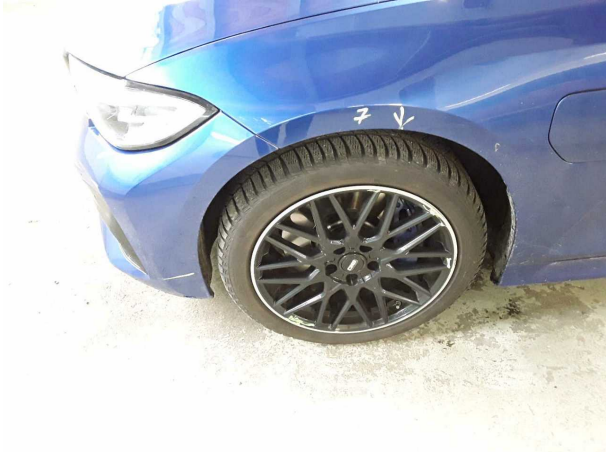
Damage #1: Wheel / tyres: Alloy rim - front left side - Scratched - No deduction

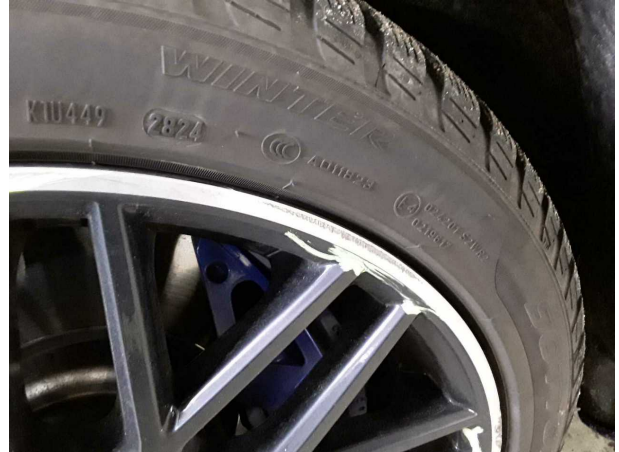
Damage #1: Wheel / tyres: Alloy rim - front left side - Scratched - No deduction

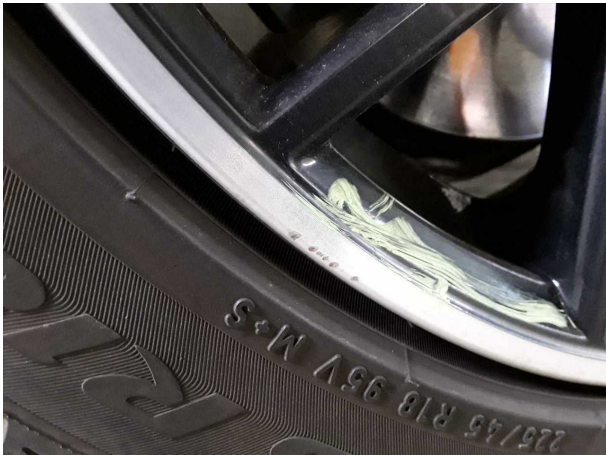
Damage #1: Wheel / tyres: Alloy rim - front left side - Scratched - No deduction

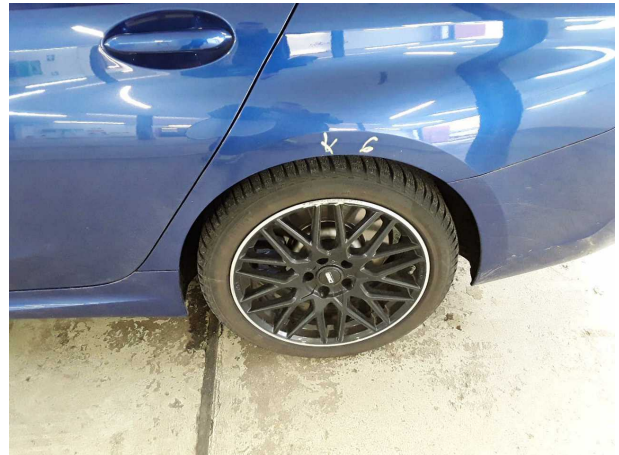
Damage #2: Wheel / tyres: Alloy rim - rear left side - Scratched - No deduction

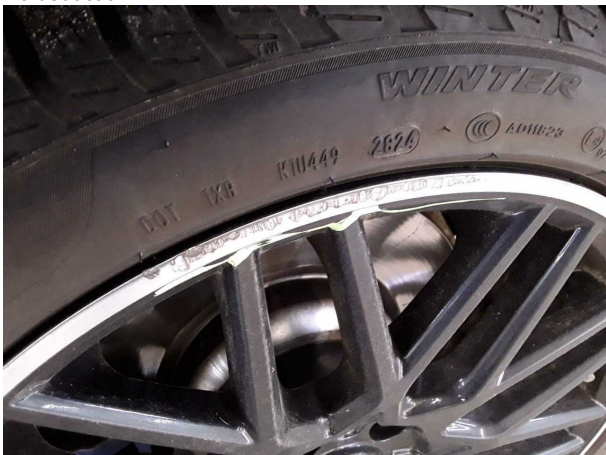
Damage #2: Wheel / tyres: Alloy rim - rear left side - Scratched - ... deduction

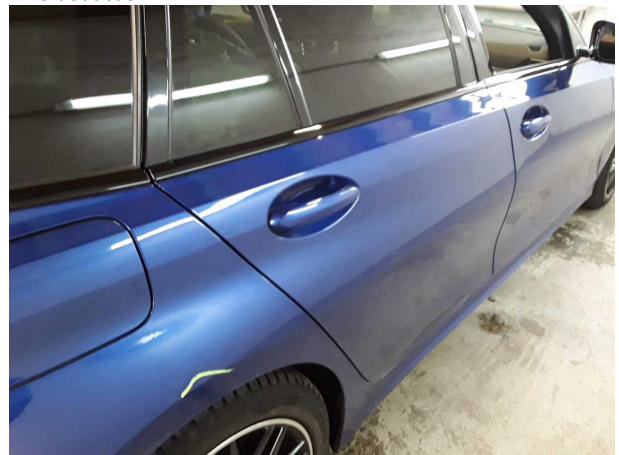
Damage #3: Door - rear right side: Door - Scratched - No deduction

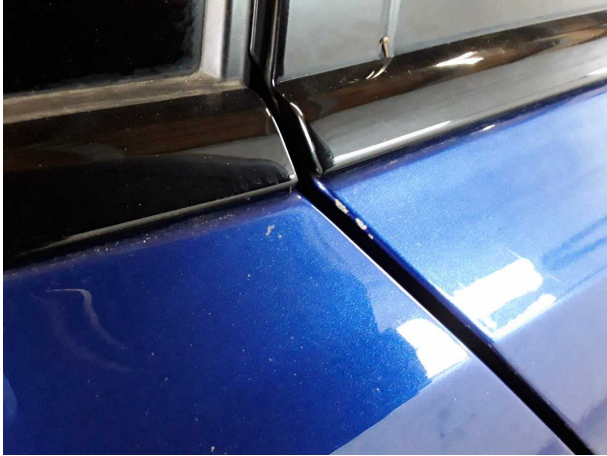
Damage #3: Door - rear right side: Door - Scratched - No deduction

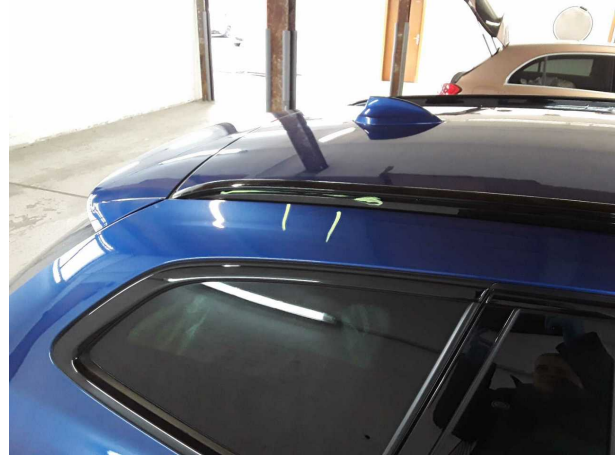
Damage #4: Roof: Roof rail - right side - Scratched - Loss in value

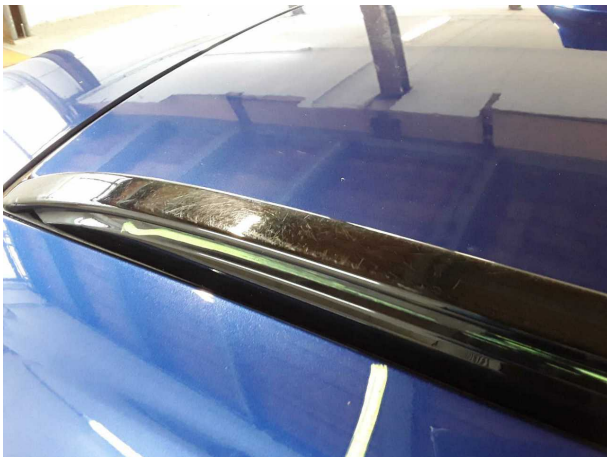
Damage #4: Roof: Roof rail - right side - Scratched - Loss in value

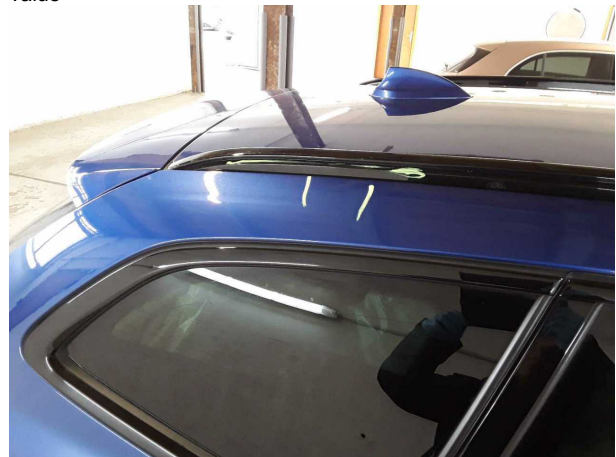
Damage #5: Roof: Roof rail - right side - Scratched - Smart repair

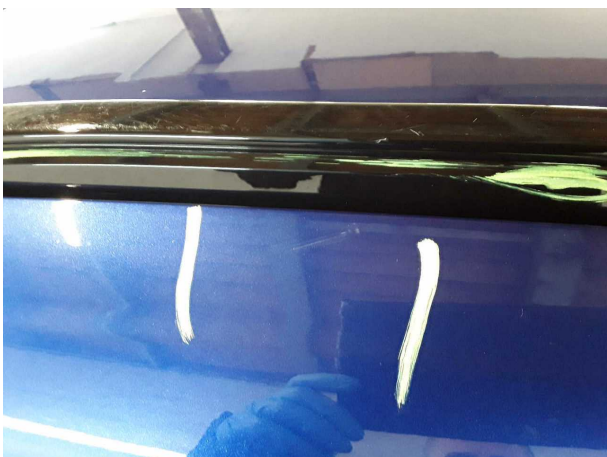
Damage #5: Roof: Roof rail - right side - Scratched - Smart repair

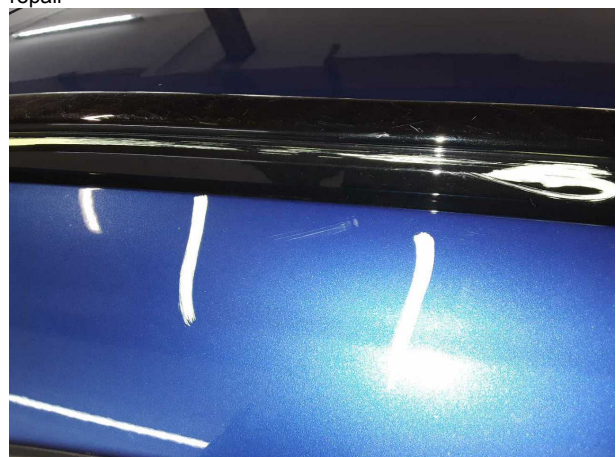
Damage #5: Roof: Roof rail - right side - Scratched - Smart repair

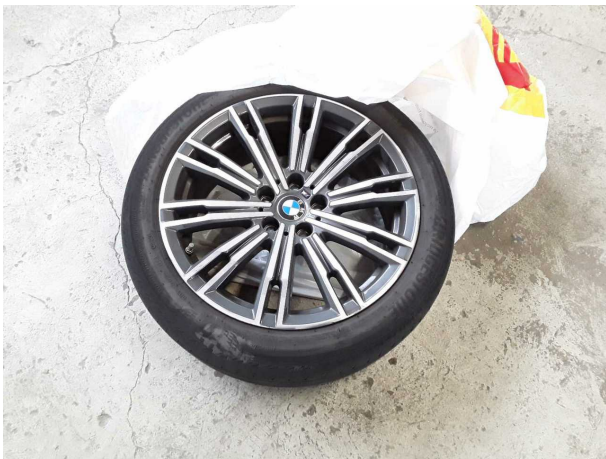
Axle	Tyre size	Manufacturer	Type of tyre	Tread depth	Roadworthy	Permissibility
1	225/45 R18 95Y	Bridgestone	Summer tyres	7mm - 7mm	Not o.k.	
2	245/40 R18 99Y	Bridgestone	Summer tyres	4mm - 4mm	o.k.

Damage #7: 2nd wheel set: 1 tyre - Damaged - Replace

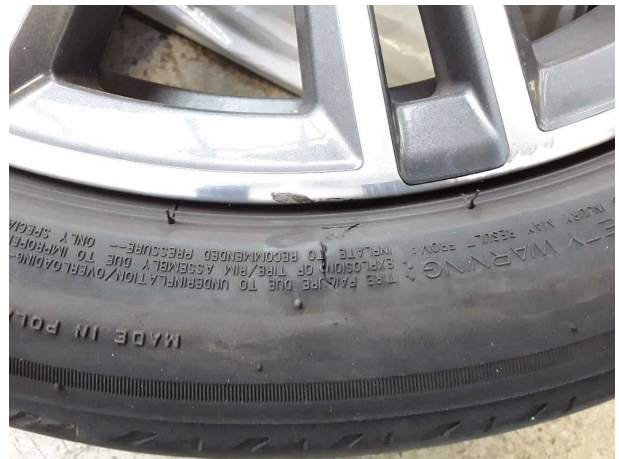
Damage #7: 2nd wheel set: 1 tyre - Damaged - Replace

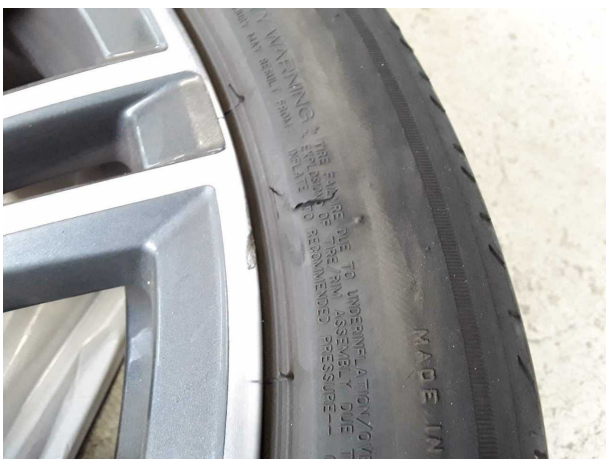
Damage #7: 2nd wheel set: 1 tyre - Damaged - Replace

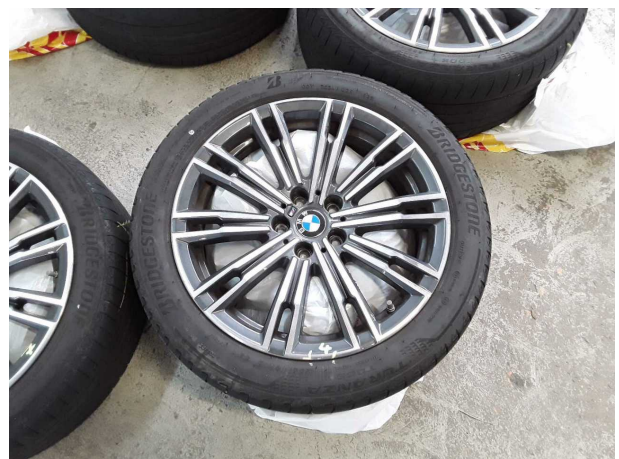
Damage #8: 2nd wheel set: 2 alloy rims - Scratched - Loss in value

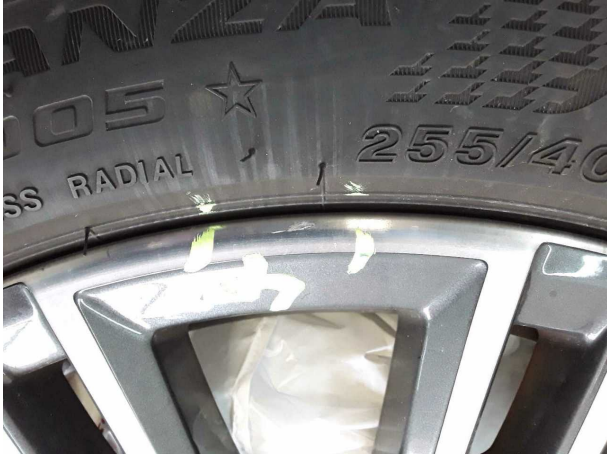
Damage #8: 2nd wheel set: 2 alloy rims - Scratched - Loss in value

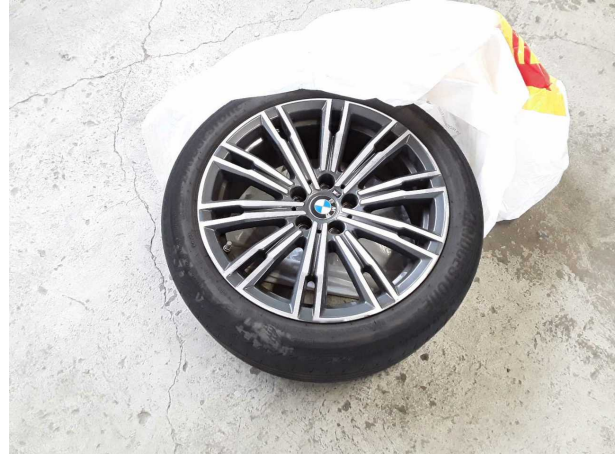
Damage #8: 2nd wheel set: 2 alloy rims - Scratched - Loss in value

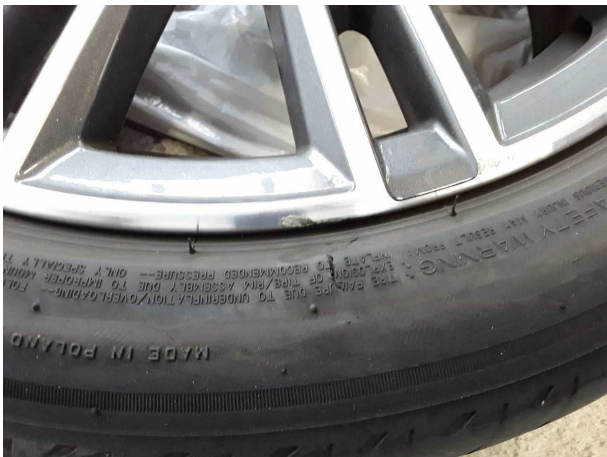
Damage #8: 2nd wheel set: 2 alloy rims - Scratched - Loss in value

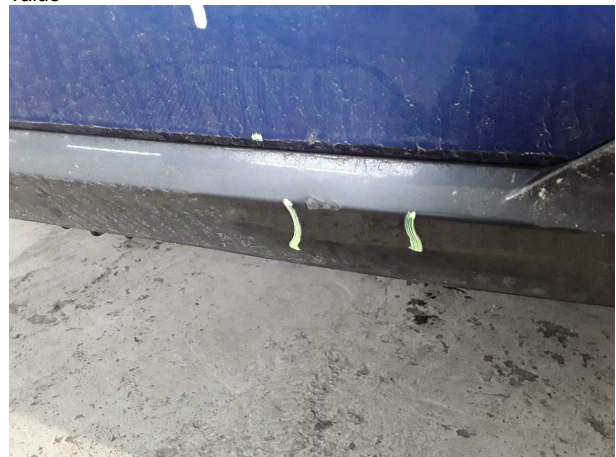
Damage #9: Rear bumper: Spoiler - Scratched - Replace

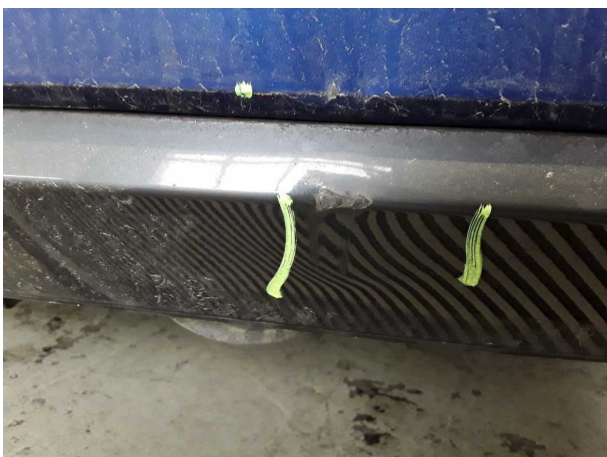
Damage #9: Rear bumper: Spoiler - Scratched - Replace

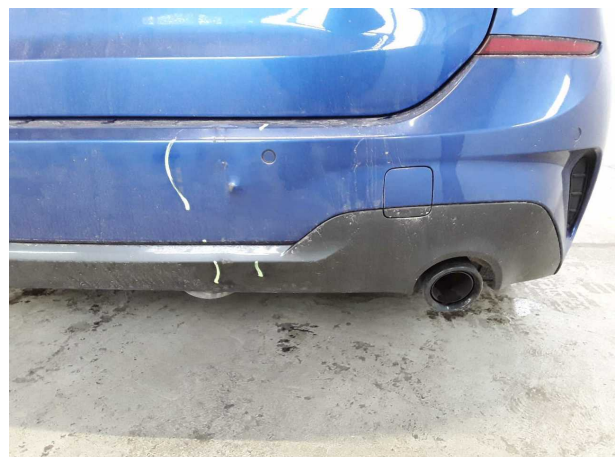
Damage #9: Rear bumper: Spoiler - Scratched - Replace

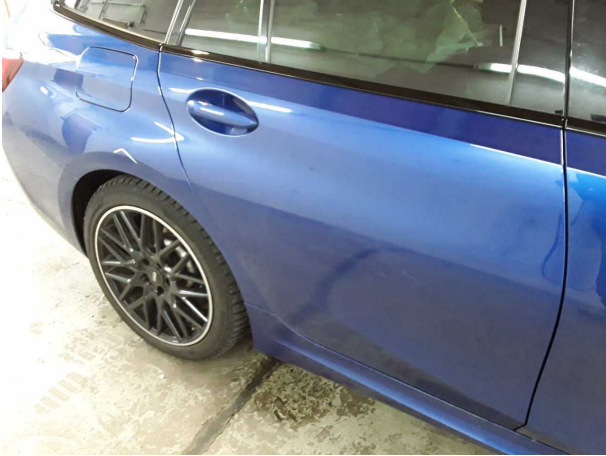
Damage #10: Door - rear right side: Door - Scratched - Repair and paint

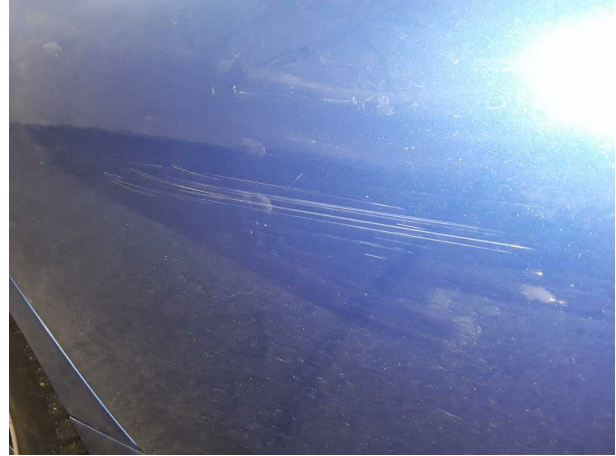
Damage #10: Door - rear right side: Door - Scratched - Repair and paint

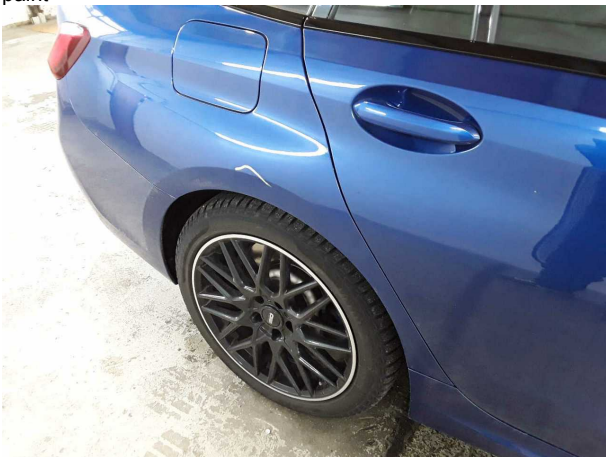
Damage #11: Side panel - rear right side: Side panel - Dent / paintcoat damage - Repair and paint

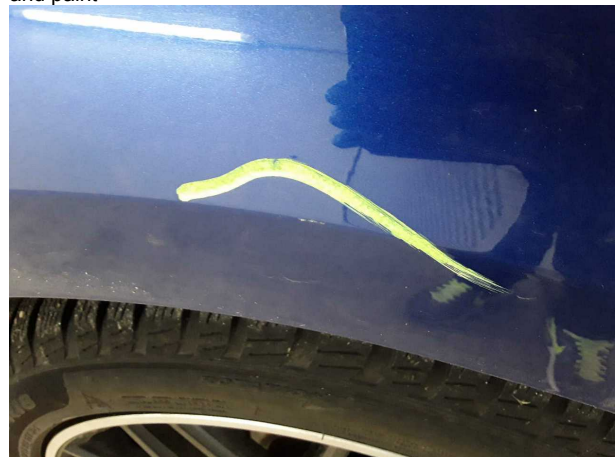
Damage #11: Side panel - rear right side: Side panel - Dent / paintcoat damage - Repair and paint

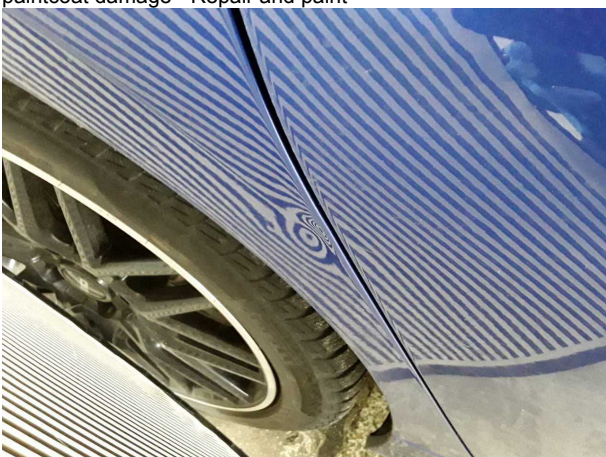
Damage #11: Side panel - rear right side: Side panel - Dent / paintcoat damage - Repair and paint

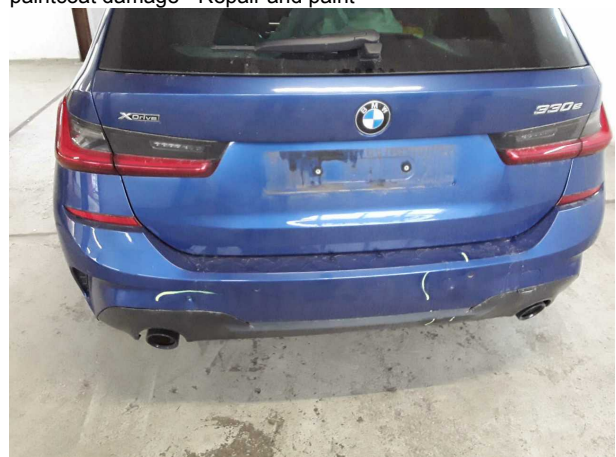
Damage #12: Rear bumper: Rear bumper - Deformed - Replace

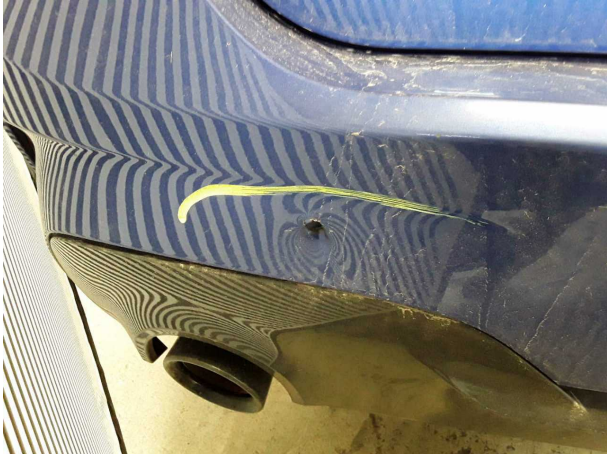
Damage #12: Rear bumper: Rear bumper - Deformed - Replace

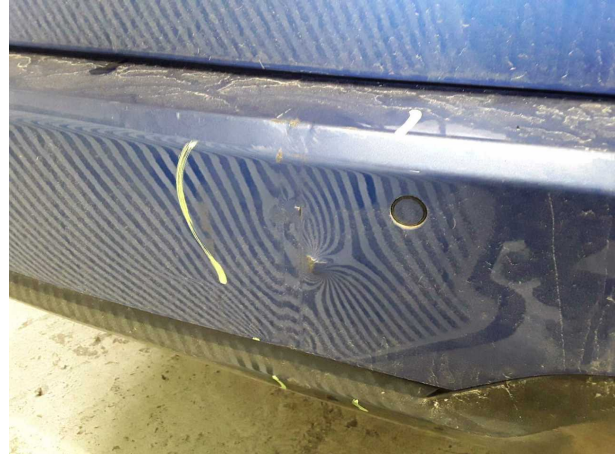
Damage #12: Rear bumper: Rear bumper - Deformed - Replace

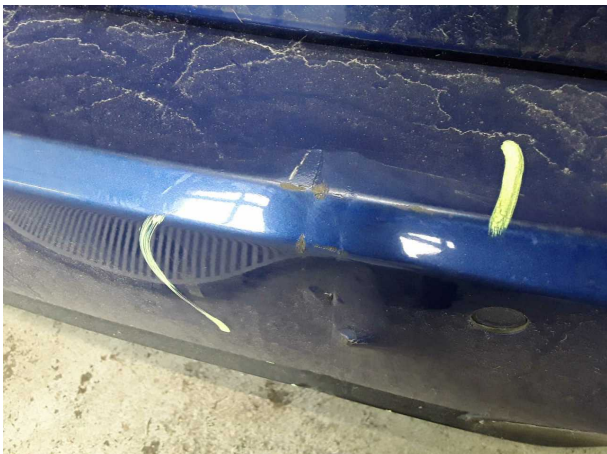
Damage #12: Rear bumper: Rear bumper - Deformed - Replace

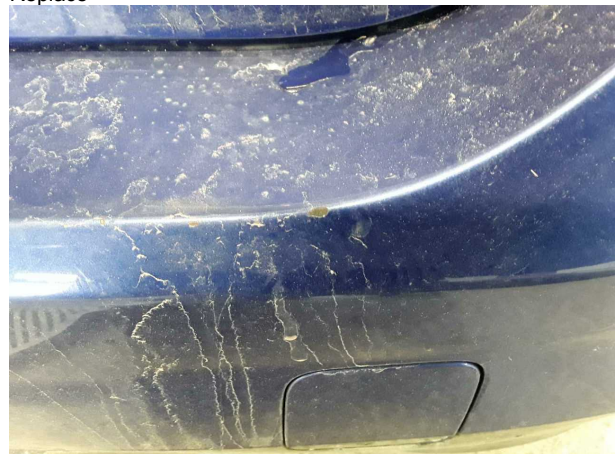
Damage #12: Rear bumper: Rear bumper - Deformed - Replace

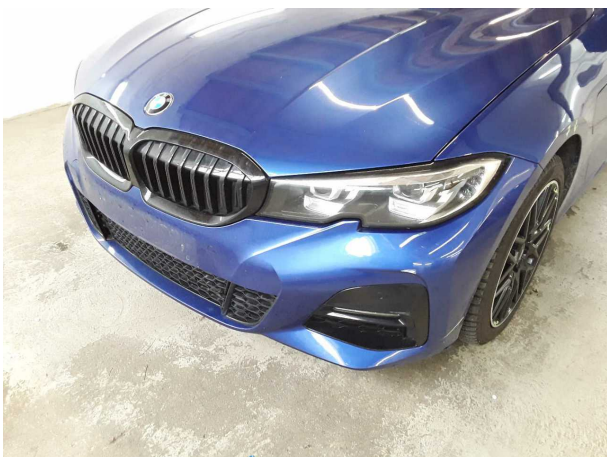
Damage #13: Front bumper: Front bumper - Deformed - Replace

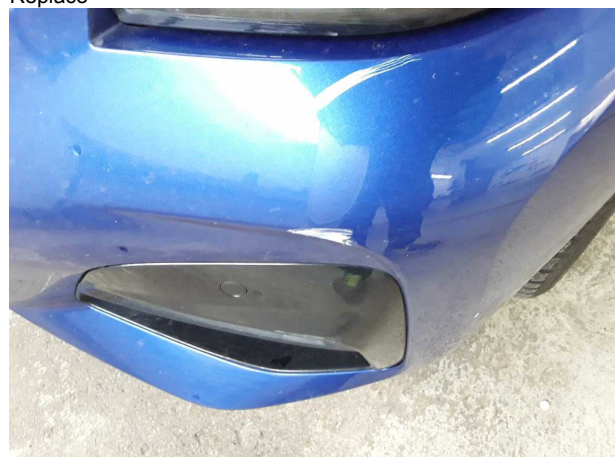
Damage #13: Front bumper: Front bumper - Deformed - Replace

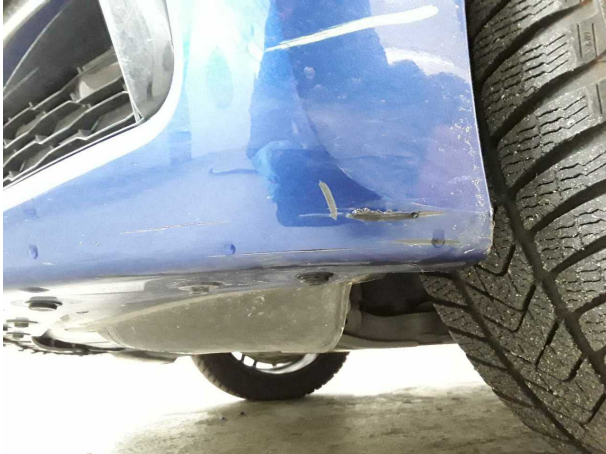
Damage #13: Front bumper: Front bumper - Deformed - Replace

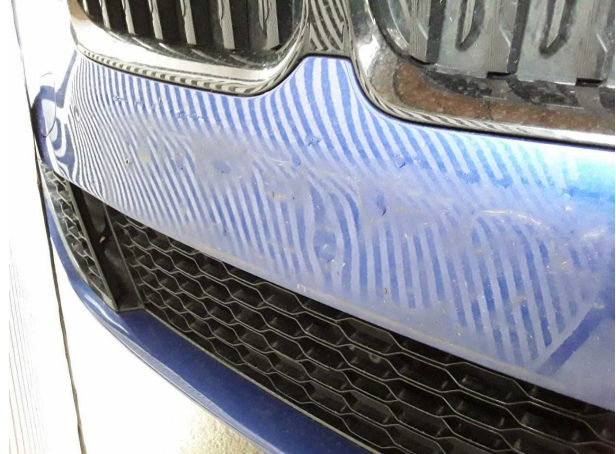
Damage #13: Front bumper: Front bumper - Deformed - Replace
