**WBA6K51060FJ98514**

## Zustandsbericht

Inspection date: 10 Feb 2025  
**Protocol number: 38348586**  
Delivery date: 10 Feb 2025

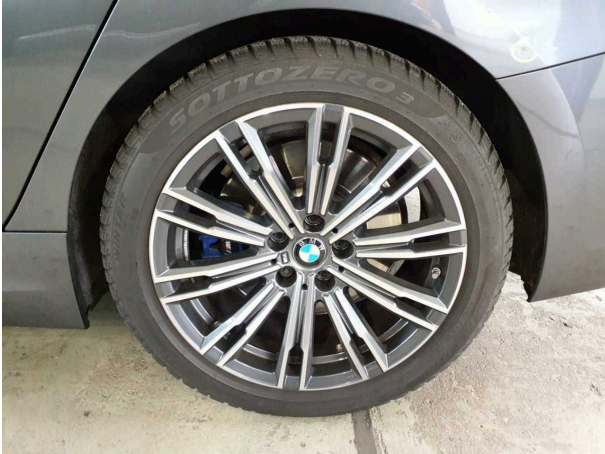
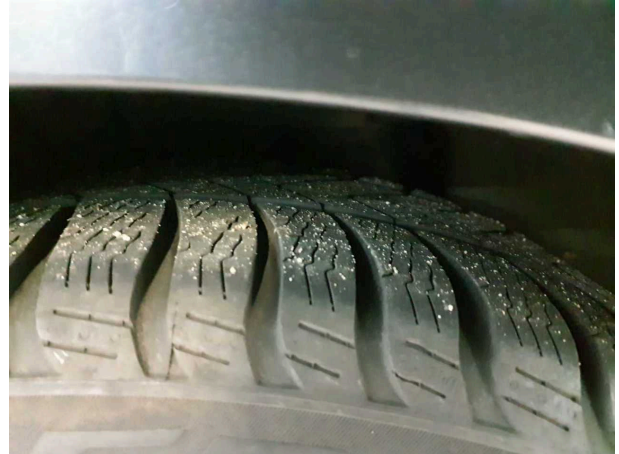
**Damage #1:** Wheel / tyres: Tyre - right - Worn - No deduction

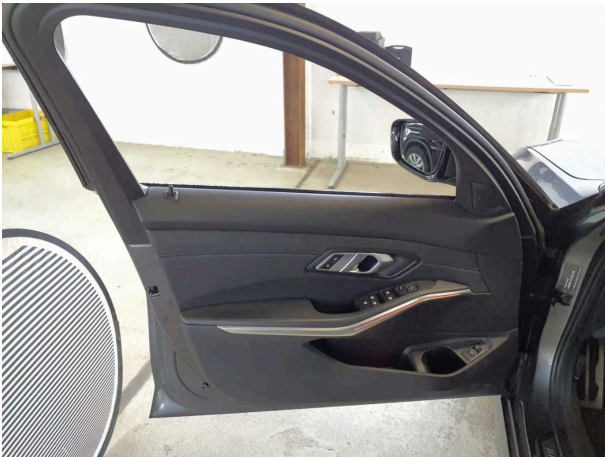
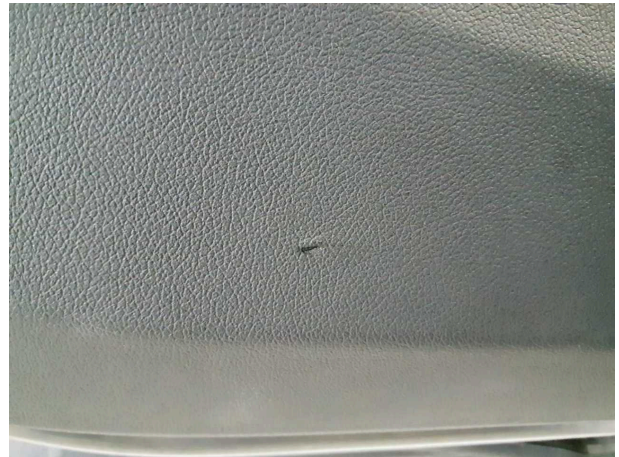
**Damage #2:** Trim / covers: Door trim - front left side - Damaged - Loss in value

**Damage #2:** Trim / covers: Door trim - front left side - Damag... - Loss in value

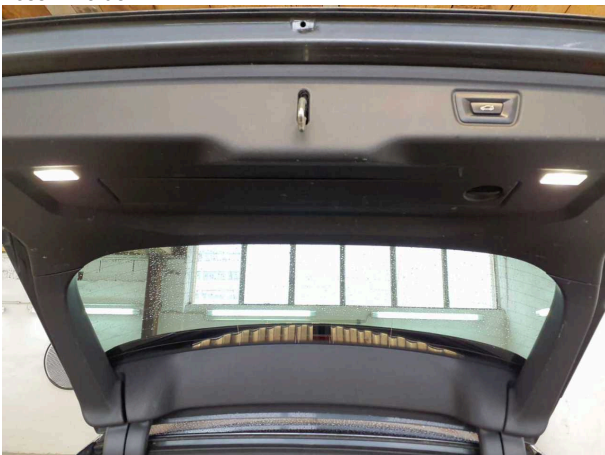
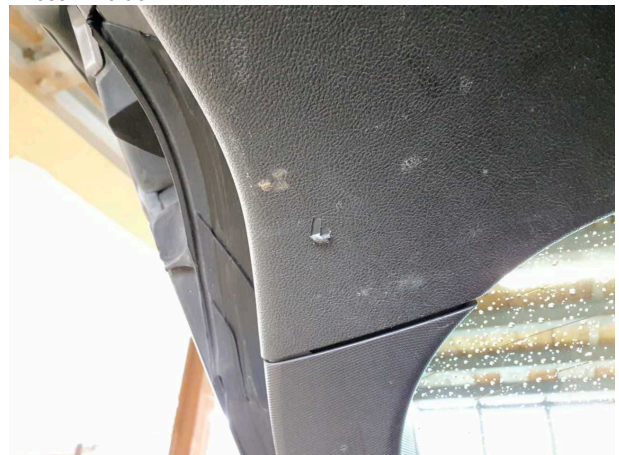
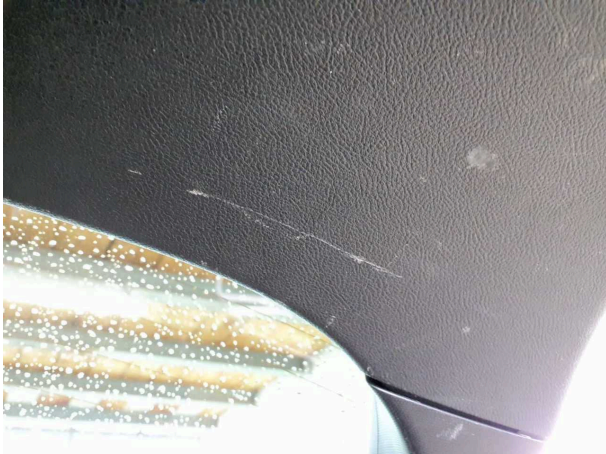
**Damage #3:** Trim / covers: Boot lid - interior trim - Scratched - Loss in value

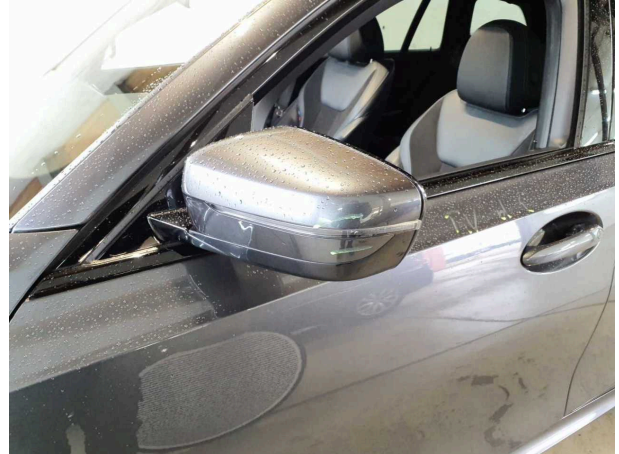
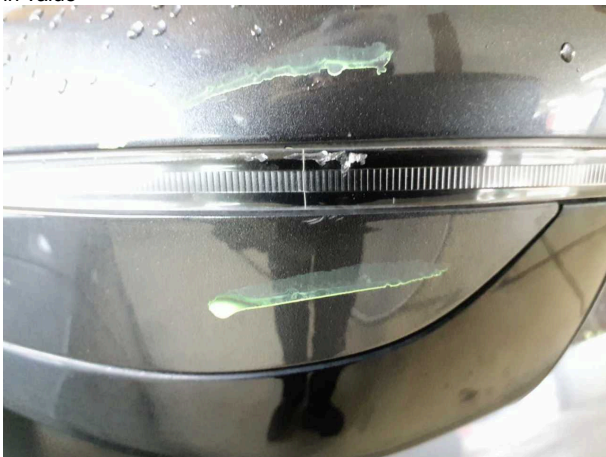
**Damage #5:** Wing mirror - left side: Cap - Scratched - Smart repair

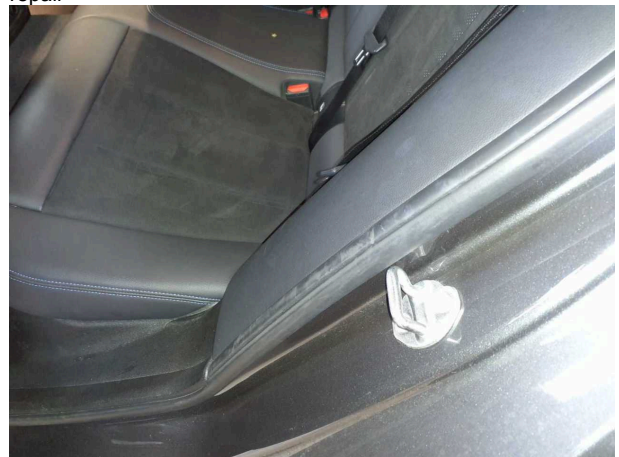
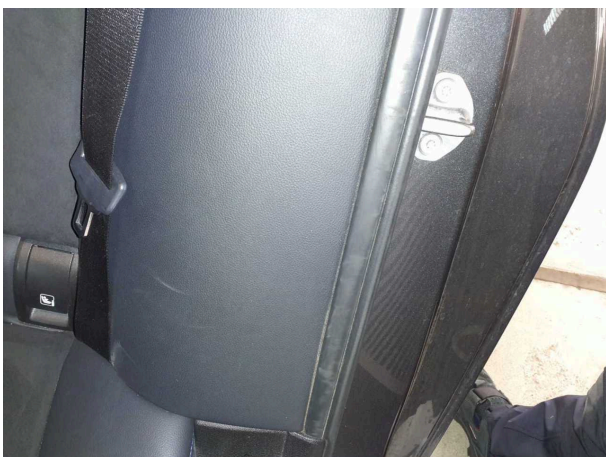
**Damage #6:** Door - rear left side: Door seal (Innen) - Abrasio... Replace

**Damage #6:** Door - rear left side: Door seal (Innen) - Abrasion - Replace

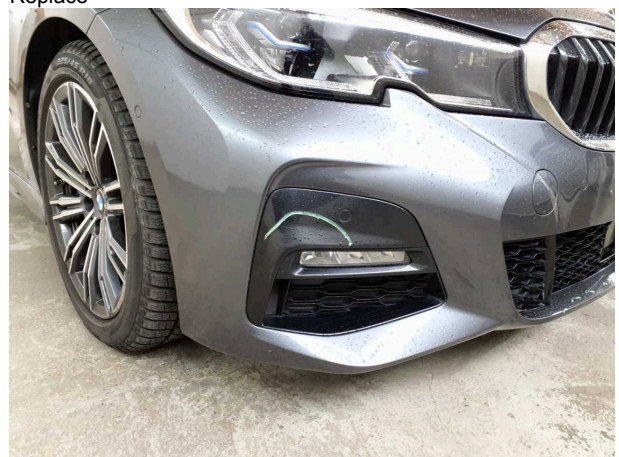
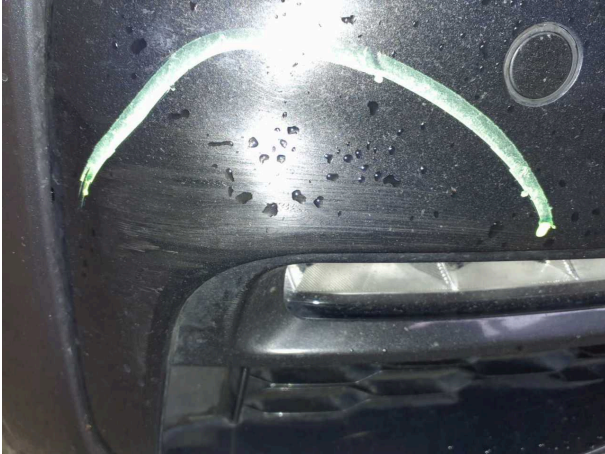
**Damage #7:** Front bumper: Cover bumper - front (VR) - Scratched - Replace

**Damage #7:** Front bumper: Cover bumper - front (VR) - Scratched...  
Replace

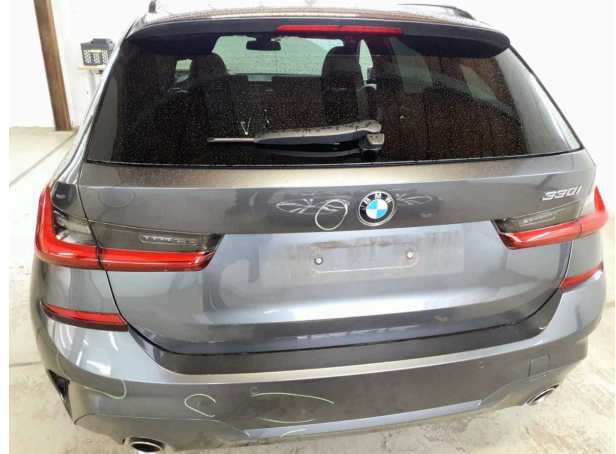
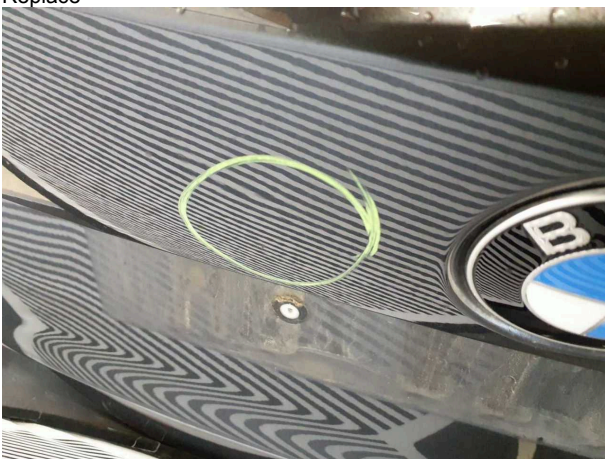
**Damage #8:** Boot lid / rear door: Boot lid - Dent(s) - Smooth  
repair work

**Damage #8:** Boot lid / rear door: Boot lid - Dent(s) - Smooth repair  
work

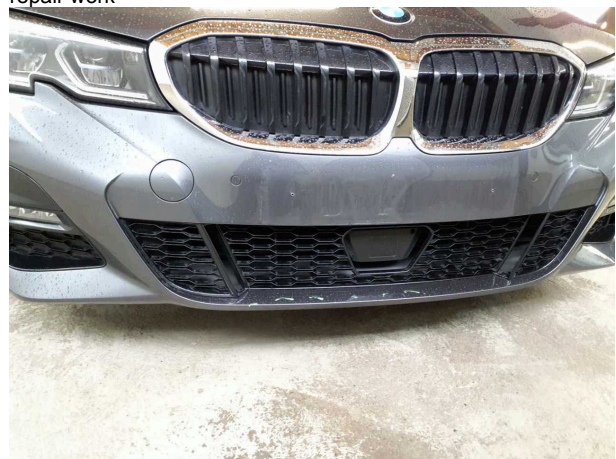
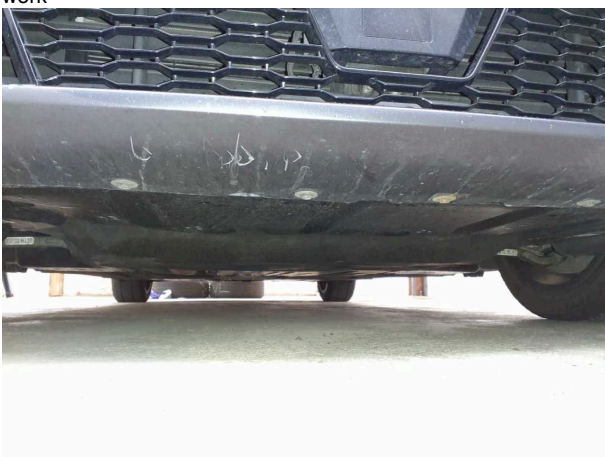
**Damage #9:** Front bumper: Front bumper - Scratched - Smart  
repair

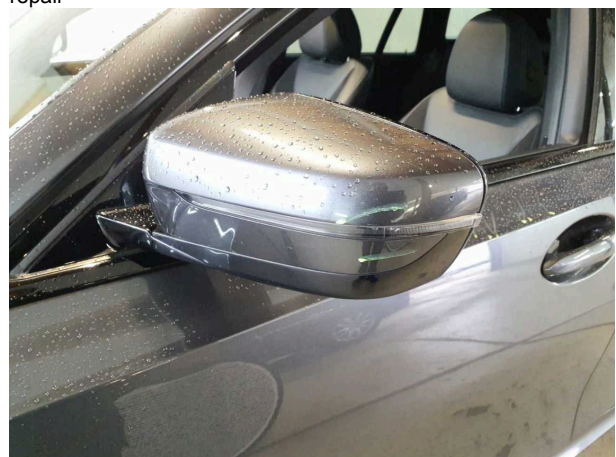
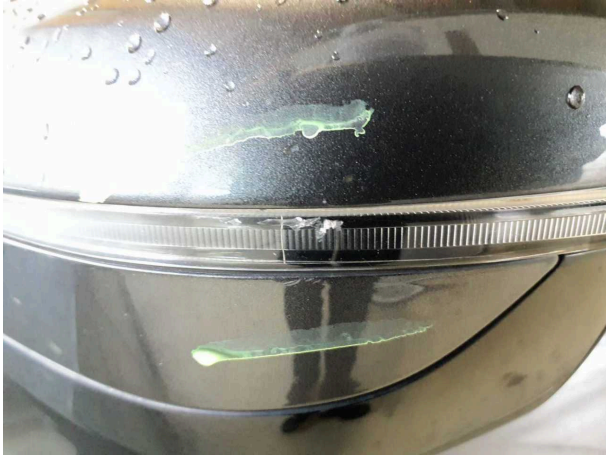
**Damage #10:** Indicator - front: Mirror - left side - Scratched -  
Replace

**Damage #10:** Indicator - front: Mirror - left side - Scratched - Replace

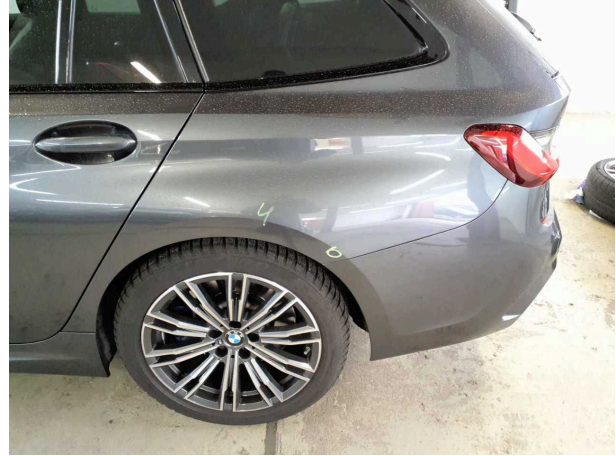
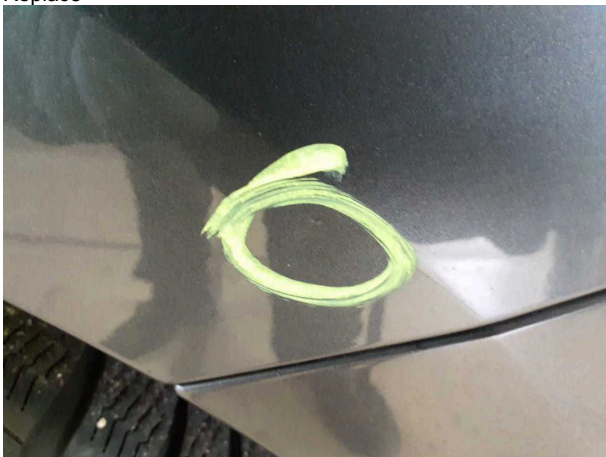
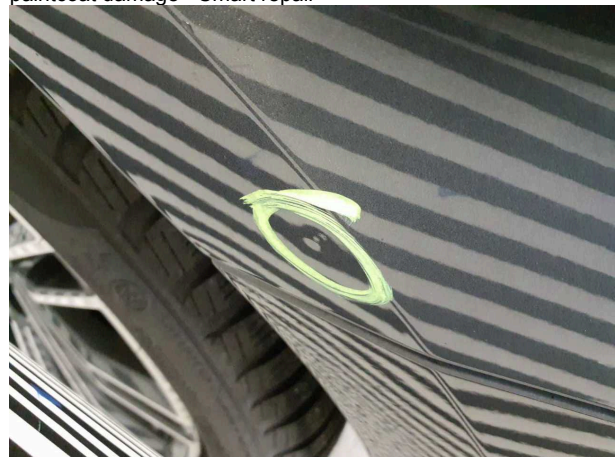
**Damage #11:** Side panel - rear left side: Side panel - Dent / paintcoat damage - Smart repair

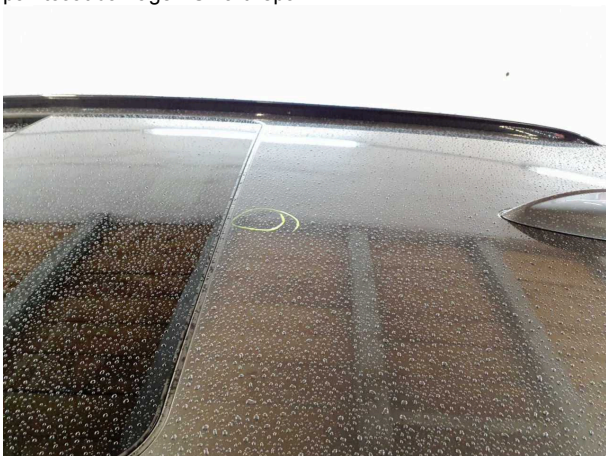
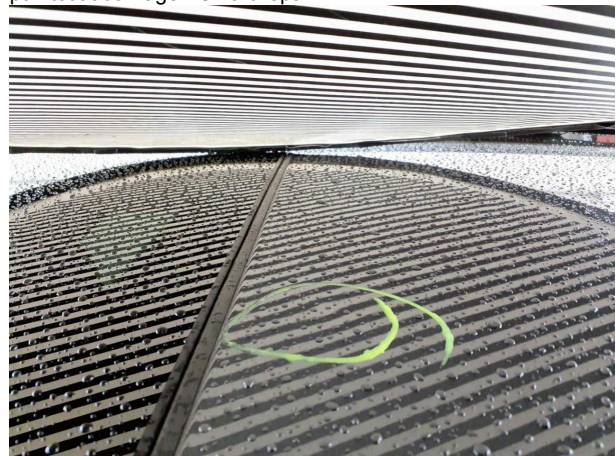
**Damage #12:** Roof: Roof - Dent(s) - Smooth repair work

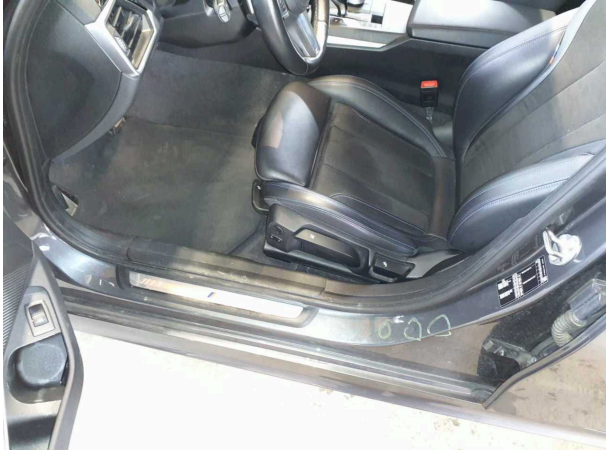
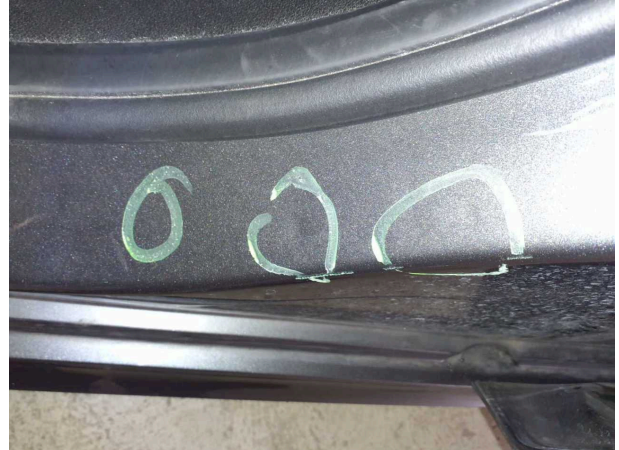
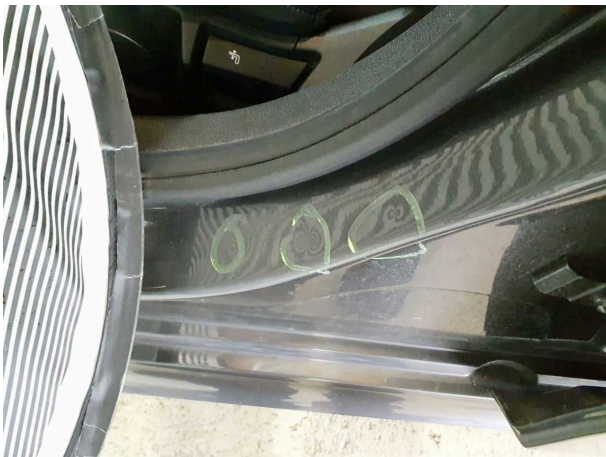
Damage #13: Sill - left side: Sill - Dent(s) - Smooth repair work

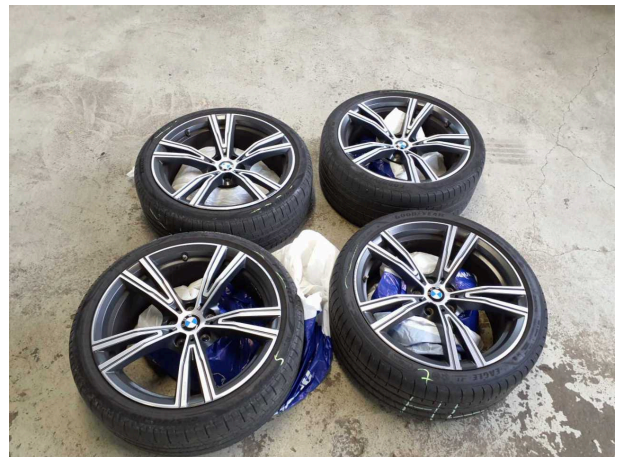
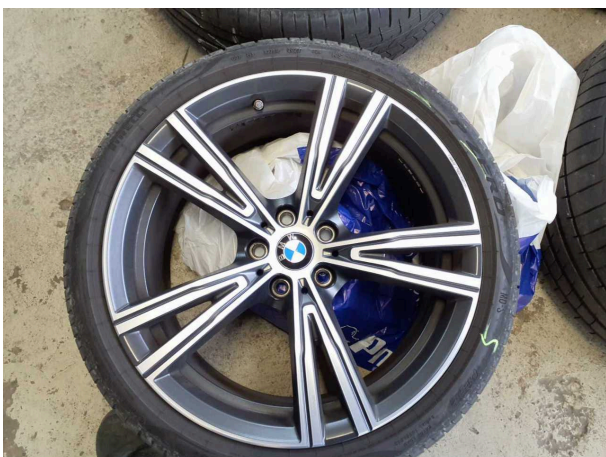
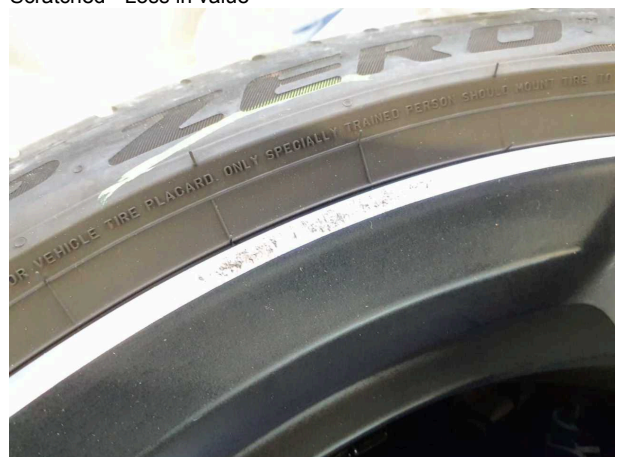
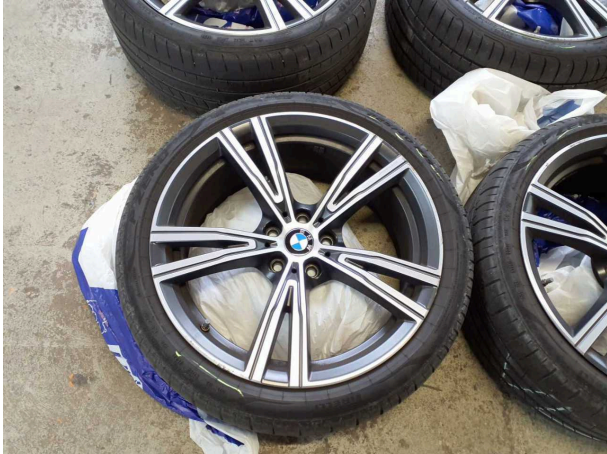
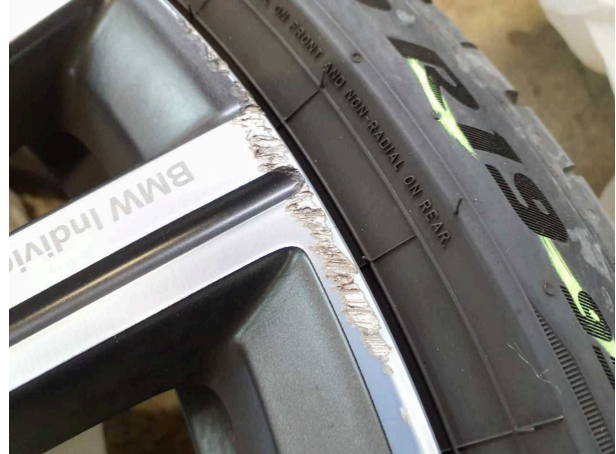
Damage #14: 2nd wheel set: Alloy rim set - complete - Scratched - Loss in value

**Damage #14:** 2nd wheel set: Alloy rim set - complete - Scratched - Loss in value

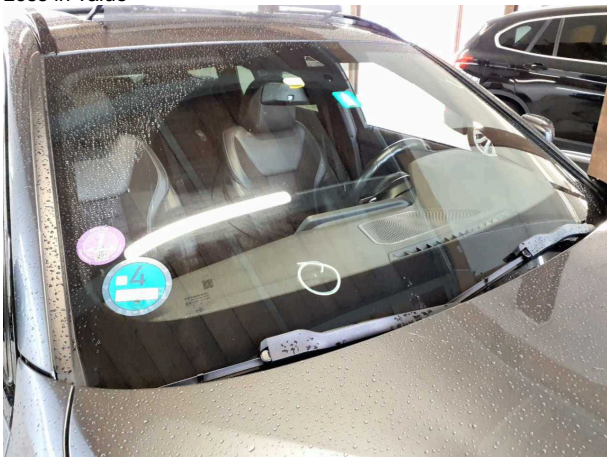
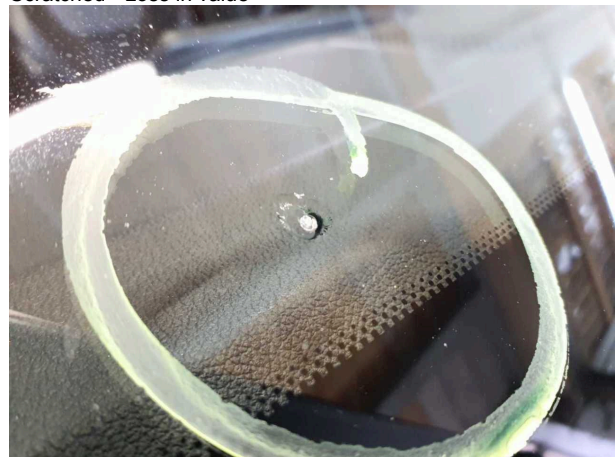
**Damage #15:** Vehicle glazing: Windscreen - Stone chips - Replace

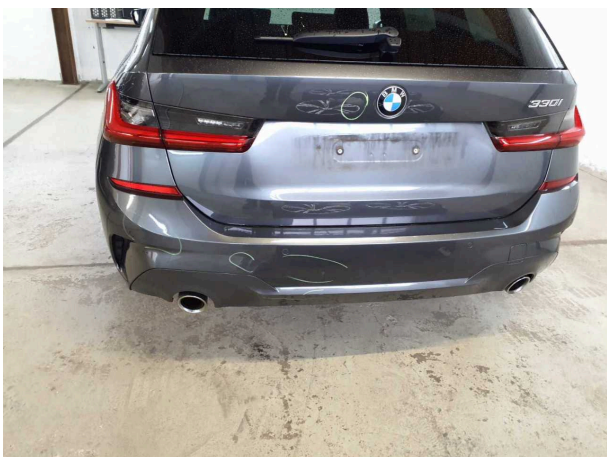
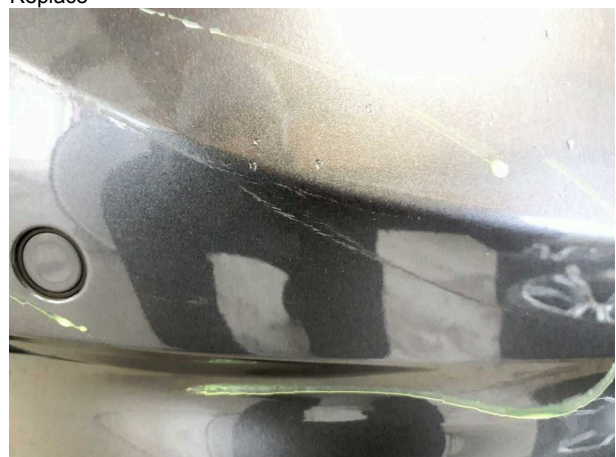
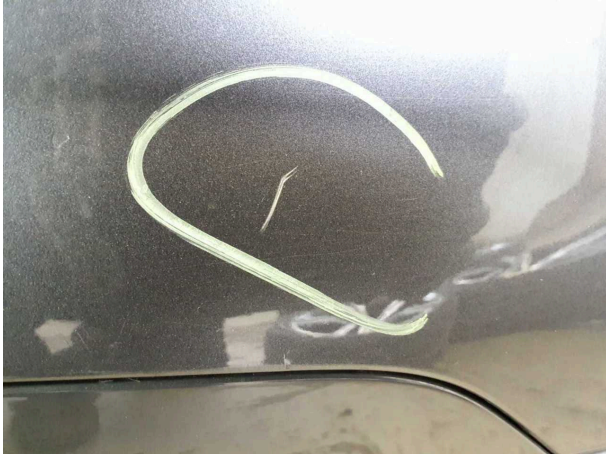
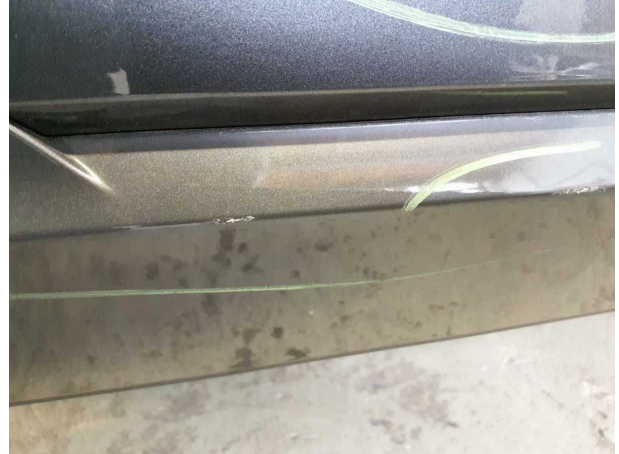
16	Rear bumper	Rear bumper - Scratched - Repair and paint
17	Door - rear right side	Door - Stone chips - Repair and paint

**Damage #16:** Rear bumper: Rear bumper - Scratched - Repair and paint

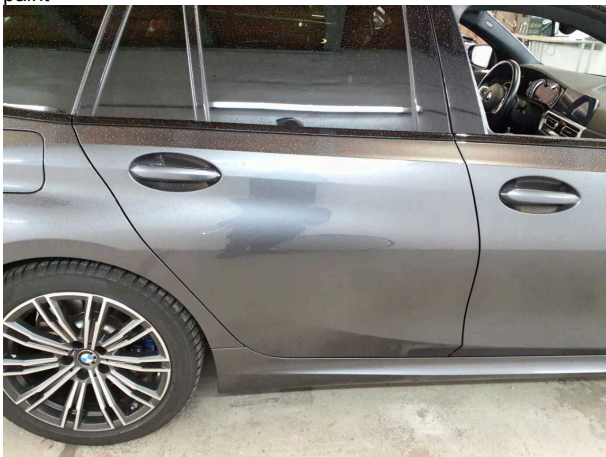
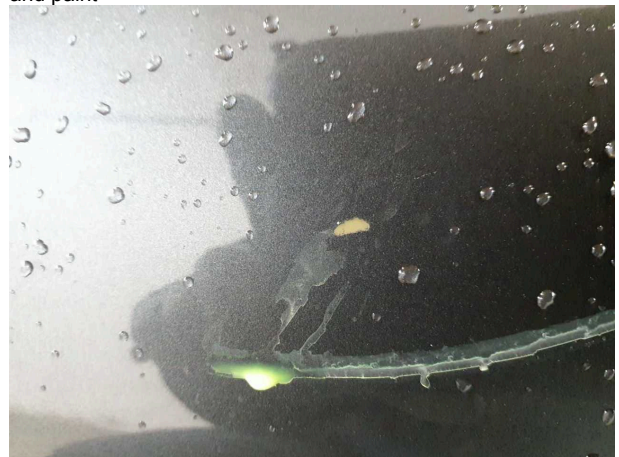
**Damage #17:** Door - rear right side: Door - Stone chips - Repair and paint
