**WBA6N31000FK91315**

## Zustandsbericht

Inspection date: 12 Mar 2025

**Protocol number: 38796763**

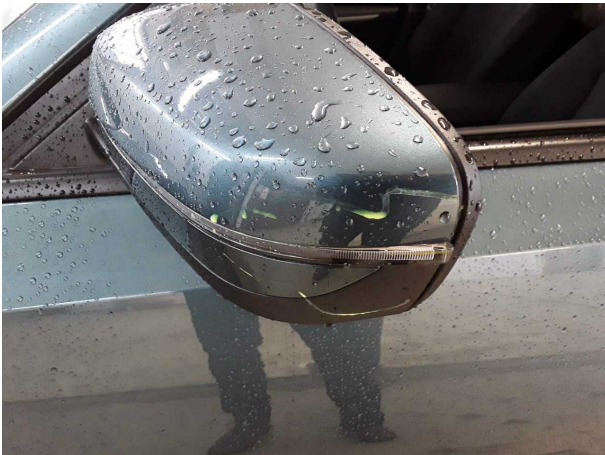
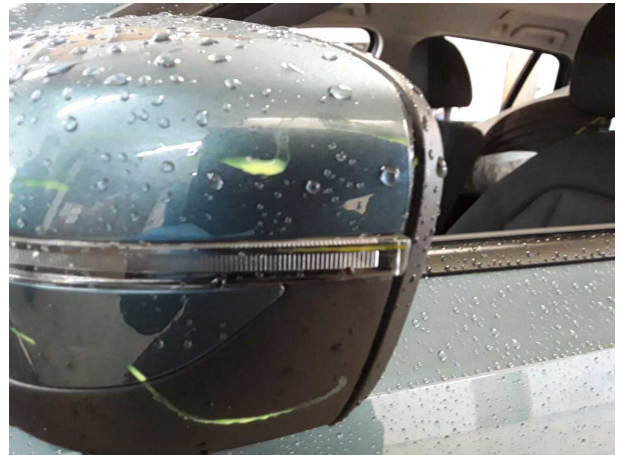
**Damage #2:** Indicator - front: Mirror - left side - Scratched - Replace

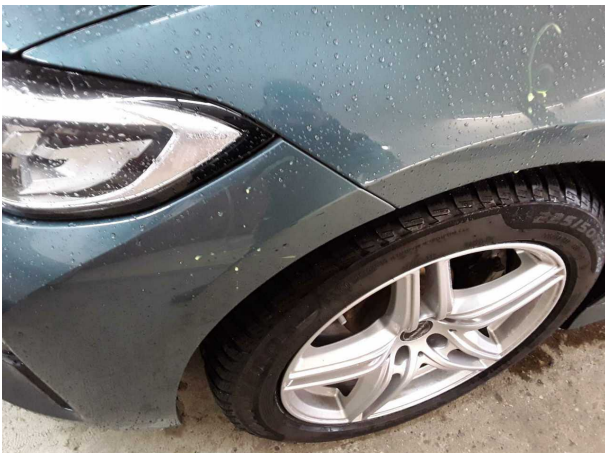
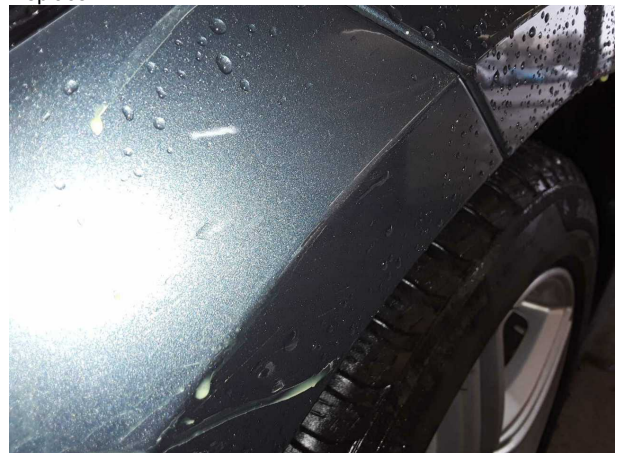
**Damage #3:** Front bumper: Front bumper - Scratched - Smart repair

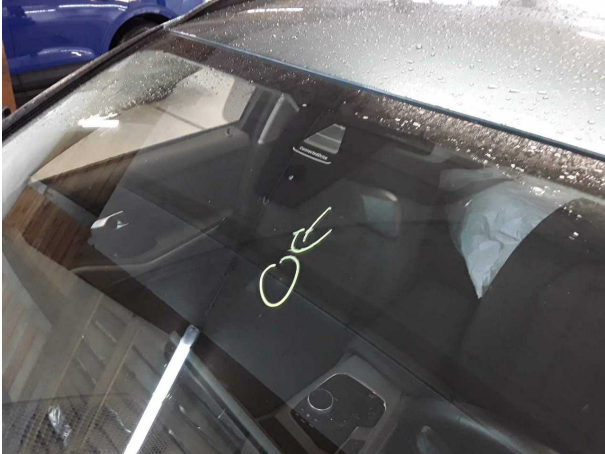
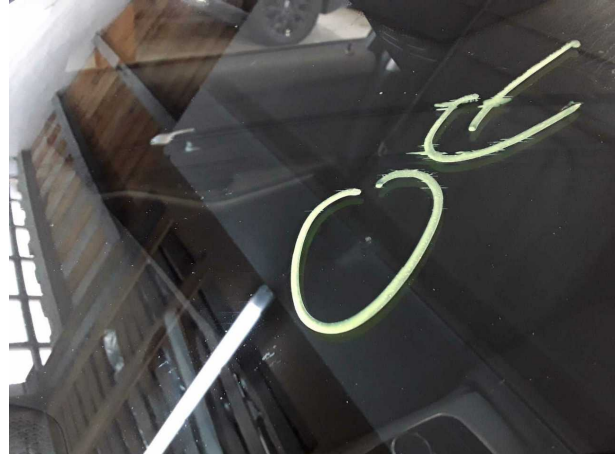
**Damage #4:** Vehicle glazing: Windscreen (Rissbildung) - Stone chips - Replace

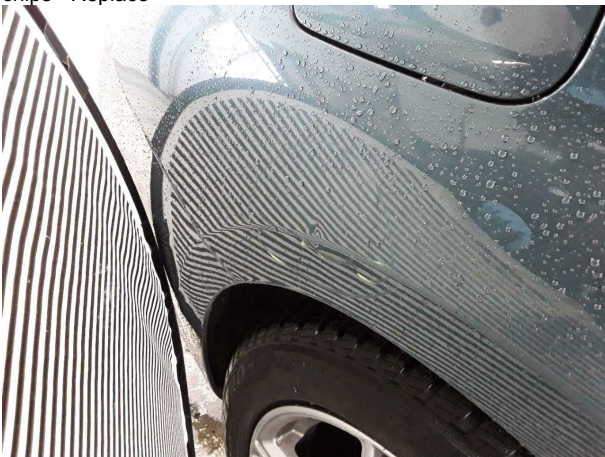
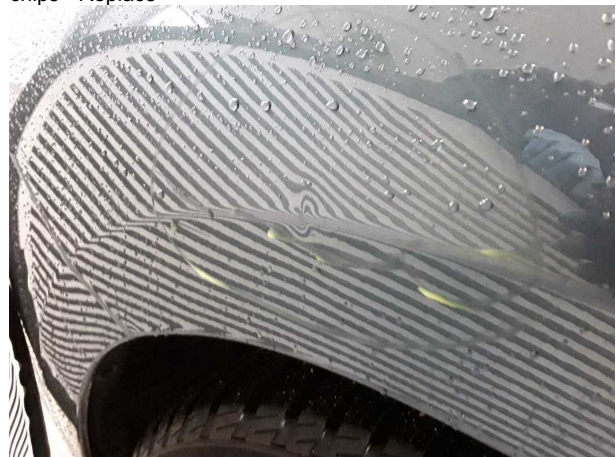
**Damage #5:** Side panel - rear right side: Side panel - dent(s) - Repair and paint

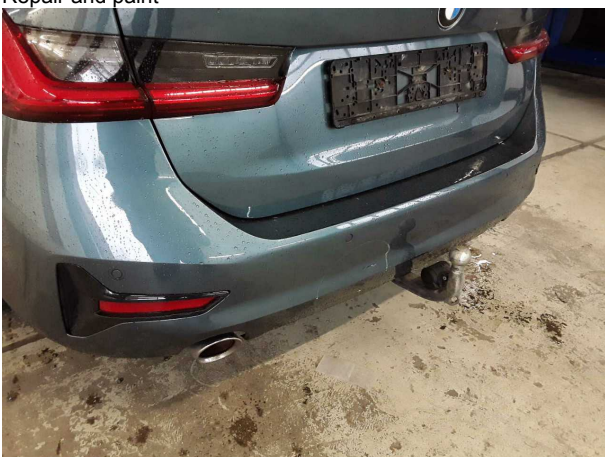
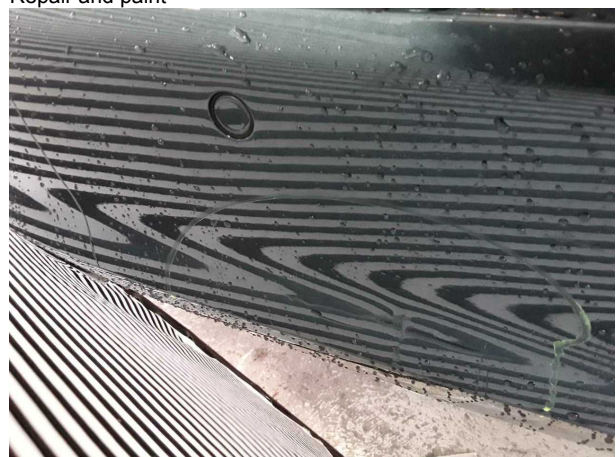
**Damage #6:** Rear bumper: Rear bumper - Deformed - Replace
