**WBA5R11090FK69169**

## Zustandsbericht

Inspection date: 27 Feb 2025  
**Protocol number: 38630065**  
Delivery date: 28 Feb 2025

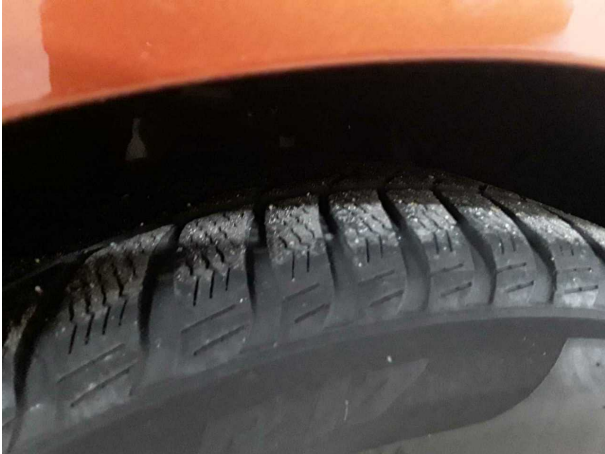
Axle	Tyre size	Manufacturer	Type of tyre	Tread depth	Roadworthy	Permissibility
1	225/50 R17 98H	Pirelli	Winter tyres	5mm - 5mm	o.k.	
2	225/50 R17 98H	Pirelli	Winter tyres	3mm - 3mm	Not o.k.

**Damage #1:** Wheel / tyres: Tyre - right - Worn - No deduction

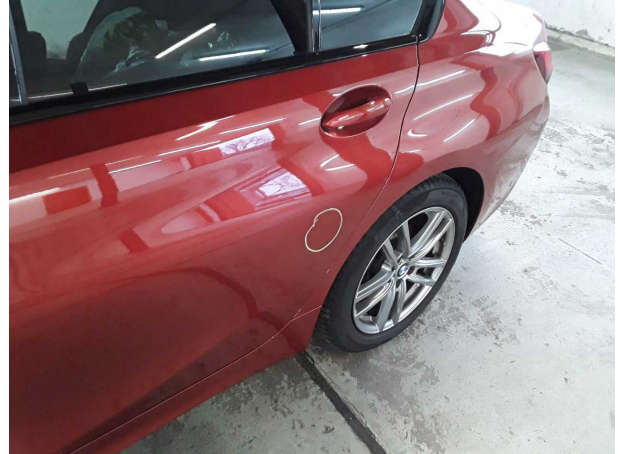
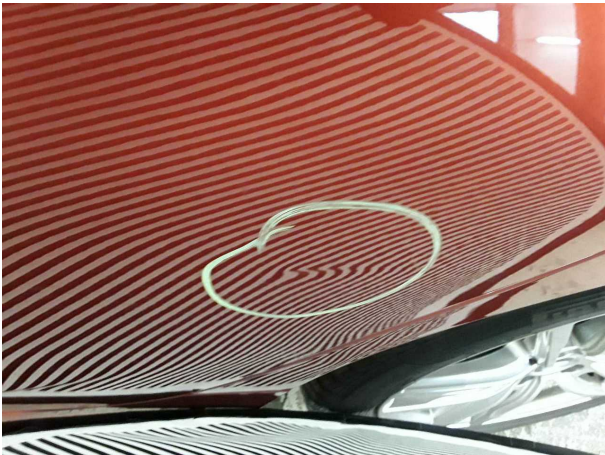
**Damage #2:** Door - rear left side: Door - dent(s) - Smooth repair work

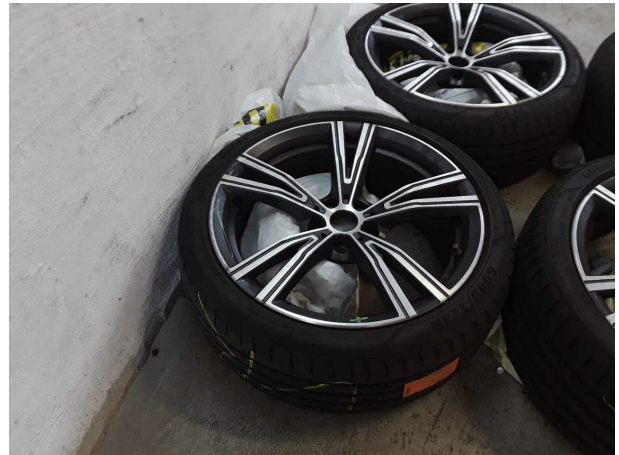
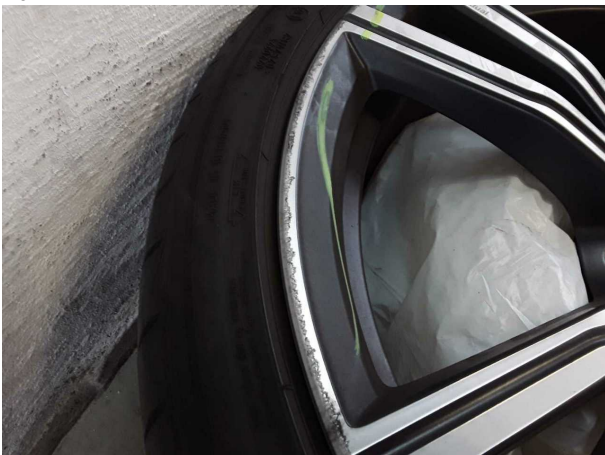
**Damage #3:** 2nd wheel set: 1 alloy rim - Scratched - Loss in value

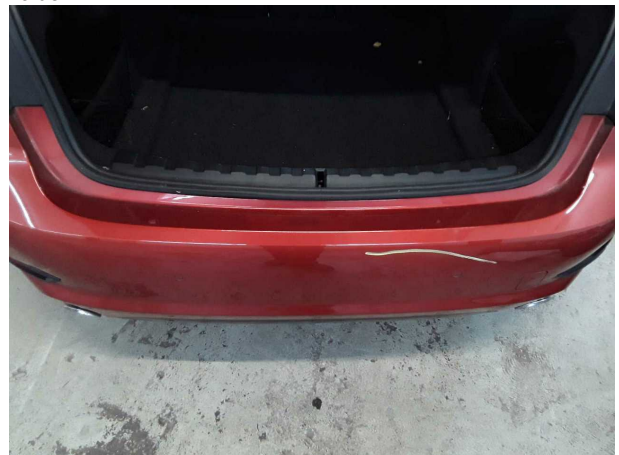
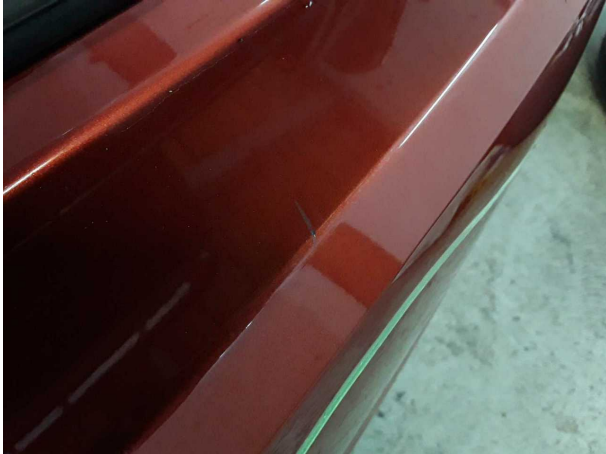
**Damage #4:** Rear bumper: Rear bumper - Scratched - Smart repair

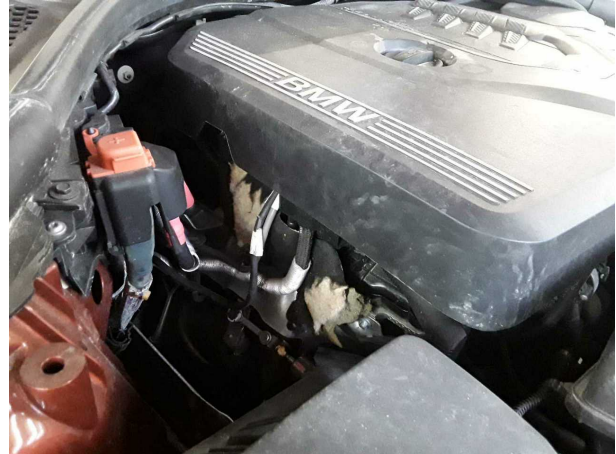
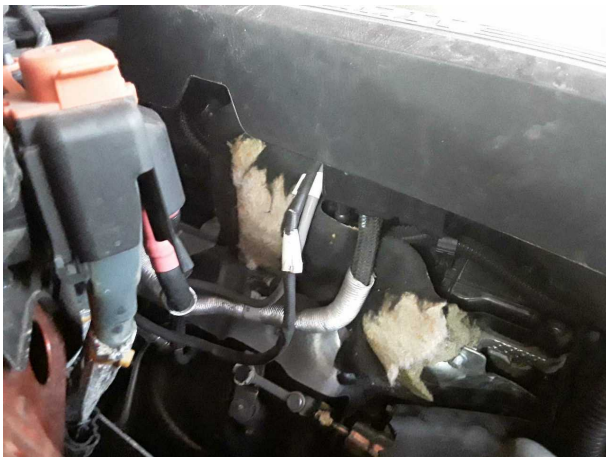
**Damage #5:** Engine: Engine cover - top / cover - Damage caused by marten / rodent - Replace

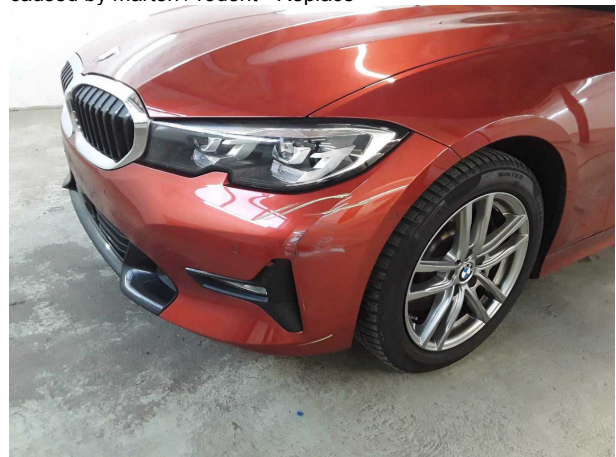
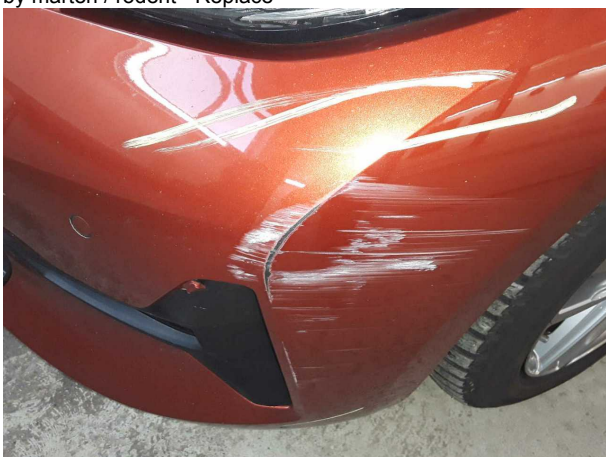
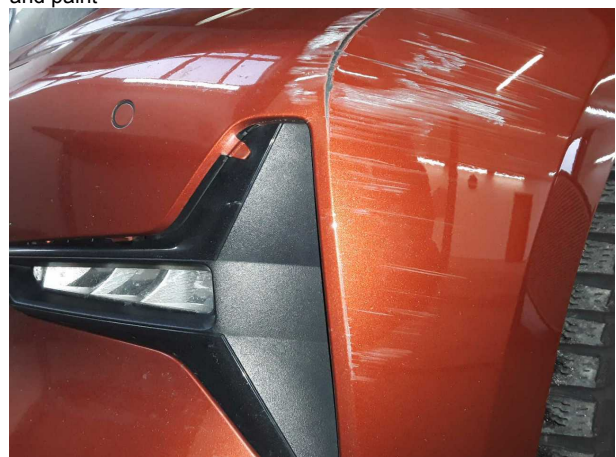
**Damage #6:** Front bumper: Front bumper - Scratched - Repair and paint

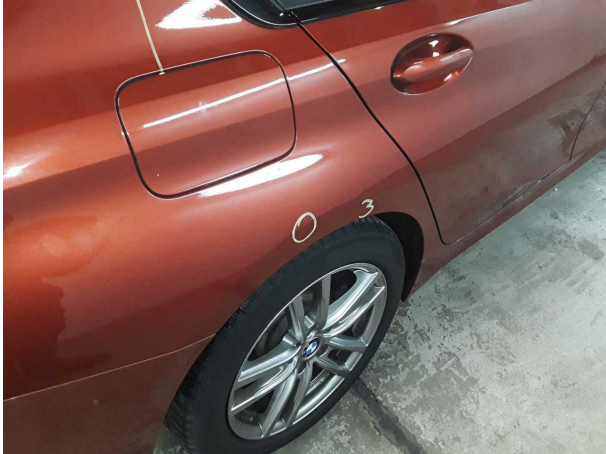
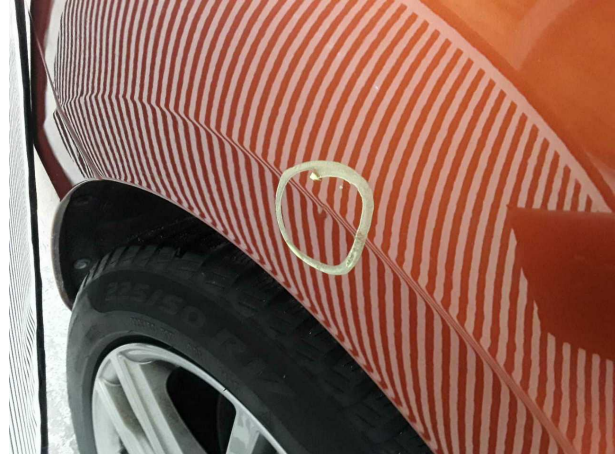
**Damage #7:** Side panel - rear right side: Side panel - Dent / paintcoat damage - Repair and paint

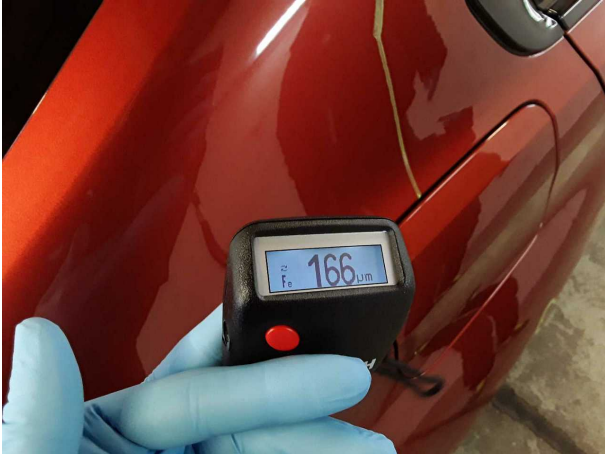
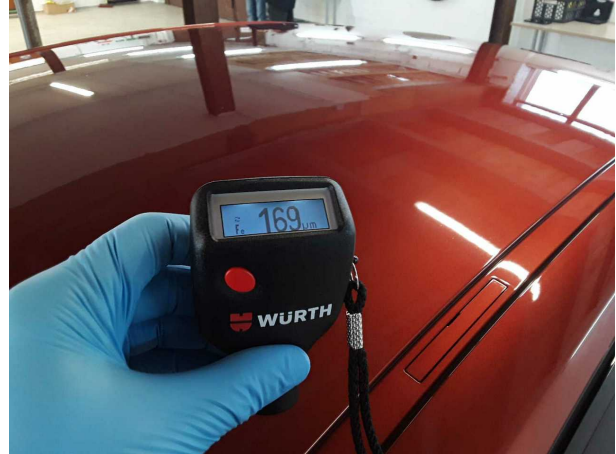
No.	Location
1	Roof, Side panel - rear right side, Door - rear right side, Professionally carried out

**Repainting 1:** Roof, Side panel - rear right side, Door - rear right side
