WBY41AW040FR75740

Zustandsbericht

Inspection date: 13 Mar 2025

Protocol number: 38837588

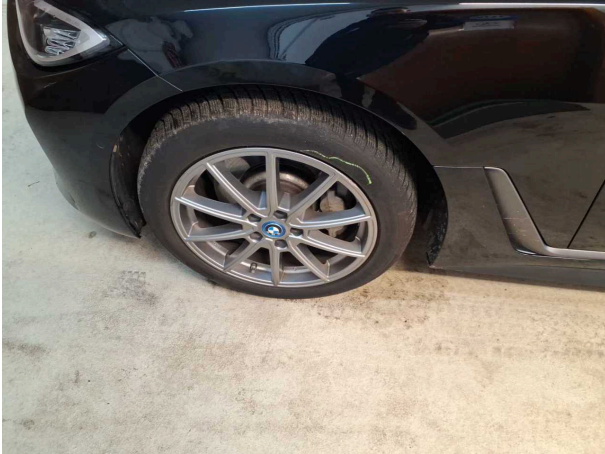
Damage #1: Wheel / tyres: Alloy rim - front left side - Scratched - No deduction

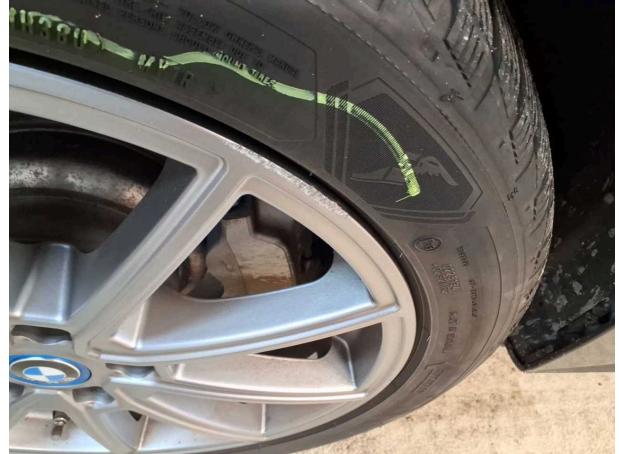
Damage #1: Wheel / tyres: Alloy rim - front left side - Scratched - No deduction

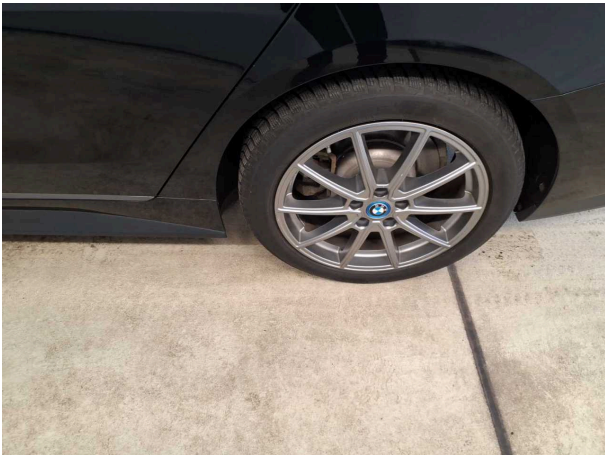
Damage #2: Wheel / tyres: Alloy rim - rear left side - Scratched - No deduction

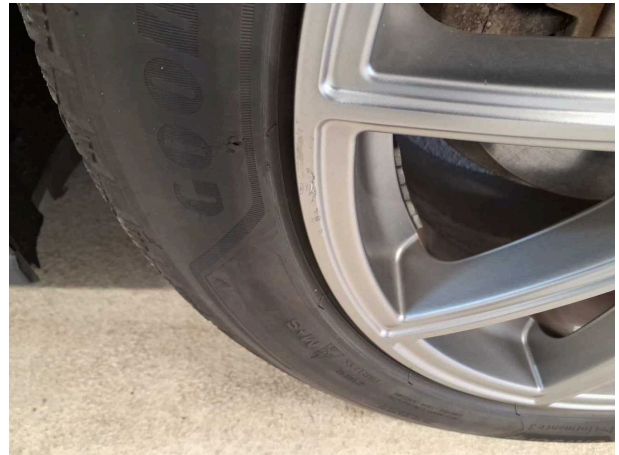
Damage #2: Wheel / tyres: Alloy rim - rear left side - Scratched - No deduction

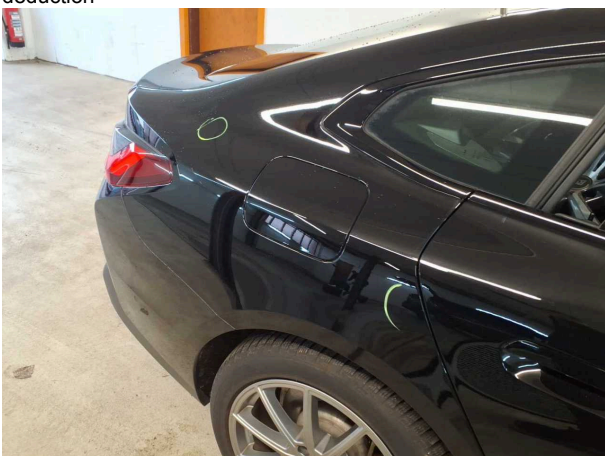
Damage #3: Side panel - rear right side: Side panel - Dent / paintcoat damage - Smart repair

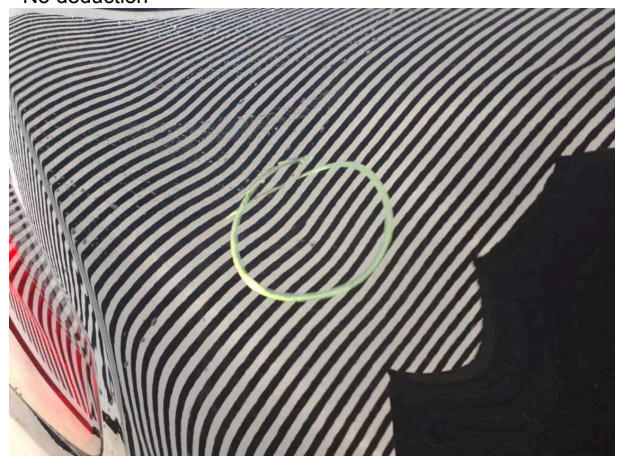
Damage #3: Side panel - rear right side: Side panel - Dent / paintcoat damage - Smart repair

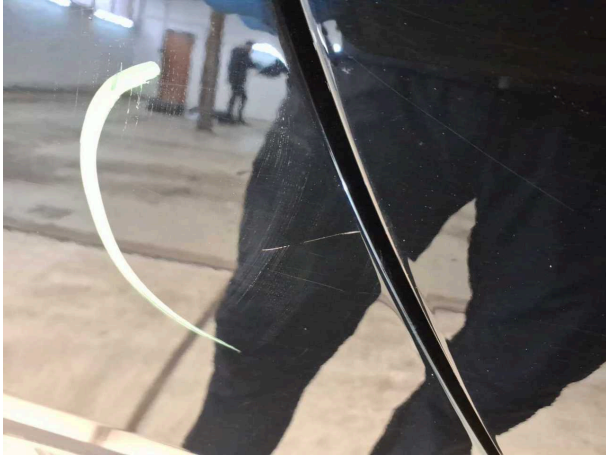
Damage #3: Side panel - rear right side: Side panel - Dent / paintcoat damage - Smart repair

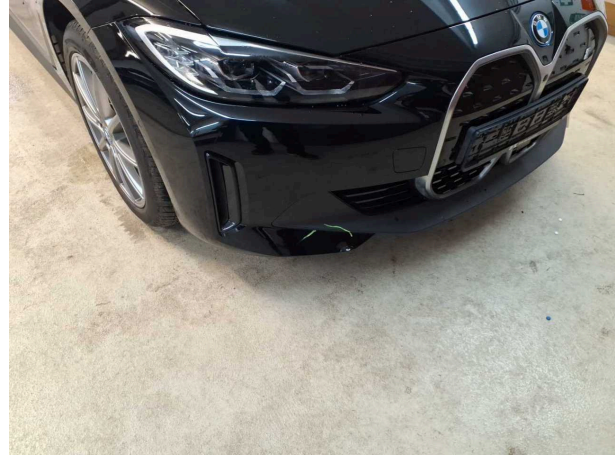
Damage #4: Front bumper: Front bumper - Deformed - Replace

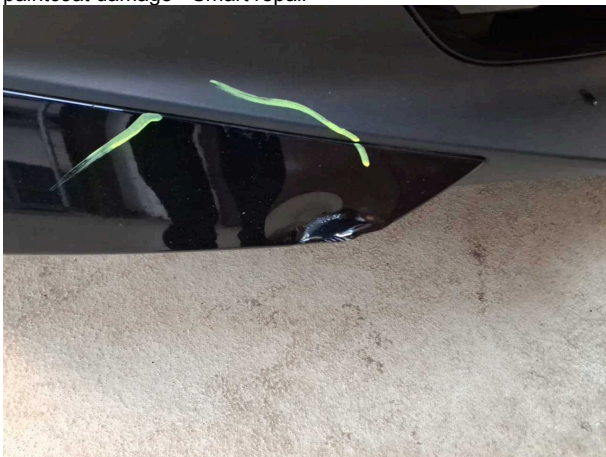
Damage #4: Front bumper: Front bumper - Deformed - Replace
