**WBA5X71090FJ95146**

## Zustandsbericht

Inspection date: 11 Mar 2025  
**Protocol number: 38791818**  
Delivery date: 11 Mar 2025

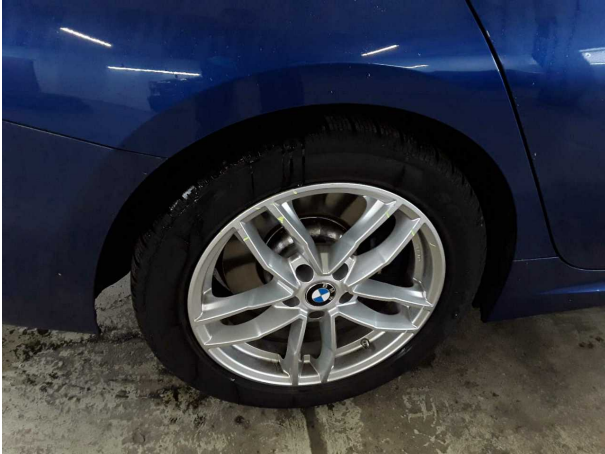
**Damage #1:** Wheel / tyres: Alloy rim - rear right side - Scratched - No deduction

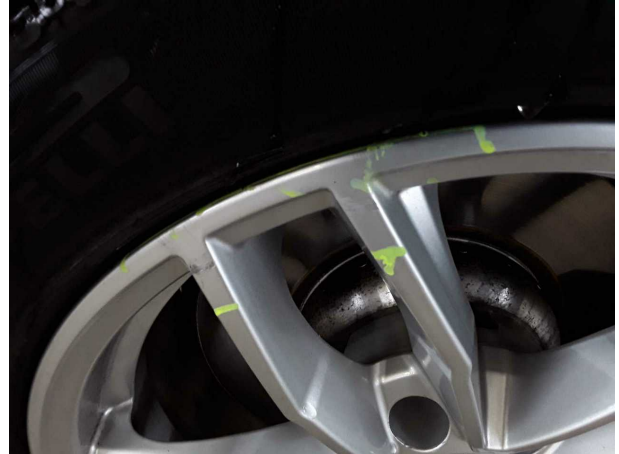
**Damage #1:** Wheel / tyres: Alloy rim - rear right side - Scratched - No deduction

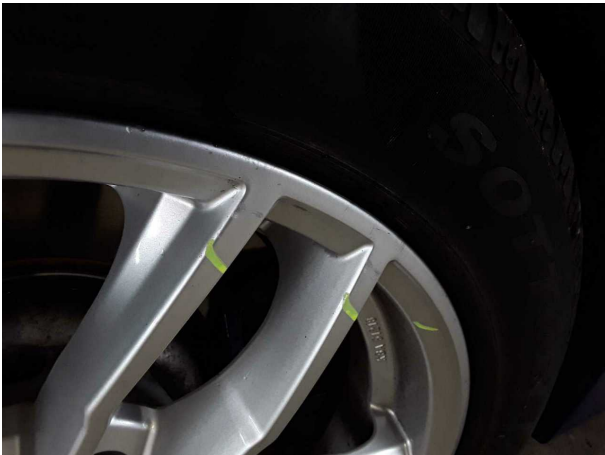
**Damage #1:** Wheel / tyres: Alloy rim - rear right side - Scratched - No deduction

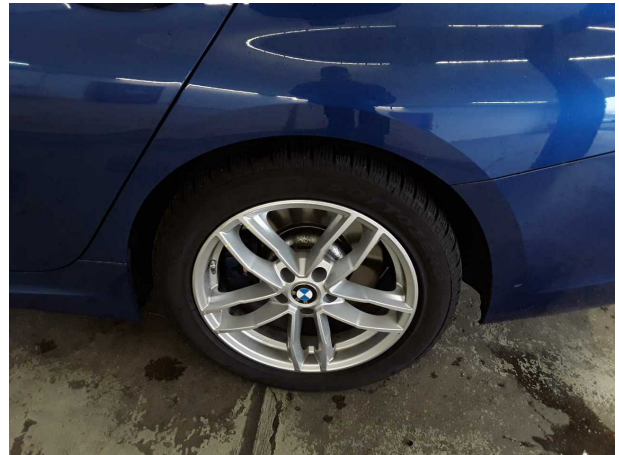
**Damage #2:** Wheel / tyres: Alloy rim - rear left side - Scratched - No deduction

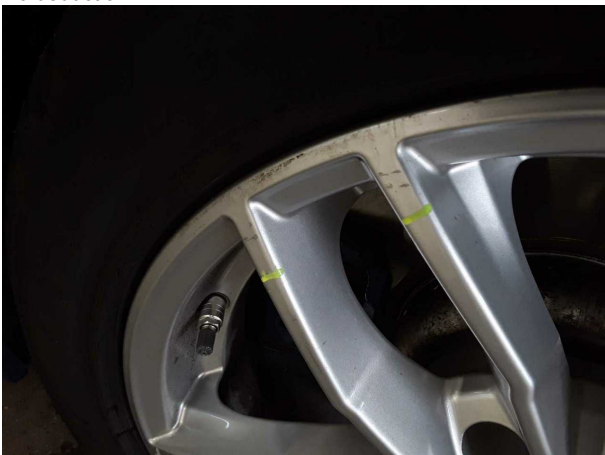
**Damage #2:** Wheel / tyres: Alloy rim - rear left side - Scratched - ... deduction

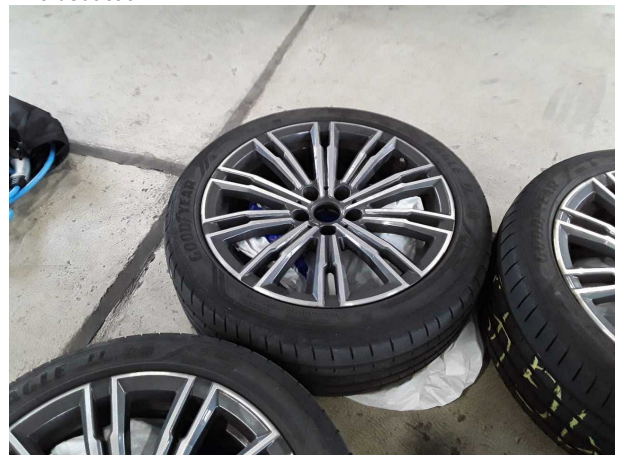
**Damage #4:** 2nd wheel set: 1 alloy rim - Scratched - Loss in value

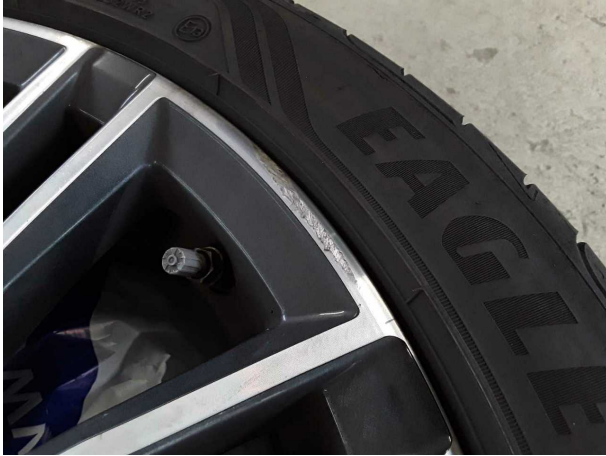
**Damage #4:** 2nd wheel set: 1 alloy rim - Scratched - Loss in value
