WAUZZZFZ8NP034397

| Type / Model | Q4 40 e-tron | Main inspection (Read from ZBI) | 04/2025 |

Zustandsbericht

Inspection date: 18 Feb 2025
Protocol number: 38457152
Delivery date: 18 Feb 2025

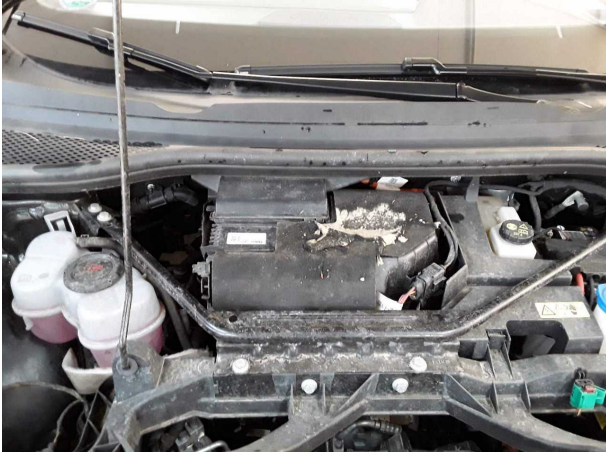
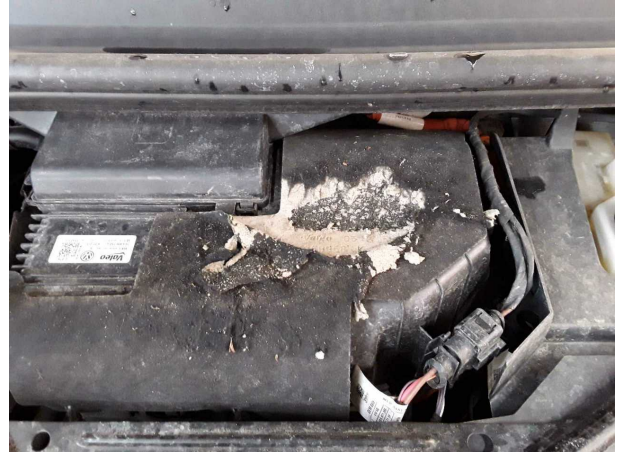
| No. | Component group | Description |
|---|---|---|
| 1 | Engine | Engine cover - top / cover - Damage caused by marten / rodent - Replace |

Damage #1: Engine: Engine cover - top / cover - Damage caused by marten / rodent - Replace

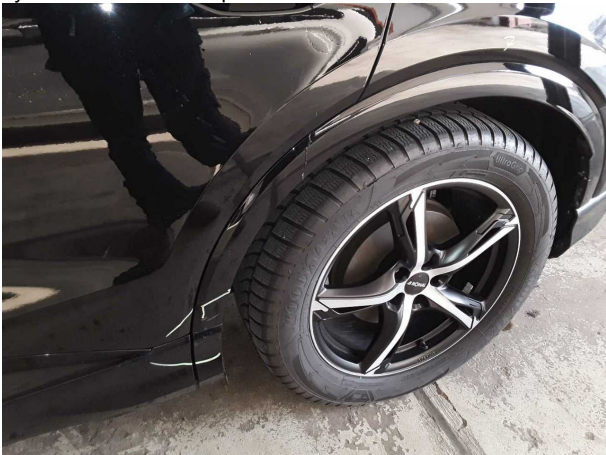
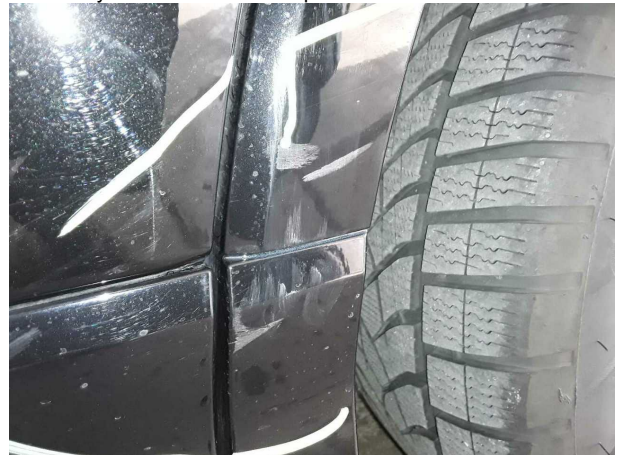
| No. | Component group | Description |
|---|---|---|
| 2 | Side panel - rear left side | Wheel well extension - Scratched - Smart repair |

Damage #2: Side panel - rear left side: Wheel well extension - Scratched - Smart repair

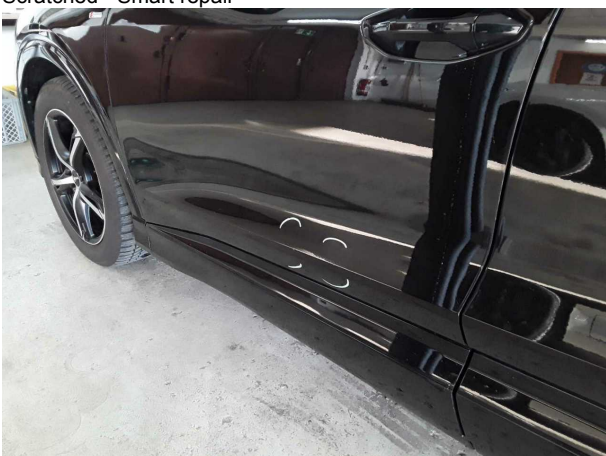
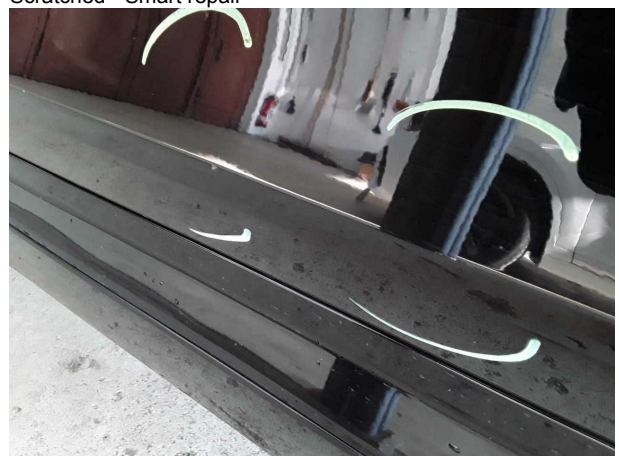
| No. | Component group | Description |
|---|---|---|
| 3 | Door - front left side | Door - Scratched - Smart repair |

Damage #3: Door - front left side: Door - Scratched - Smart repair

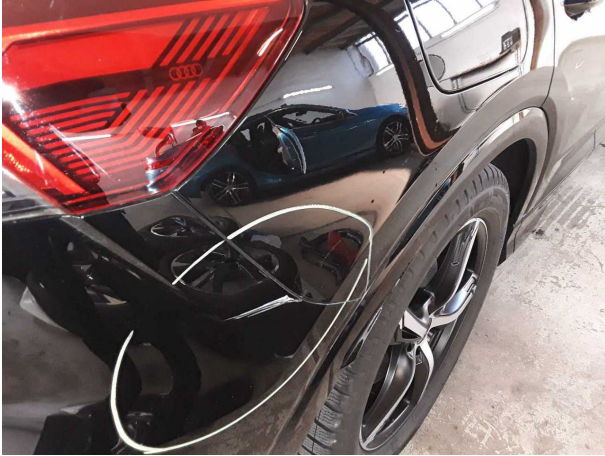
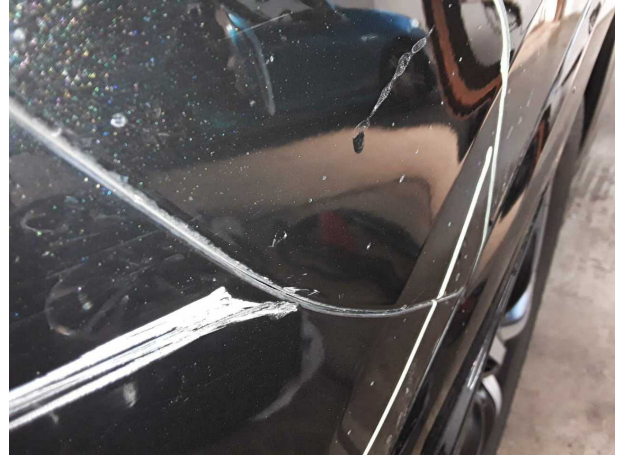
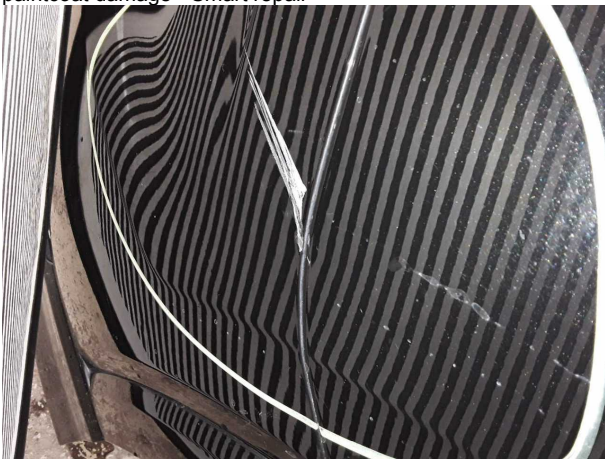
| No. | Component group | Description |
|---|---|---|
| 4 | Side panel - rear right side | Side panel - Dent / paintcoat damage - Smart repair |

Damage #4: Side panel - rear right side: Side panel - Dent / paintcoat damage - Smart repair

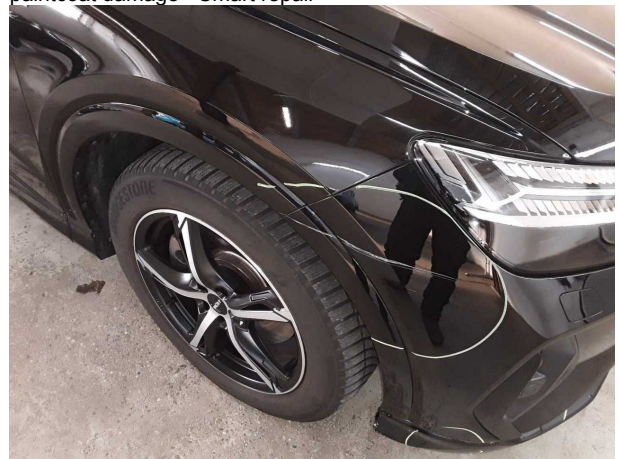
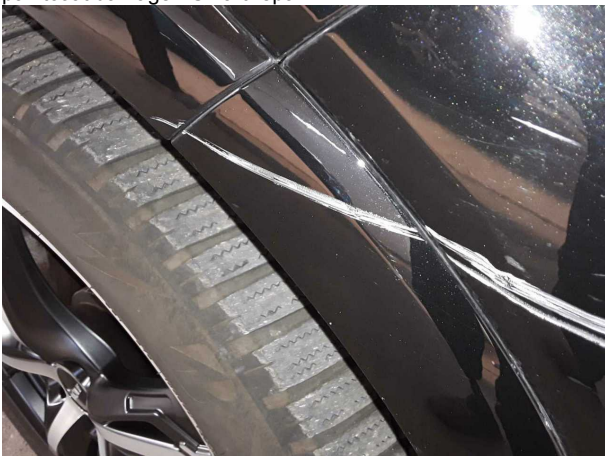
| No. | Component group | Description |
|---|---|---|
| 5 | Mudguard - right side | Wheel well extension - Scratched - Paint |

Damage #5: Mudguard - right side: Wheel well extension - Scratched - Paint

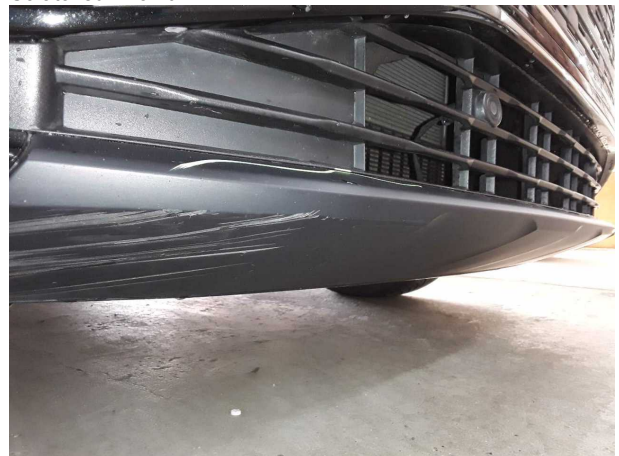
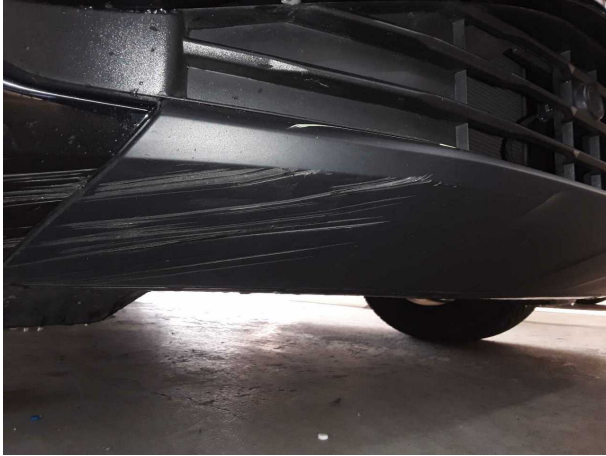
| No. | Component group | Description |
|---|---|---|
| 6 | Front bumper | Spoiler - Scratched - Replace |

Damage #6: Front bumper: Spoiler - Scratched - Replace

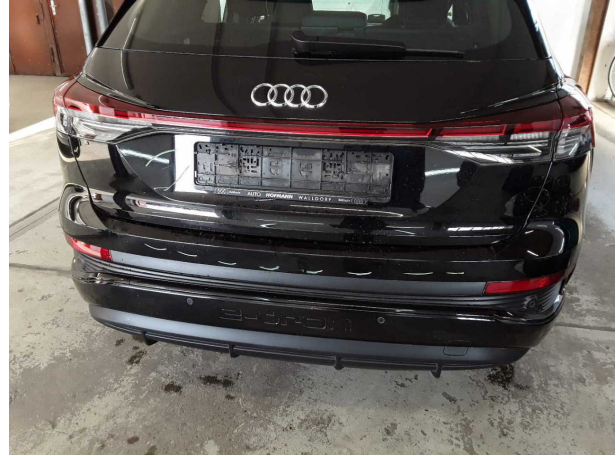
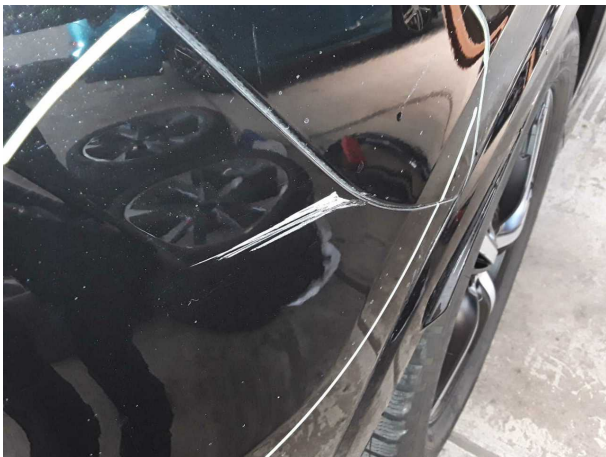
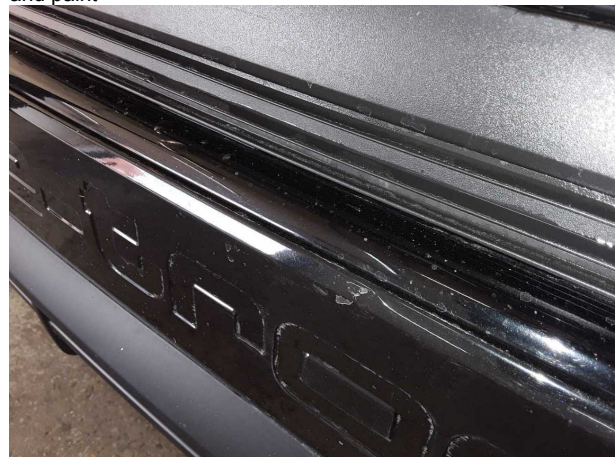
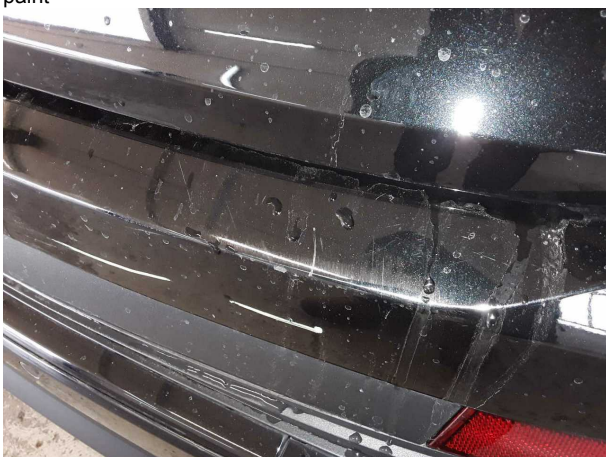
| No. | Component group | Description |
|---|---|---|
| 7 | Rear bumper | Rear bumper - Scratched - Repair and paint |

Damage #7: Rear bumper: Rear bumper - Scratched - Repair and paint

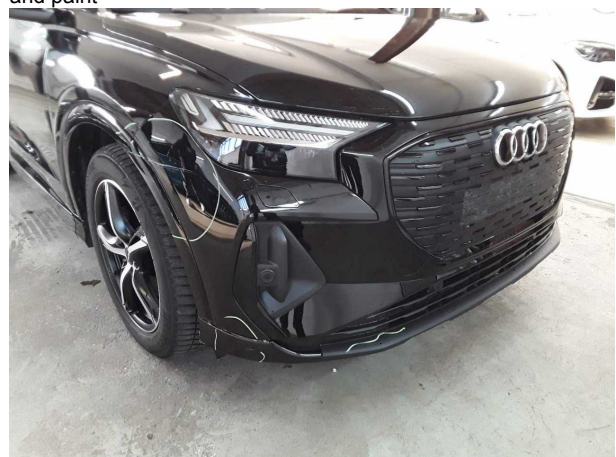
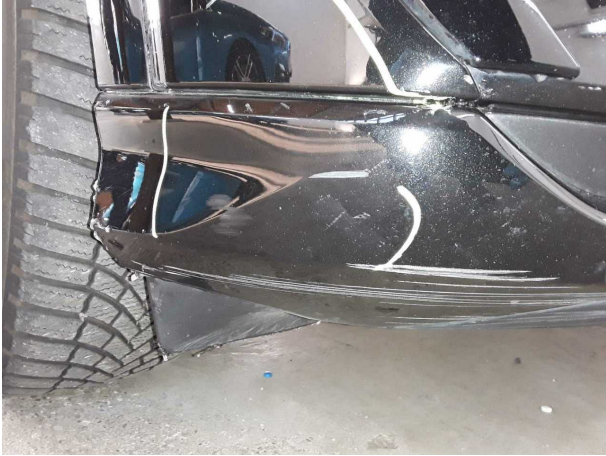
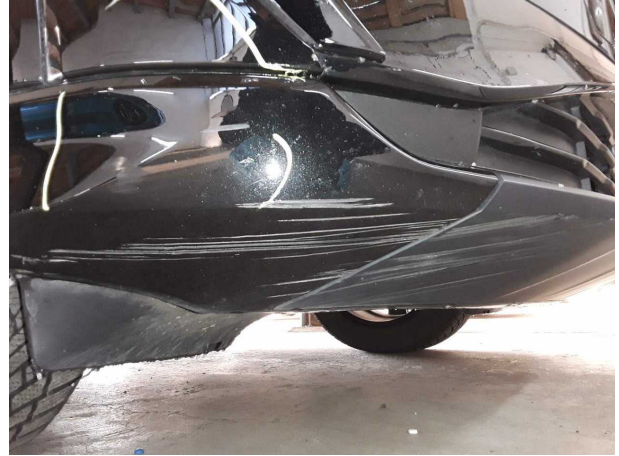
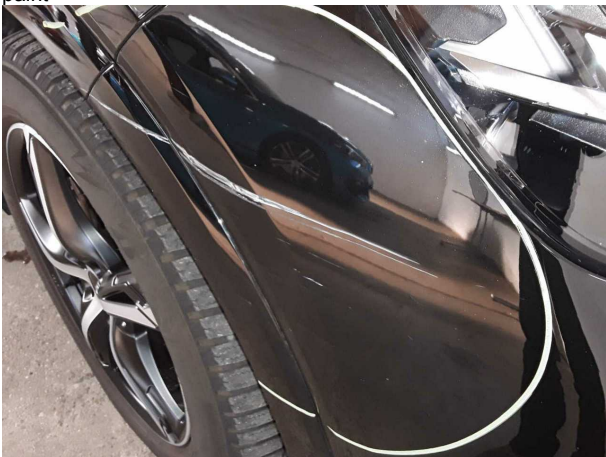
| No. | Component group | Description |
|---|---|---|
| 8 | Front bumper | Front bumper - Scratched - Repair and paint |

Damage #8: Front bumper: Front bumper - Scratched - Repair and paint

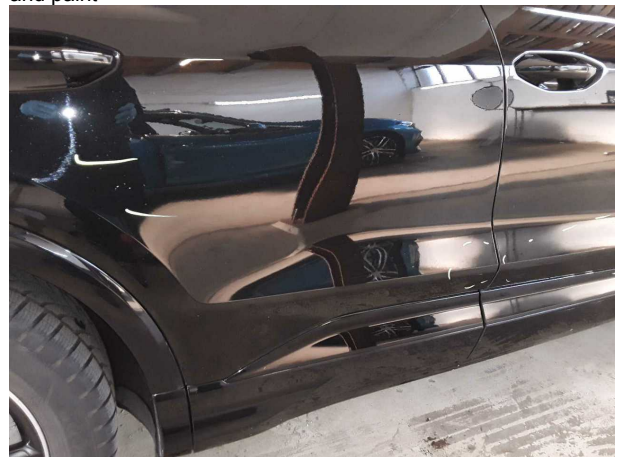
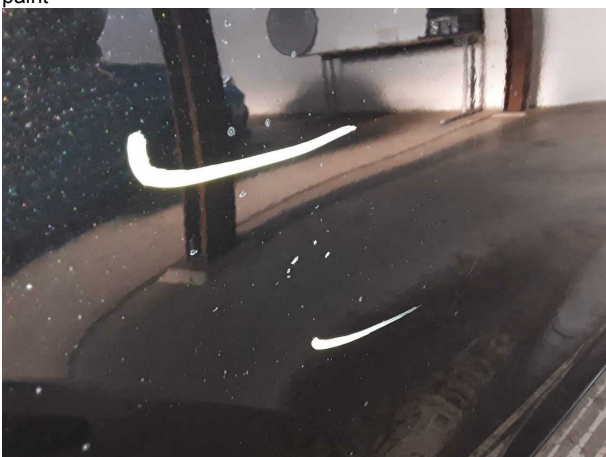
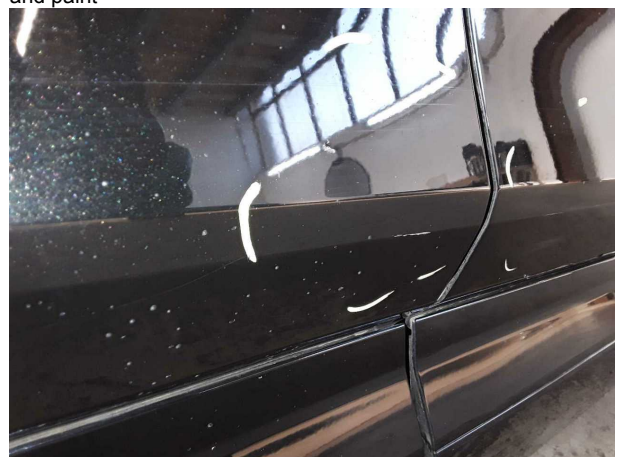
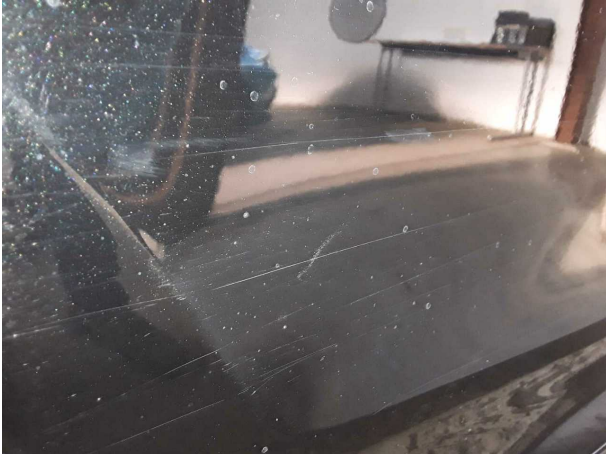
| No. | Component group | Description |
|---|---|---|
| 9 | Door - rear right side | Door - Scratched - Repair and paint |

Damage #9: Door - rear right side: Door - Scratched - Repair and paint

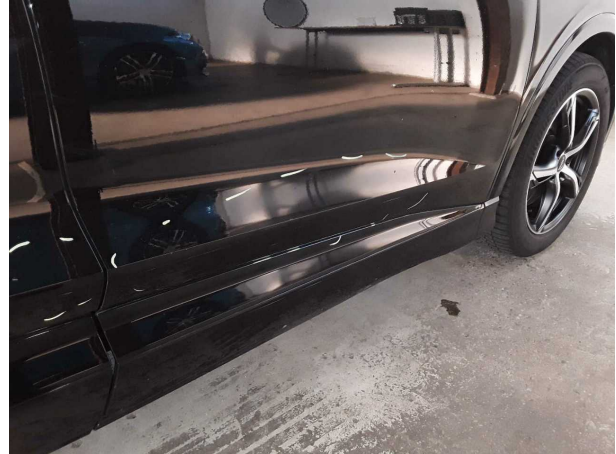
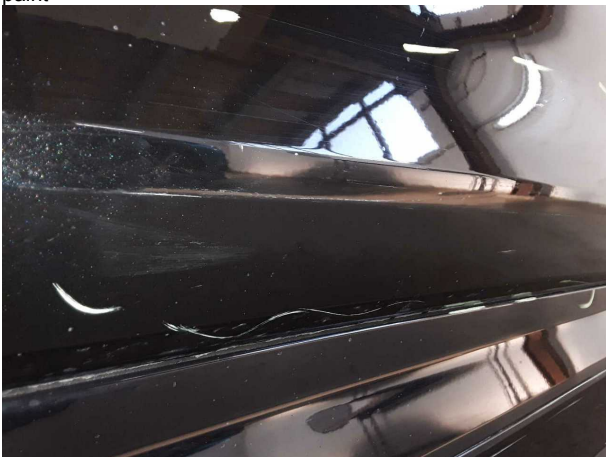
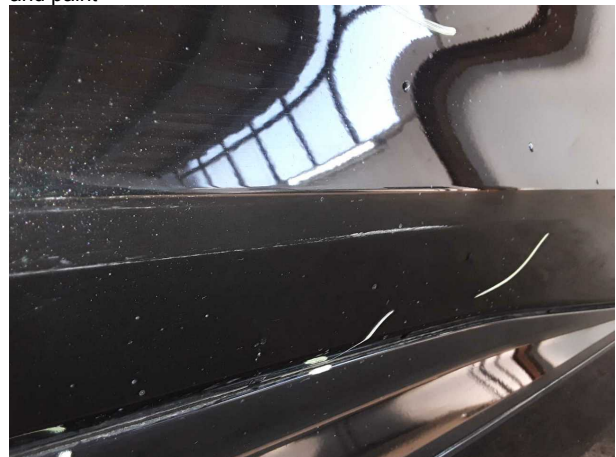
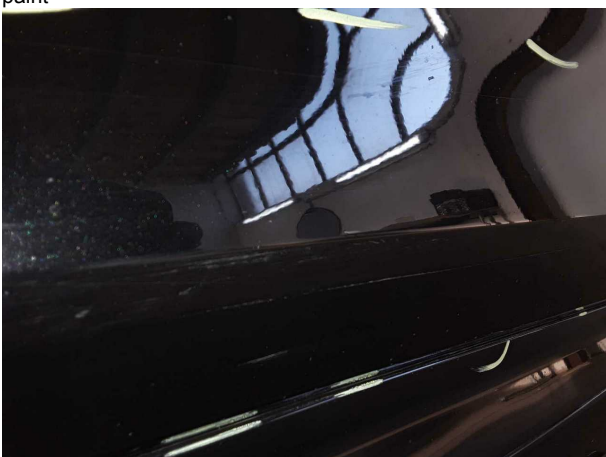
| No. | Component group | Description |
|---|---|---|
| 10 | Door - front right side | Door - Scratched - Repair and paint |

Damage #10: Door - front right side: Door - Scratched - Repair and paint

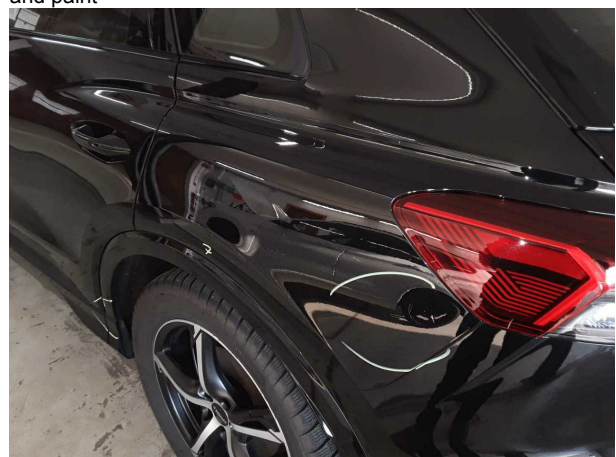
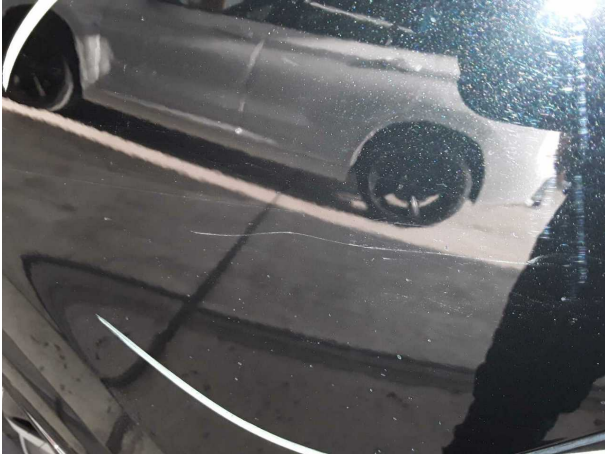
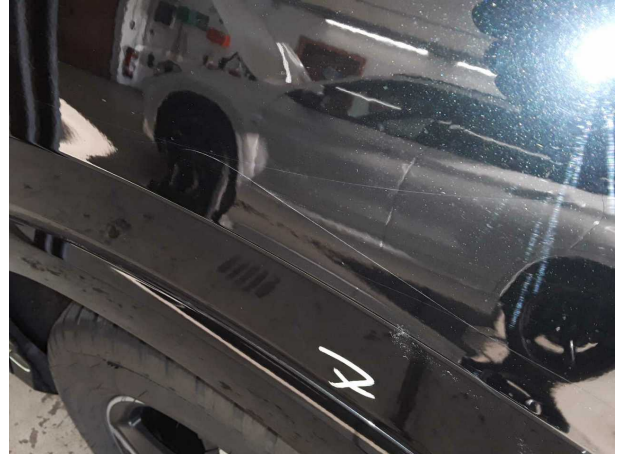
| No. | Component group | Description |
|---|---|---|
| 11 | Side panel - rear left side | Side panel - Scratched - Repair and paint |

Damage #11: Side panel - rear left side: Side panel - Scratch... - Repair and paint

Damage #11: Side panel - rear left side: Side panel - Scratched - Repair and paint

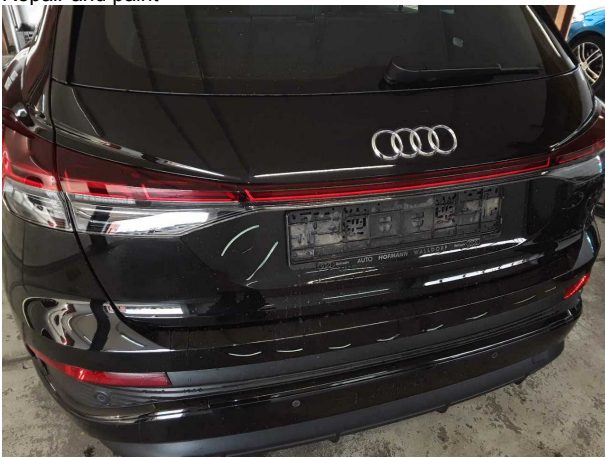
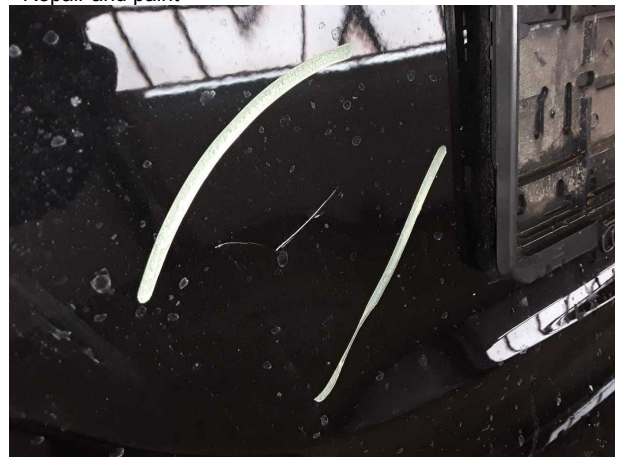
| No. | Component group | Description |
|---|---|---|
| 12 | Boot lid / rear door | Boot lid - Scratched - Repair and paint |

Damage #12: Boot lid / rear door: Boot lid - Scratched - Repair and paint
