WBA5P510X0FK85216

Zustandsbericht

TÜV SÜD Auto Plus GmbH
Gutenbergstr. 13
70771 Leinfelden-Echterdingen

Inspection date: 14 Mar 2025
Protocol number: 38849599
Delivery date: 14 Mar 2025

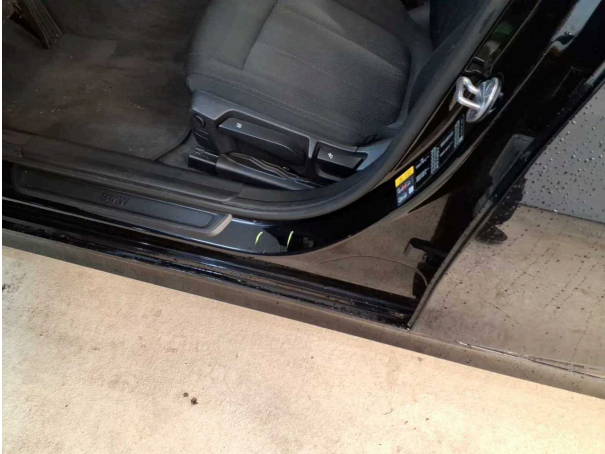
Damage #1: Sill - left side: Sill - Scratch(es) - Smart repair

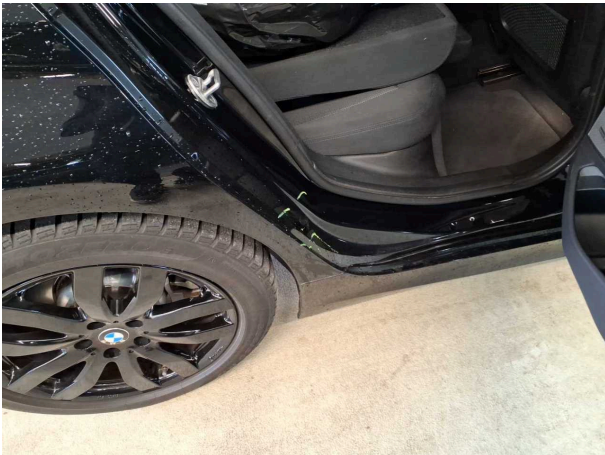
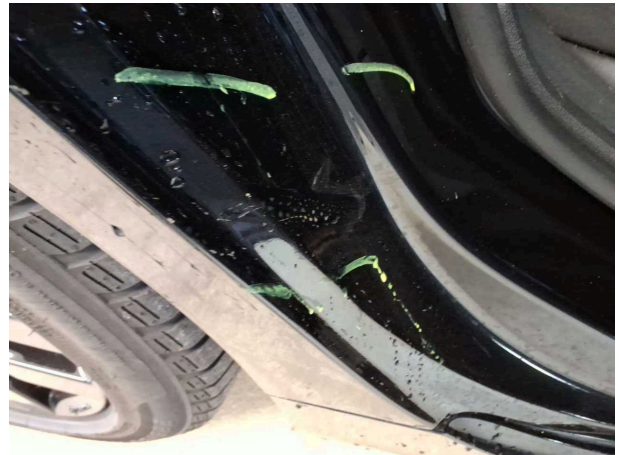
Damage #2: Side panel - rear right side: Sill - Scratched - Smart repair

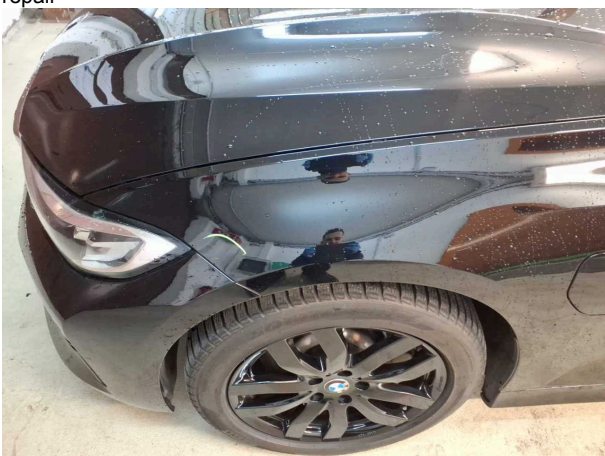
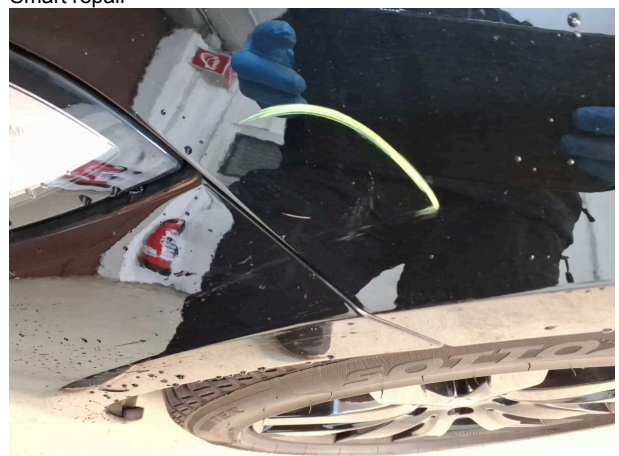
Damage #3: Mudguard - left side: Mudguard - left side - Scratche...
Repair and paint

Damage #3: Mudguard - left side: Mudguard - left side -
Scratched - Repair and paint
