WBA5P51020FK85100

## Zustandsbericht

Inspection date: 20 Mar 2025

**Protocol number:** 38942504

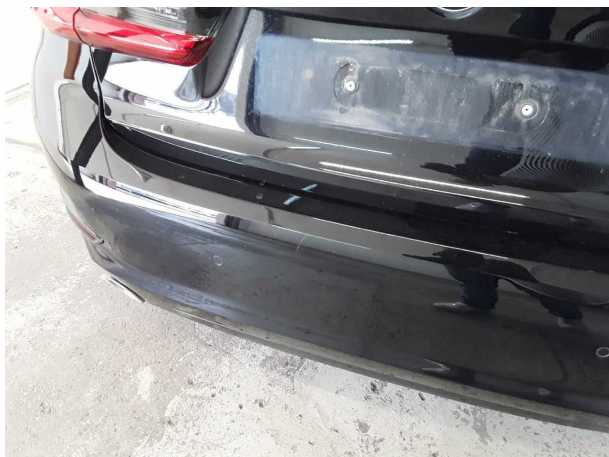
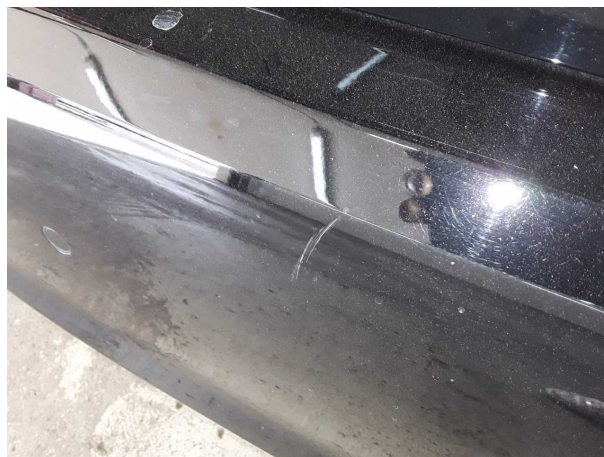
| No. | Component group | Description |
|---|---|---|
| 2 | Rear bumper | Rear bumper - Scratch(es) - Cover / polish |

**Damage #2:** Rear bumper: Rear bumper - Scratch(es) - Cover / polish

**Damage #2:** Rear bumper: Rear bumper - Scratch(es) - Cove... polish

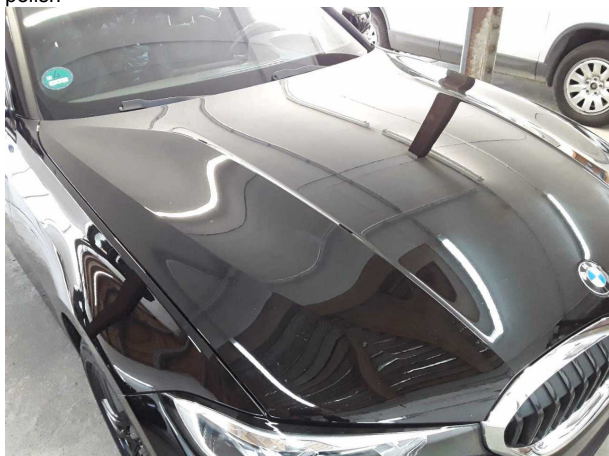
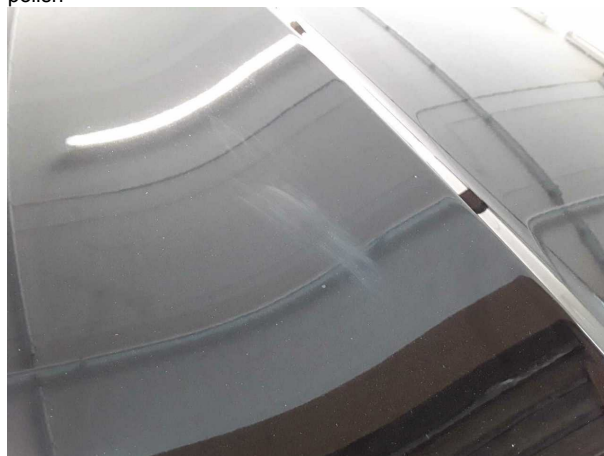
| No. | Component group | Description |
|---|---|---|
| 3 | Bonnet | Bonnet - Scratch(es) - Conditioning |

**Damage #3:** Bonnet: Bonnet - Scratch(es) - Conditioning

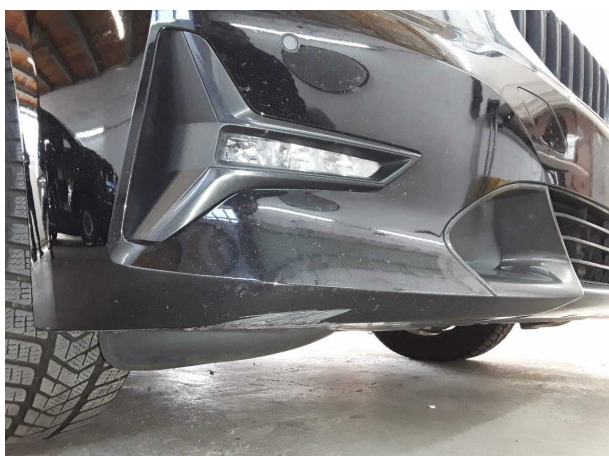
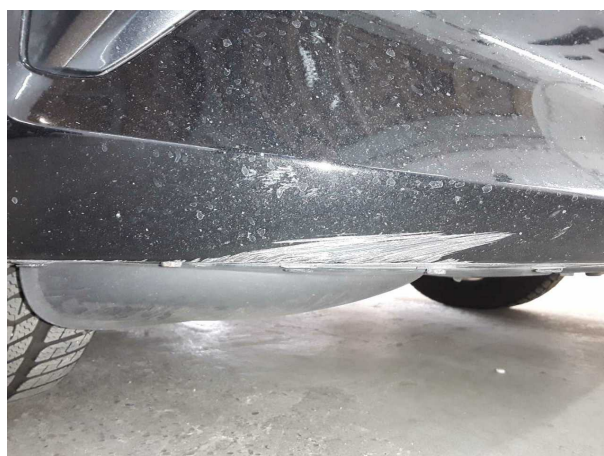
| No. | Component group | Description |
|---|---|---|
| 4 | Front bumper | Front bumper - Scratched - Smart repair |

**Damage #4:** Front bumper: Front bumper - Scratched - Smart repair

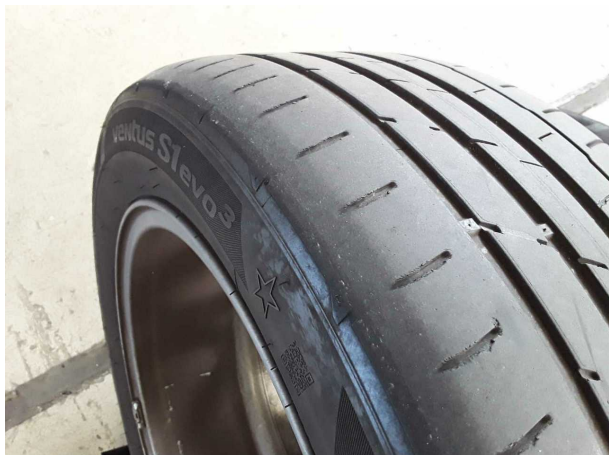
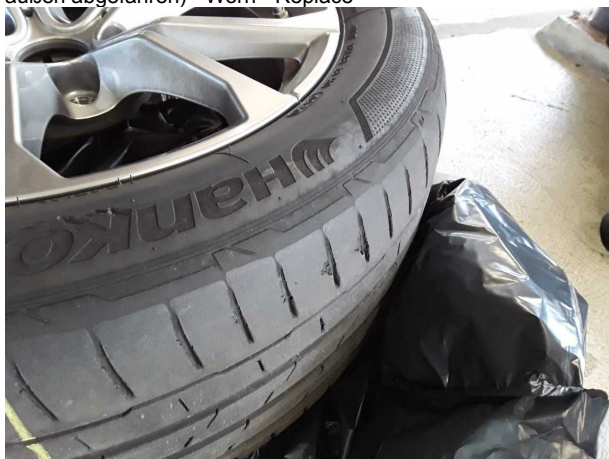
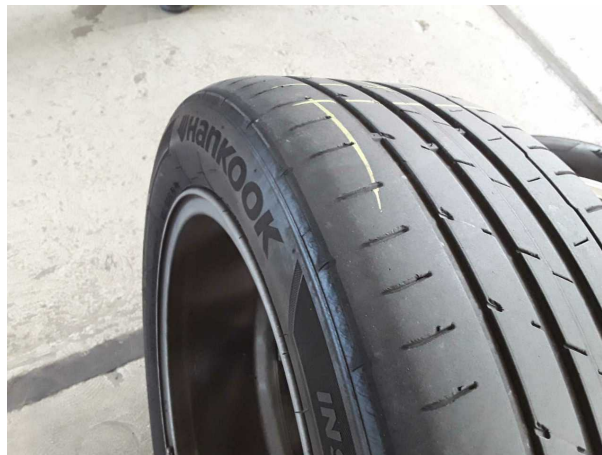
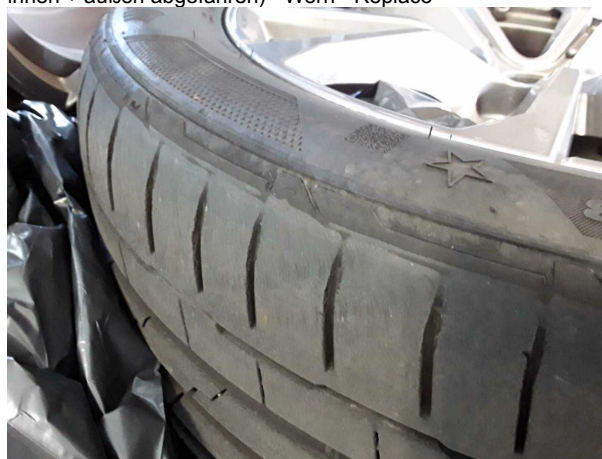
| No. | Component group | Description |
|---|---|---|
| 5 | 2nd wheel set | Tyres - complete set (Sommer /innen + außen abgefahren) - Worn - Replace |

**Damage #5:** 2nd wheel set: Tyres - complete set (Sommer /innen + außen abgefahren) - Worn - Replace

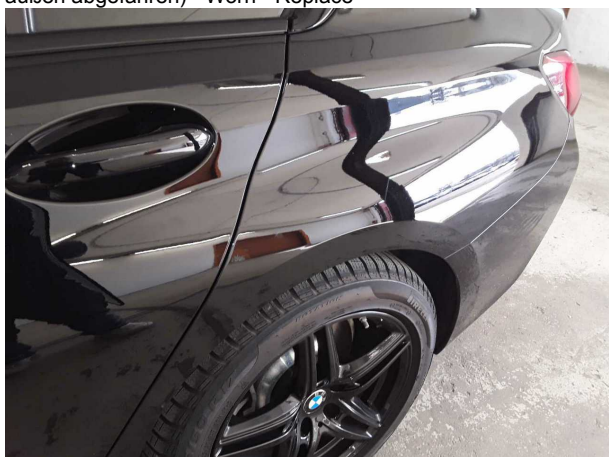
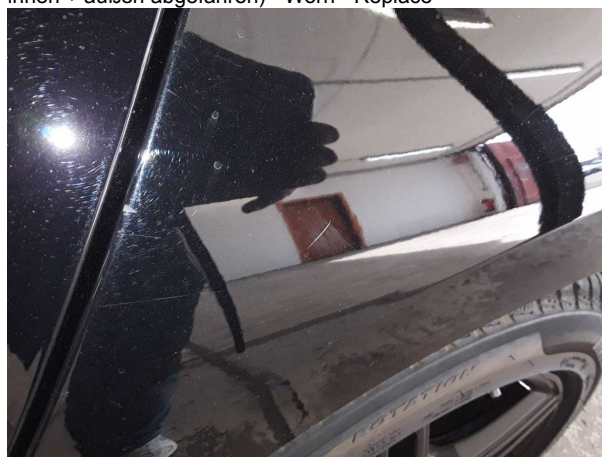
| No. | Component group | Description |
|---|---|---|
| 6 | Side panel - rear left side | Side panel - Scratch(es) - Paint |

**Damage #6:** Side panel - rear left side: Side panel - Scratch(es) - Paint

**Damage #6:** Side panel - rear left side: Side panel - Scratch(...) - Paint

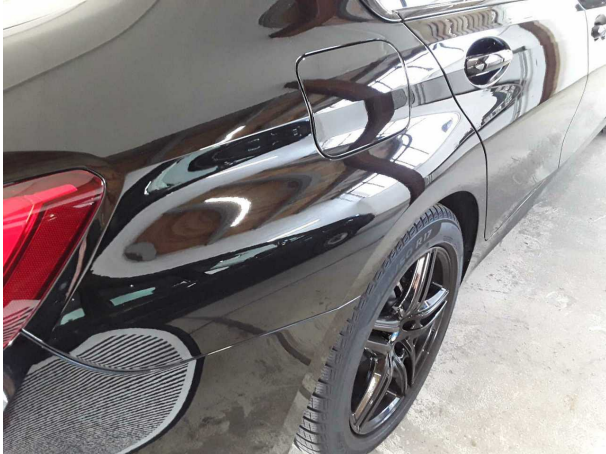
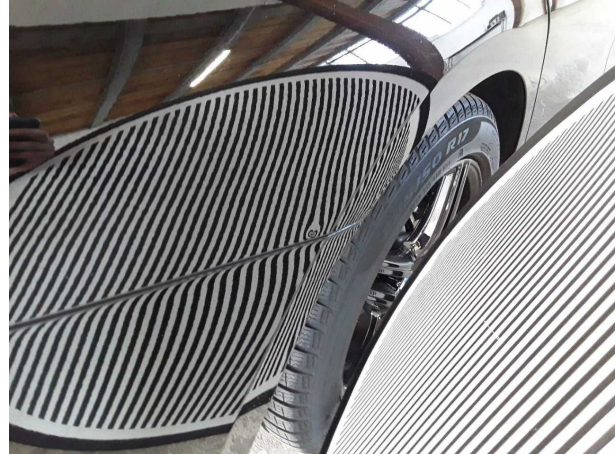
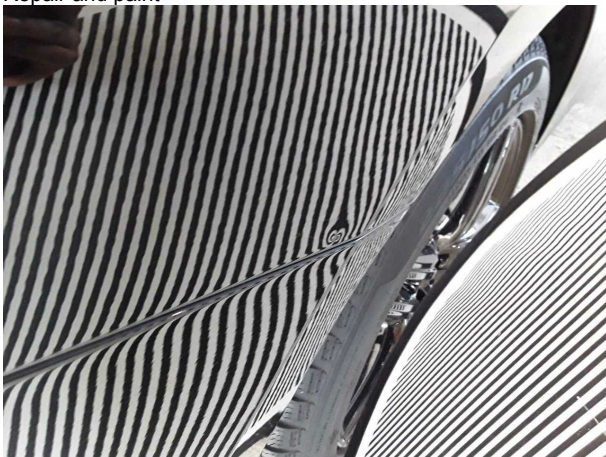
| No. | Component group | Description |
|---|---|---|
| 7 | Side panel - rear right side | Side panel - dent(s) - Repair and paint |

**Damage #7:** Side panel - rear right side: Side panel - dent(s) - Repair and paint
