**WAUZZZ8V2LA036527**

## Vehicle details

Inspection date: 19 Mar 2025  
**Protocol number: 38922373**  
Delivery date: 19 Mar 2025

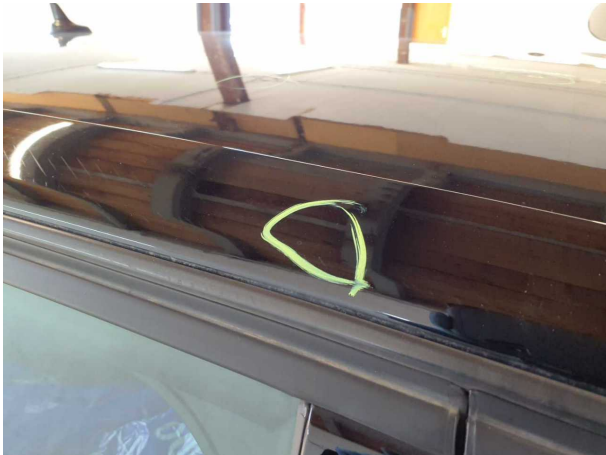
| No. | Component group | Description |
|---|---|---|
| 2 | Roof | Roof rail - right side - Dent / paintcoat damage - Smooth repair work |

**Damage #2:** Roof: Roof rail - right side - Dent / paintcoat damage - Smooth repair work

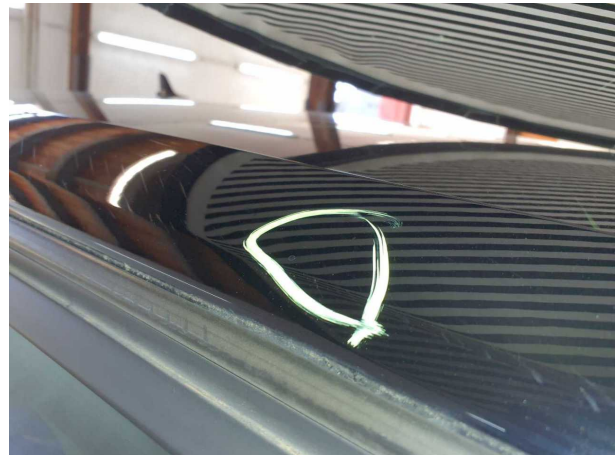
**Damage #2:** Roof: Roof rail - right side - Dent / paintcoat damage - Smooth repair work

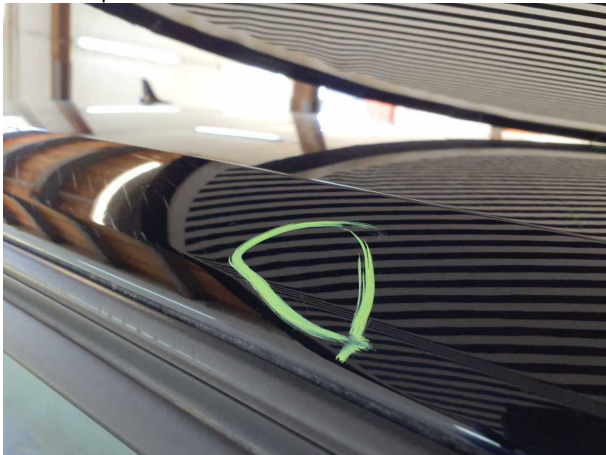
**Damage #2:** Roof: Roof rail - right side - Dent / paintcoat damage - Smooth repair work

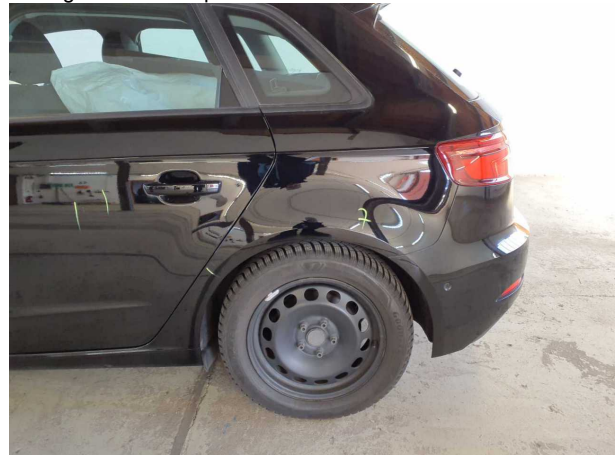
| No. | Component group | Description |
|---|---|---|
| 3 | Side panel - rear left side | Side panel - Scratch(es) - Smart repair |

**Damage #3:** Side panel - rear left side: Side panel - Scratch(...) - Smart repair

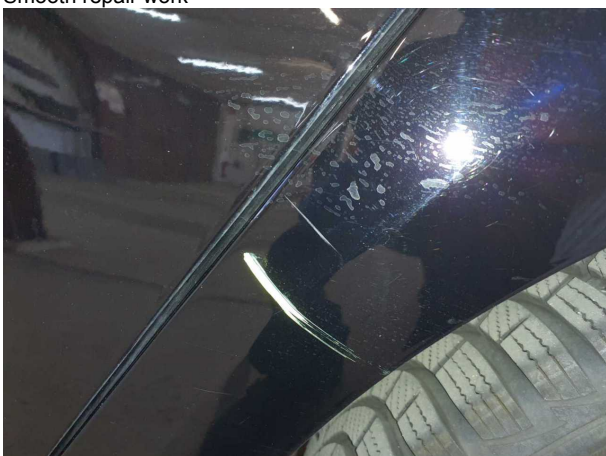
**Damage #3:** Side panel - rear left side: Side panel - Scratch(es) - Smart repair

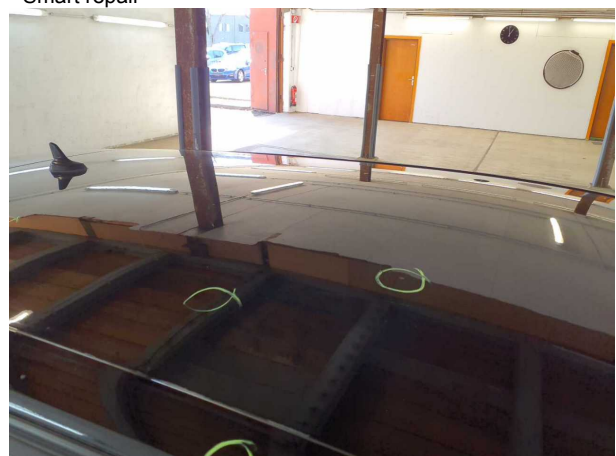
| No. | Component group | Description |
|---|---|---|
| 4 | Roof | Roof - dent(s) - Smooth repair work |

**Damage #4:** Roof: Roof - dent(s) - Smooth repair work

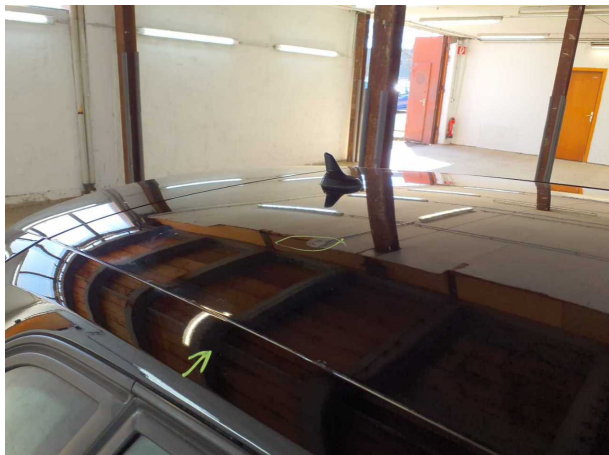
**Damage #4:** Roof: Roof - dent(s) - Smooth repair work

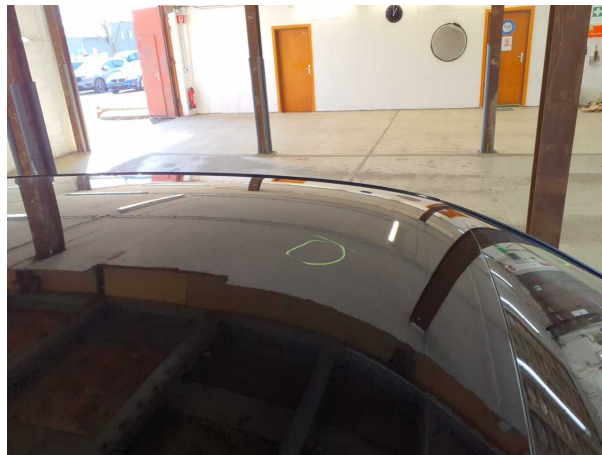
**Damage #4:** Roof: Roof - dent(s) - Smooth repair work

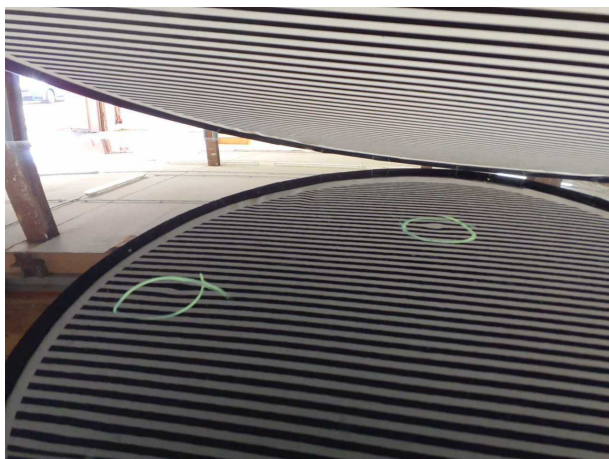
**Damage #4:** Roof: Roof - dent(s) - Smooth repair work

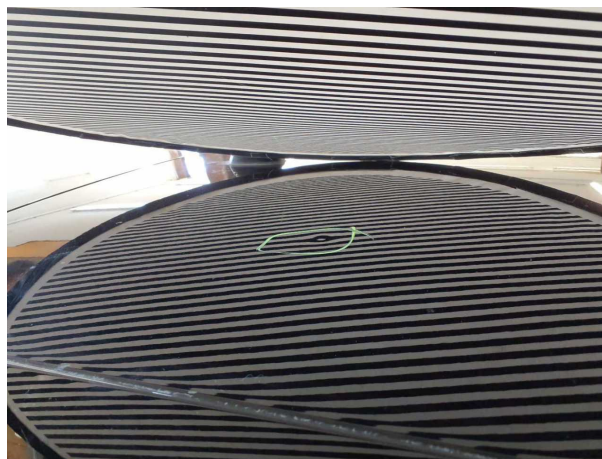
**Damage #4:** Roof: Roof - dent(s) - Smooth repair work

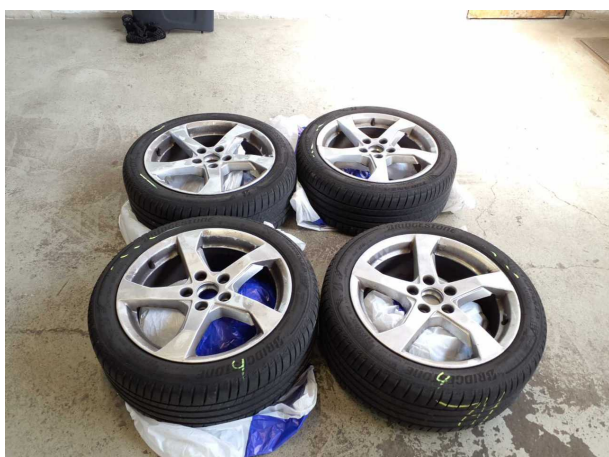
| No. | Component group | Description |
|---|---|---|
| 5 | 2nd wheel set | Alloy rim set - complete - Scratched - Loss in value |

**Damage #5:** 2nd wheel set: Alloy rim set - complete - Scratched - Loss in value

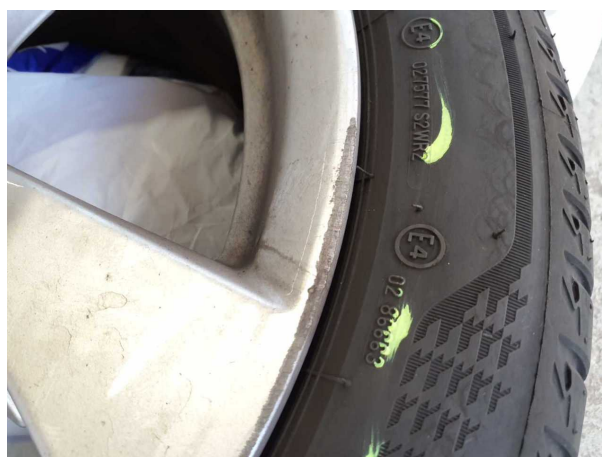
**Damage #5:** 2nd wheel set: Alloy rim set - complete - Scratch... - Loss in value

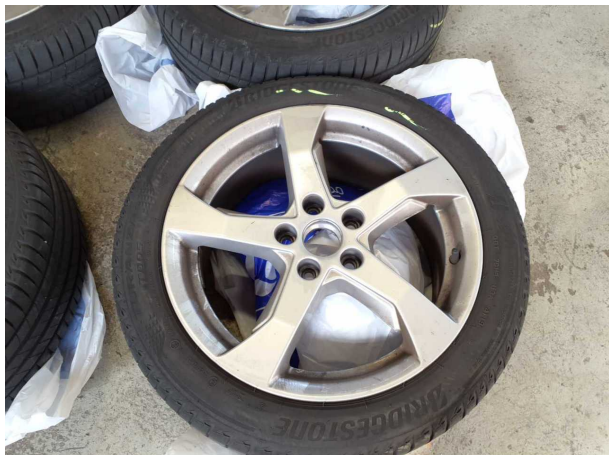
**Damage #5:** 2nd wheel set: Alloy rim set - complete - Scratched - Loss in value

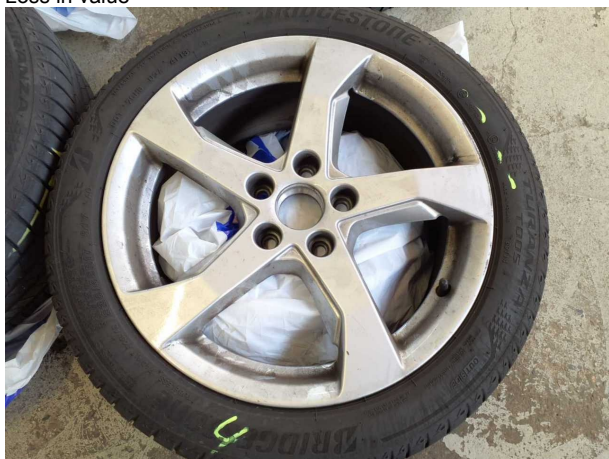
**Damage #5:** 2nd wheel set: Alloy rim set - complete - Scratched - Loss in value

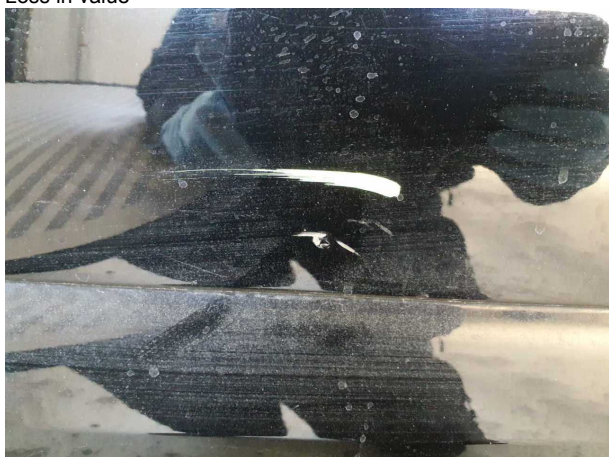
| No. | Component group | Description |
|---|---|---|
| 6 | Rear bumper | Rear bumper - Scratched - Repair and paint |

**Damage #6:** Rear bumper: Rear bumper - Scratched - Repair and paint

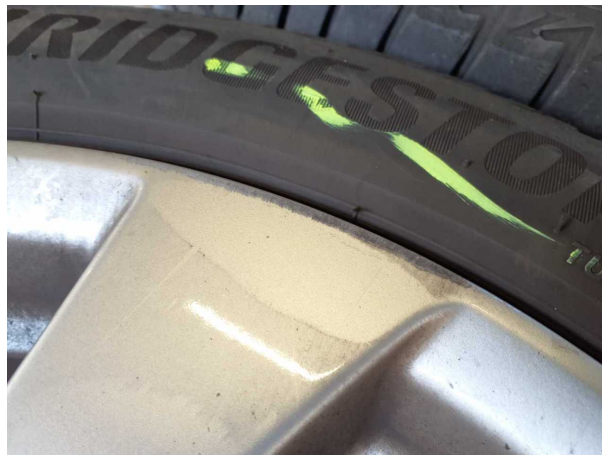
**Damage #5:** 2nd wheel set: Alloy rim set - complete - Scratch... - Loss in value

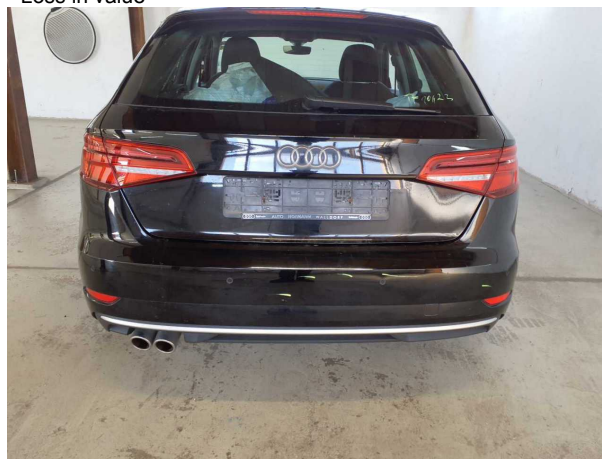
**Damage #6:** Rear bumper: Rear bumper - Scratched - Repair and paint

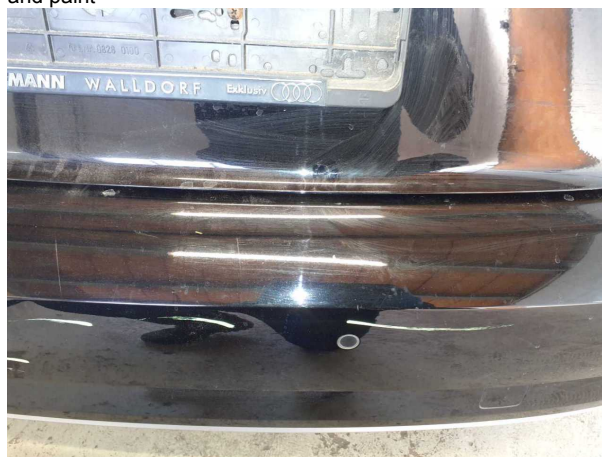
**Damage #6:** Rear bumper: Rear bumper - Scratched - Repair and paint

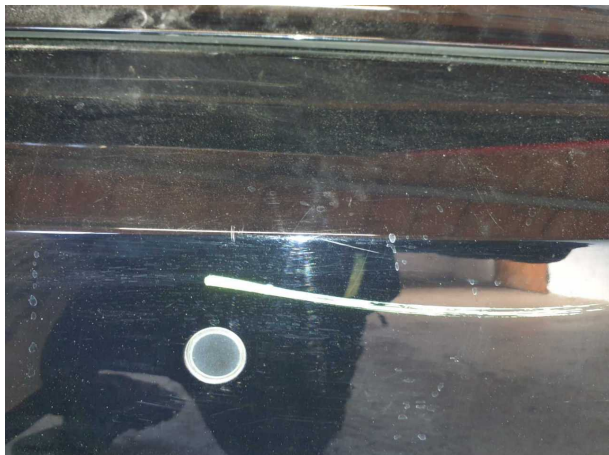
**Damage #6:** Rear bumper: Rear bumper - Scratched - Repair and paint

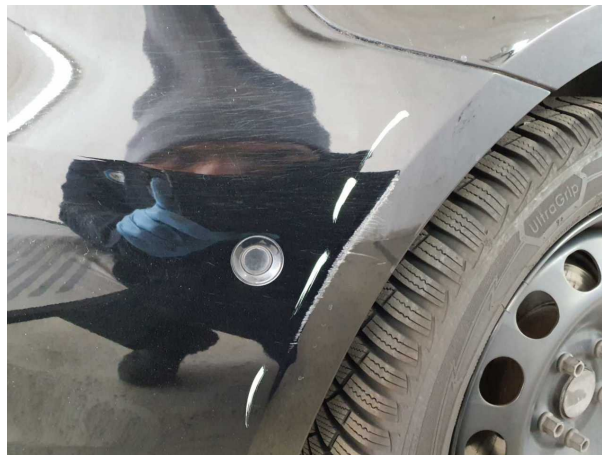
**Damage #6:** Rear bumper: Rear bumper - Scratched - Repair and paint

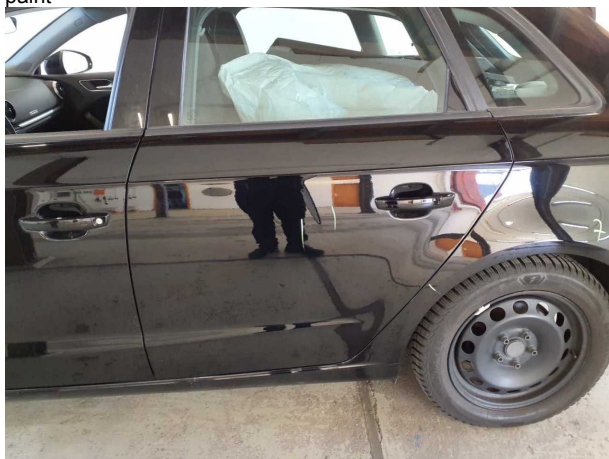
| No. | Component group | Description |
|---|---|---|
| 7 | Door - rear left side | Door - Scratched - Paint |

**Damage #7:** Door - rear left side: Door - Scratched - Paint

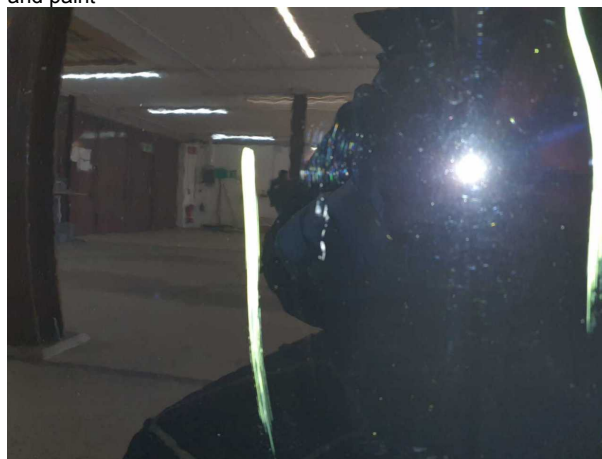
**Damage #7:** Door - rear left side: Door - Scratched - Paint

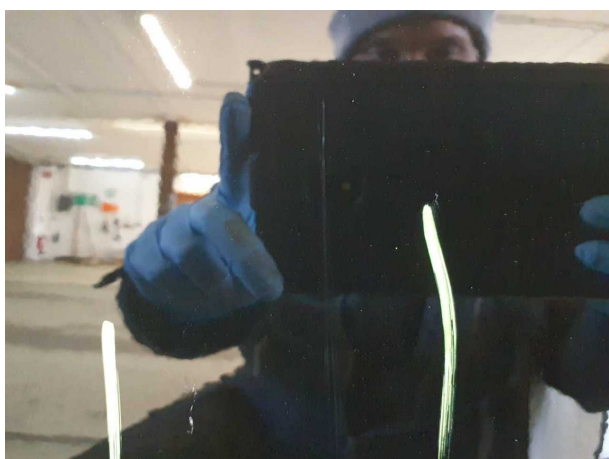
**Damage #7:** Door - rear left side: Door - Scratched - Paint

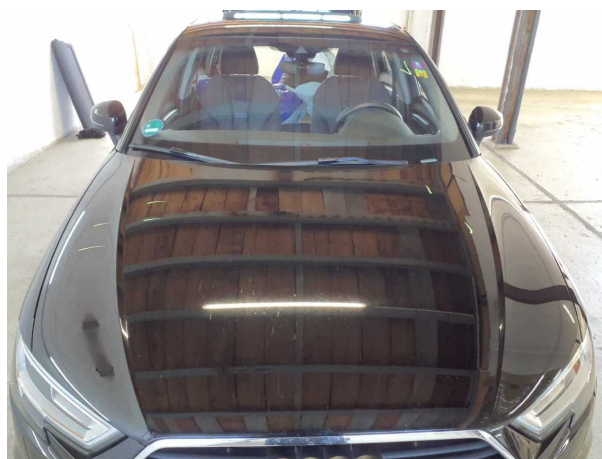
| No. | Component group | Description |
|---|---|---|
| 8 | Bonnet | Bonnet - Scratched - Paint |

**Damage #8:** Bonnet: Bonnet - Scratched - Paint

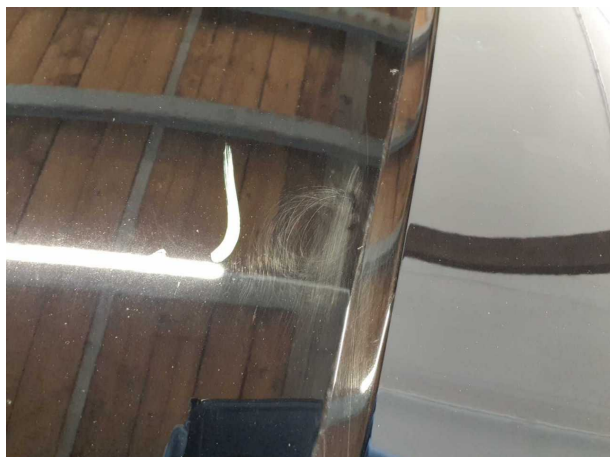
**Damage #8:** Bonnet: Bonnet - Scratched - Paint

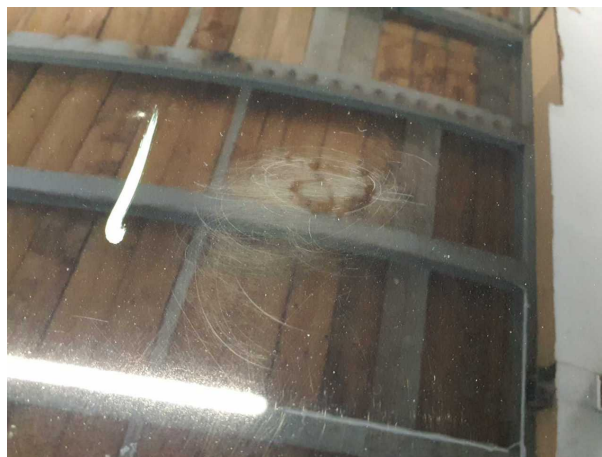
**Damage #8:** Bonnet: Bonnet - Scratched - Paint

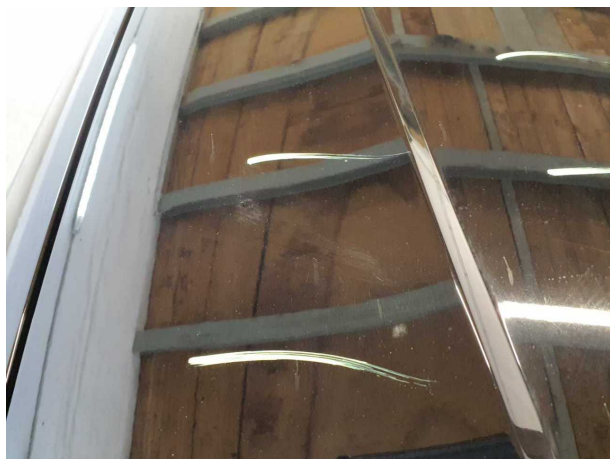
**Damage #8:** Bonnet: Bonnet - Scratched - Paint

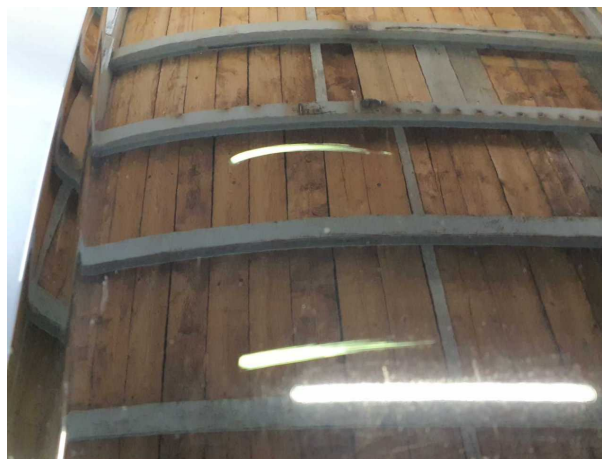
**Damage #8:** Bonnet: Bonnet - Scratched - Paint

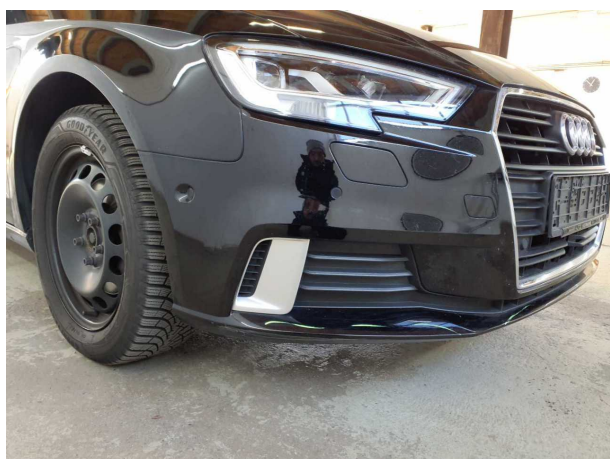
| No. | Component group | Description |
|---|---|---|
| 9 | Front bumper | Front bumper - Scratched - Repair and paint |

**Damage #9:** Front bumper: Front bumper - Scratched - Repair and paint

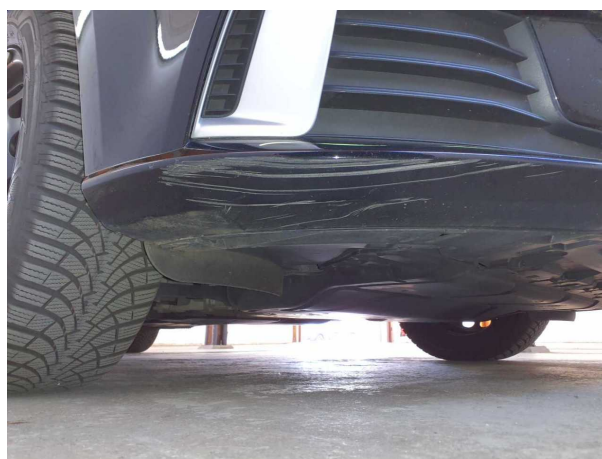
**Damage #9:** Front bumper: Front bumper - Scratched - Repair and paint

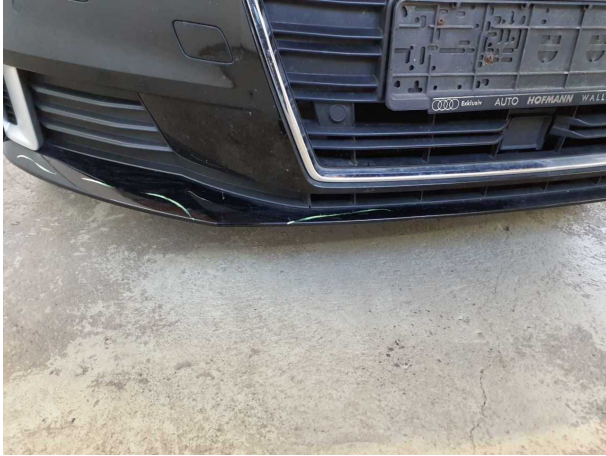
**Damage #9:** Front bumper: Front bumper - Scratched - Repair and paint

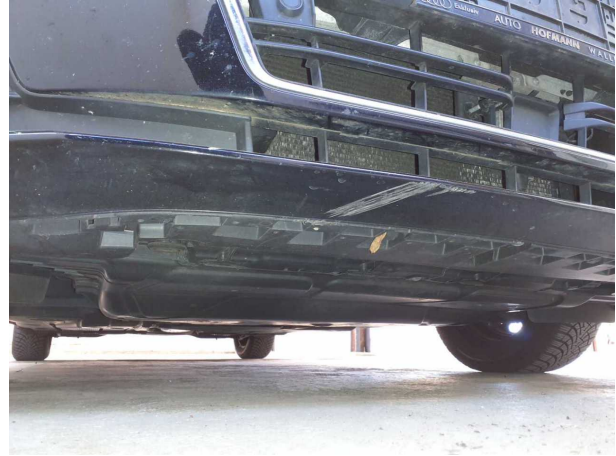
**Damage #9:** Front bumper: Front bumper - Scratched - Repair and paint
