**WBA6N31020FK94071**

## Zustandsbericht

**TÜV SÜD Auto Plus GmbH**  
Gutenbergstr. 13  
70771 Leinfelden-Echterdingen

Inspection date: 26 Feb 2025  
**Protocol number: 38602890**  
Delivery date: 26 Feb 2025

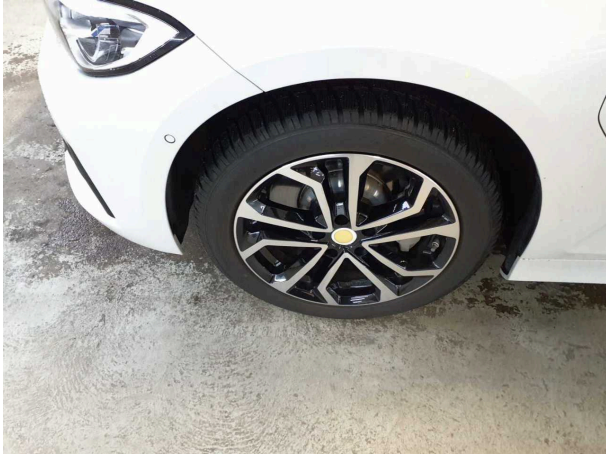
Axle	Tyre size	Manufacturer	Type of tyre	Tread depth	Roadworthy	Permissibility
1	225/50 R17 98H	Dunlop	Winter tyres	4mm - 4mm	Not o.k.	
2	225/50 R17 98H	Goodyear	Winter tyres	7mm - 7mm	o.k.

**Damage #2:** Wheel / tyres: Tyre - front - Worn - No deduction

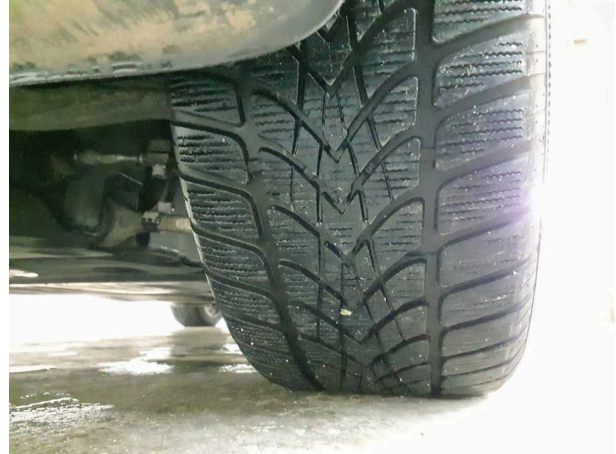
**Damage #2:** Wheel / tyres: Tyre - front - Worn - No deduction

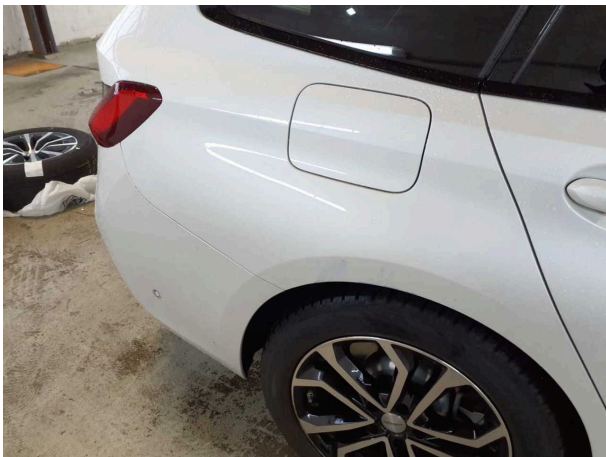
**Damage #3:** Side panel - rear right side: Side panel - Scratch(es) - Cover / polish

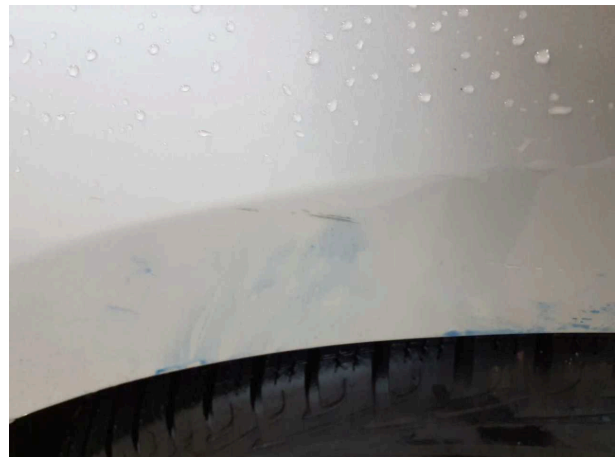
**Damage #3:** Side panel - rear right side: Side panel - Scratch(es) - Cover / polish

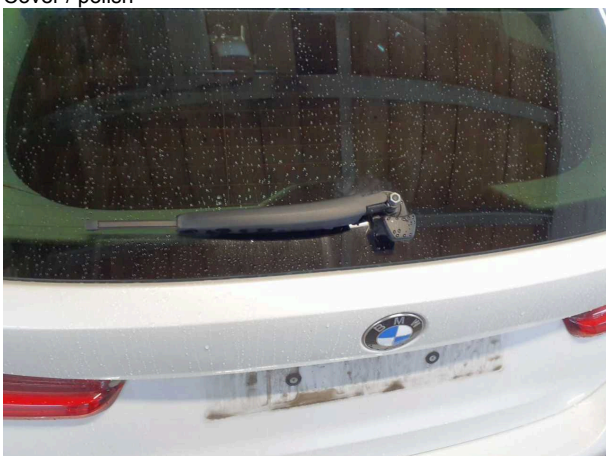
**Damage #4:** Screen cleaning: Wiper arm - rear (Abdeckung fehlt) - Replace

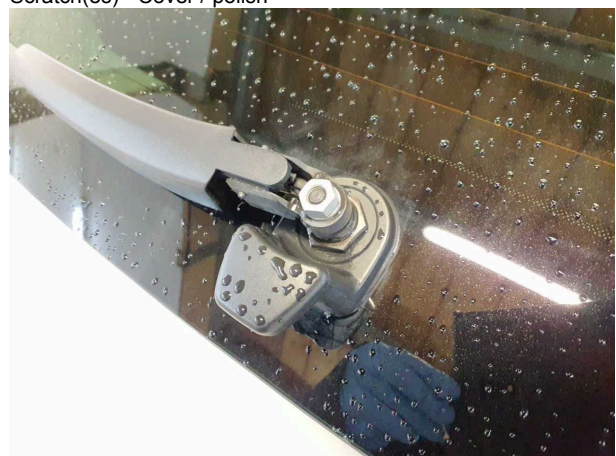
**Damage #4:** Screen cleaning: Wiper arm - rear (Abdeckung fehlt) - Replace

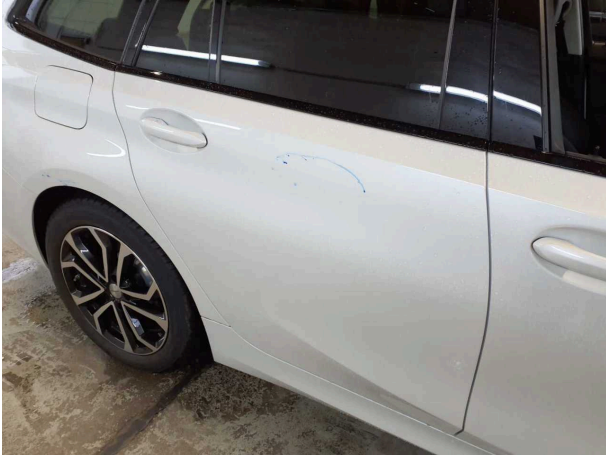
**Damage #5:** Door - rear right side: Door - Scratch(es) - Repair and paint

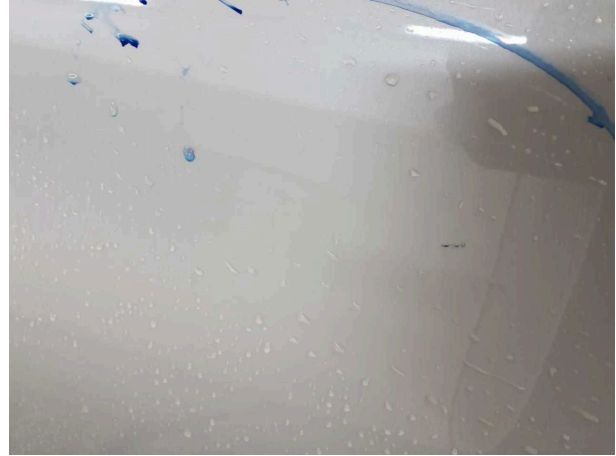
**Damage #5:** Door - rear right side: Door - Scratch(es) - Repair and paint

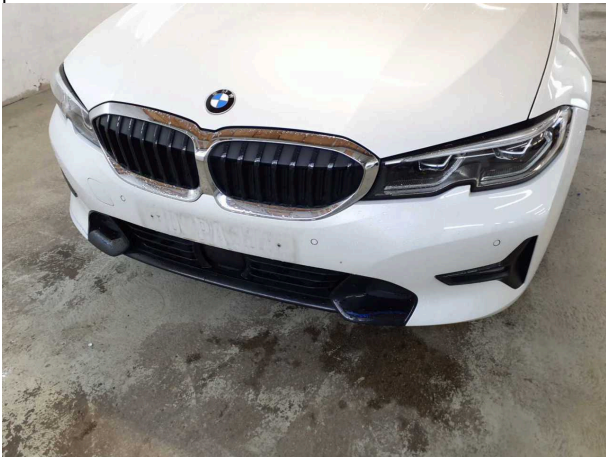
**Damage #6:** Front bumper: Front bumper - Scratched - Repair and paint

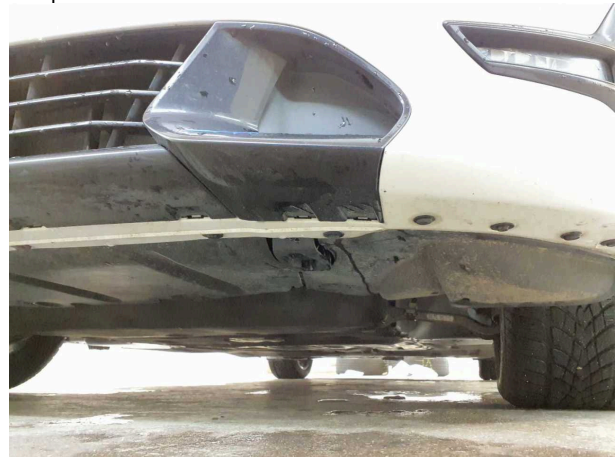
**Damage #6:** Front bumper: Front bumper - Scratched - Repair and paint

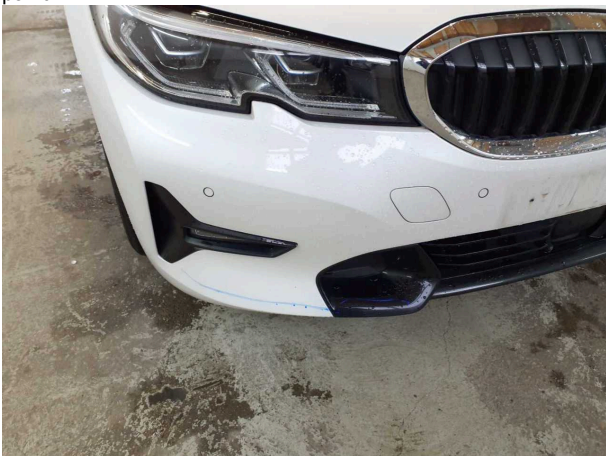
**Damage #6:** Front bumper: Front bumper - Scratched - Repair and paint

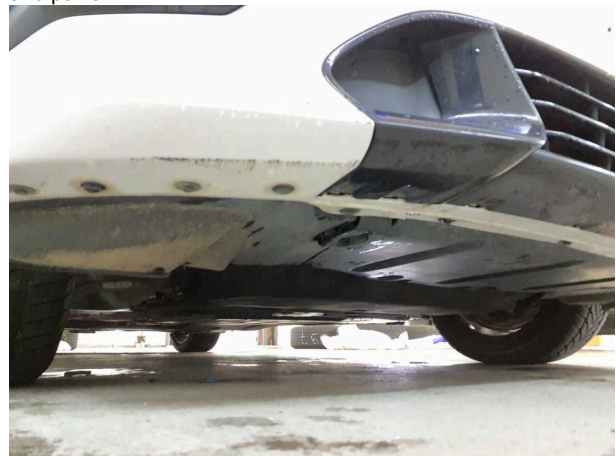
**Damage #6:** Front bumper: Front bumper - Scratched - Repair and paint

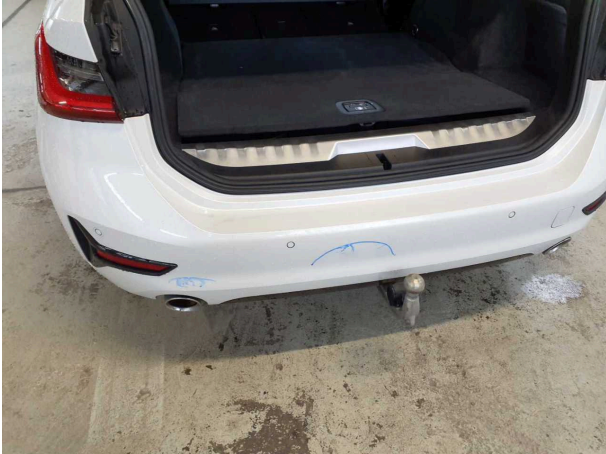
Damage #7: Rear bumper: Rear bumper - Deformed - Replace

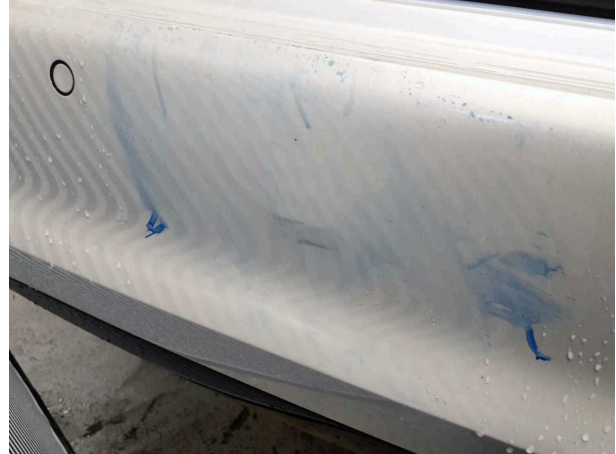
Damage #7: Rear bumper: Rear bumper - Deformed - Replace

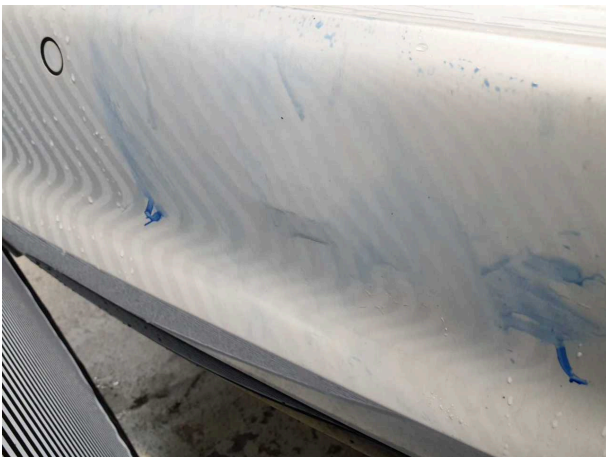
Damage #7: Rear bumper: Rear bumper - Deformed - Replace

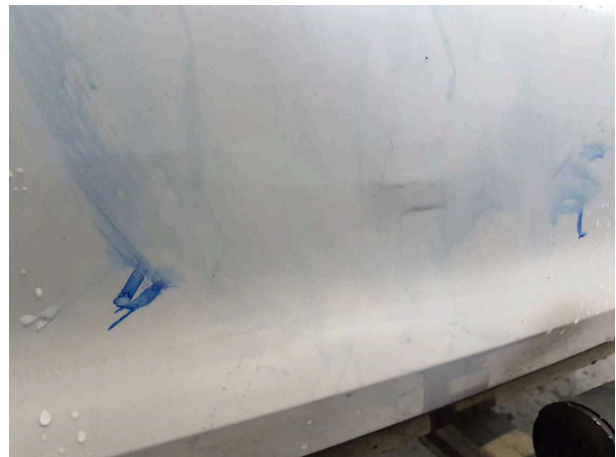
Damage #7: Rear bumper: Rear bumper - Deformed - Replace

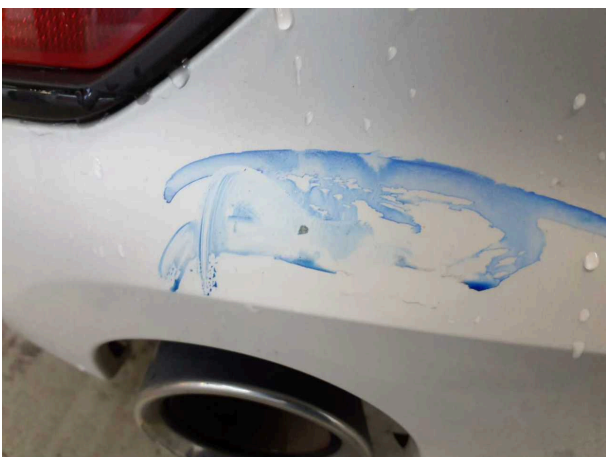
Damage #7: Rear bumper: Rear bumper - Deformed - Replace
