**WAUZZZGY2MA075163**

## Zustandsbericht

**TÜV SÜD Auto Plus GmbH**  
Gutenbergstr. 13  
70771 Leinfelden-Echterdingen

Inspection date: 18 Mar 2025  
**Protocol number: 38906723**

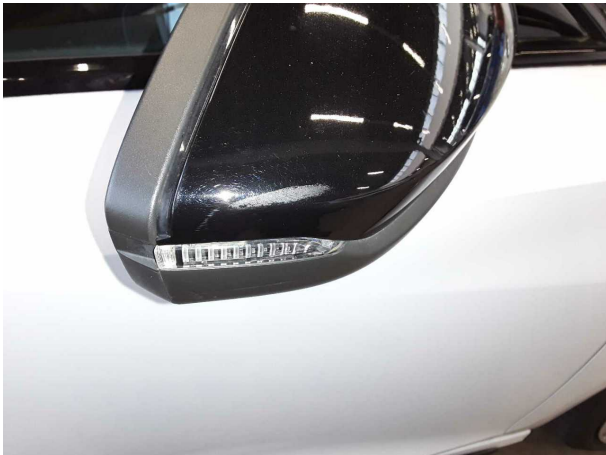
**Damage #3:** Wing mirror - right side: Mirror housing - Scratch(es) - Smart repair

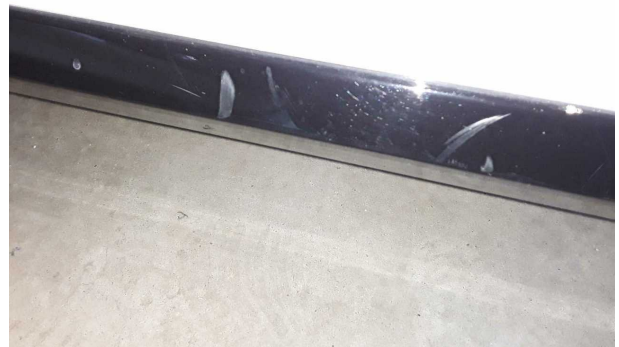
**Damage #4:** Sill - left side: Trim - Scratch(es) - Smart repair

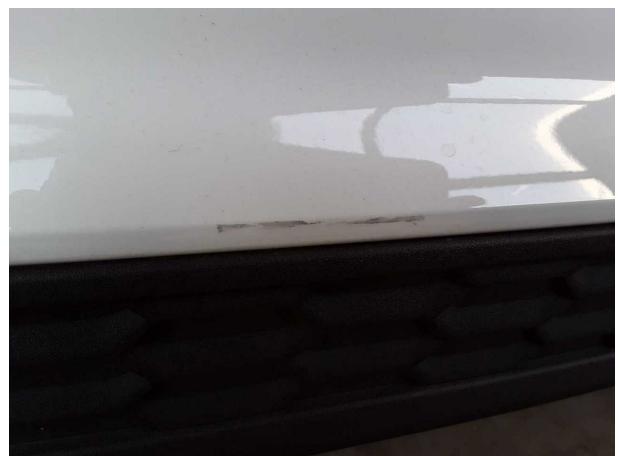
**Damage #5:** Rear bumper: Rear bumper - Scratch(es) - Smart repair

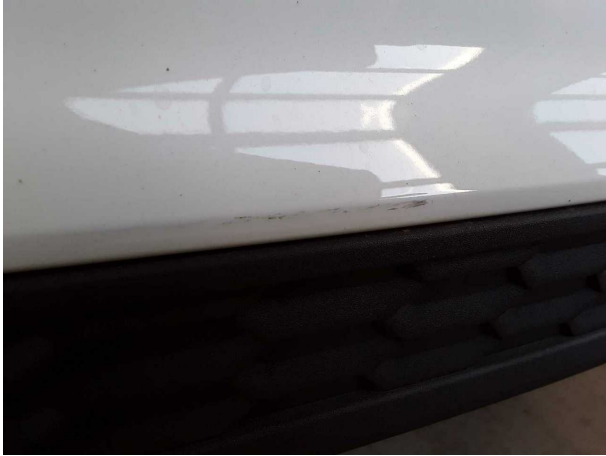
**Damage #5:** Rear bumper: Rear bumper - Scratch(es) - Smart repair

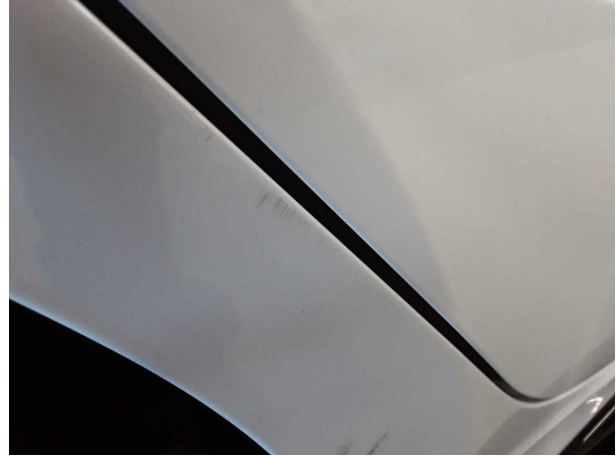
**Damage #6:** Side panel - rear right side: Wheel arch - Scratch(es) - Smart repair

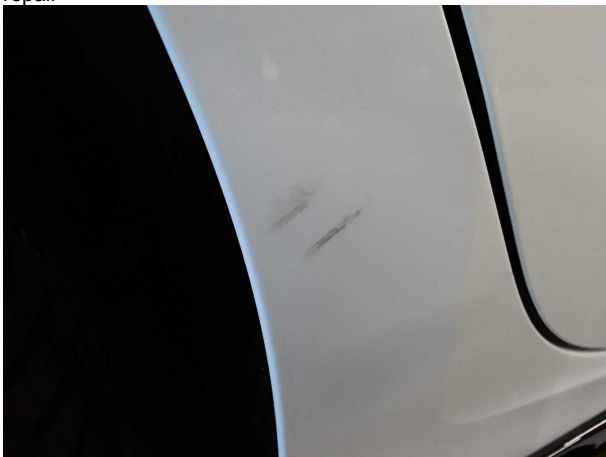
**Damage #6:** Side panel - rear right side: Wheel arch - Scratch(es) - Smart repair

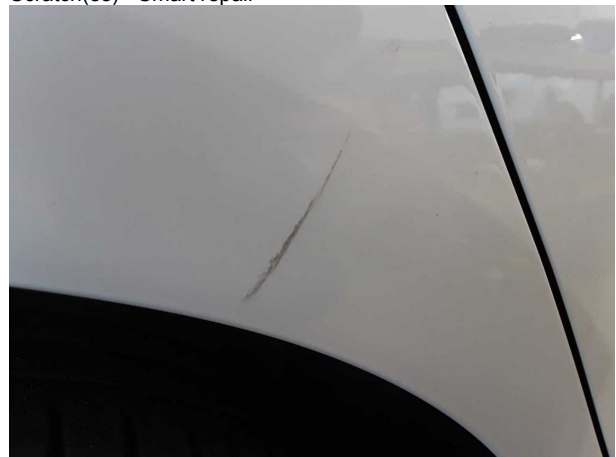
**Damage #6:** Side panel - rear right side: Wheel arch - Scratch(es) - Smart repair

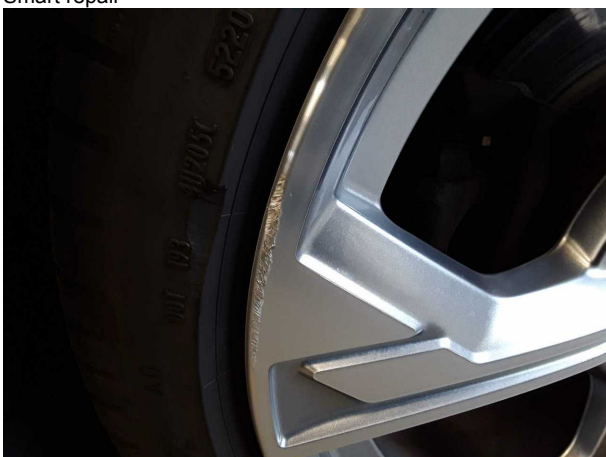
**Damage #7:** Wheel / tyres: Alloy rim - rear left side (Materialabtrag optisch zu hoch) - Scratched - Loss in value

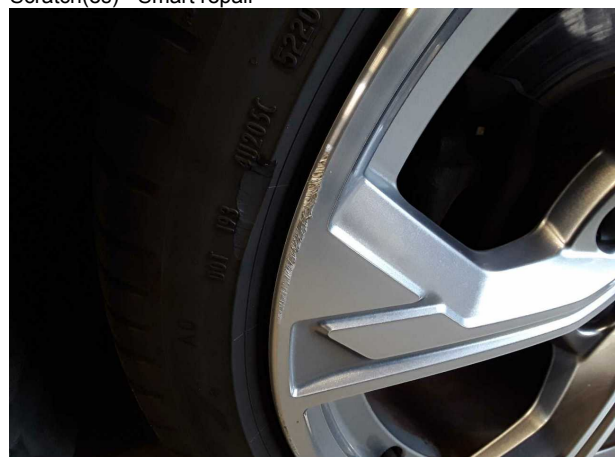
**Damage #7:** Wheel / tyres: Alloy rim - rear left side (Materialabtrag optisch zu hoch) - Scratched - Loss in value

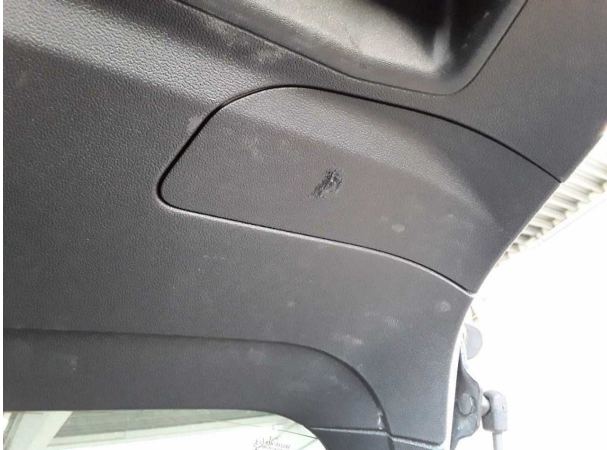
**Damage #8:** Trim / covers: Boot lining - Scratched - Loss in value

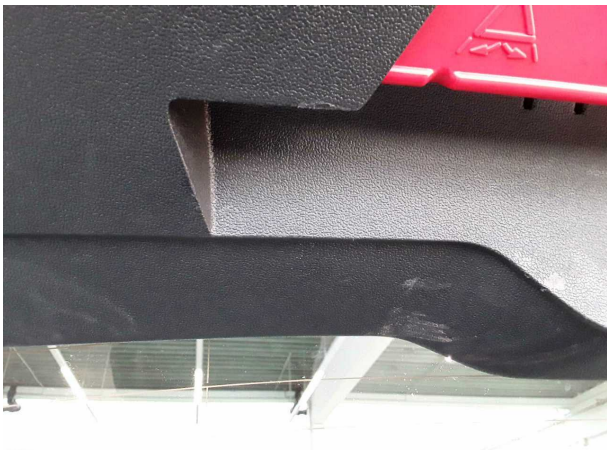
**Damage #8:** Trim / covers: Boot lining - Scratched - Loss in value

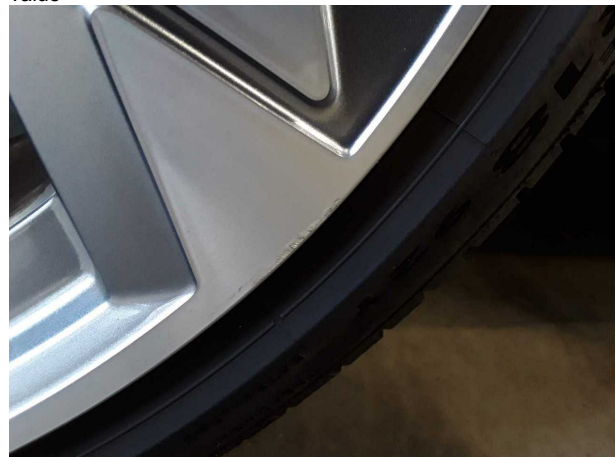
**Damage #9:** Wheel / tyres: Alloy rim - rear right side (Materialabtrag optisch gering) - Scratched - Loss in value

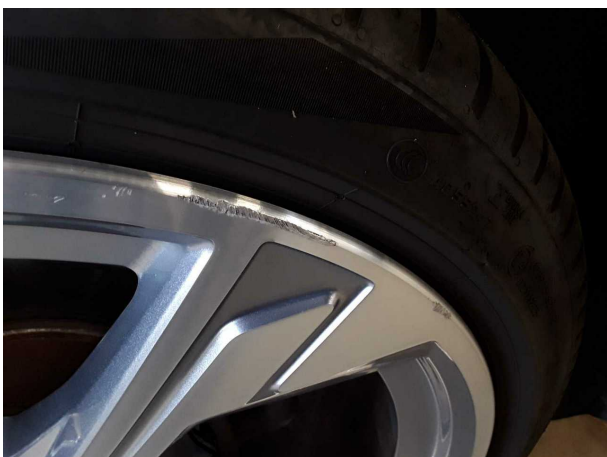
**Damage #9:** Wheel / tyres: Alloy rim - rear right side (Materialabtrag optisch gering) - Scratched - Loss in value

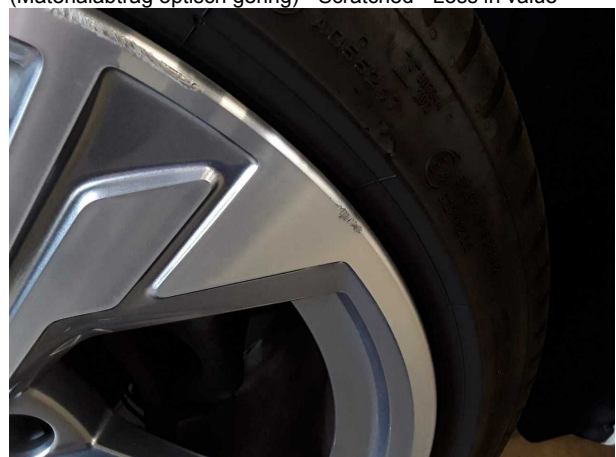
**Damage #9:** Wheel / tyres: Alloy rim - rear right side (Materialabtrag optisch gering) - Scratched - Loss in value

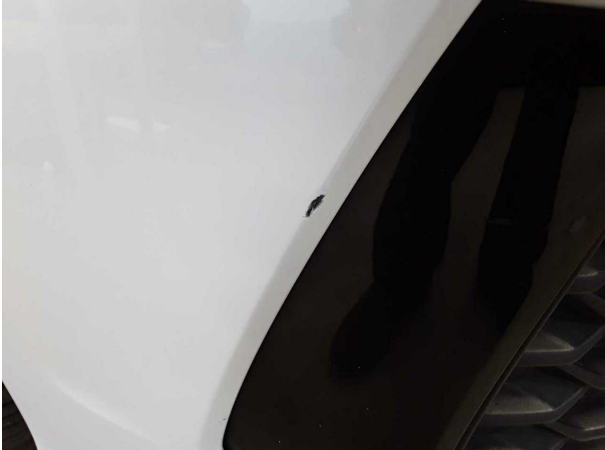
**Damage #10:** Front bumper: Front bumper - Scratched - Repair and paint

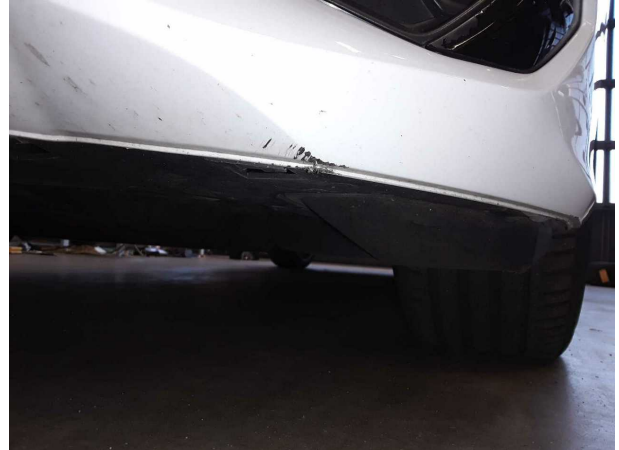
**Damage #10:** Front bumper: Front bumper - Scratched - Rep... and paint

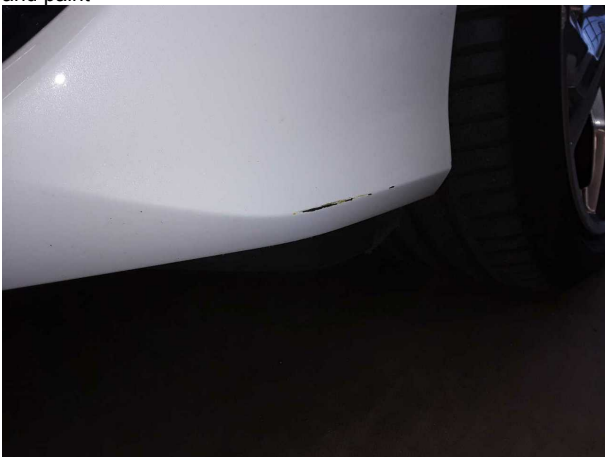
**Damage #10:** Front bumper: Front bumper - Scratched - Repair and paint

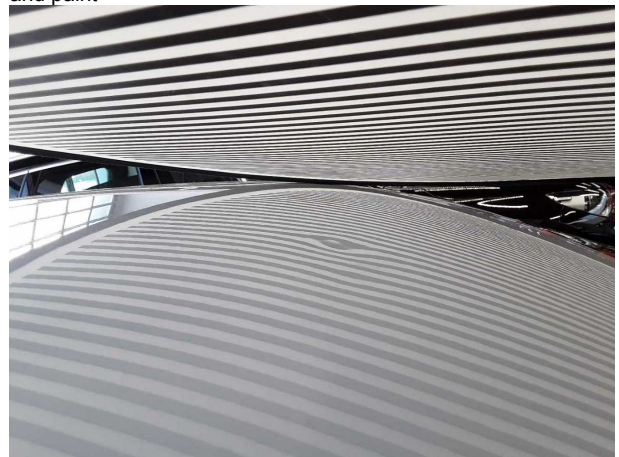
**Damage #11:** Roof: Roof - dent(s) - Repair and paint

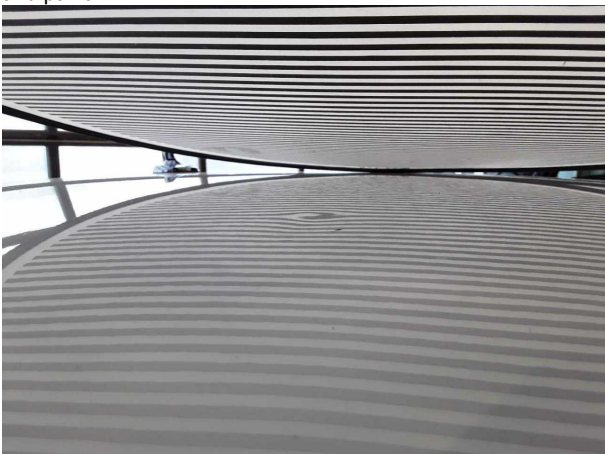
**Damage #11:** Roof: Roof - dent(s) - Repair and paint

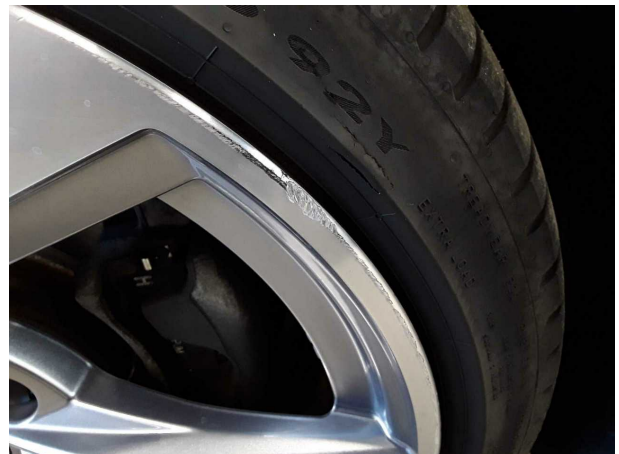
**Damage #12:** Wheel / tyres: Alloy rim - front right side (Materialabtrag optisch zu hoch) - Scratched - Replace

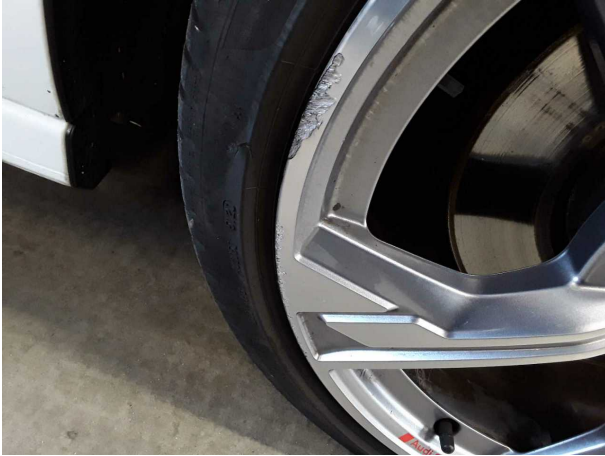
**Damage #12:** Wheel / tyres: Alloy rim - front right side  
(Materialabtrag optisch zu hoch) - Scratched - Replace

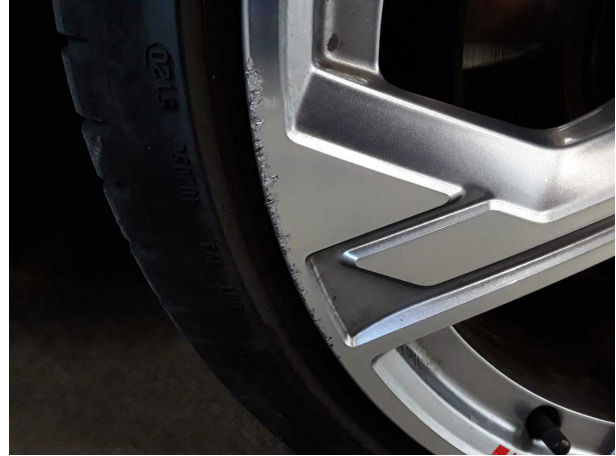
**Damage #12:** Wheel / tyres: Alloy rim - front right side  
(Materialabtrag optisch zu hoch) - Scratched - Replace

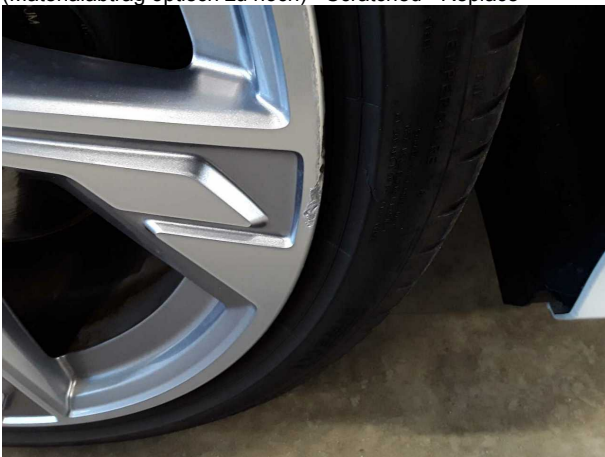
**Damage #12:** Wheel / tyres: Alloy rim - front right side  
(Materialabtrag optisch zu hoch) - Scratched - Replace

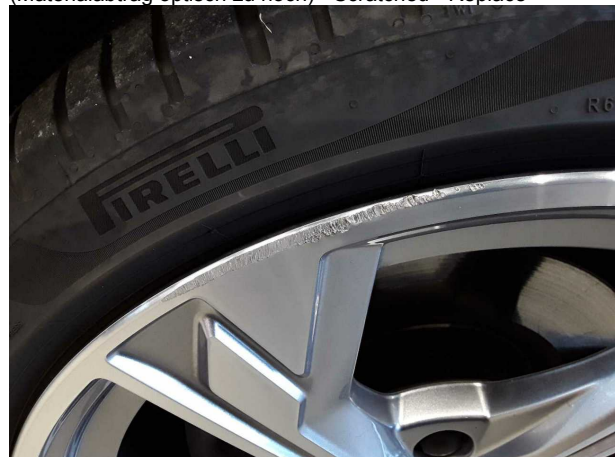
**Damage #13:** Wheel / tyres: Alloy rim - front left side  
(Materialabtrag optisch zu hoch) - Scratched - Replace

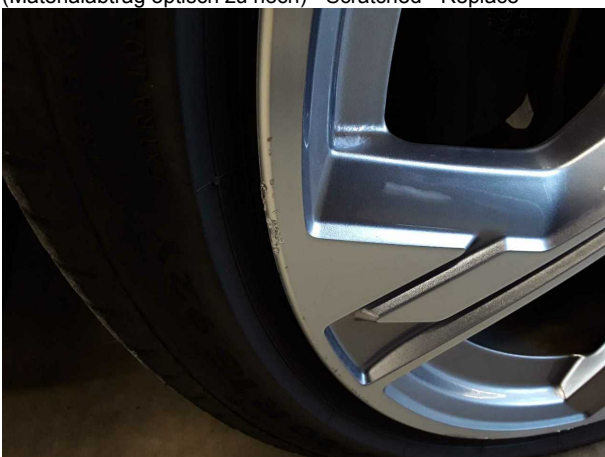
**Damage #13:** Wheel / tyres: Alloy rim - front left side  
(Materialabtrag optisch zu hoch) - Scratched - Replace

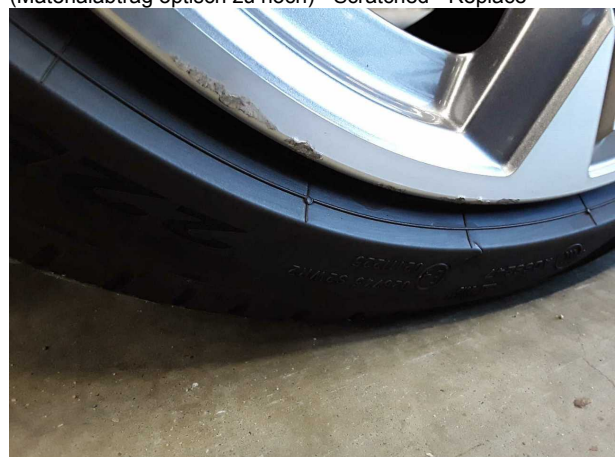
**Damage #13:** Wheel / tyres: Alloy rim - front left side  
(Materialabtrag optisch zu hoch) - Scratched - Replace
