**WBY61EF0805W96152**

**TÜV SÜD Auto Plus GmbH**  
Gutenbergstr. 13  
70771 Leinfelden-Echterdingen

Inspection date: 14 Apr 2025  
**Protocol number: 39308340**

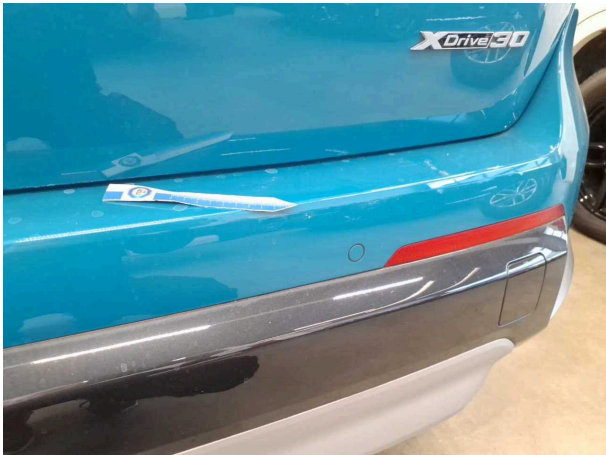
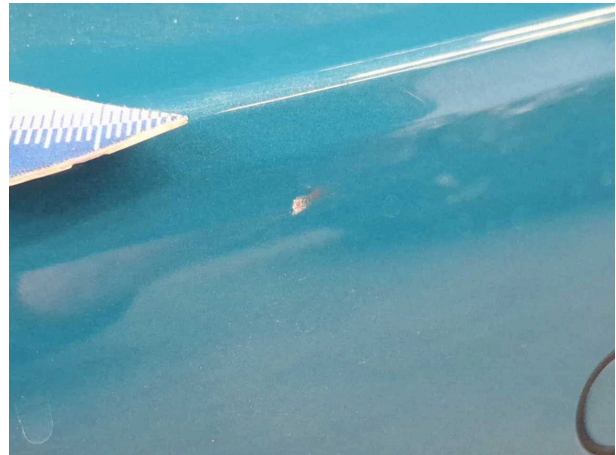
| No. | Component group | Description |
|---|---|---|
| 1 | Rear bumper | Rear bumper - Scratch(es) - Smart repair |

**Damage #1:** Rear bumper: Rear bumper - Scratch(es) - Smart repair

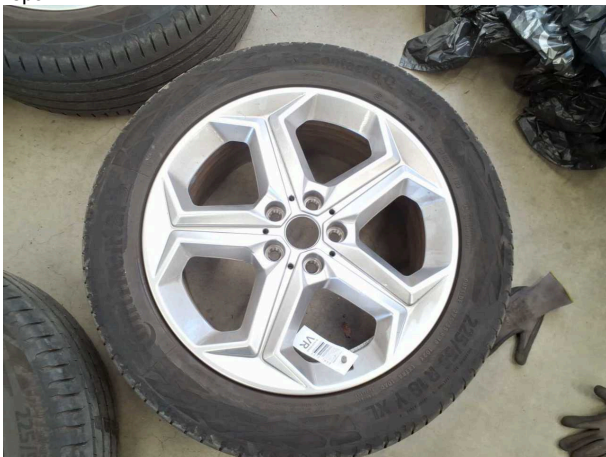
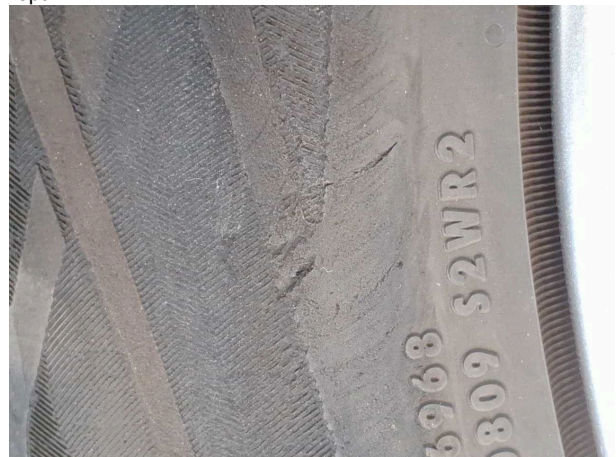
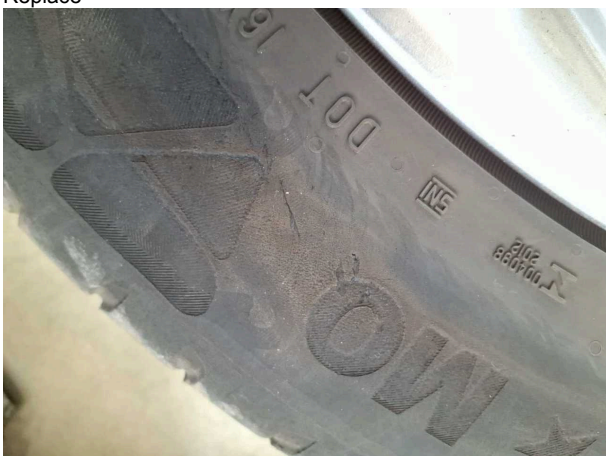
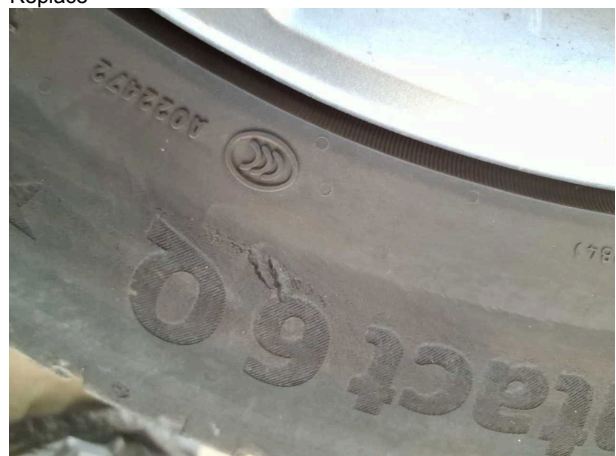
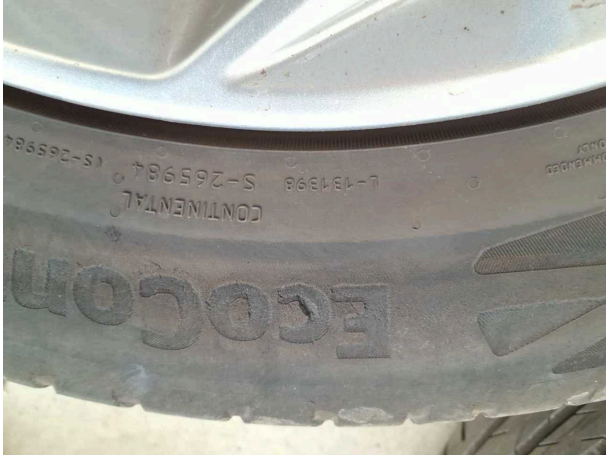
| No. | Component group | Description |
|---|---|---|
| 2 | Wheel / tyres | Tyre - front left side - Broken / torn - Replace |

**Damage #2:** Wheel / tyres: Tyre - front left side - Broken / torn - Replace
