**WBA11CG060CG70224**

## Zustandsbericht

**TÜV SÜD Auto Plus GmbH**  
Gutenbergstr. 13  
70771 Leinfelden-Echterdingen

Inspection date: 3 Apr 2025  
**Protocol number:** 39158568  
Delivery date: 3 Apr 2025

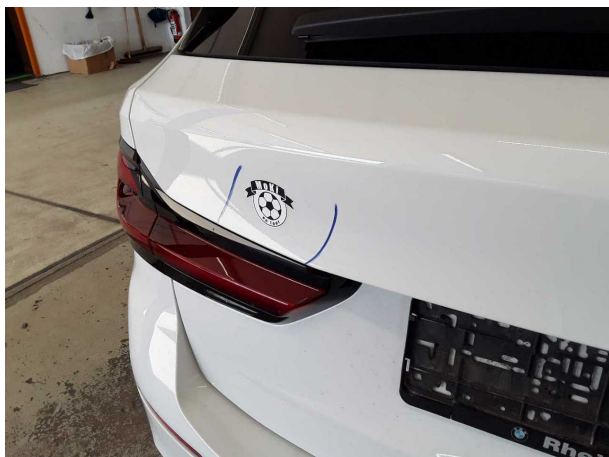
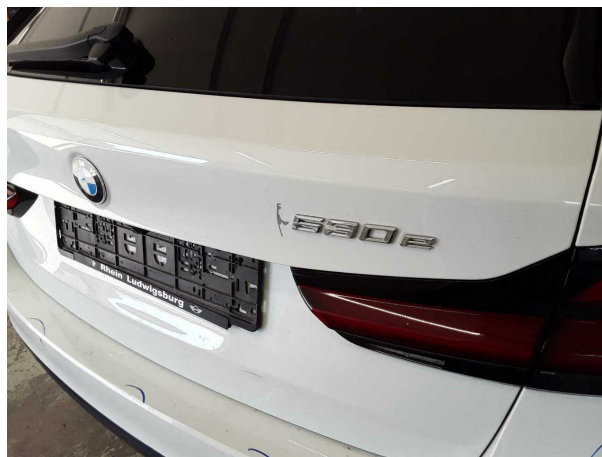
| No. | Component group | Description |
|---|---|---|
| 1 | Boot lid / rear door | Boot lid - Glued / labelled - De-glue / neutralise |

**Damage #1:** Boot lid / rear door: Boot lid - Glued / labelled - De-glue / neutralise

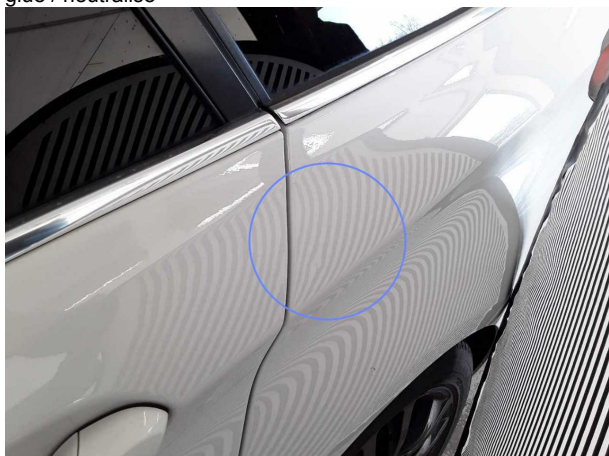
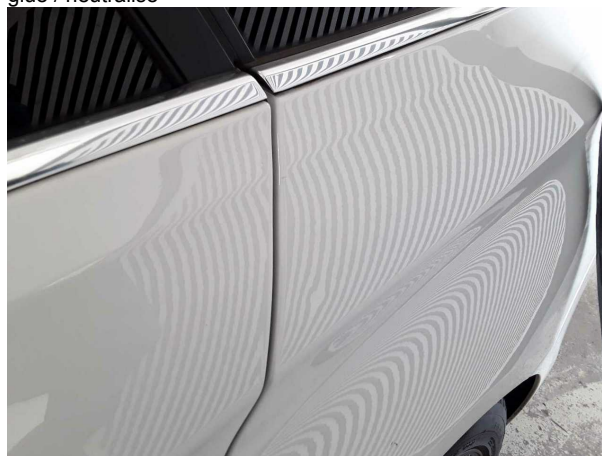
| No. | Component group | Description |
|---|---|---|
| 2 | Side panel - rear left side | Side panel - dent(s) - Smooth repair work |

**Damage #2:** Side panel - rear left side: Side panel - dent(s) - Smooth repair work

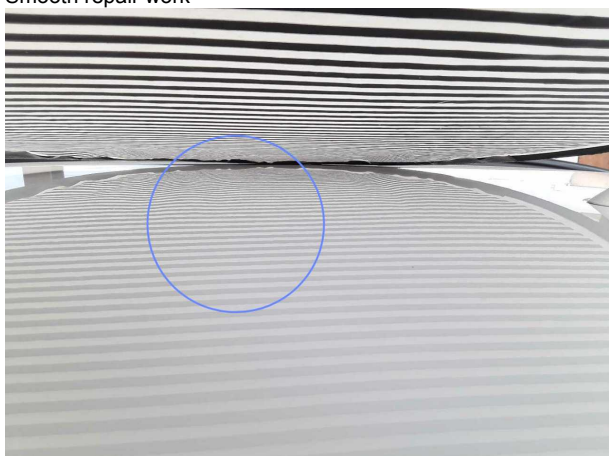
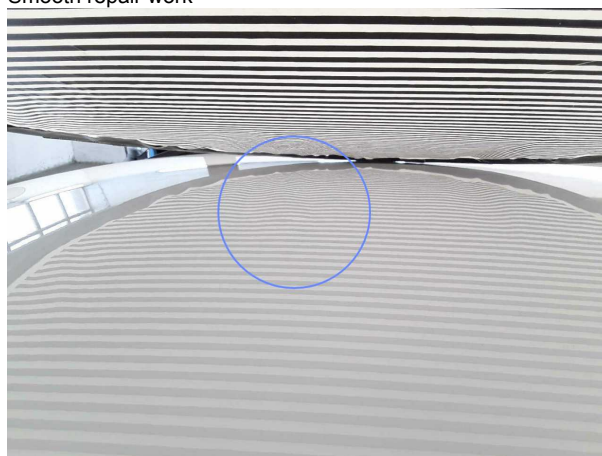
| No. | Component group | Description |
|---|---|---|
| 3 | Roof | Roof - dent(s) - Smooth repair work |

**Damage #3:** Roof: Roof - dent(s) - Smooth repair work

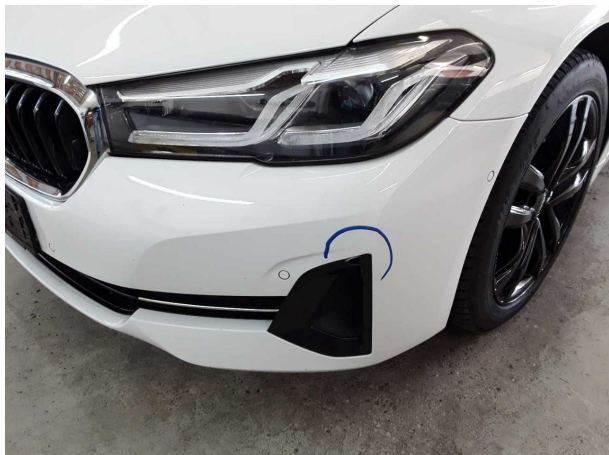
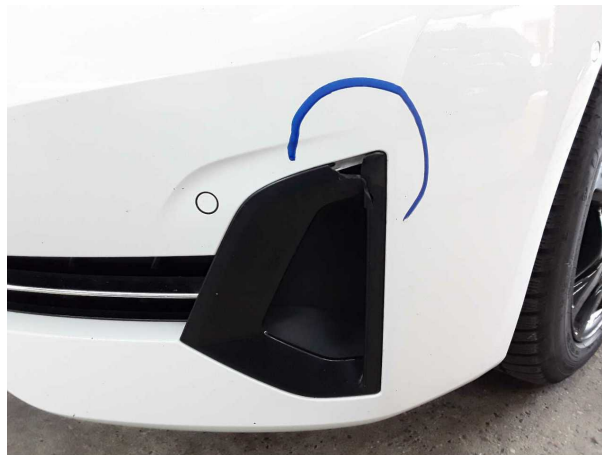
| No. | Component group | Description |
|---|---|---|
| 4 | Front bumper | Air-inlet grille - Broken / torn - Replace |

**Damage #4:** Front bumper: Air-inlet grille - Broken / torn - Replace

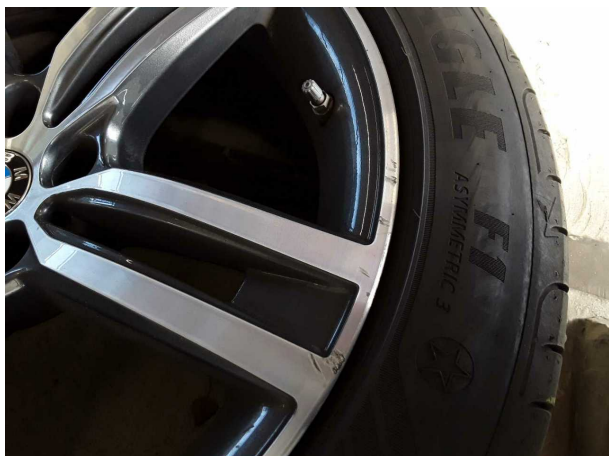
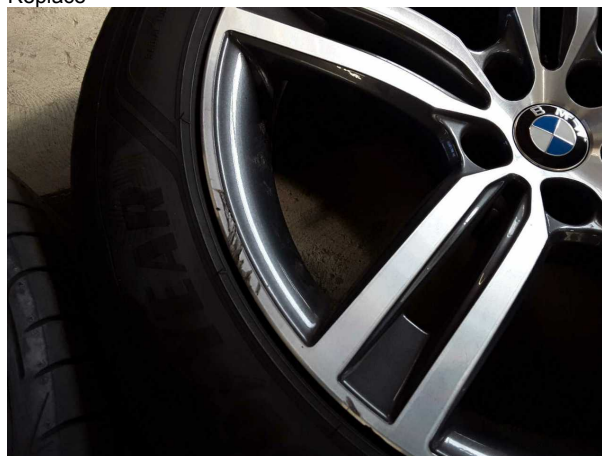
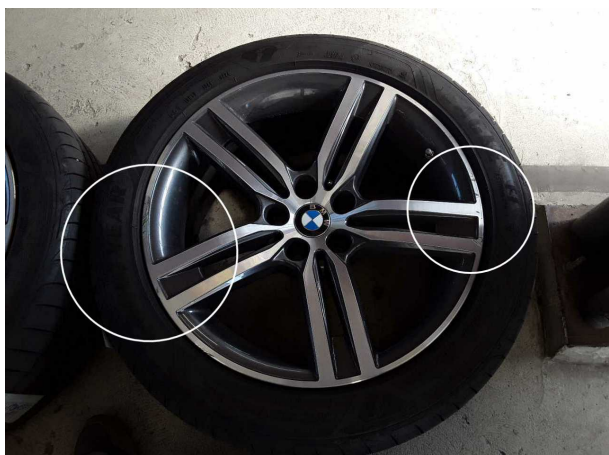
| No. | Component group | Description |
|---|---|---|
| 5 | 2nd wheel set | 1 alloy rim - Scratched - Loss in value |

**Damage #5:** 2nd wheel set: 1 alloy rim - Scratched - Loss in value

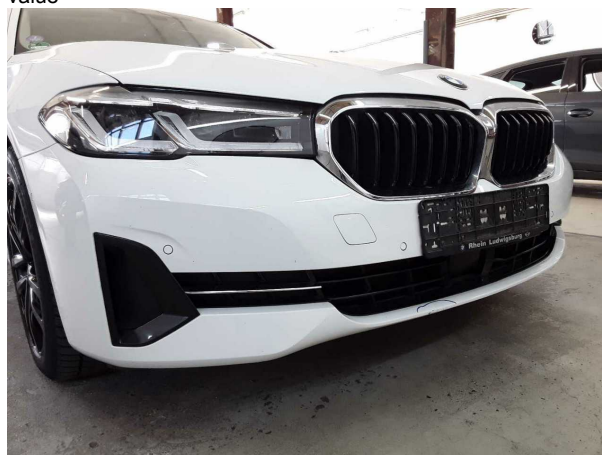
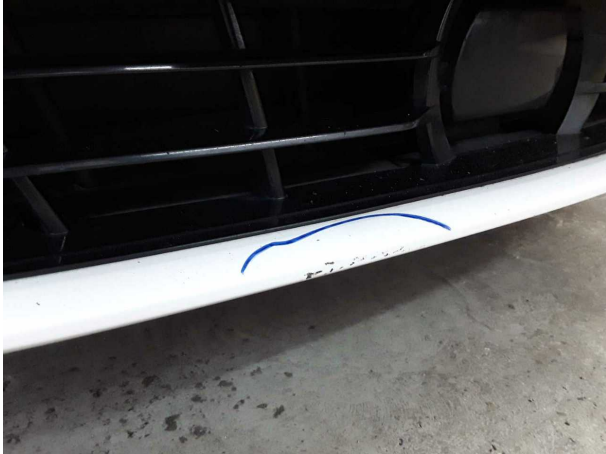
| No. | Component group | Description |
|---|---|---|
| 6 | Front bumper | Front bumper - Scratched - Smart repair |

**Damage #6:** Front bumper: Front bumper - Scratched - Smart repair

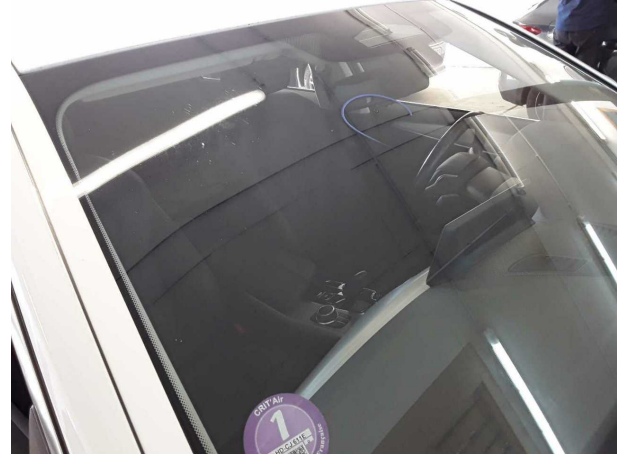
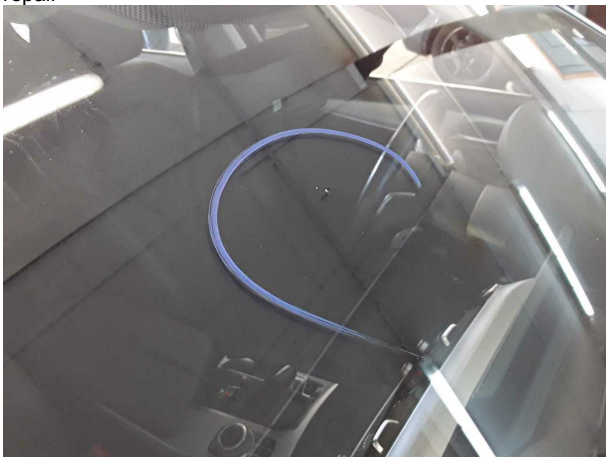
| No. | Component group | Description |
|---|---|---|
| 7 | Vehicle glazing | Windscreen - Stone chips - Replace |

**Damage #7:** Vehicle glazing: Windscreen - Stone chips - Replace

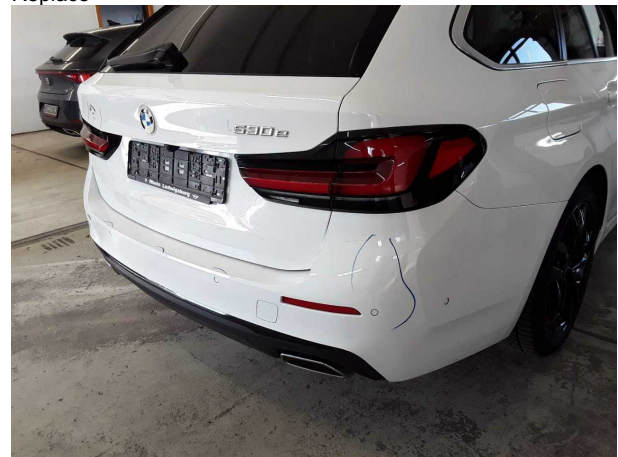
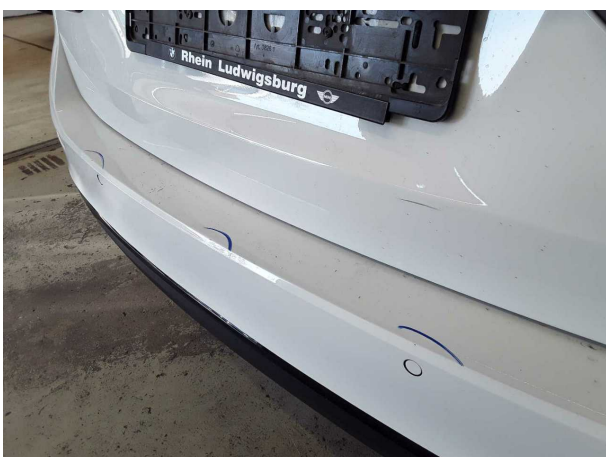
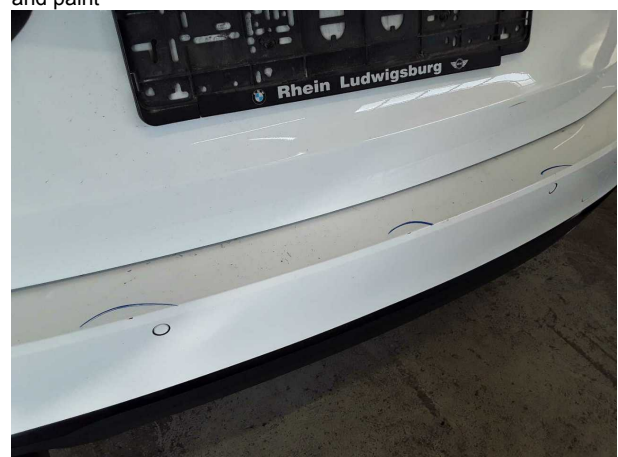
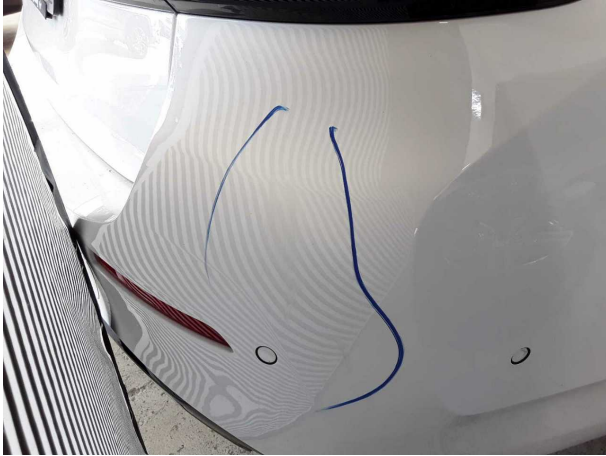
| No. | Component group | Description |
|---|---|---|
| 8 | Rear bumper | Rear bumper - Scratched - Repair and paint |

**Damage #8:** Rear bumper: Rear bumper - Scratched - Repair and paint
