## Vehicle details

## Zustandsbericht

Inspection date: 10 Apr 2025

**Protocol number:** 39347250

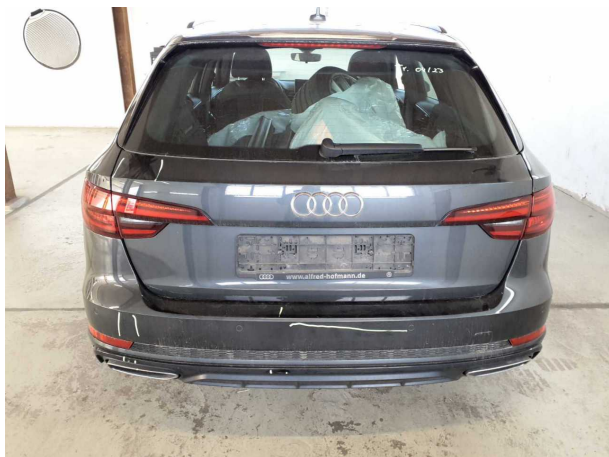
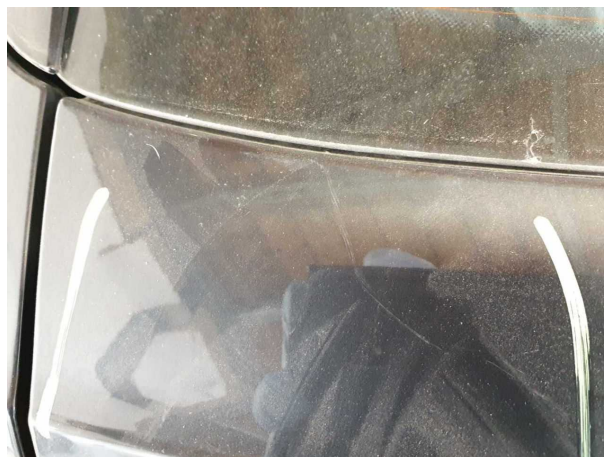
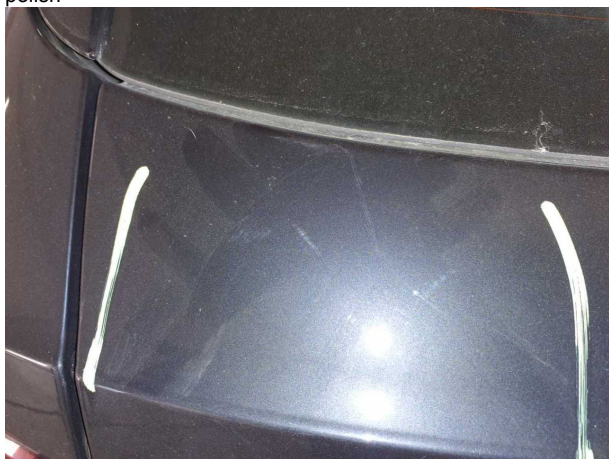
| No. | Component group | Description |
|---|---|---|
| 2 | Boot lid / rear door | Boot lid - Scratch(es) - Cover / polish |

**Damage #2:** Boot lid / rear door: Boot lid - Scratch(es) - Cover / polish

**Damage #2:** Boot lid / rear door: Boot lid - Scratch(es) - Cove...  
polish

**Damage #2:** Boot lid / rear door: Boot lid - Scratch(es) - Cover /  
polish

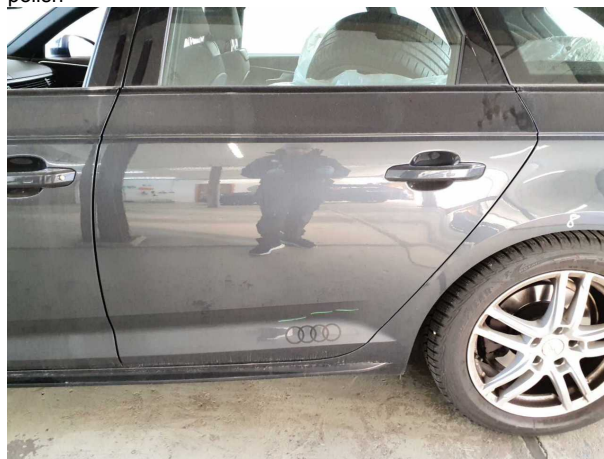
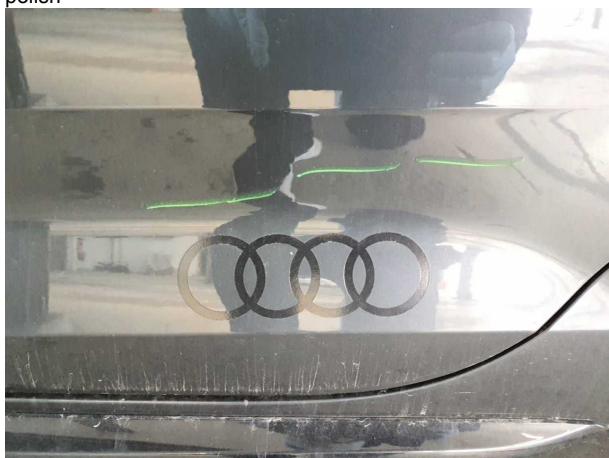
| No. | Component group | Description |
|---|---|---|
| 3 | Door - rear left side | Door - Glued / labelled - De-glue / neutralise |

**Damage #3:** Door - rear left side: Door - Glued / labelled - De-  
glue / neutralise

**Damage #3:** Door - rear left side: Door - Glued / labelled - De-glu...  
neutralise

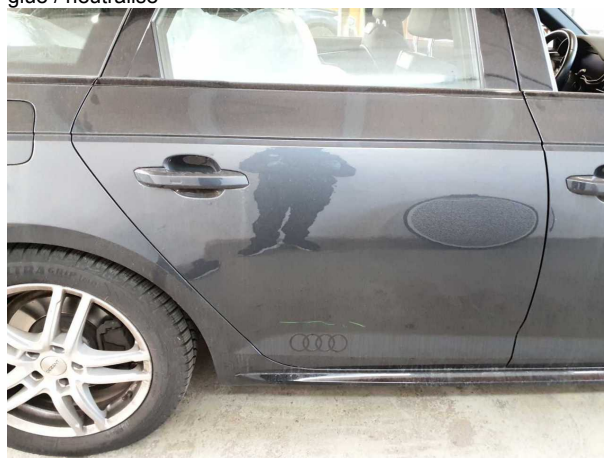
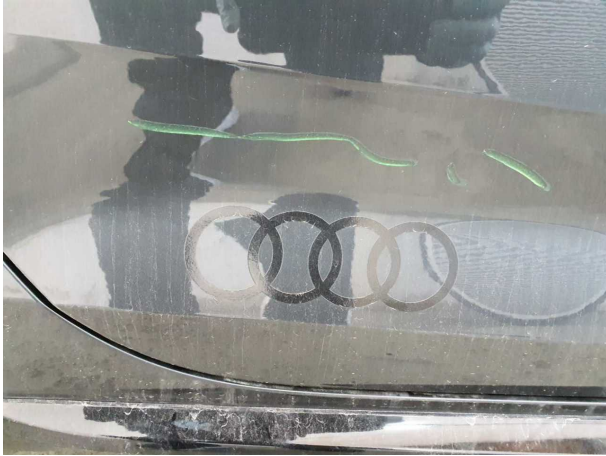
| No. | Component group | Description |
|---|---|---|
| 4 | Door - rear right side | Door - Glued / labelled - De-glue / neutralise |

**Damage #4:** Door - rear right side: Door - Glued / labelled - De-  
glue / neutralise

**Damage #4:** Door - rear right side: Door - Glued / labelled - De-glue / neutralise

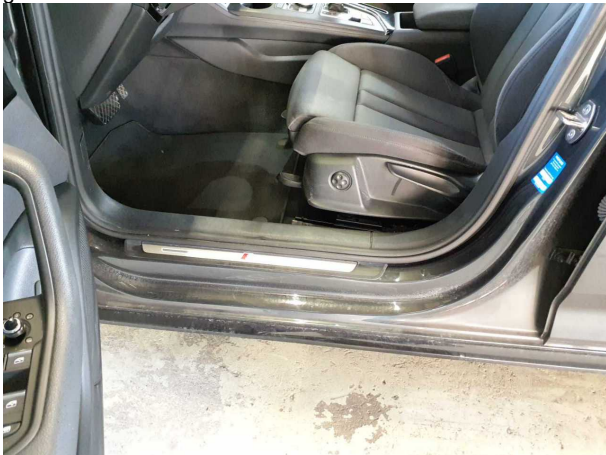
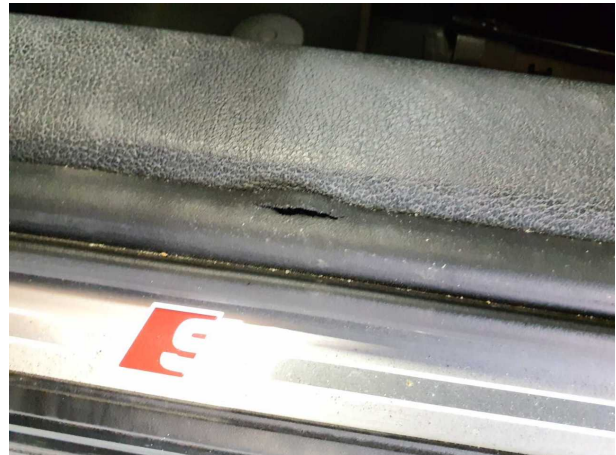
| No. | Component group | Description |
|---|---|---|
| 7 | Body | Door seal - front left side - Damaged - Replace |

**Damage #7:** Body: Door seal - front left side - Damaged - Replace

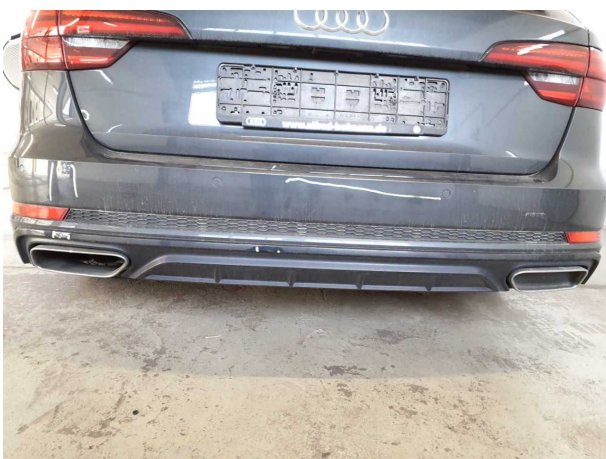
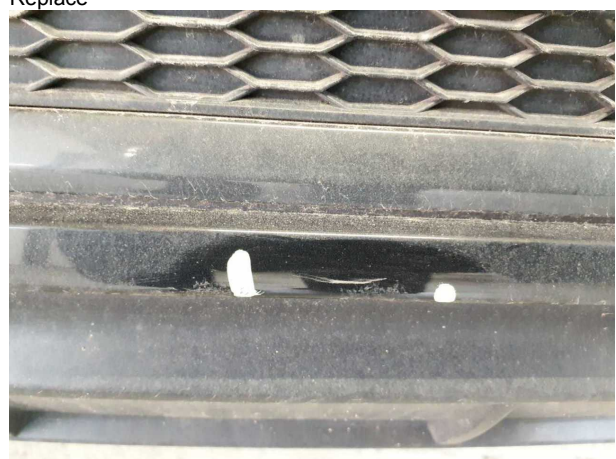
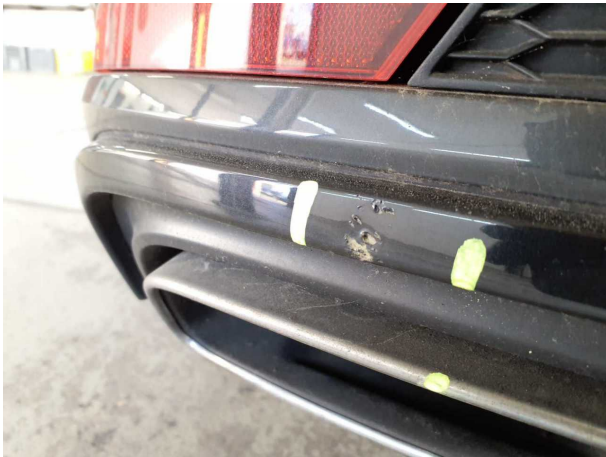
| No. | Component group | Description |
|---|---|---|
| 8 | Rear bumper | Spoiler - Scratched - Replace |

**Damage #8:** Rear bumper: Spoiler - Scratched - Replace

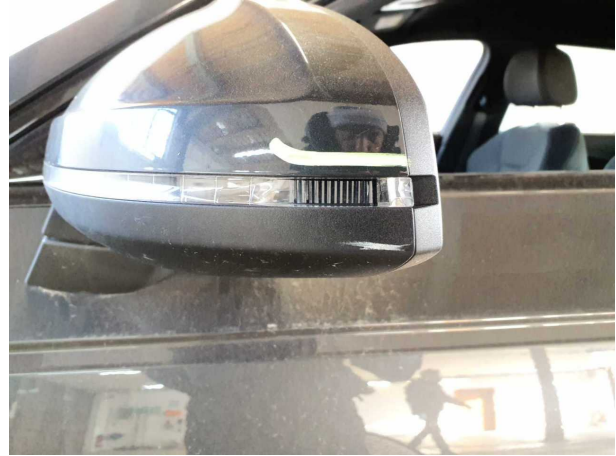
| No. | Component group | Description |
|---|---|---|
| 6 | Wing mirror - left side | Mirror housing - Scratched - Loss in value |

**Damage #6:** Wing mirror - left side: Mirror housing - Scratches...  
Loss in value

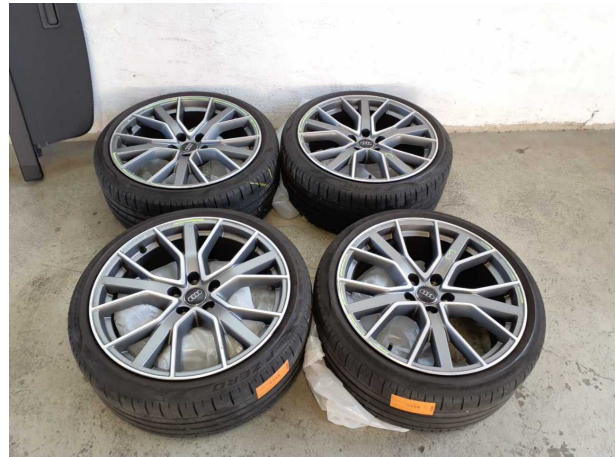
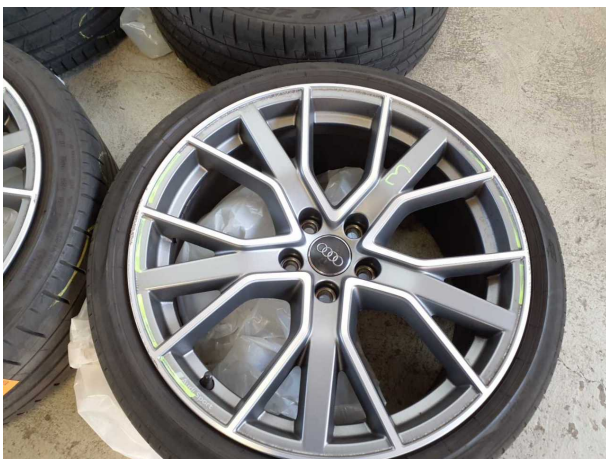
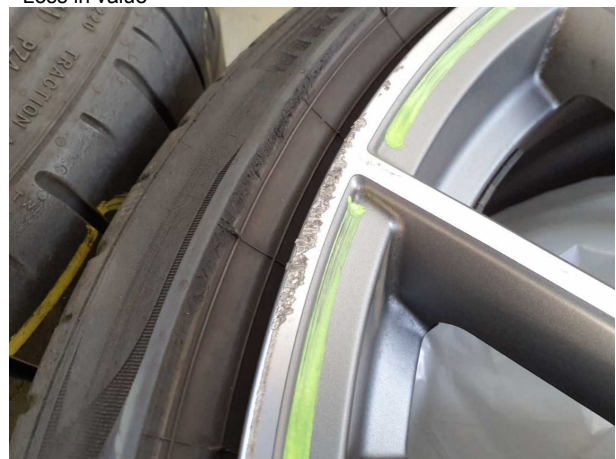
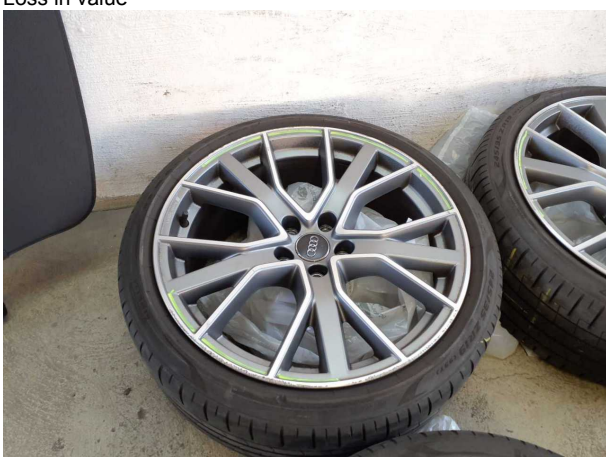
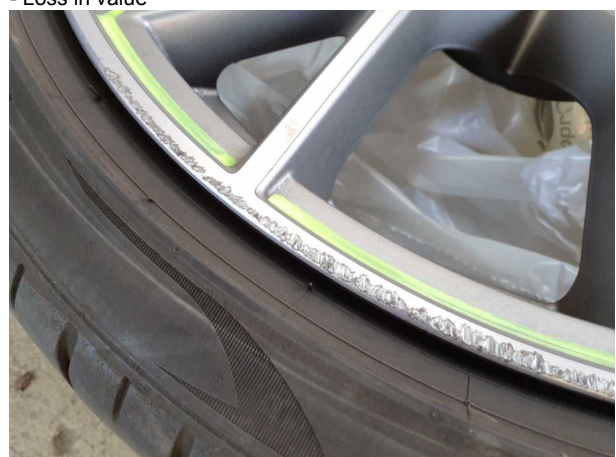
| No. | Component group | Description |
|---|---|---|
| 9 | 2nd wheel set | Alloy rim set - complete - Scratched - Loss in value |

**Damage #9:** 2nd wheel set: Alloy rim set - complete - Scratch...  
- Loss in value

**Damage #9:** 2nd wheel set: Alloy rim set - complete - Scratched -  
Loss in value

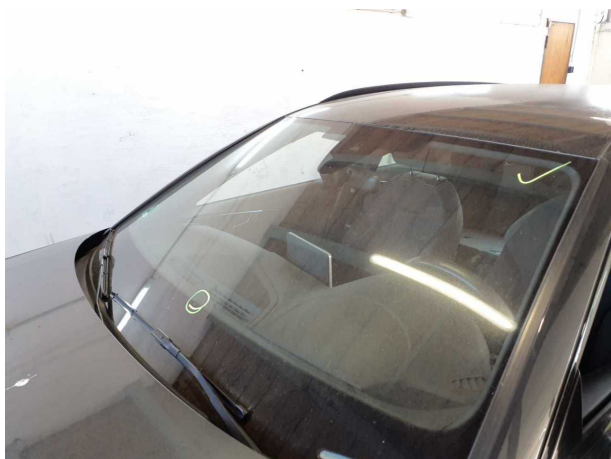
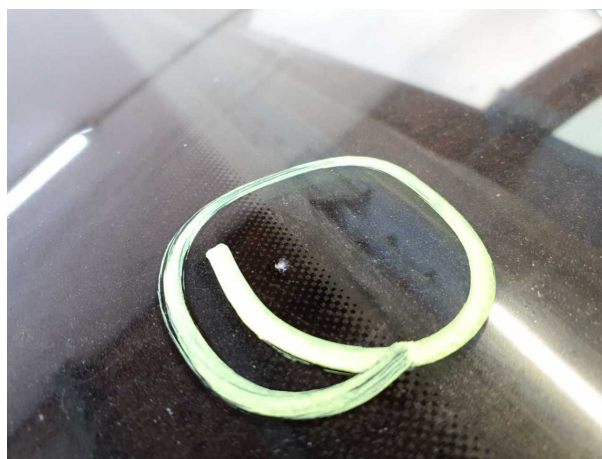
| No. | Component group | Description |
|---|---|---|
| 10 | Vehicle glazing | Windscreen with rain sensor - Stone chips - Replace |

**Damage #10:** Vehicle glazing: Windscreen with rain sensor - Stone chips - Replace

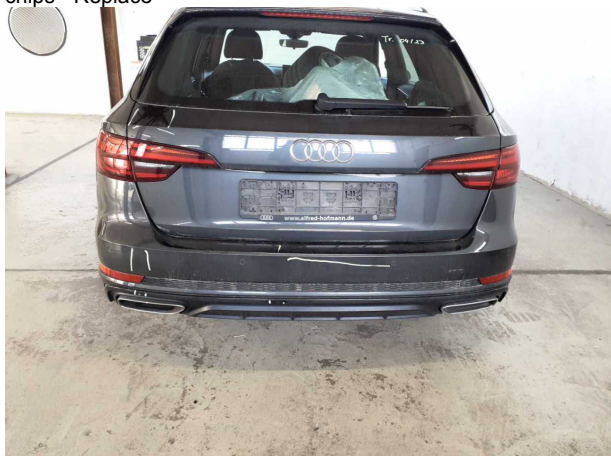
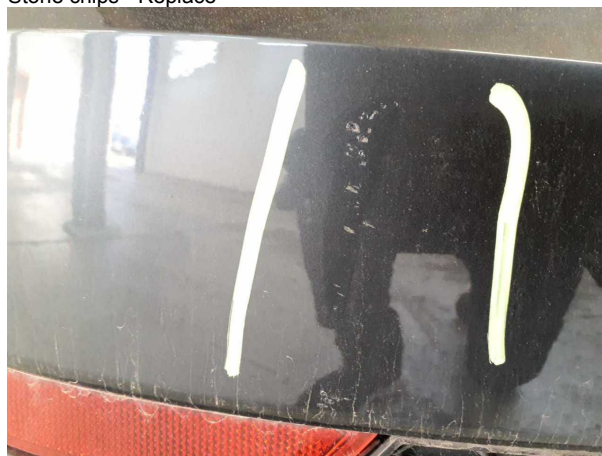
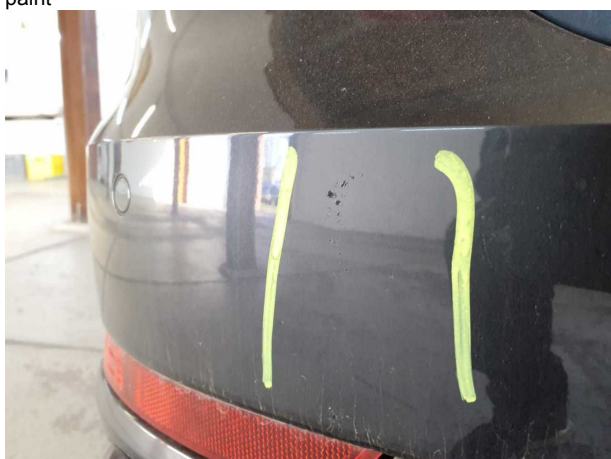
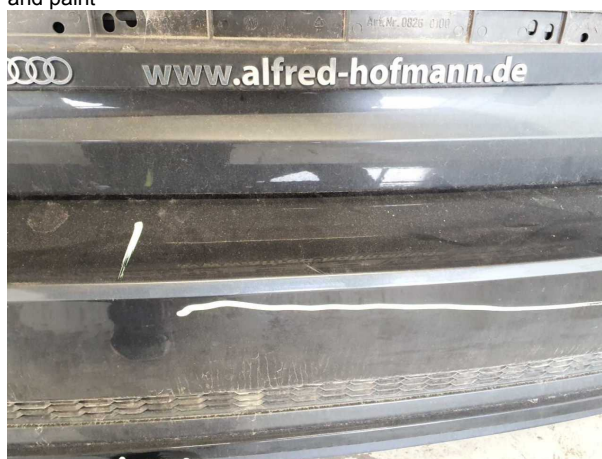
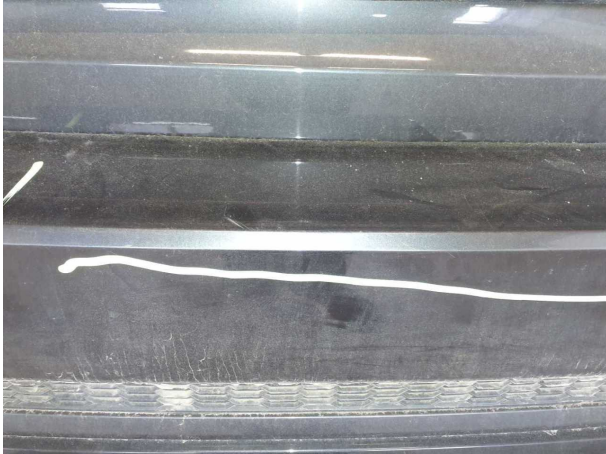
| No. | Component group | Description |
|---|---|---|
| 11 | Rear bumper | Rear bumper - Scratched - Repair and paint |

**Damage #11:** Rear bumper: Rear bumper - Scratched - Repair and paint

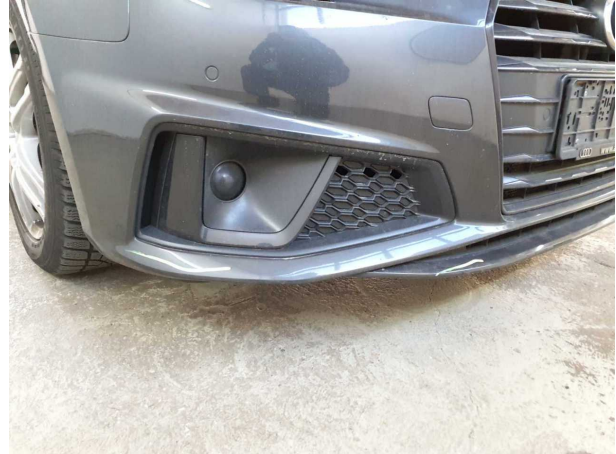
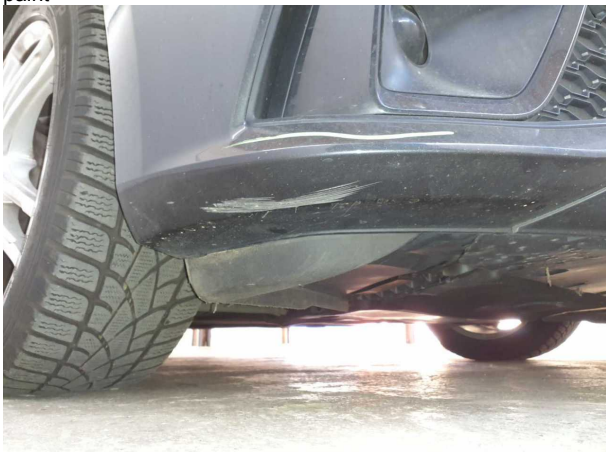
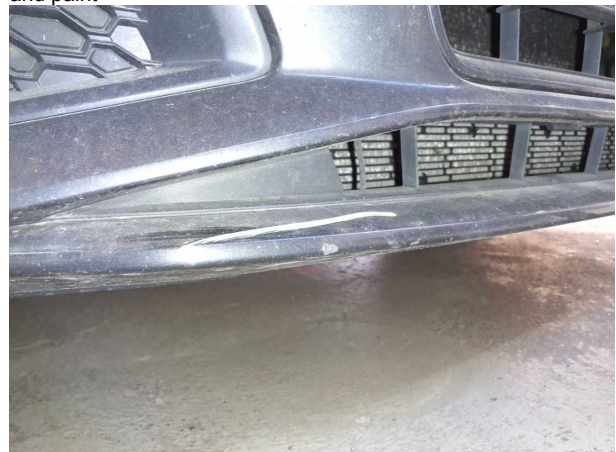
| No. | Component group | Description |
|---|---|---|
| 12 | Front bumper | Front bumper - Scratched - Repair and paint |

**Damage #12:** Front bumper: Front bumper - Scratched - Rep... and paint

**Damage #12:** Front bumper: Front bumper - Scratched - Repair and paint

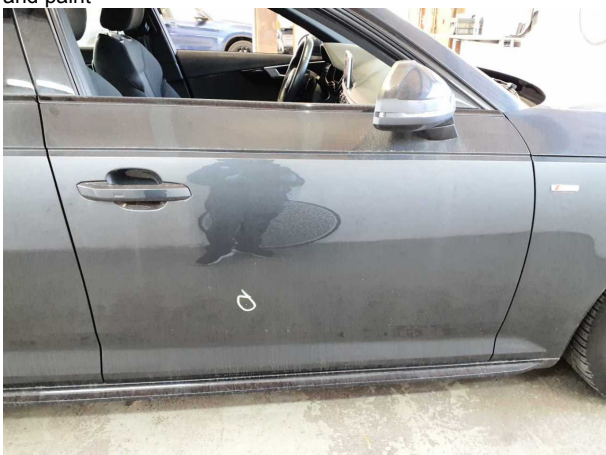
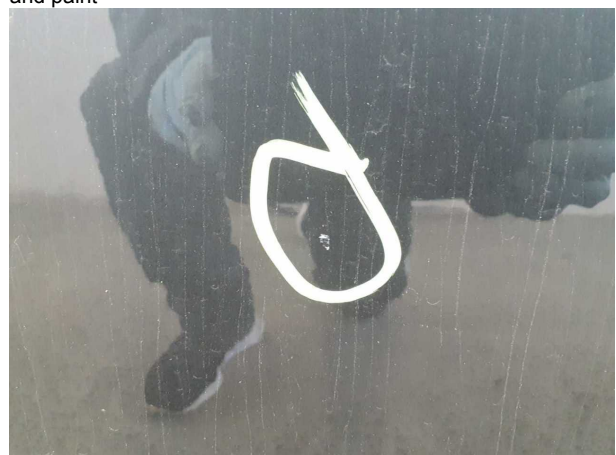
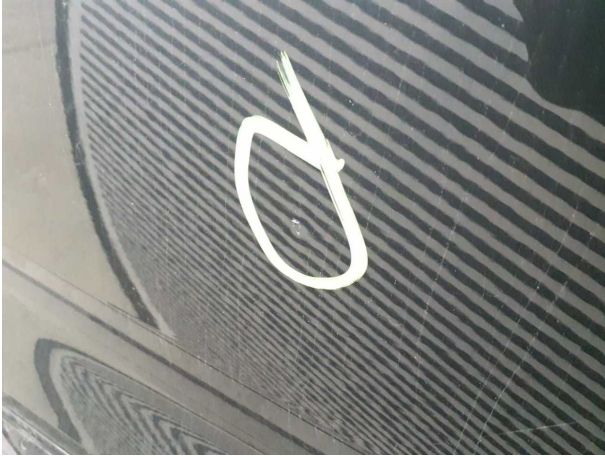
| No. | Component group | Description |
|---|---|---|
| 13 | Door - front right side | Door - Dent / paintcoat damage - Repair and paint |

**Damage #13:** Door - front right side: Door - Dent / paintcoat damage - Repair and paint
