WBA5P51040FL16704

## Vehicle details

| Manufacturer | BMW | Next maintenance in | 15,000 km |
| Type / Model | 330e | Main inspection (Report on hand) | 05/2026 |

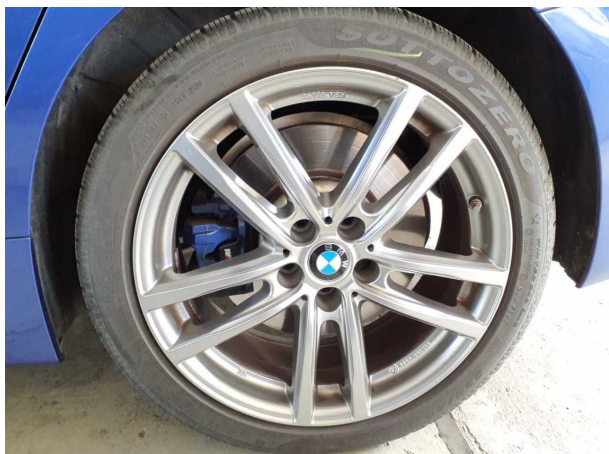
| No. | Component group | Description |
|---|---|---|
| 1 | Wheel / tyres | Alloy rim - rear left side - Scratched - No deduction |

**Damage #1:** Wheel / tyres: Alloy rim - rear left side - Scratched - ... deduction

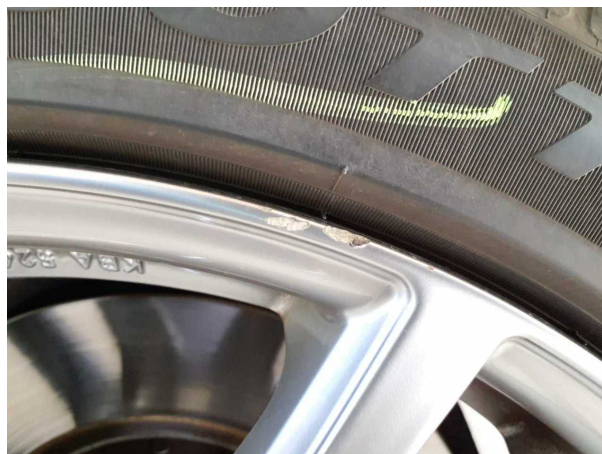
**Damage #1:** Wheel / tyres: Alloy rim - rear left side - Scratched - No deduction

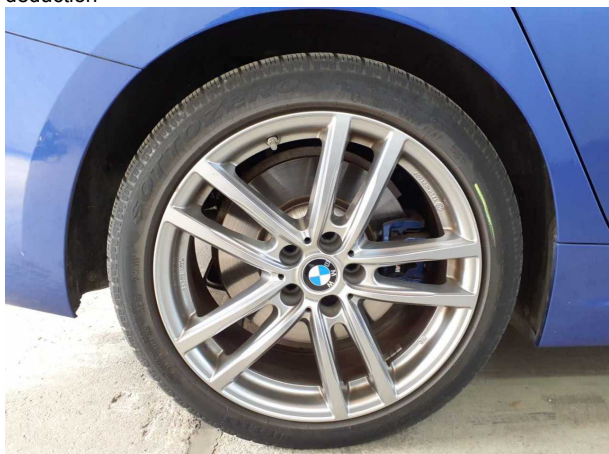
| No. | Component group | Description |
|---|---|---|
| 2 | Wheel / tyres | Alloy rim - rear right side - Scratched - No deduction |

**Damage #2:** Wheel / tyres: Alloy rim - rear right side - Scratched - No deduction

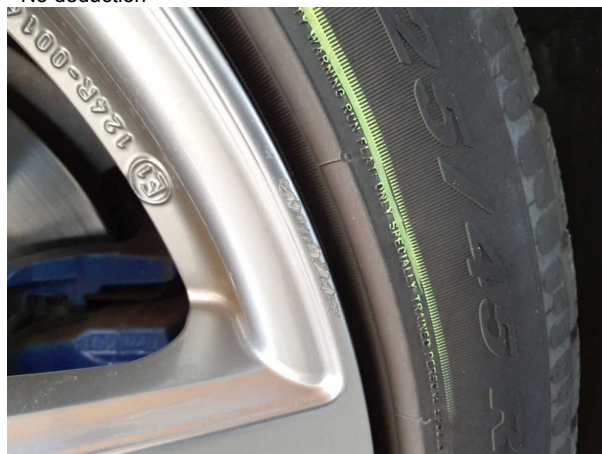
**Damage #2:** Wheel / tyres: Alloy rim - rear right side - Scratched - No deduction

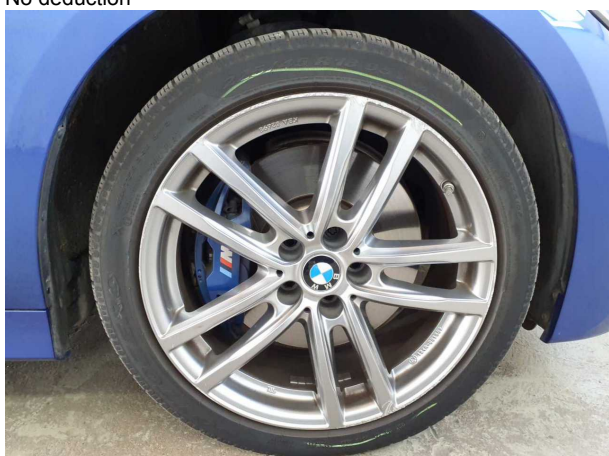
| No. | Component group | Description |
|---|---|---|
| 3 | Wheel / tyres | Alloy rim - front right side - Scratched - No deduction |

**Damage #3:** Wheel / tyres: Alloy rim - front right side - Scratched - No deduction

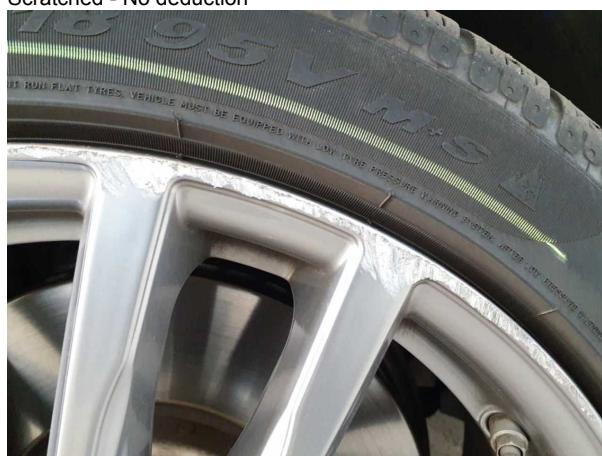
**Damage #3:** Wheel / tyres: Alloy rim - front right side - Scratched - No deduction

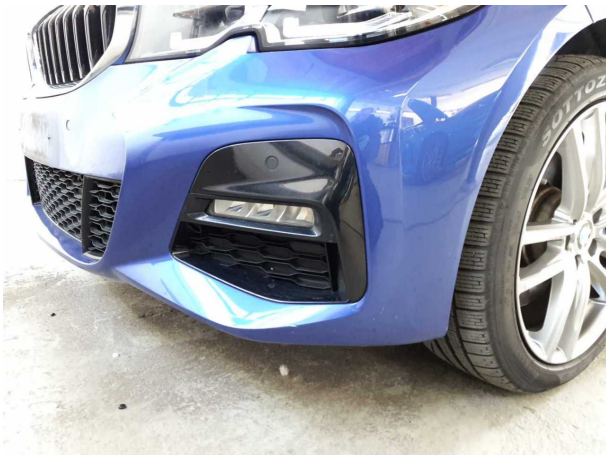
| No. | Component group | Description |
|---|---|---|
| 4 | Front bumper | Front bumper - Scratched - Smart repair |

**Damage #4:** Front bumper: Front bumper - Scratched - Smart repair

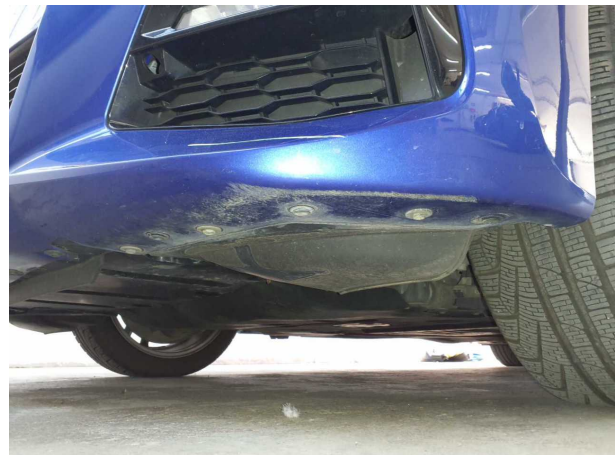
**Damage #4:** Front bumper: Front bumper - Scratched - Smart repair

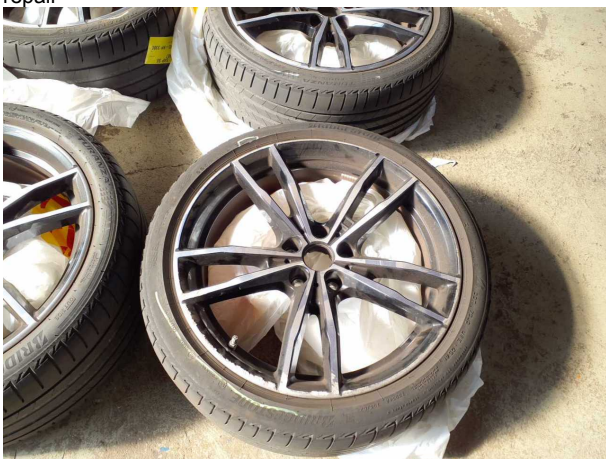
| No. | Component group | Description |
|---|---|---|
| 5 | 2nd wheel set | 1 tyre - Damaged - Replace |

**Damage #5:** 2nd wheel set: 1 tyre - Damaged - Replace

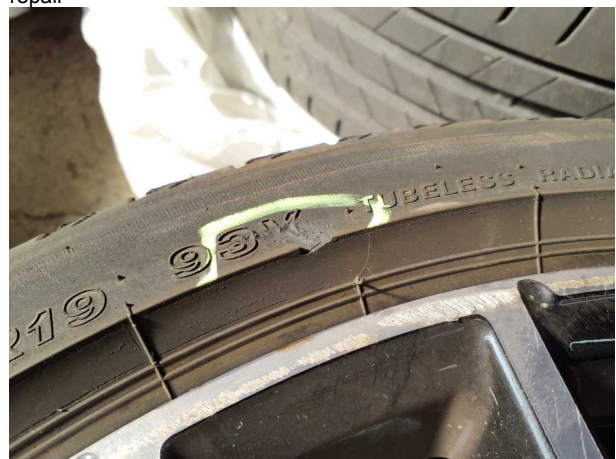
**Damage #5:** 2nd wheel set: 1 tyre - Damaged - Replace

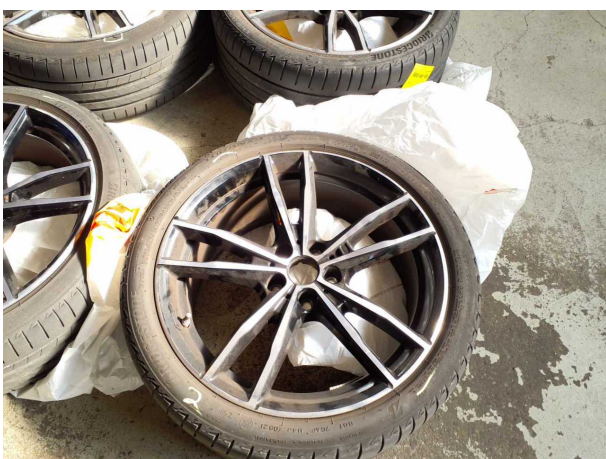
| No. | Component group | Description |
|---|---|---|
| 6 | 2nd wheel set | 2 tyres - Worn - Replace |

| Axle | Tyre size | Manufacturer | Type of tyre | Tread depth | Roadworthy | Permissibility |
|---|---|---|---|---|---|---|
| 2 | 255/35 R19 96Y | Bridgestone | Summer tyres | 2mm - 2mm | Not o.k. | |

**Damage #6:** 2nd wheel set: 2 tyres - Worn - Replace

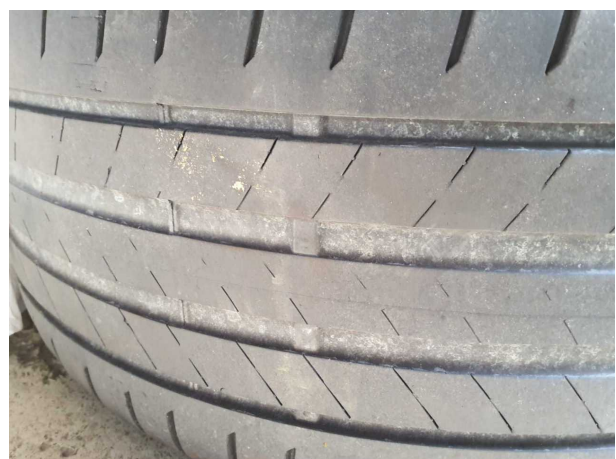
**Damage #6:** 2nd wheel set: 2 tyres - Worn - Replace

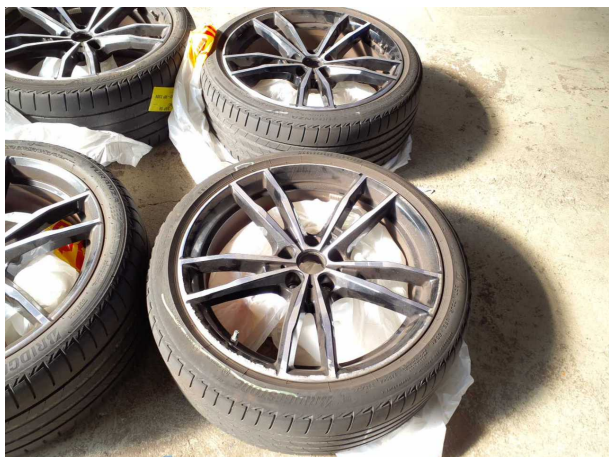
| No. | Component group | Description |
|---|---|---|
| 7 | 2nd wheel set | 3 alloy rims - Scratched - Loss in value |

Damage #7: 2nd wheel set: 3 alloy rims - Scratched - Loss in value

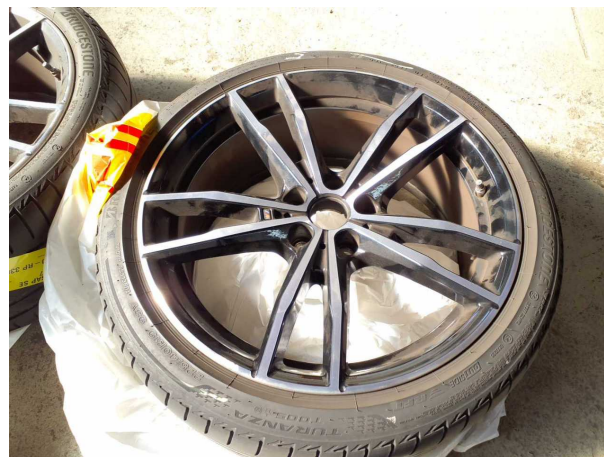
Damage #7: 2nd wheel set: 3 alloy rims - Scratched - Loss in value

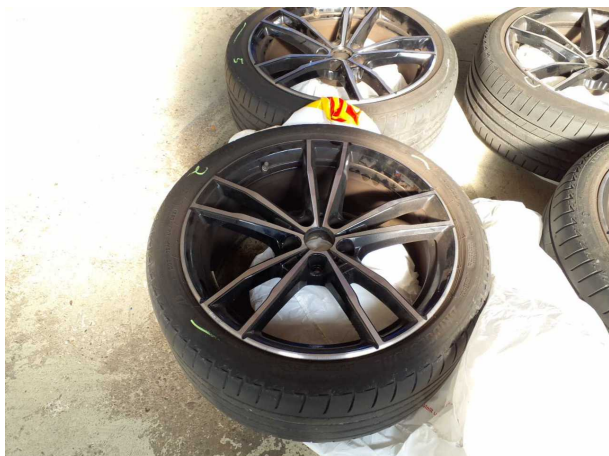
Damage #7: 2nd wheel set: 3 alloy rims - Scratched - Loss in value

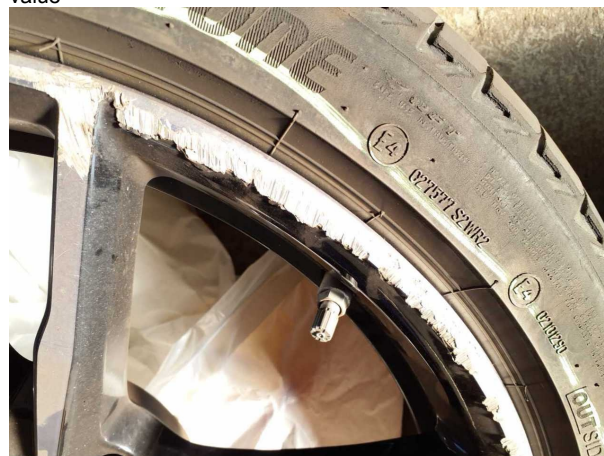
Damage #7: 2nd wheel set: 3 alloy rims - Scratched - Loss in value

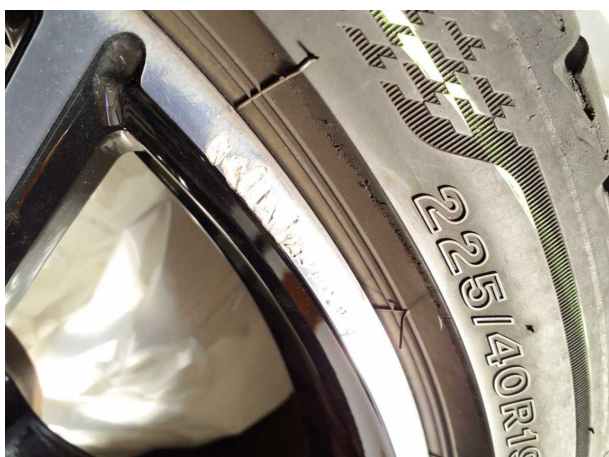
Damage #7: 2nd wheel set: 3 alloy rims - Scratched - Loss in value

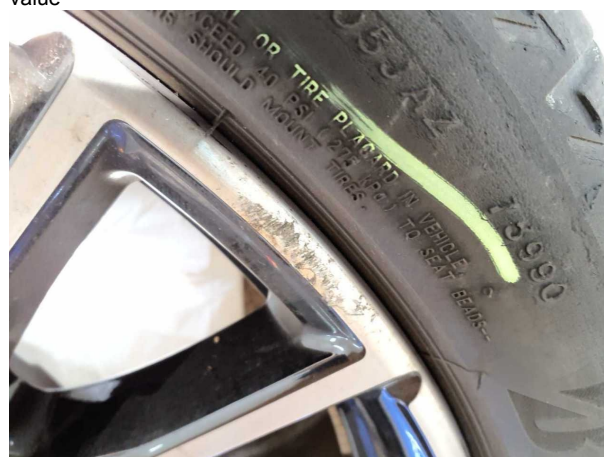
Damage #7: 2nd wheel set: 3 alloy rims - Scratched - Loss in value

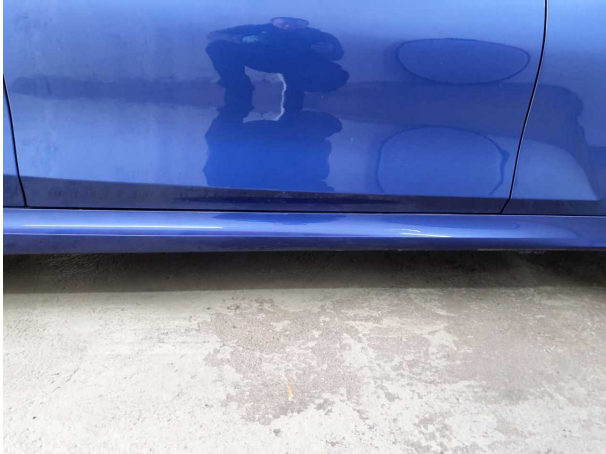
| No. | Component group | Description |
|---|---|---|
| 8 | Sill - right side | Trim - Scratched - Paint |

**Damage #8:** Sill - right side: Trim - Scratched - Paint

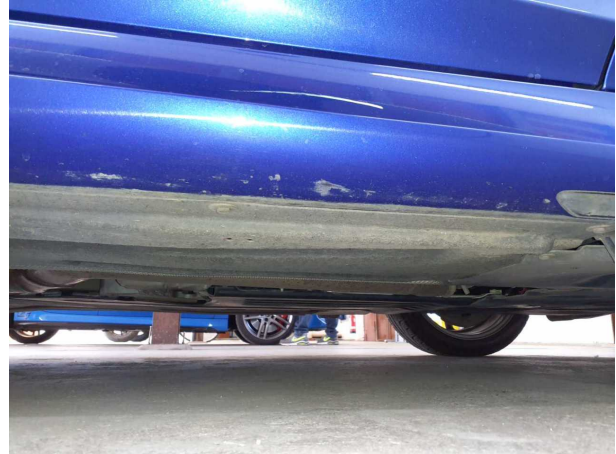
**Damage #8:** Sill - right side: Trim - Scratched - Paint

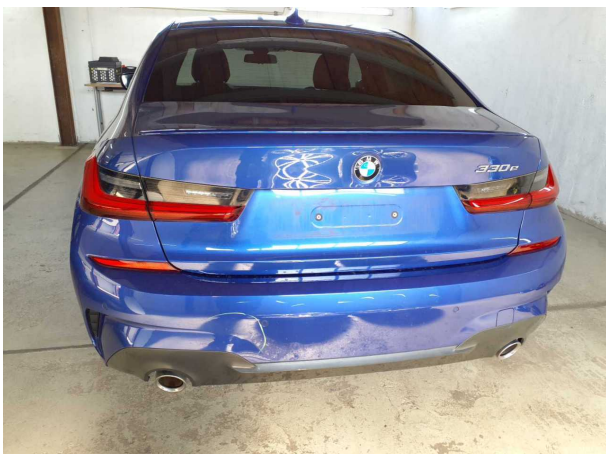
| No. | Component group | Description |
|---|---|---|
| 9 | Rear bumper | Rear bumper - Scratched - Repair and paint |

**Damage #9:** Rear bumper: Rear bumper - Scratched - Repair and paint

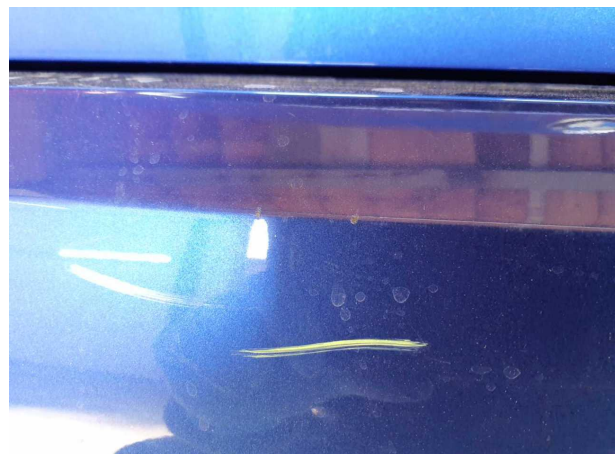
**Damage #9:** Rear bumper: Rear bumper - Scratched - Repair and paint

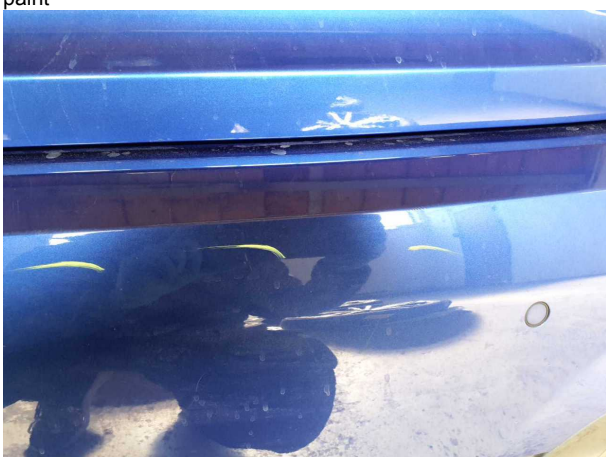
**Damage #9:** Rear bumper: Rear bumper - Scratched - Repair and paint

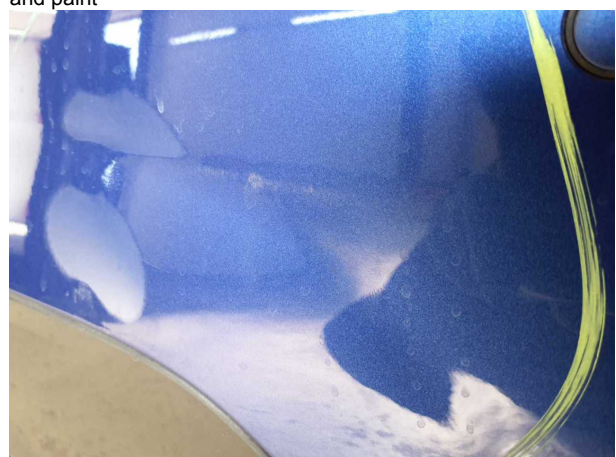
**Damage #9:** Rear bumper: Rear bumper - Scratched - Repair and paint

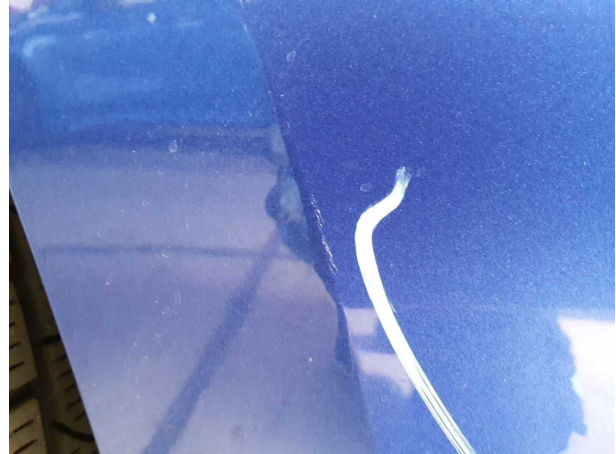
**Damage #9:** Rear bumper: Rear bumper - Scratched - Repair and paint

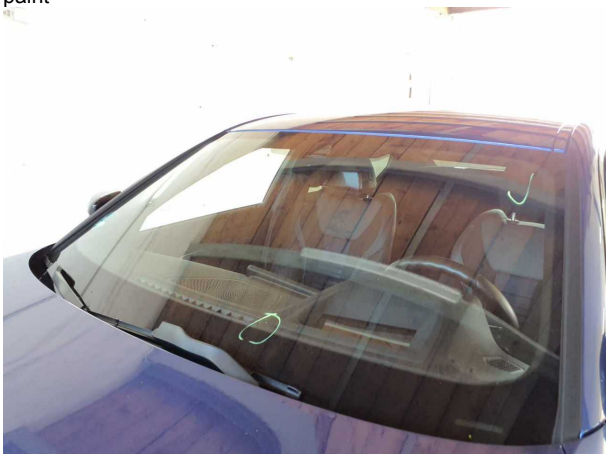
| No. | Component group | Description |
|---|---|---|
| 10 | Vehicle glazing | Windscreen - Stone chips - Replace |

**Damage #10:** Vehicle glazing: Windscreen - Stone chips - Replace

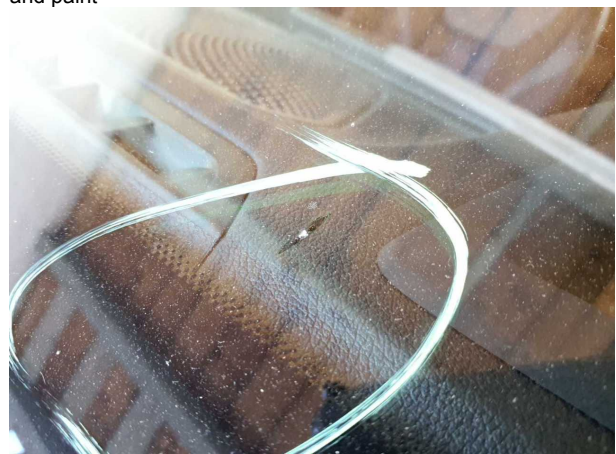
**Damage #10:** Vehicle glazing: Windscreen - Stone chips - Replace

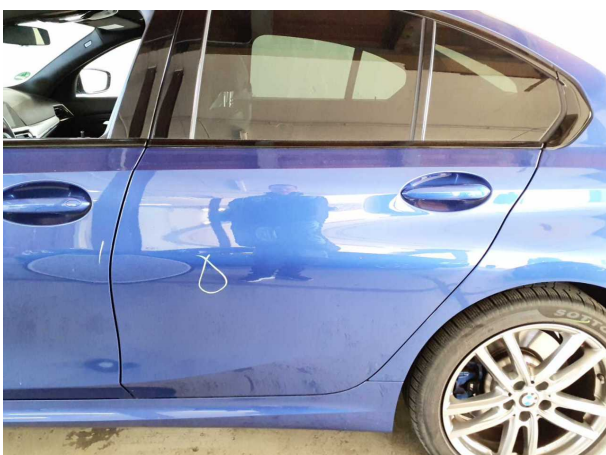
| No. | Component group | Description |
|---|---|---|
| 11 | Door - rear left side | Door - Dent / paintcoat damage - Repair and paint |

**Damage #11:** Door - rear left side: Door - Dent / paintcoat damage...  
Repair and paint

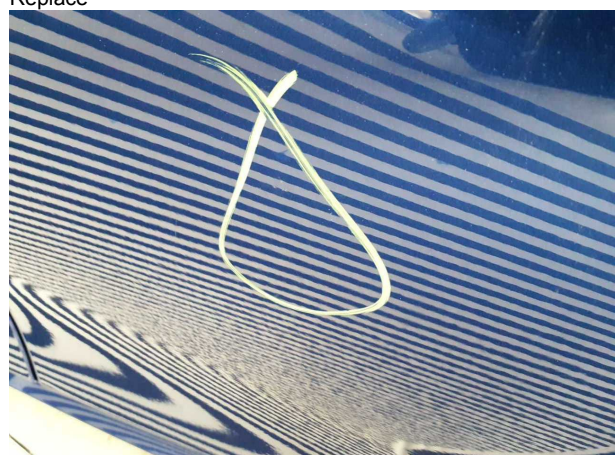
**Damage #11:** Door - rear left side: Door - Dent / paintcoat damage - Repair and paint

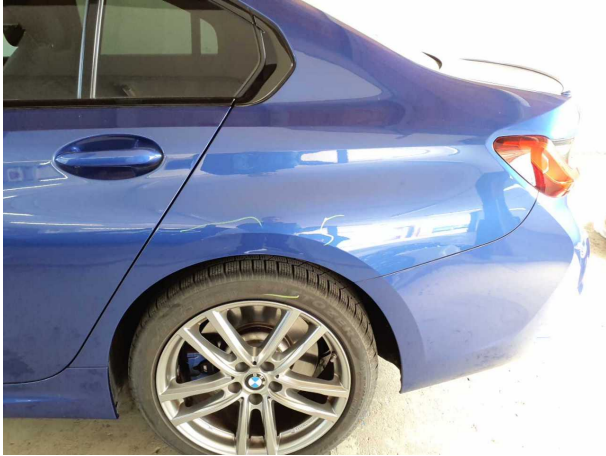
| No. | Component group | Description |
|---|---|---|
| 12 | Side panel - rear left side | Side panel - Dent / paintcoat damage - Repair and paint |

**Damage #12:** Side panel - rear left side: Side panel - Dent / paintcoat damage - Repair and paint

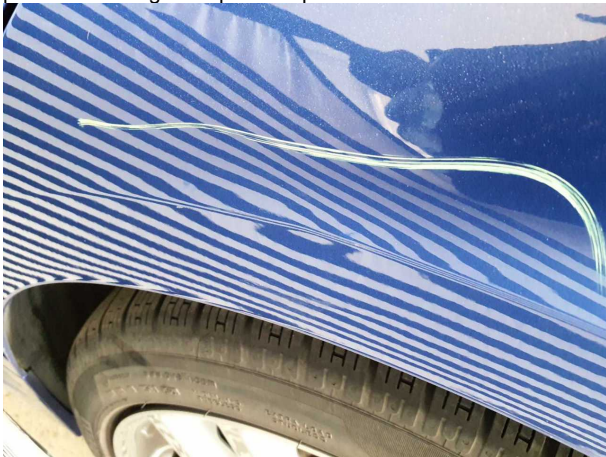
**Damage #12:** Side panel - rear left side: Side panel - Dent / paintcoat damage - Repair and paint

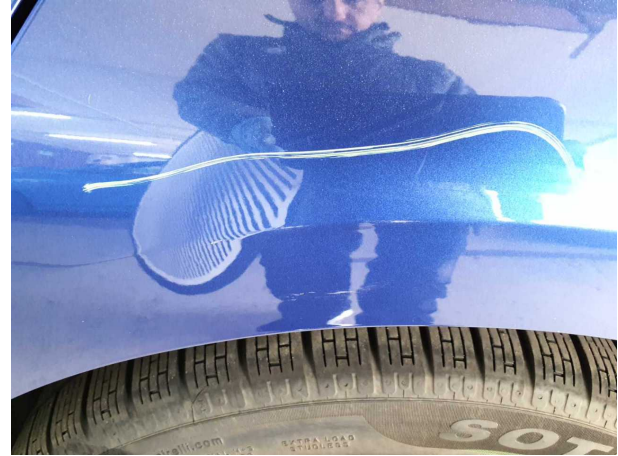
**Damage #12:** Side panel - rear left side: Side panel - Dent / paintcoat damage - Repair and paint
