**TÜV SÜD Auto Plus GmbH**  
Gutenbergstr. 13  
70771 Leinfelden-Echterdingen

Inspection date: 7 Apr 2025  
**Protocol number:** 39204349  
Delivery date: 7 Apr 2025

**WBA6N71040FK99912**

| <b>Manufacturer</b> | BMW | <b>Next maintenance in</b> | 22,000 km |

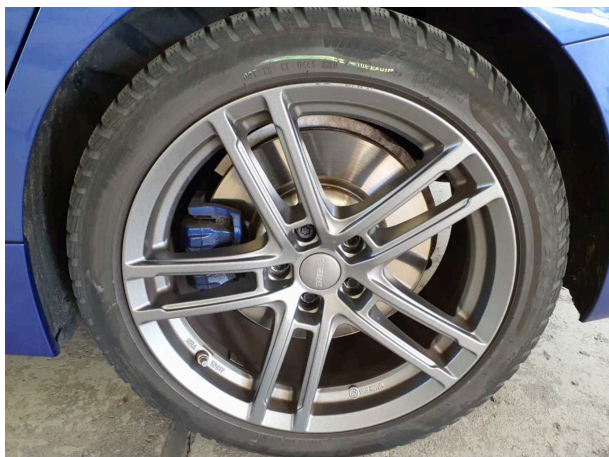
| No. | Component group | Description |
|---|---|---|
| 1 | Wheel / tyres | Alloy rim - rear left side - Scratched - No deduction |

**Damage #1:** Wheel / tyres: Alloy rim - rear left side - Scratched - ...  
deduction

**Damage #1:** Wheel / tyres: Alloy rim - rear left side - Scratched  
- No deduction

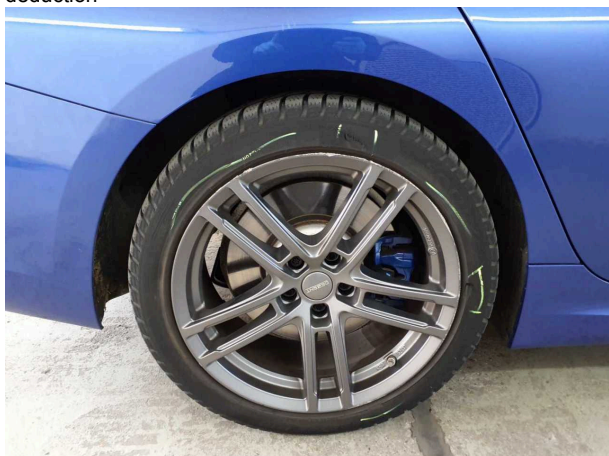
| No. | Component group | Description |
|---|---|---|
| 2 | Wheel / tyres | Alloy rim - rear right side - Scratched - No deduction |

**Damage #2:** Wheel / tyres: Alloy rim - rear right side - Scratched -  
No deduction

**Damage #2:** Wheel / tyres: Alloy rim - rear right side -  
Scratched - No deduction

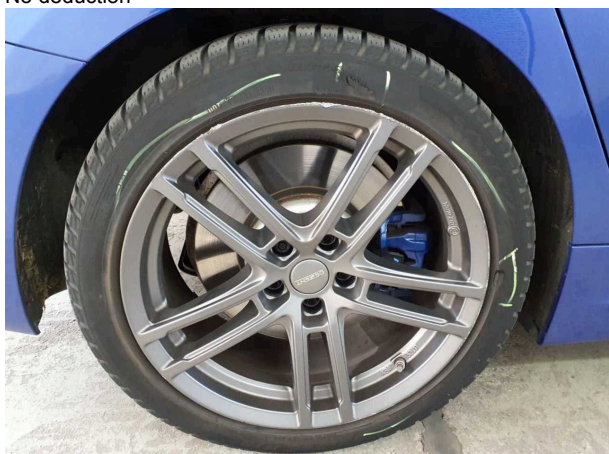
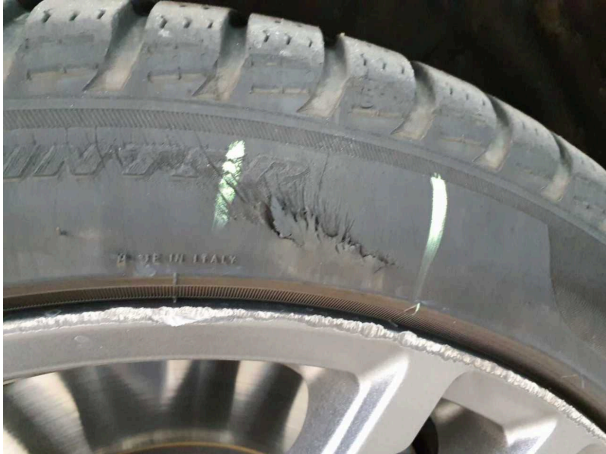
| No. | Component group | Description |
|---|---|---|
| 3 | Wheel / tyres | Tyre - rear right side - Damaged - No deduction |

**Damage #3:** Wheel / tyres: Tyre - rear right side - Damaged - No  
deduction

**Damage #3:** Wheel / tyres: Tyre - rear right side - Damaged -  
No deduction

**Damage #3:** Wheel / tyres: Tyre - rear right side - Damaged - No deduction

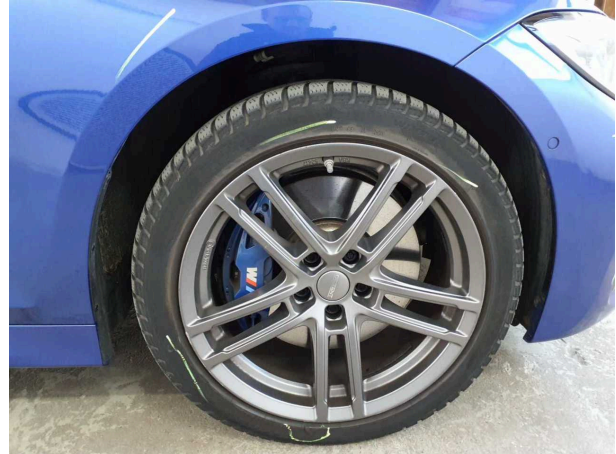
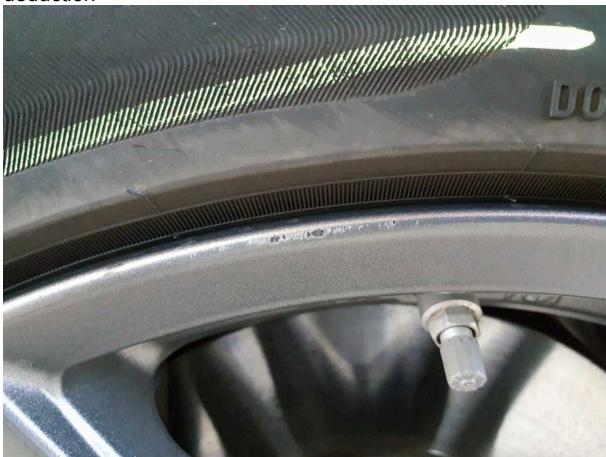
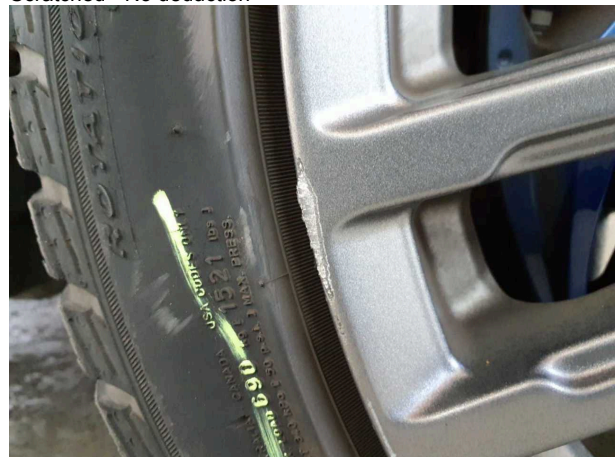
| No. | Component group | Description |
|---|---|---|
| 4 | Wheel / tyres | Alloy rim - front right side - Scratched - No deduction |

**Damage #4:** Wheel / tyres: Alloy rim - front right side - Scratched - No deduction

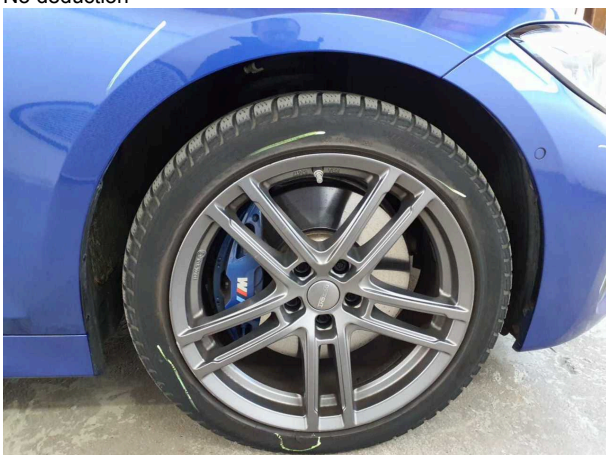
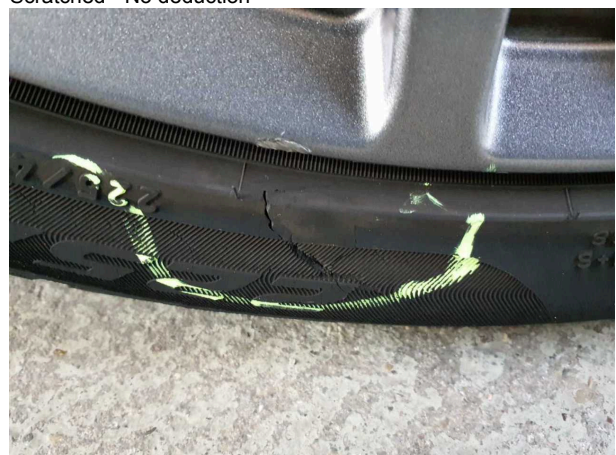
| No. | Component group | Description |
|---|---|---|
| 5 | Wheel / tyres | Tyre - front right side - Damaged - No deduction |

**Damage #5:** Wheel / tyres: Tyre - front right side - Damaged - No deduction

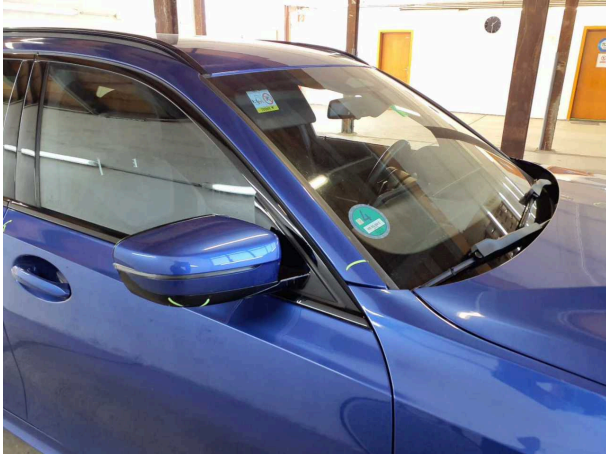
| No. | Component group | Description |
|---|---|---|
| 6 | Roof | Roof rail - right side - Scratch(es) - Cover / polish |

**Damage #6:** Roof: Roof rail - right side - Scratch(es) - Cover / polish

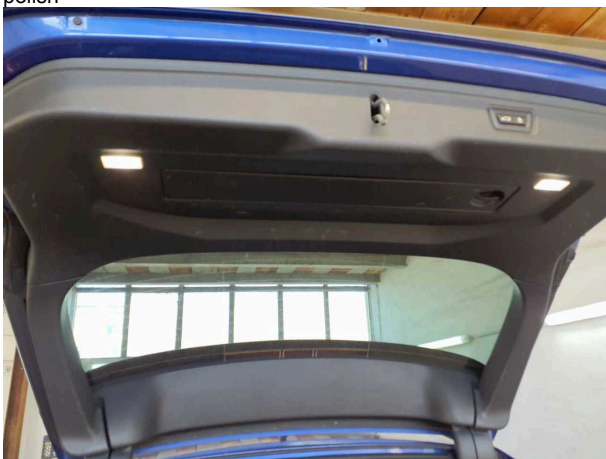
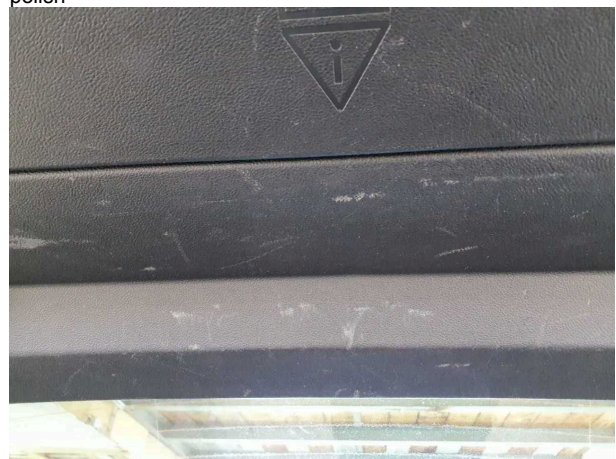
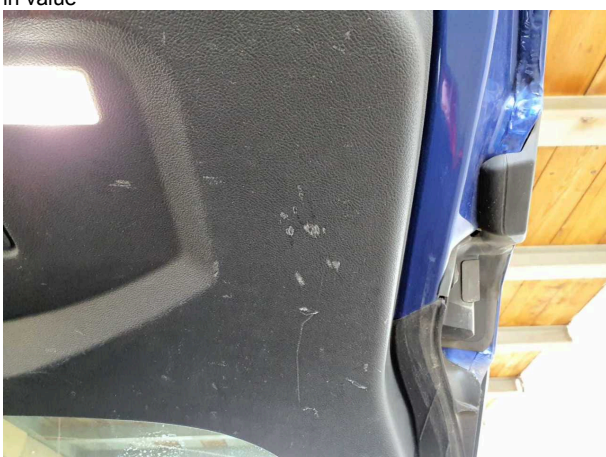
| No. | Component group | Description |
|---|---|---|
| 9 | Trim / covers | Boot lid - interior trim - Scratched - Loss in value |

**Damage #9:** Trim / covers: Boot lid - interior trim - Scratched - Loss in value

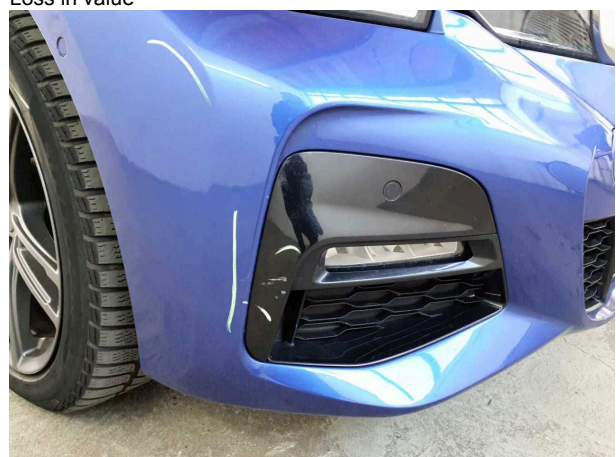
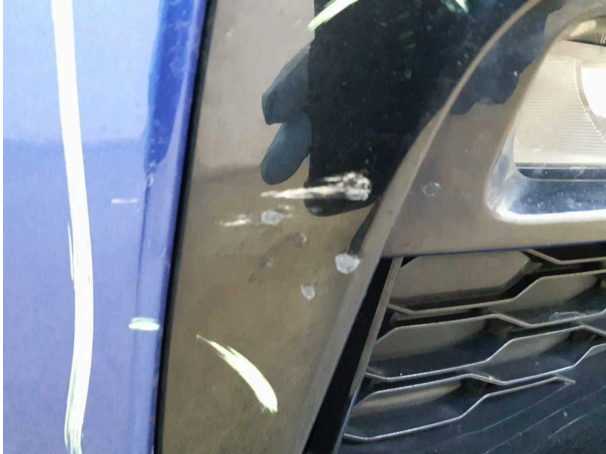
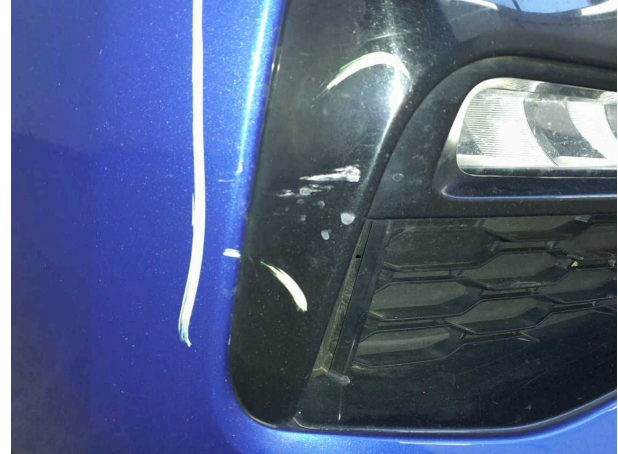
| No. | Component group | Description |
|---|---|---|
| 10 | Front bumper | Cover bumper - front (Vr) - Scratched - Replace |

**Damage #10:** Front bumper: Cover bumper - front (Vr) - Scratched - Replace

**Damage #10:** Front bumper: Cover bumper - front (Vr) - Scratched...  
Replace

**Damage #10:** Front bumper: Cover bumper - front (Vr) -  
Scratched - Replace

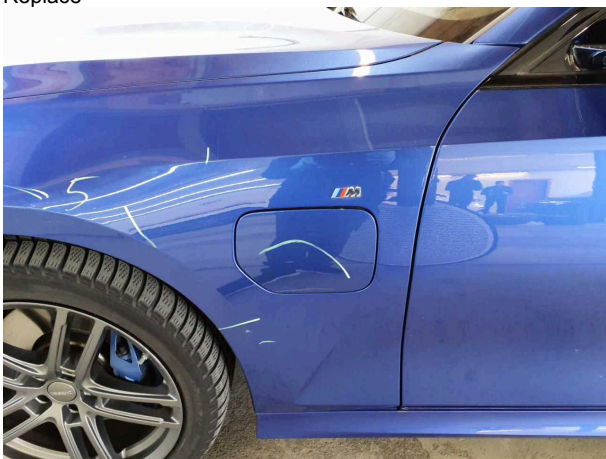
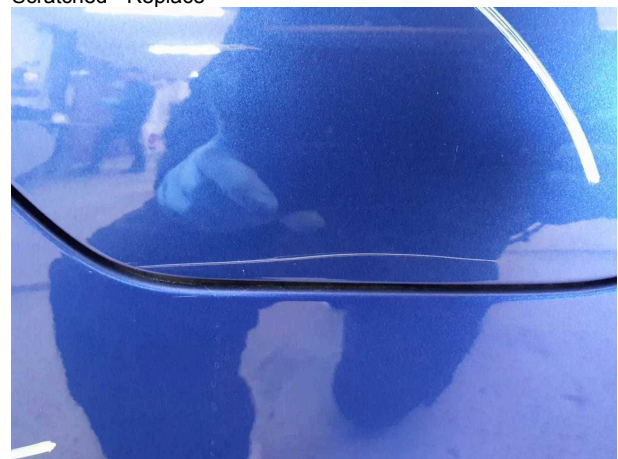
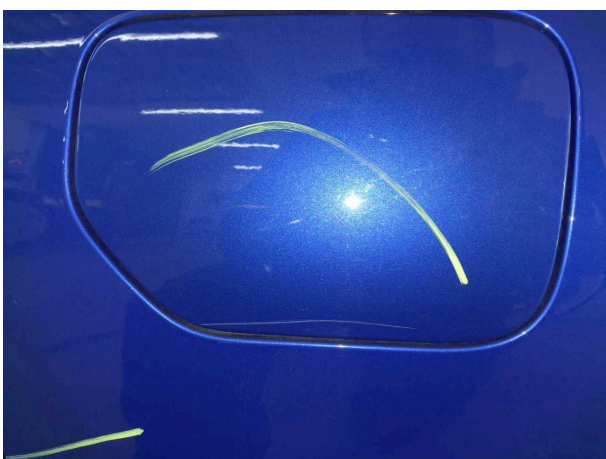
| No. | Component group | Description |
|---|---|---|
| 11 | Fuel system | Tank cap - Scratched - Paint |

**Damage #11:** Fuel system: Tank cap - Scratched - Paint

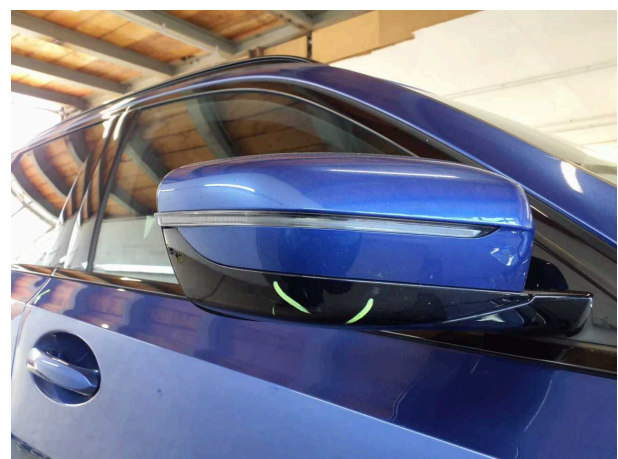
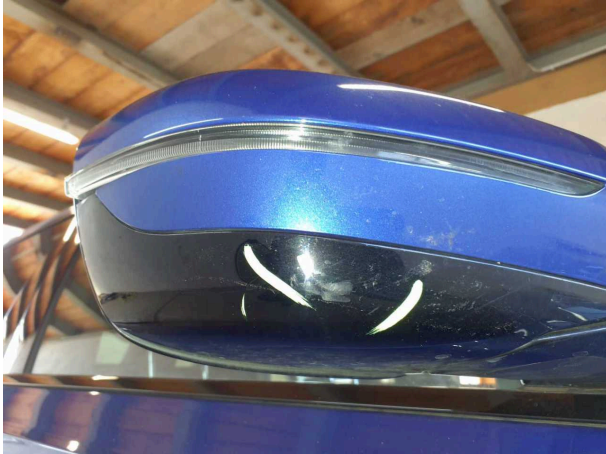
| No. | Component group | Description |
|---|---|---|
| 12 | Wing mirror - right side | Mirror housing - Scratched - Smart repair |

**Damage #12:** Wing mirror - right side: Mirror housing -  
Scratched - Smart repair

**Damage #12:** Wing mirror - right side: Mirror housing - Scratched - Smart repair

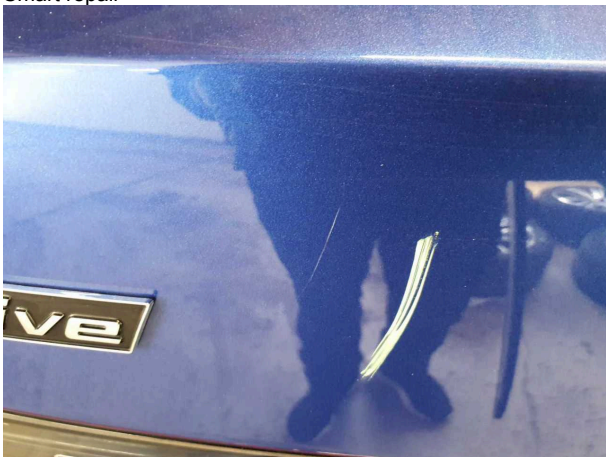
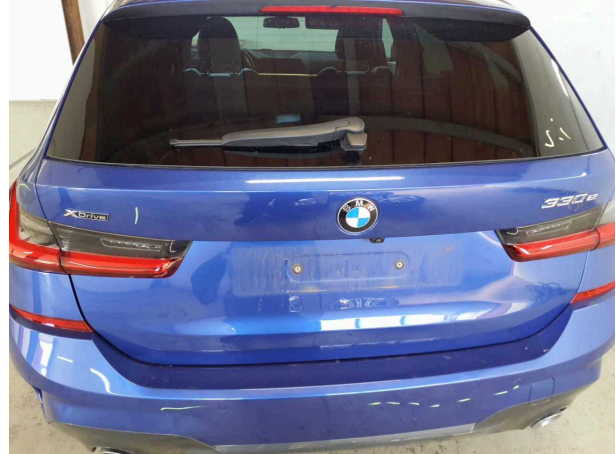
| No. | Component group | Description |
|---|---|---|
| 13 | Boot lid / rear door | Boot lid - Scratch(es) - Smart repair |

**Damage #13:** Boot lid / rear door: Boot lid - Scratch(es) - Smart repair

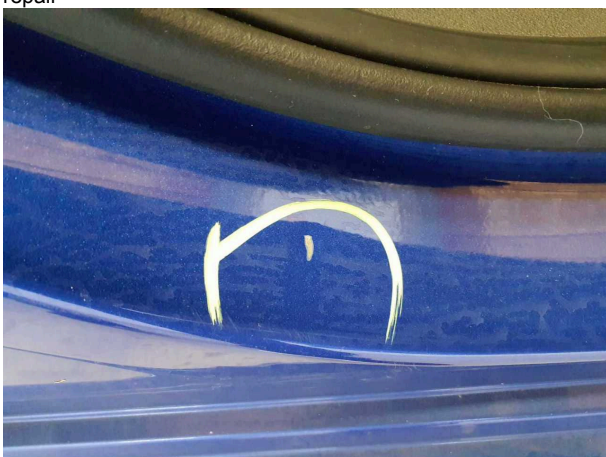
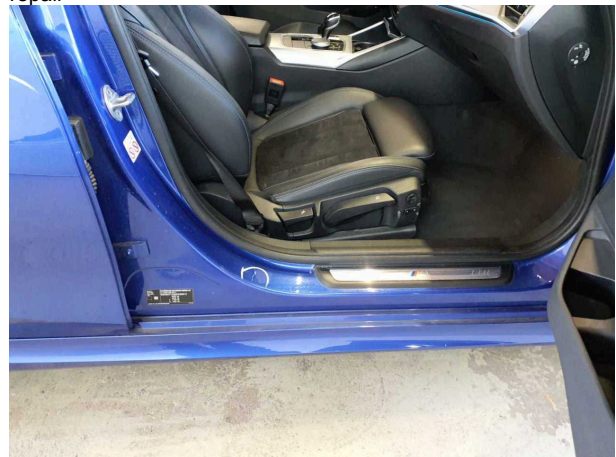
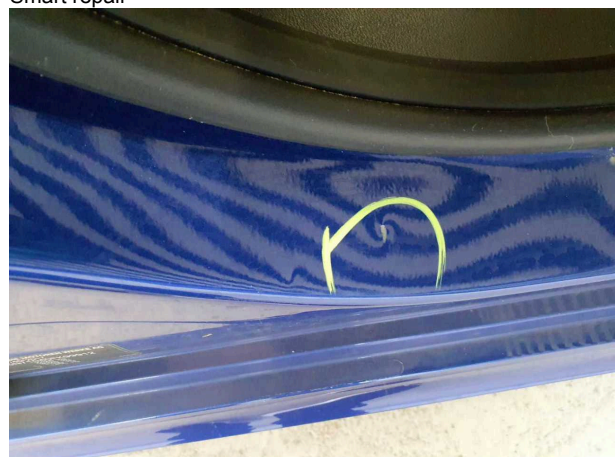
| No. | Component group | Description |
|---|---|---|
| 14 | Sill - right side | Sill - Dent / paintcoat damage - Smart repair |

**Damage #14:** Sill - right side: Sill - Dent / paintcoat damage - Smart repair

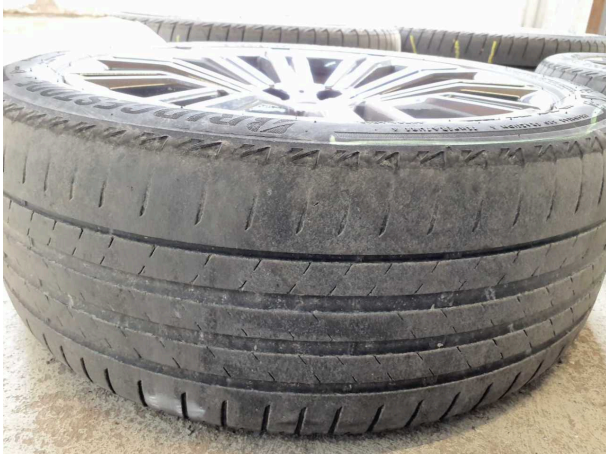
| No. | Component group | Description |
|---|---|---|
| 15 | Front axle | Axles / undercarriage - Malposition - Set / adjust |

**Damage #15:** Front axle: Axles / undercarriage - Malposition - Set / adjust

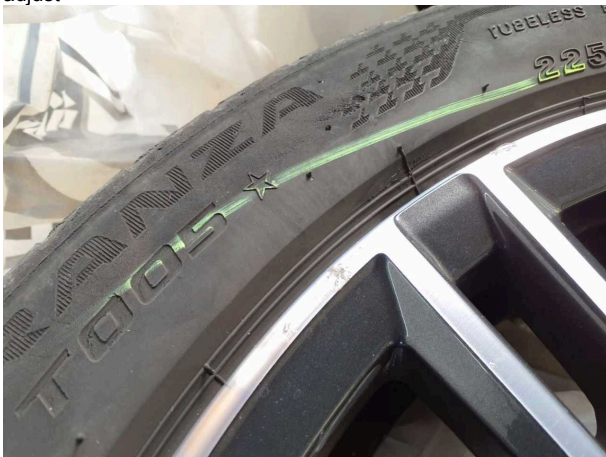
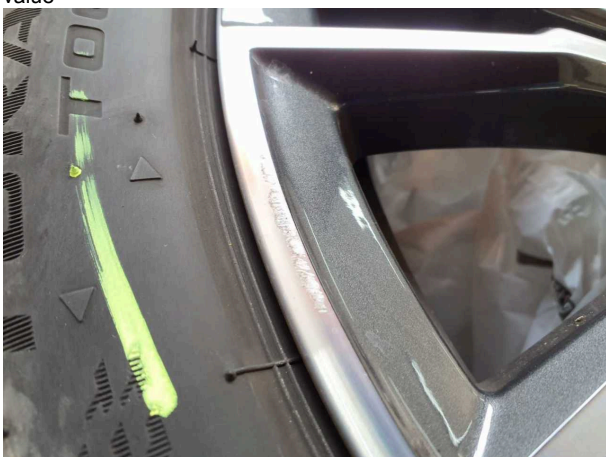
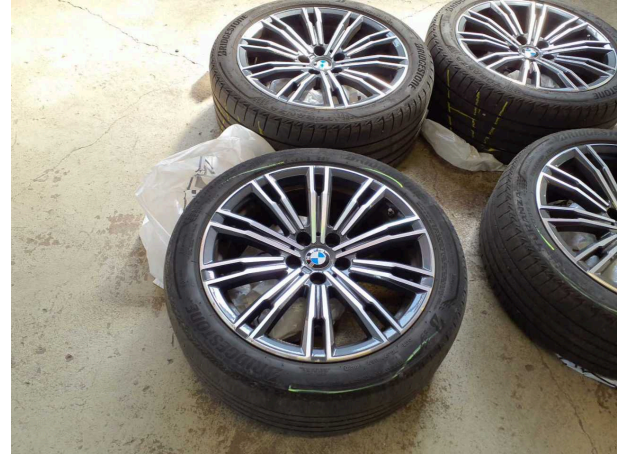
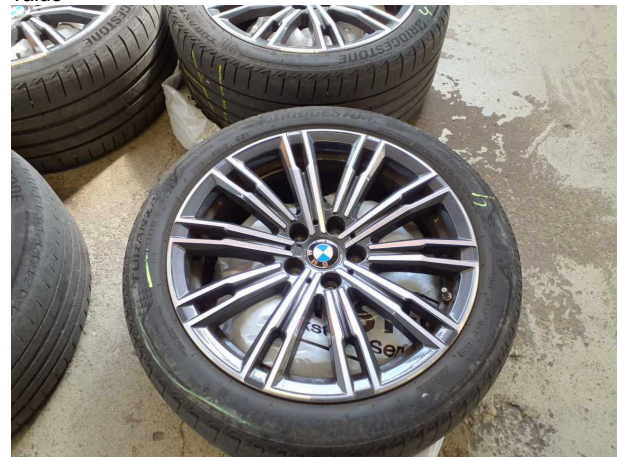
| No. | Component group | Description |
|---|---|---|
| 16 | 2nd wheel set | 2 alloy rims - Scratched - Loss in value |

**Damage #16:** 2nd wheel set: 2 alloy rims - Scratched - Loss in value

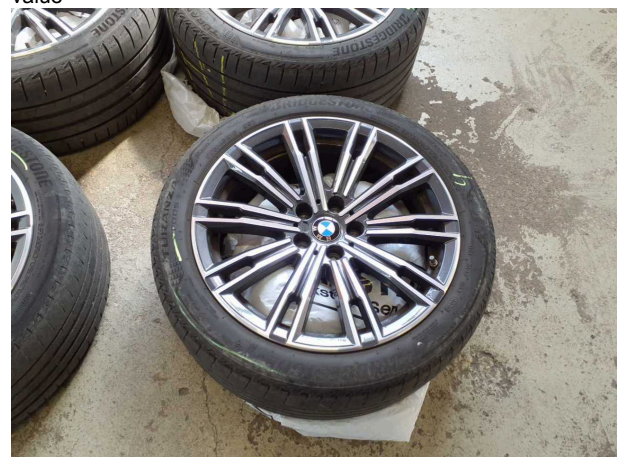
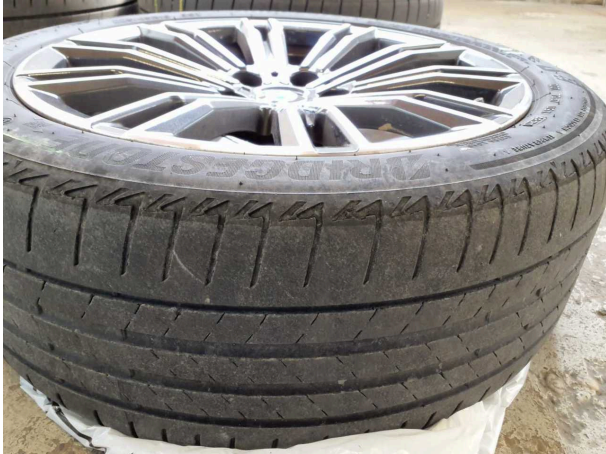
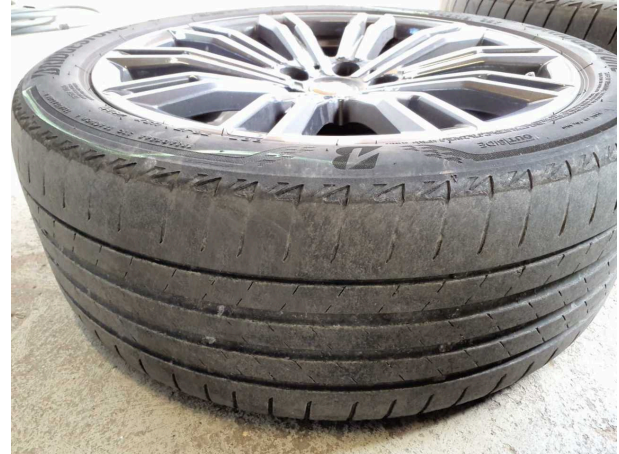
| No. | Component group | Description |
|---|---|---|
| 17 | 2nd wheel set | 2 tyres - Worn - Replace |

**Damage #17:** 2nd wheel set: 2 tyres - Worn - Replace

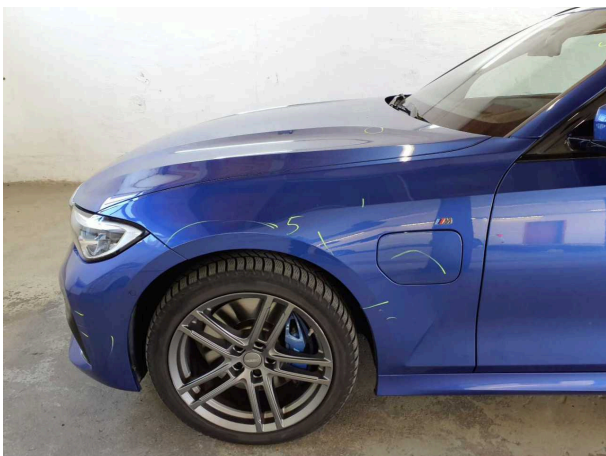
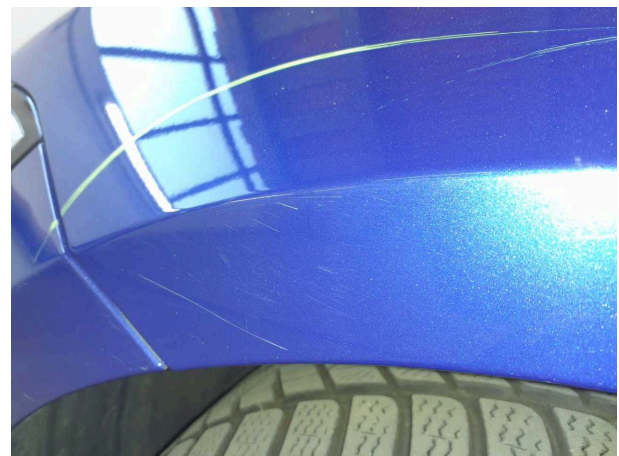
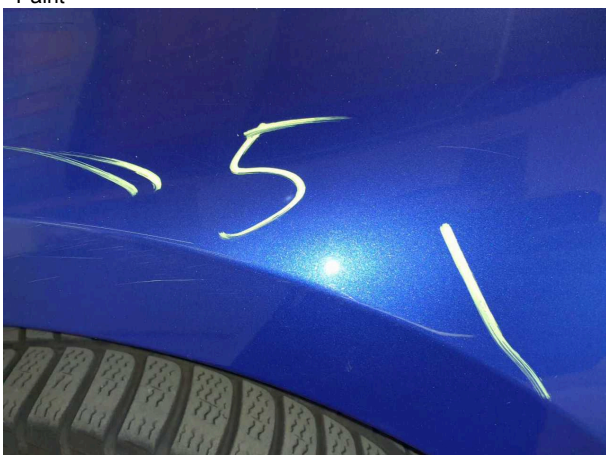
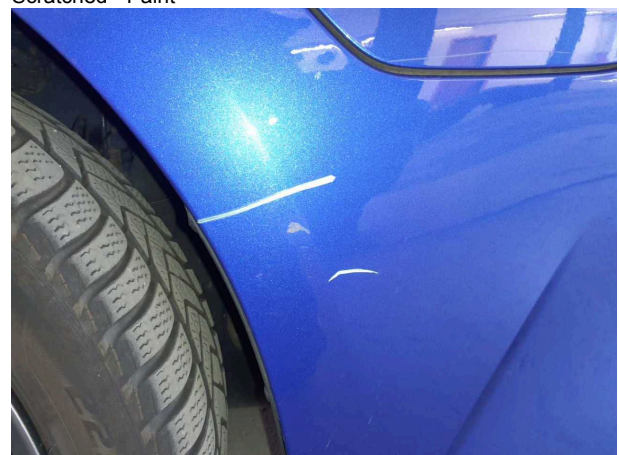
| No. | Component group | Description |
|---|---|---|
| 18 | Mudguard - left side | Mudguard - left side - Scratched - Paint |

**Damage #18:** Mudguard - left side: Mudguard - left side - Scratch...  
- Paint

**Damage #18:** Mudguard - left side: Mudguard - left side -  
Scratched - Paint

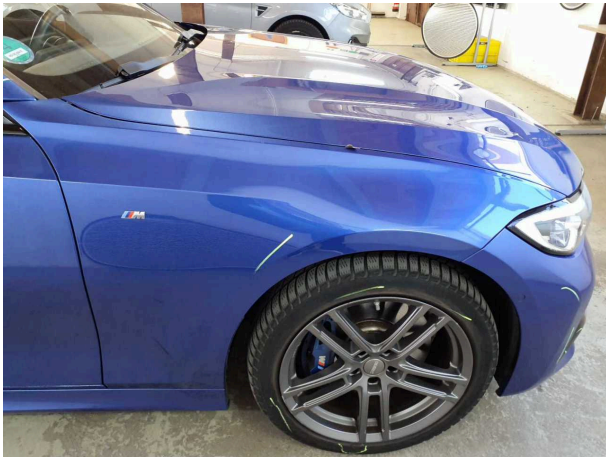
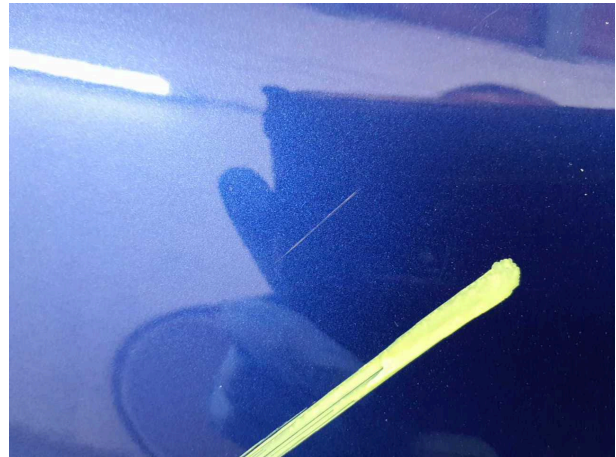
| No. | Component group | Description |
|---|---|---|
| 19 | Mudguard - right side | Mudguard - right side - Scratch(es) - Paint |

**Damage #19:** Mudguard - right side: Mudguard - right side - Scratch(es) - Paint

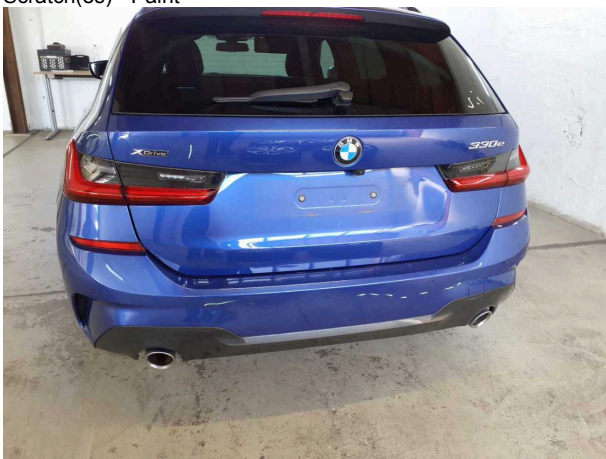
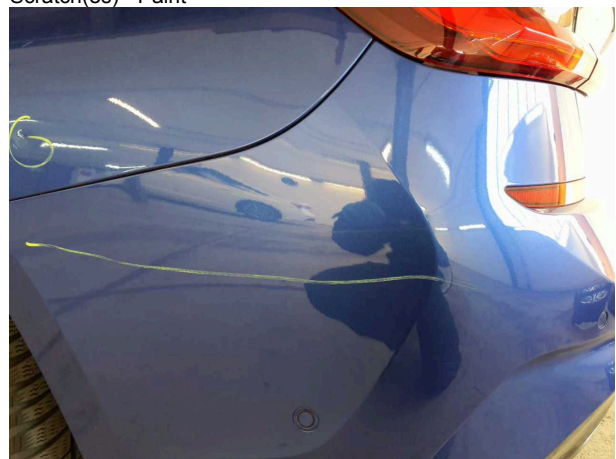
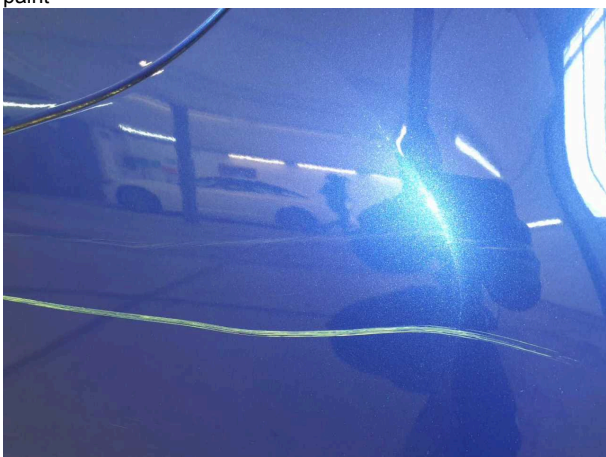
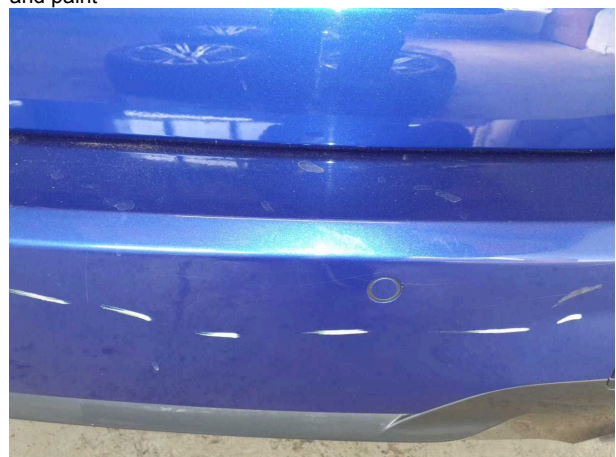
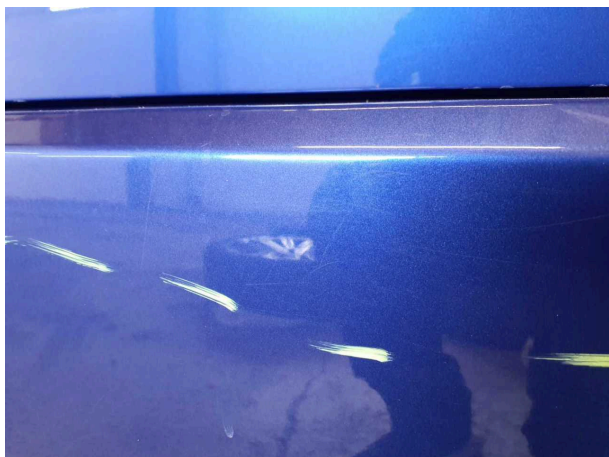
| No. | Component group | Description |
|---|---|---|
| 20 | Rear bumper | Rear bumper - Scratched - Repair and paint |

**Damage #20:** Rear bumper: Rear bumper - Scratched - Repair and paint

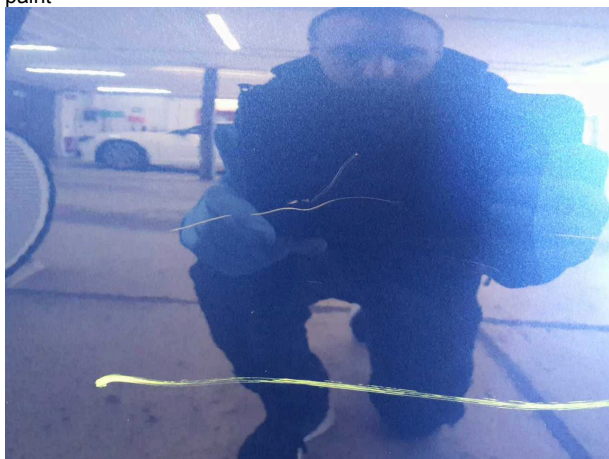
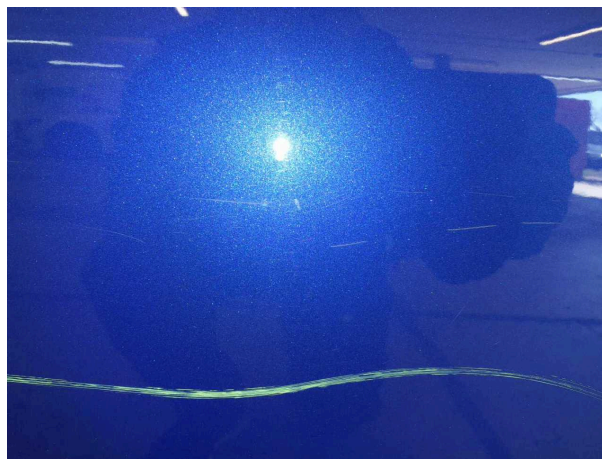
| No. | Component group | Description |
|---|---|---|
| 21 | Door - rear left side | Door - Scratched - Paint |

**Damage #21:** Door - rear left side: Door - Scratched - Paint

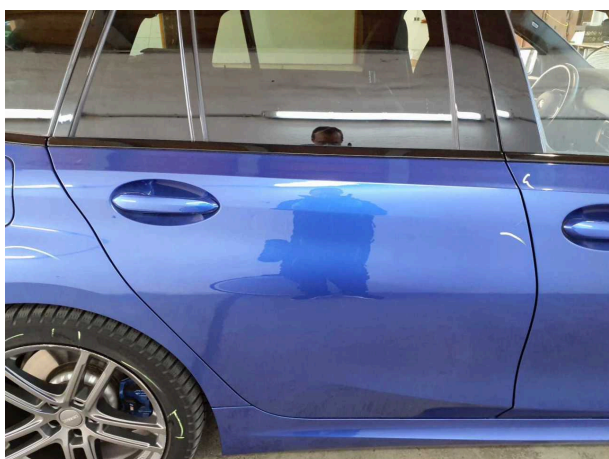
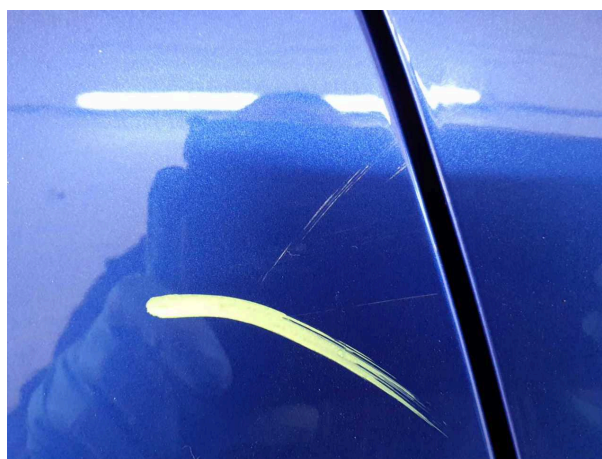
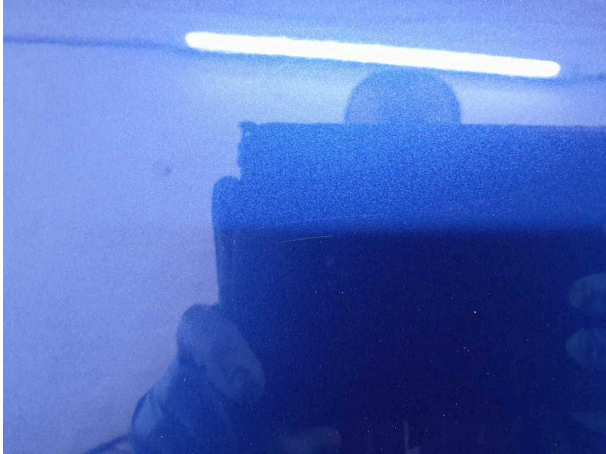
| No. | Component group | Description |
|---|---|---|
| 22 | Door - rear right side | Door - Scratched - Paint |

**Damage #22:** Door - rear right side: Door - Scratched - Paint

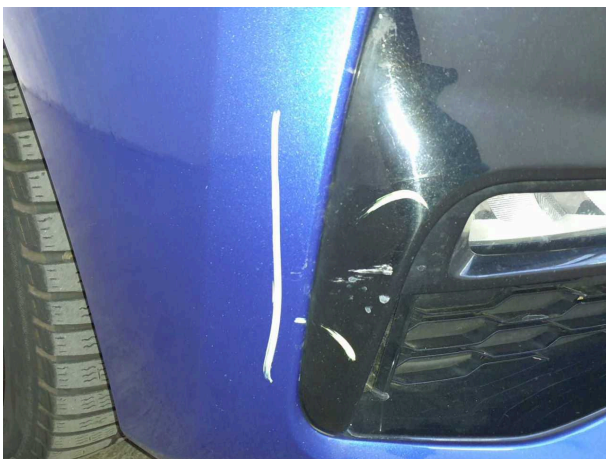
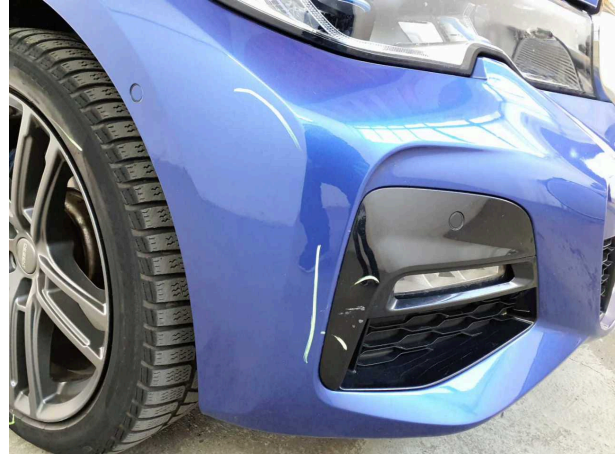
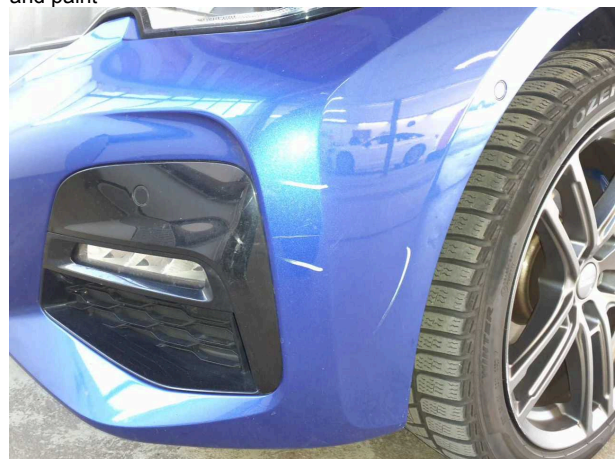
| No. | Component group | Description |
|---|---|---|
| 23 | Front bumper | Front bumper - Scratched - Repair and paint |

**Damage #23:** Front bumper: Front bumper - Scratched - Repair and paint

**Damage #23:** Front bumper: Front bumper - Scratched - Rep... and paint

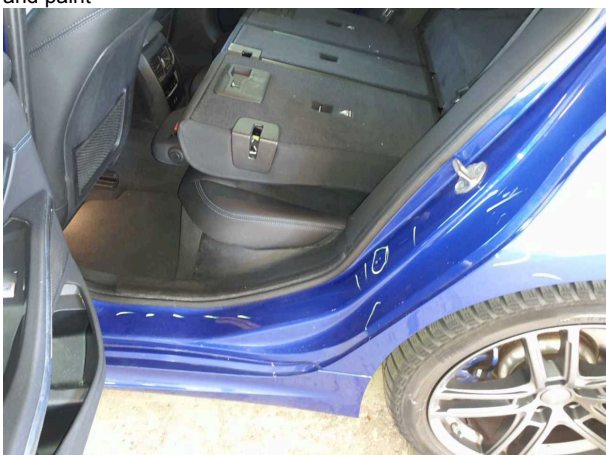
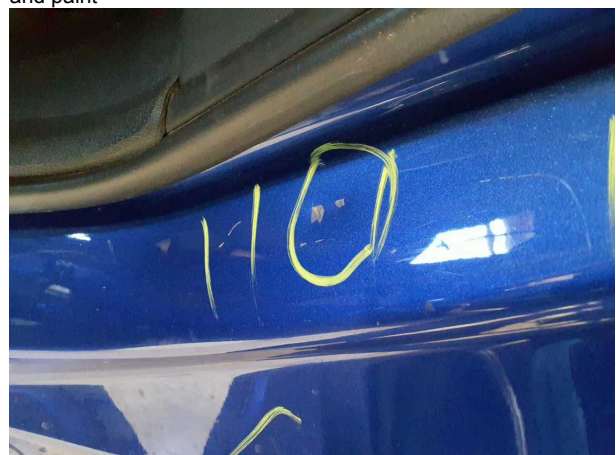
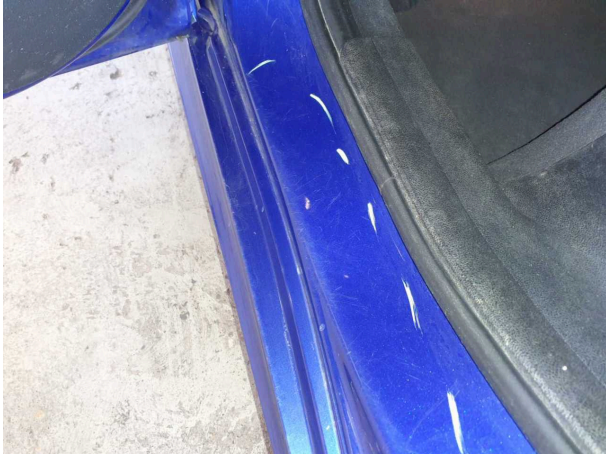
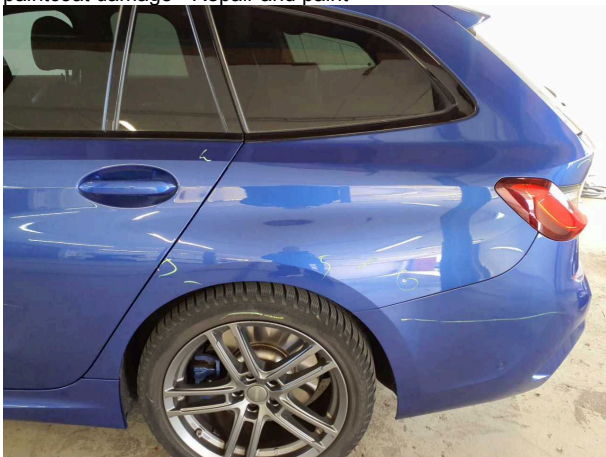
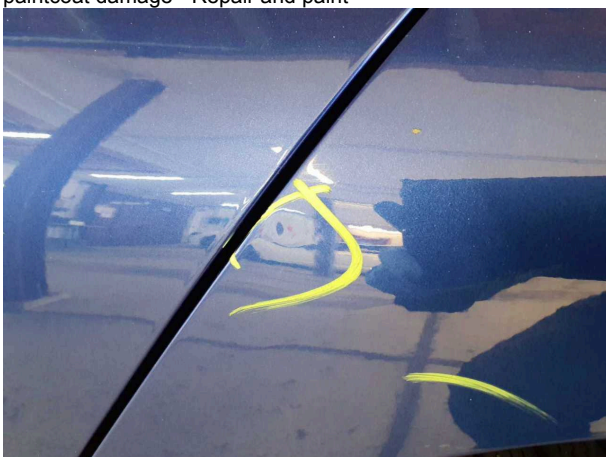
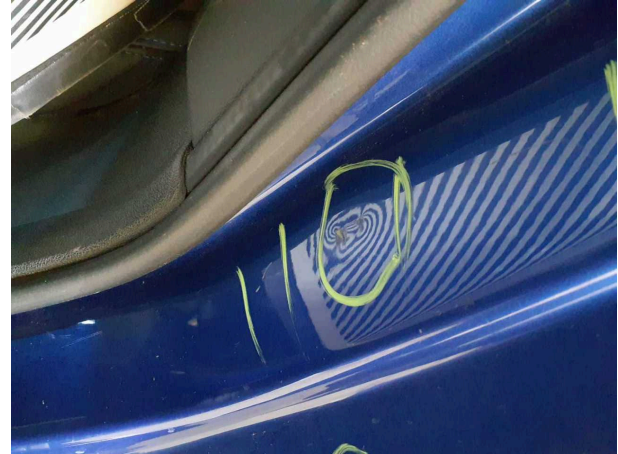
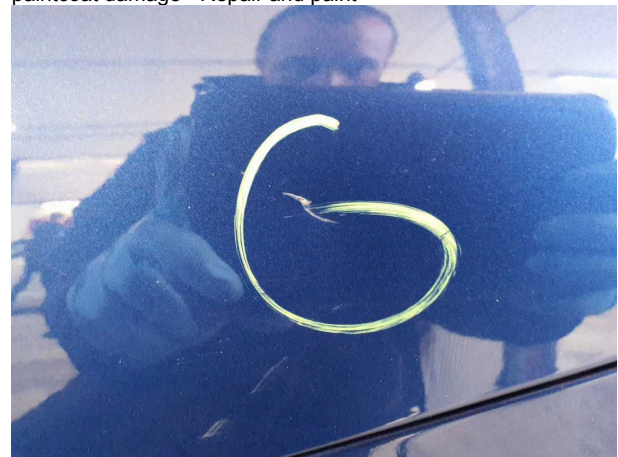
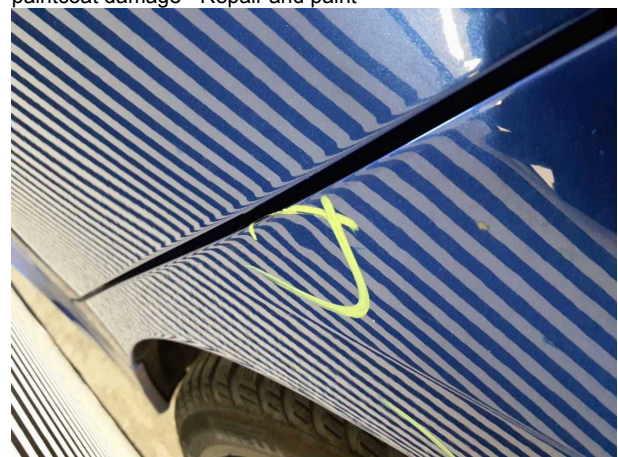
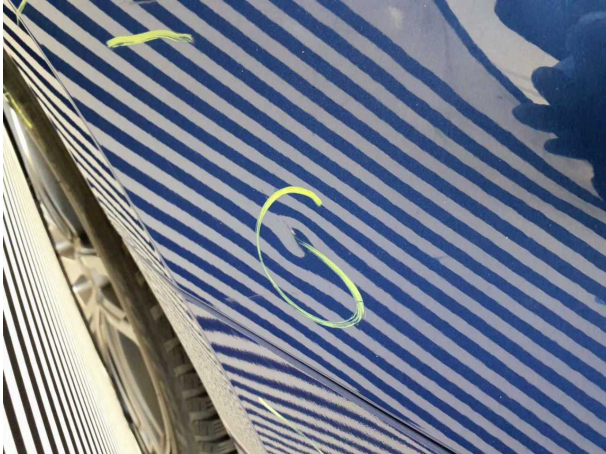
| No. | Component group | Description |
|---|---|---|
| 24 | Side panel - rear left side | Side panel - Dent / paintcoat damage - Repair and paint |

**Damage #24:** Side panel - rear left side: Side panel - Dent / paintcoat damage - Repair and paint

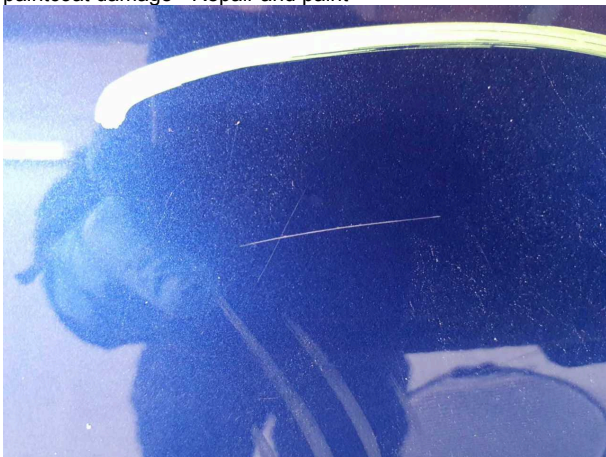
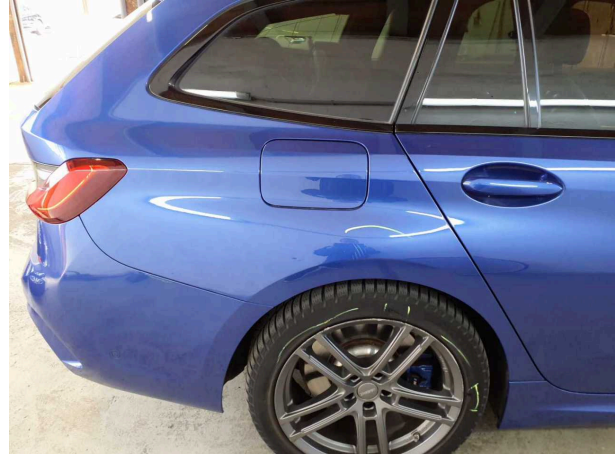
| No. | Component group | Description |
|---|---|---|
| 25 | Side panel - rear right side | Side panel - Scratch(es) - Paint |

**Damage #25:** Side panel - rear right side: Side panel - Scratch(es) - Paint

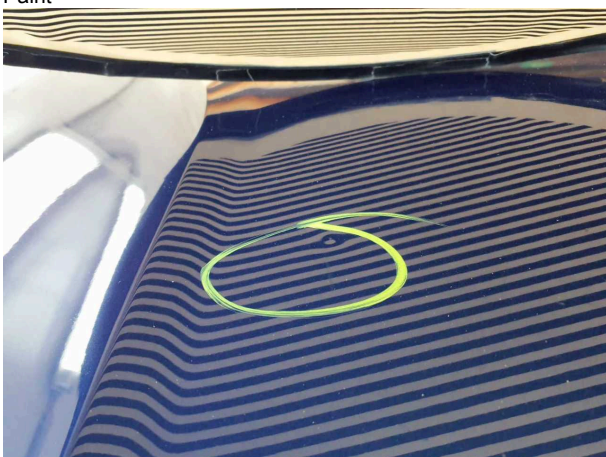
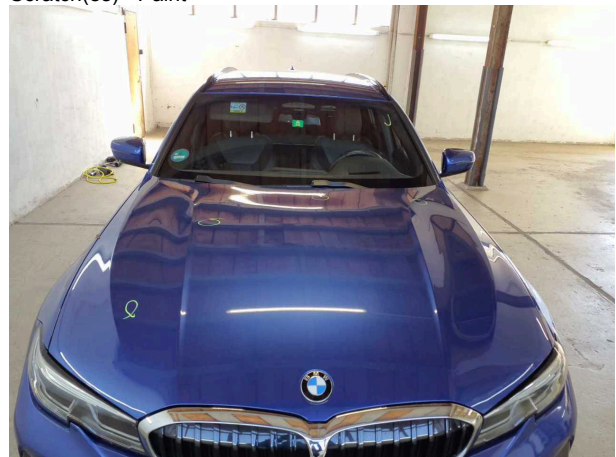
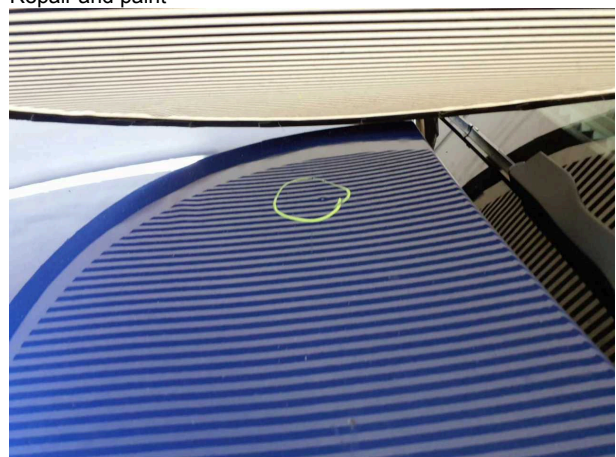
| No. | Component group | Description |
|---|---|---|
| 26 | Bonnet | Bonnet - Dent / paintcoat damage - Repair and paint |

**Damage #26:** Bonnet: Bonnet - Dent / paintcoat damage - Repair and paint
