WBA5X91010FL21740

## Zustandsbericht

Inspection date: 29 Apr 2025

**Protocol number:** 39500825

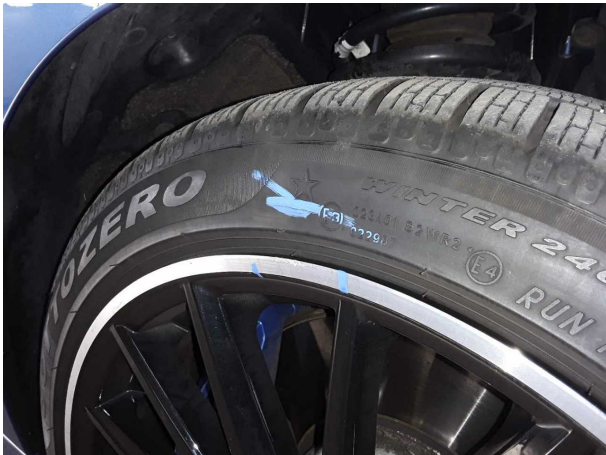
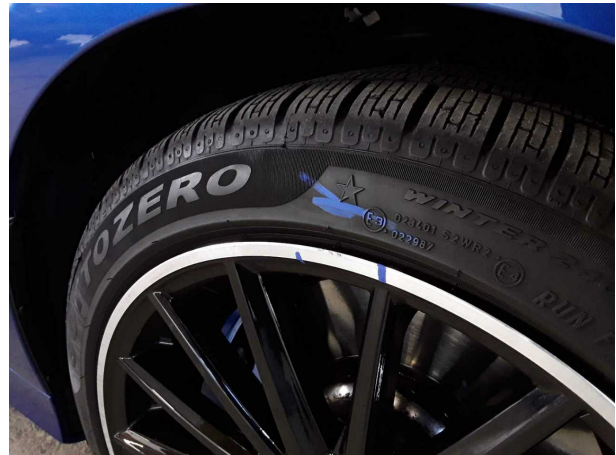
| No. | Component group | Description |
|---|---|---|
| 1 | Wheel / tyres | Alloy rim - front right side - Scratched - No deduction |

**Damage #1:** Wheel / tyres: Alloy rim - front right side - Scratched - No deduction

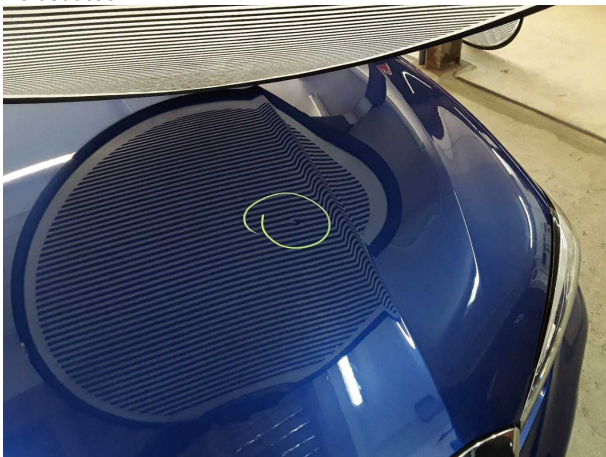
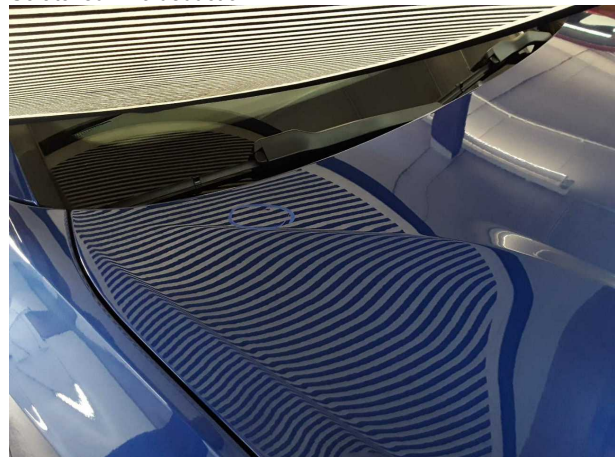
| No. | Component group | Description |
|---|---|---|
| 2 | Bonnet | Bonnet - dent(s) - Smooth repair work |

**Damage #2:** Bonnet: Bonnet - dent(s) - Smooth repair work

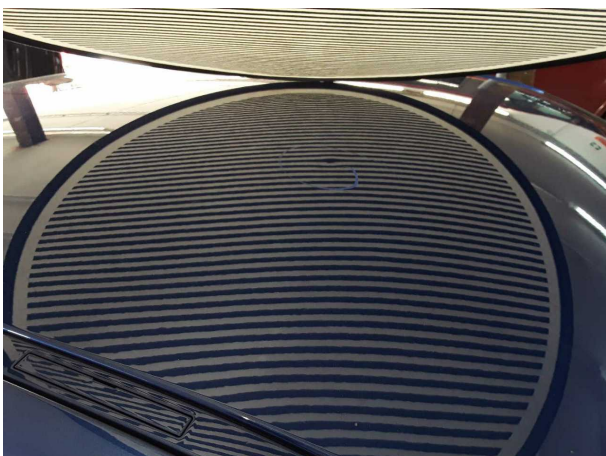
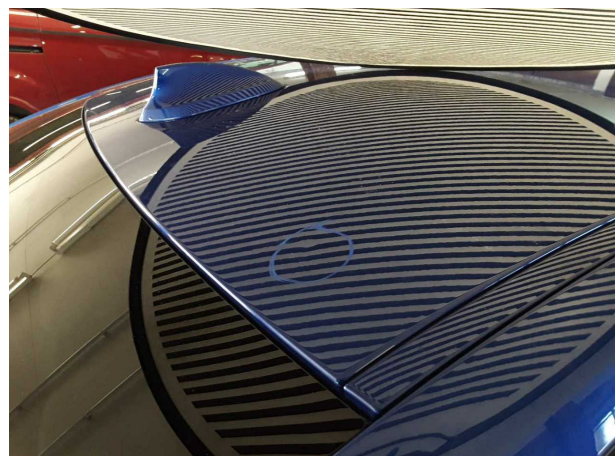
| No. | Component group | Description |
|---|---|---|
| 3 | Roof | Roof - dent(s) - Smooth repair work |

**Damage #3:** Roof: Roof - dent(s) - Smooth repair work

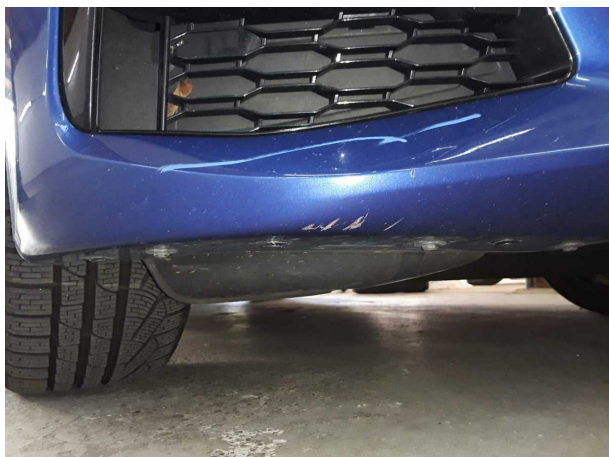
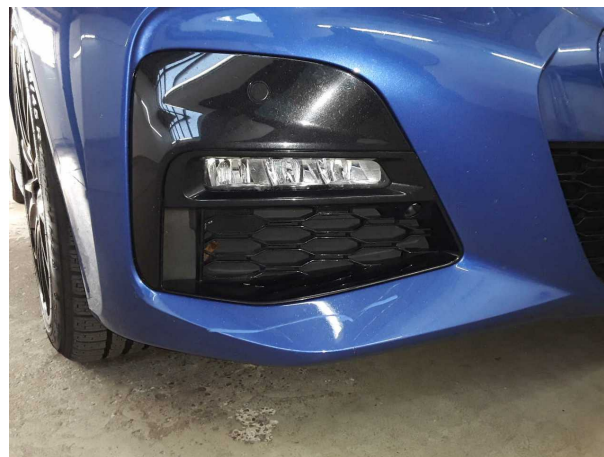
| No. | Component group | Description |
|---|---|---|
| 4 | Front bumper | Front bumper - Scratched - Smart repair |

**Damage #4:** Front bumper: Front bumper - Scratched - Smart repair

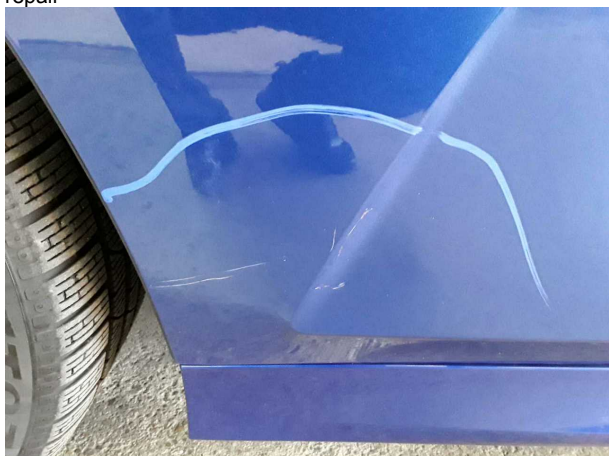
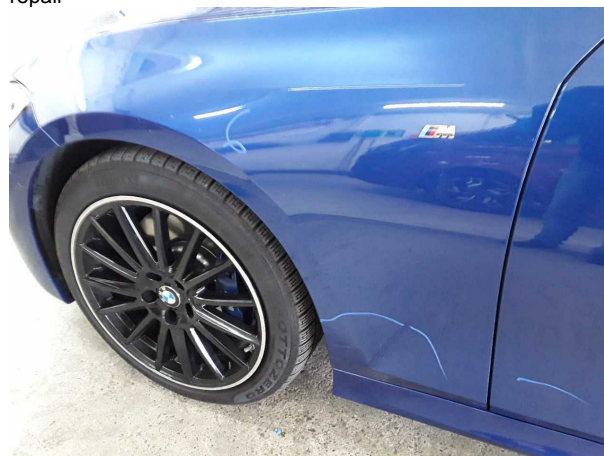
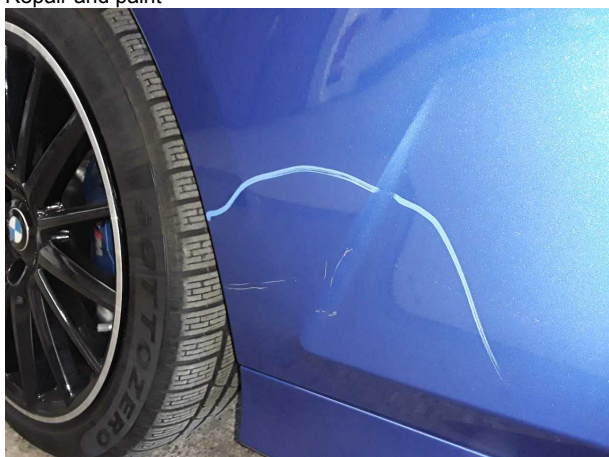
| No. | Component group | Description |
|---|---|---|
| 5 | Mudguard - left side | Mudguard - left side - Scratched - Repair and paint |

**Damage #5:** Mudguard - left side: Mudguard - left side - Scratched - Repair and paint

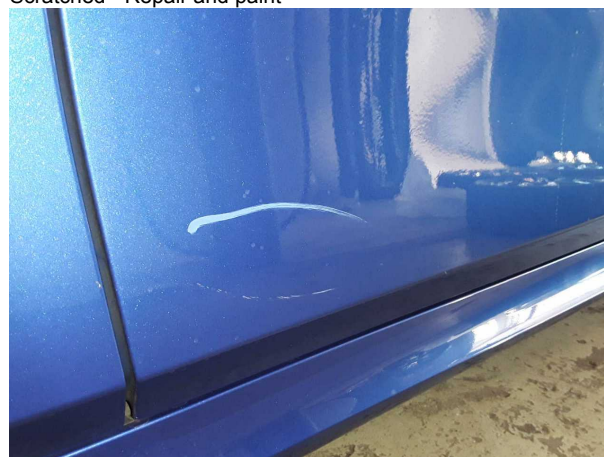
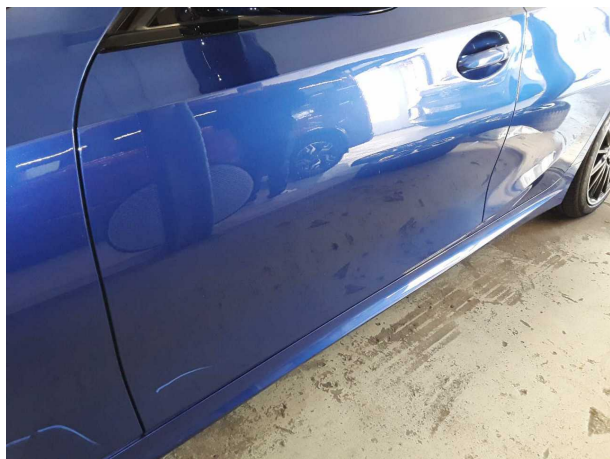
| No. | Component group | Description |
|---|---|---|
| 6 | Door - front left side | Door - Scratched - Repair and paint |

**Damage #6:** Door - front left side: Door - Scratched - Repair and paint
