**WBA41FY010FS28900**

## Zustandsbericht

**TÜV SÜD Auto Partner GmbH**  
Gutenbergstr. 13  
70771 Leinfelden-Echterdingen

Inspection date: 30 Apr 2025  
**Protocol number:** 39539791  
Delivery date: 2 May 2025

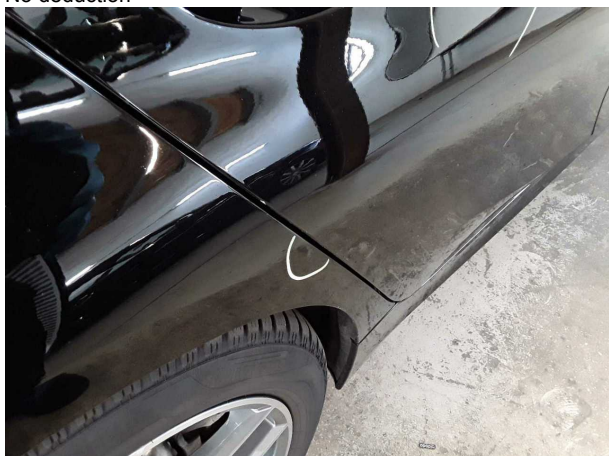
| No. | Component group | Description |
|---|---|---|
| 2 | Side panel - rear right side | Side panel - dent(s) - Smooth repair work |

**Damage #2:** Side panel - rear right side: Side panel - dent(s) - Smooth repair work

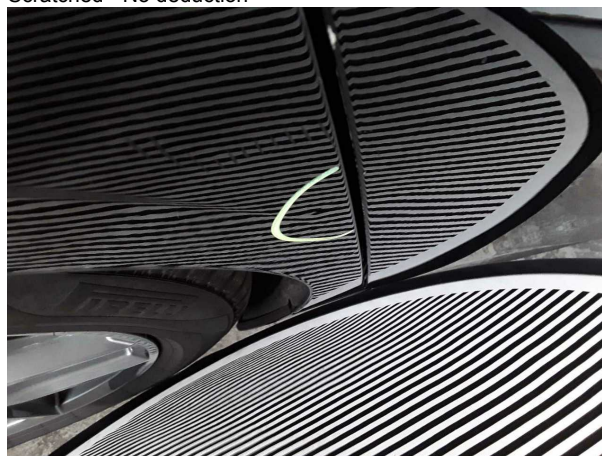
**Damage #2:** Side panel - rear right side: Side panel - dent(s) - Smooth repair work

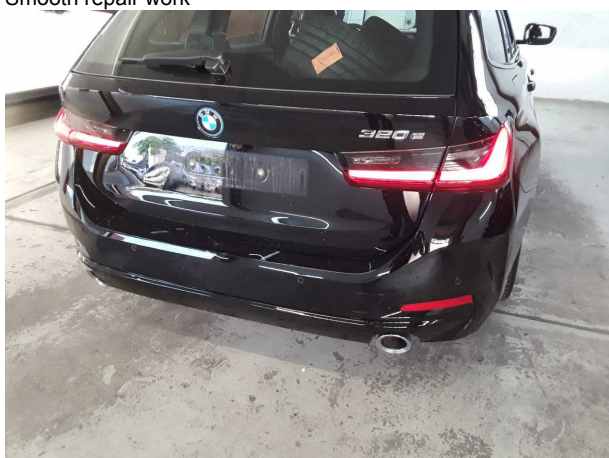
| No. | Component group | Description |
|---|---|---|
| 3 | Rear bumper | Rear bumper - Scratched - Repair and paint |

**Damage #3:** Rear bumper: Rear bumper - Scratched - Repair and paint

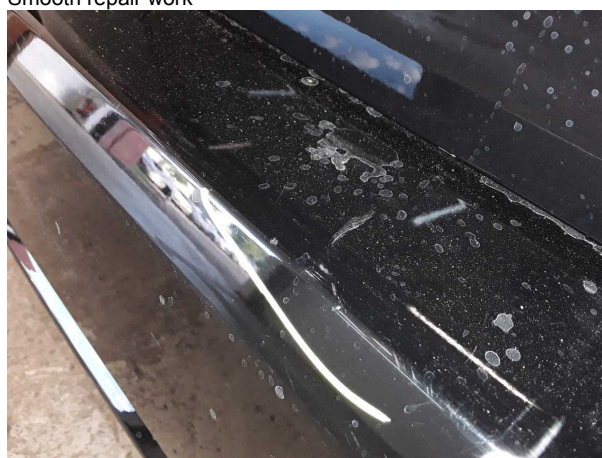
**Damage #3:** Rear bumper: Rear bumper - Scratched - Repair and paint

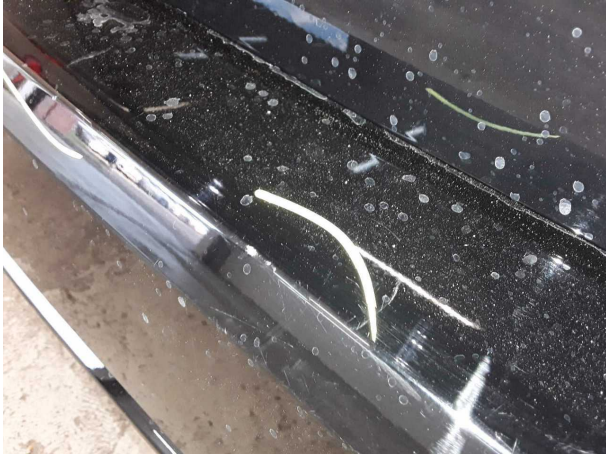
**Damage #3:** Rear bumper: Rear bumper - Scratched - Repair and paint

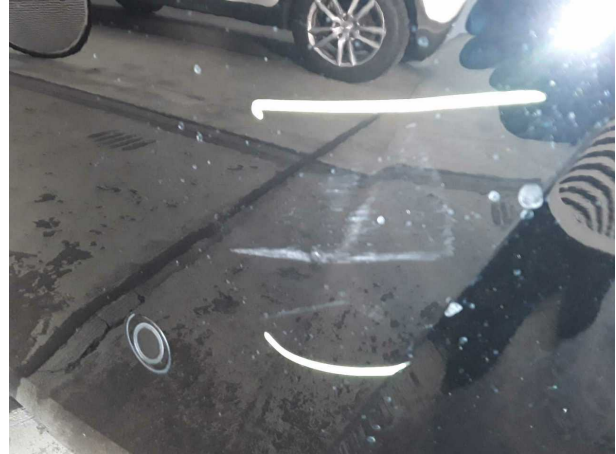
**Damage #3:** Rear bumper: Rear bumper - Scratched - Repair and paint

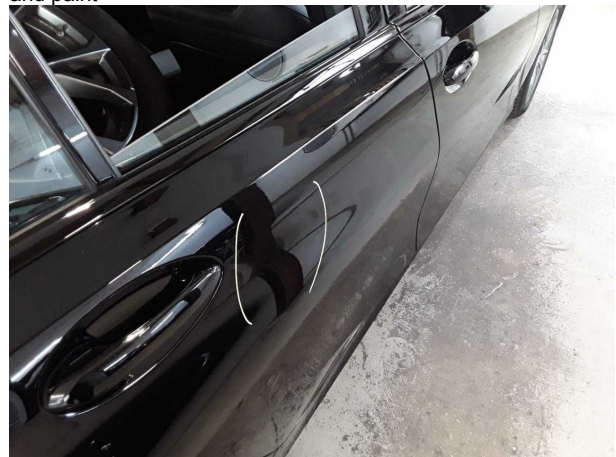
| No. | Component group | Description |
|---|---|---|
| 4 | Door - rear right side | Door - Scratched - Repair and paint |

**Damage #4:** Door - rear right side: Door - Scratched - Repair and paint

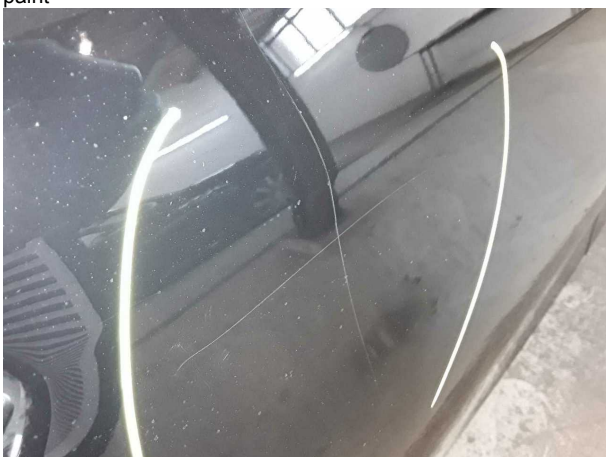
**Damage #4:** Door - rear right side: Door - Scratched - Repair and paint

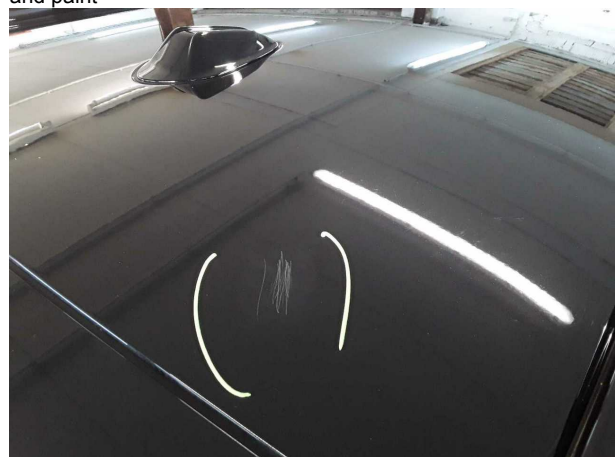
| No. | Component group | Description |
|---|---|---|
| 5 | Roof | Roof - Scratched - Repair and paint |

**Damage #5:** Roof: Roof - Scratched - Repair and paint

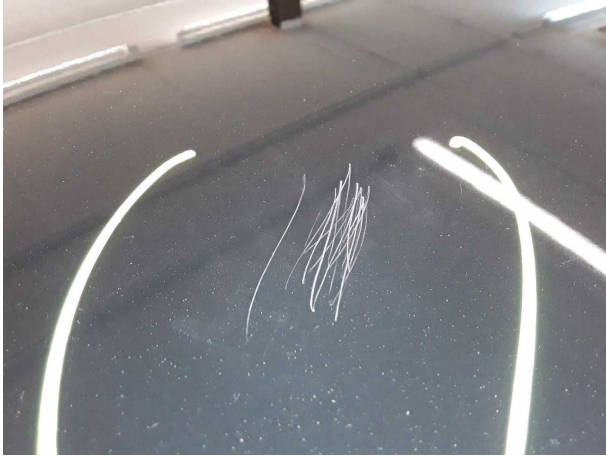
**Damage #5:** Roof: Roof - Scratched - Repair and paint
