**WBAJP310X0CD50993**

| Type / Model | 5er-Reihe 520d Touring A<br>Kombi5-türig | Main inspection | |

## Zustandsbericht

Inspection date: 14 Apr 2025  
**Protocol number: 39373981**

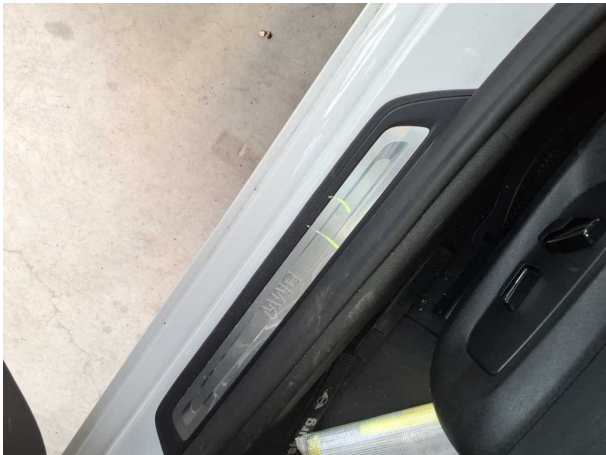
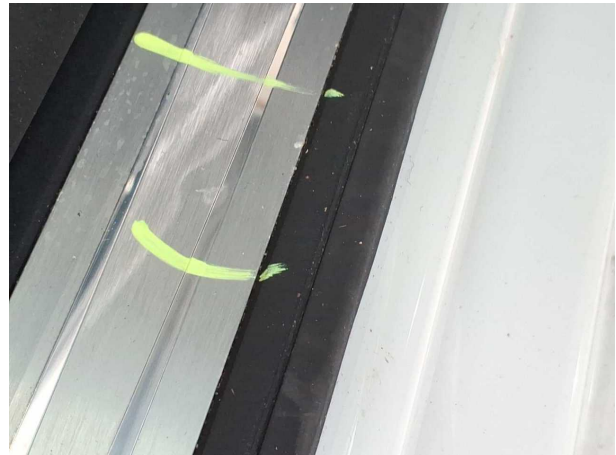
| No. | Component group | Description |
|---|---|---|
| 1 | Trim / covers | Brightware / decorative strip (Vr Einstiegsleiste) - dent(s) - Replace |

**Damage #1:** Trim / covers: Brightware / decorative strip (Vr Einstiegsleiste) - dent(s) - Replace

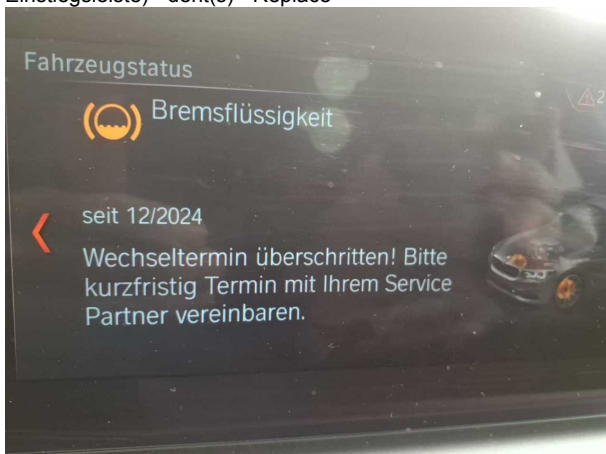
| No. | Component group | Description |
|---|---|---|
| 2 | Braking system | Brake fluid - Due - Replace |

**Damage #2:** Braking system: Brake fluid - Due - Replace

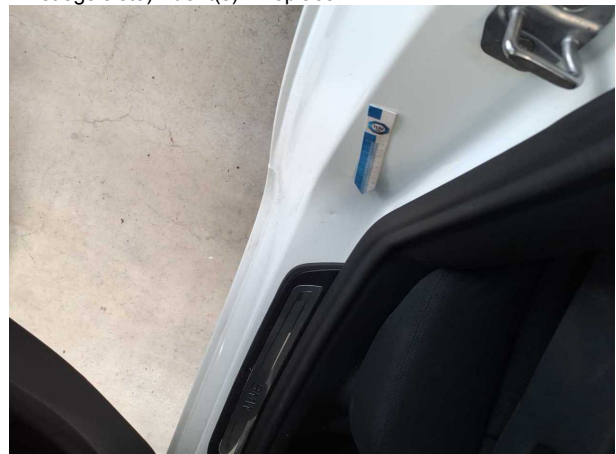
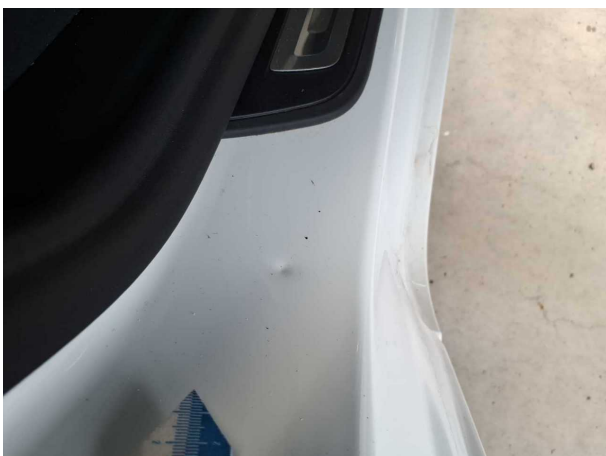
| No. | Component group | Description |
|---|---|---|
| 3 | Side panel - rear right side | Sill - dent(s) - Smooth repair work |

**Damage #3:** Side panel - rear right side: Sill - dent(s) - Smooth repair work

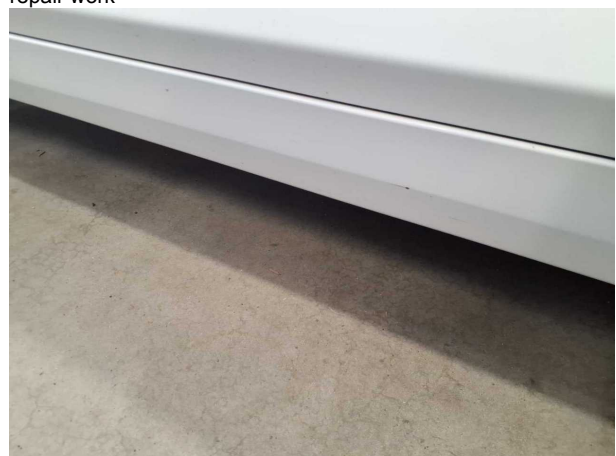
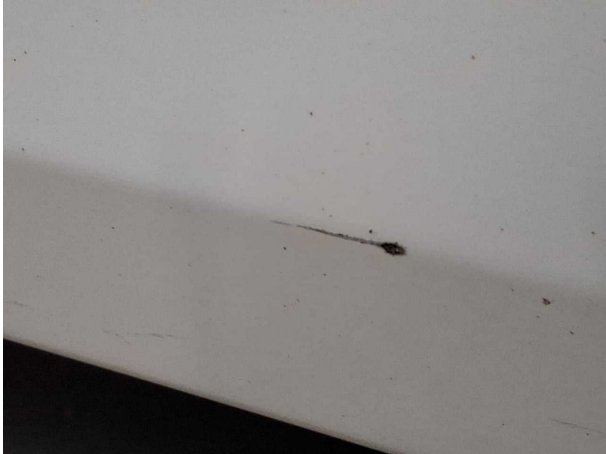
| No. | Component group | Description |
|---|---|---|
| 4 | Sill - left side | Sill - Scratch(es) - Smart repair |

**Damage #4:** Sill - left side: Sill - Scratch(es) - Smart repair work

**Damage #4:** Sill - left side: Sill - Scratch(es) - Smart repair

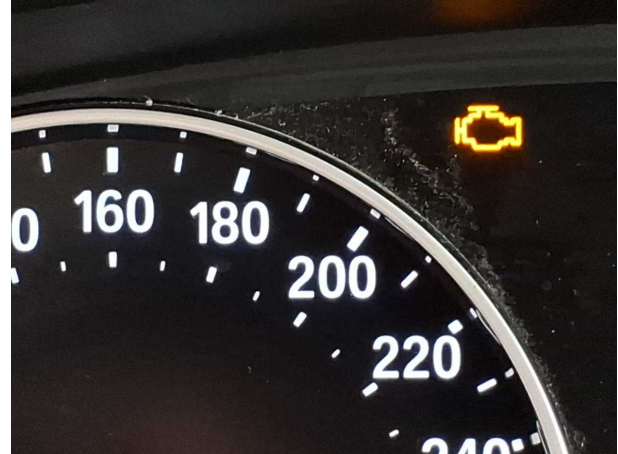
| No. | Component group | Description |
|---|---|---|
| 5 | Instrument panel | Indicator light (Folgekosten möglich) - on - Perform diagnosis |

**Damage #5:** Instrument panel: Indicator light (Folgekosten möglich) - on - Perform diagnosis

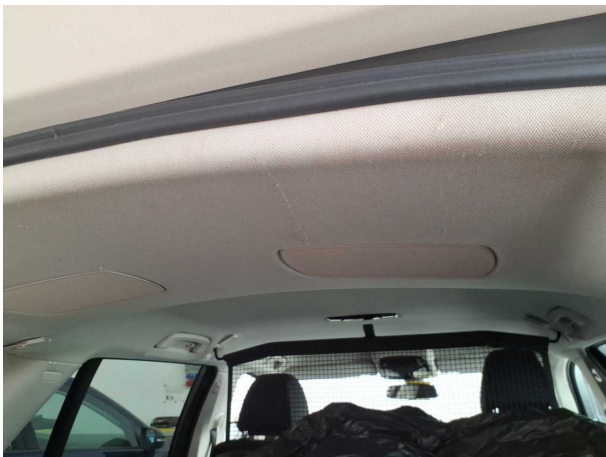
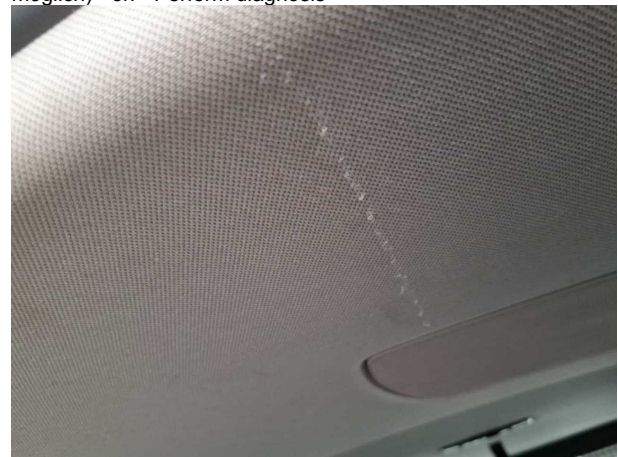
| No. | Component group | Description |
|---|---|---|
| 6 | Trim / covers | Roof lining - Scratch(es) - Loss in value |

**Damage #6:** Trim / covers: Roof lining - Scratch(es) - Loss in value

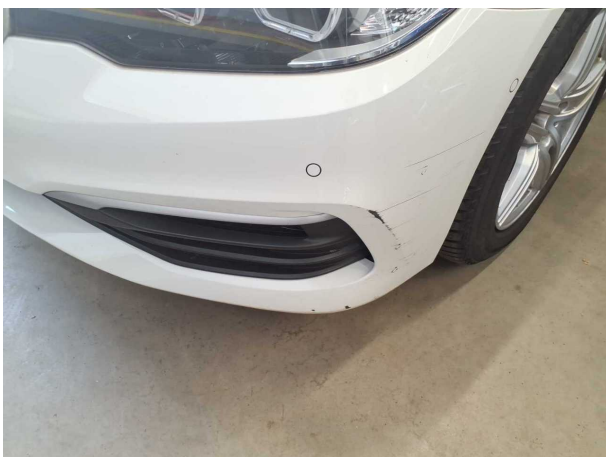
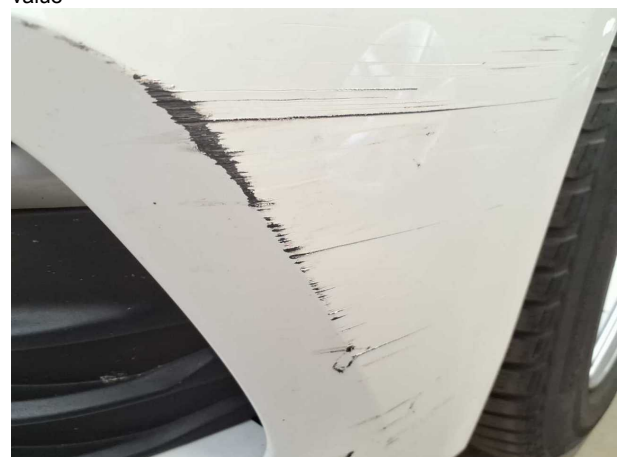
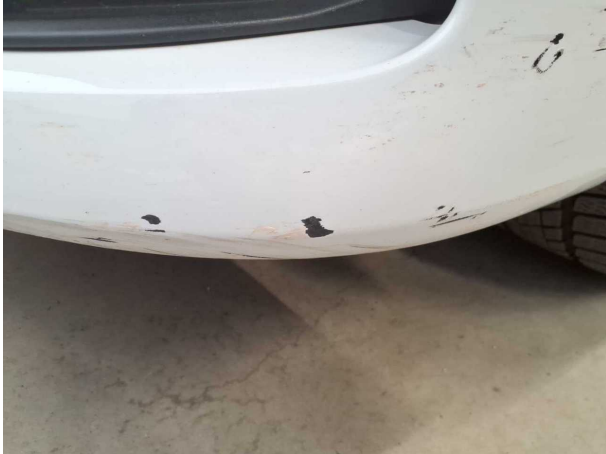
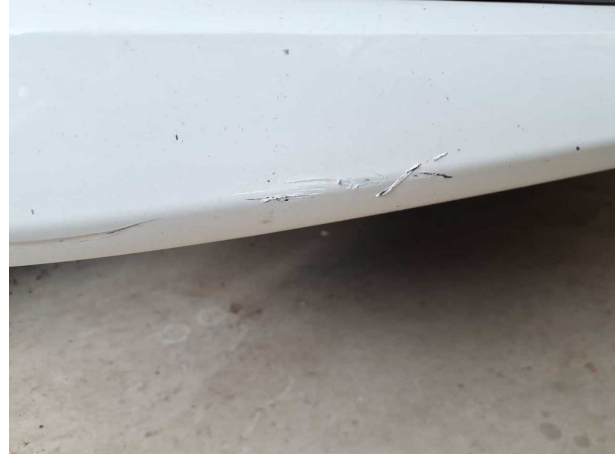
| No. | Component group | Description |
|---|---|---|
| 7 | Front bumper | Front bumper - Scratched - Repair and paint |

**Damage #7:** Front bumper: Front bumper - Scratched - Repair and paint

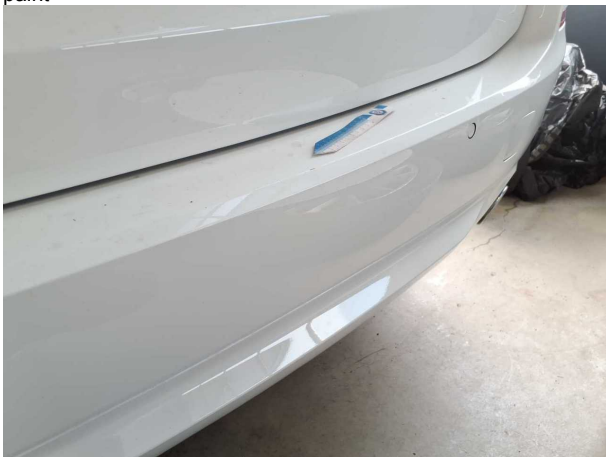
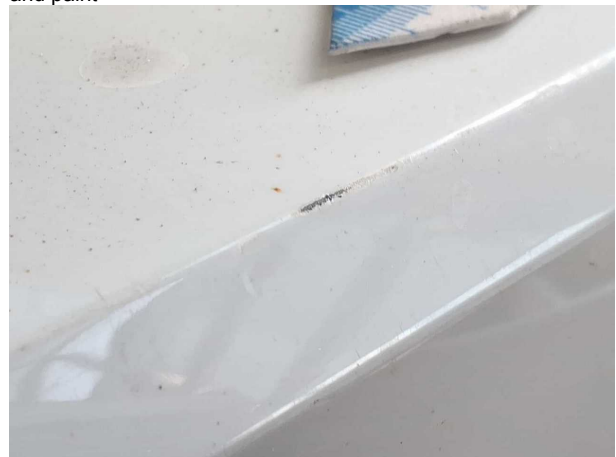
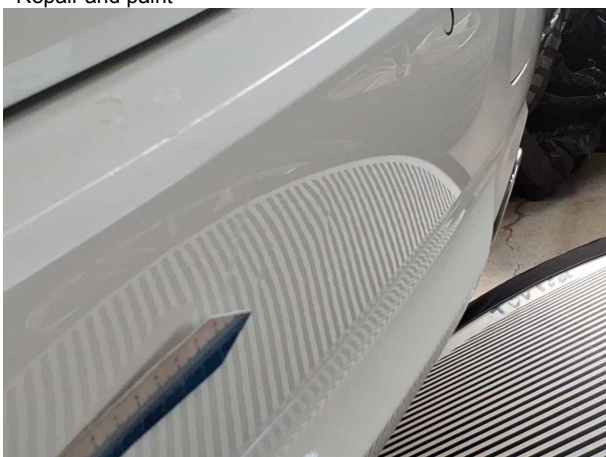
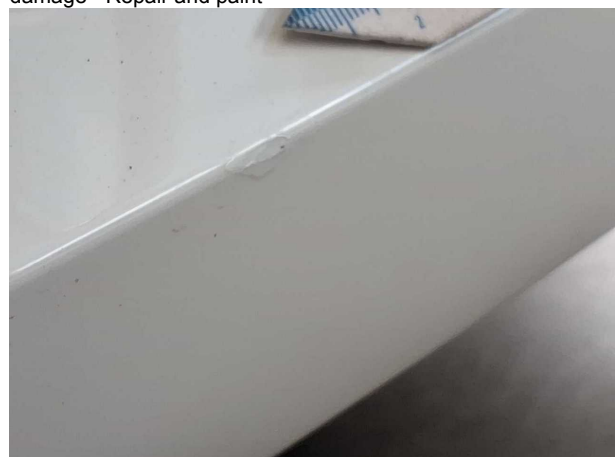
| No. | Component group | Description |
|---|---|---|
| 8 | Rear bumper | Rear bumper - Dent / paintcoat damage - Repair and paint |

**Damage #8:** Rear bumper: Rear bumper - Dent / paintcoat damage - Repair and paint

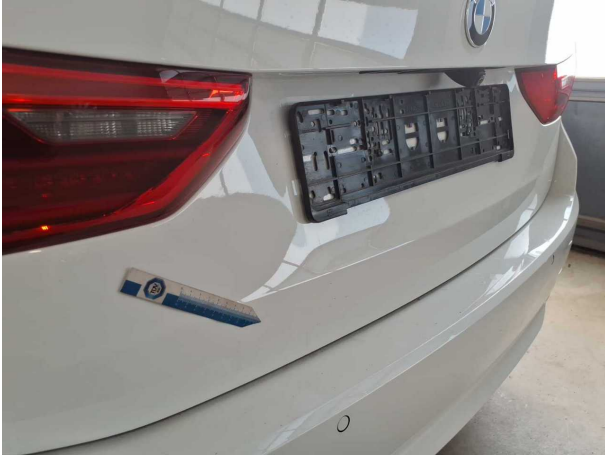
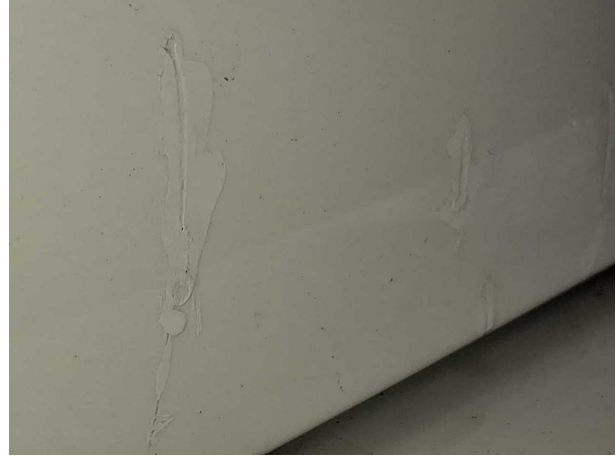
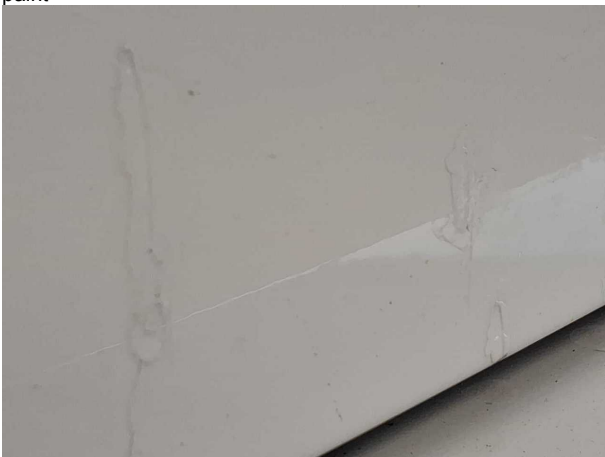
| No. | Component group | Description |
|---|---|---|
| 9 | Boot lid / rear door | Boot lid - Scratch(es) - Repair and paint |

**Damage #9:** Boot lid / rear door: Boot lid - Scratch(es) - Repair and paint
