WBA21FY090FS20924

## Zustandsbericht

Inspection date: 28 Apr 2025  
**Protocol number:** 39496373  
Delivery date: 28 Apr 2025

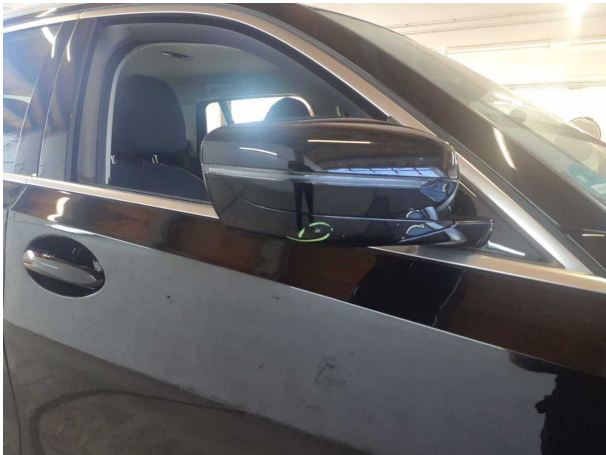
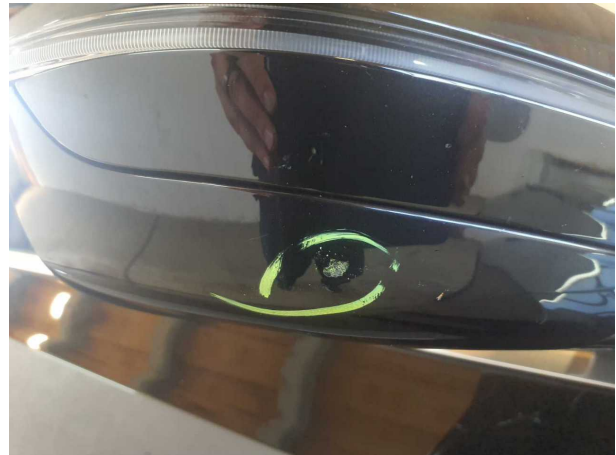
| No. | Component group | Description |
|---|---|---|
| 1 | Wing mirror - right side | Mirror housing - Scratched - Smart repair |

**Damage #1:** Wing mirror - right side: Mirror housing - Scratched - Smart repair

**Damage #1:** Wing mirror - right side: Mirror housing - Scratch... - Smart repair

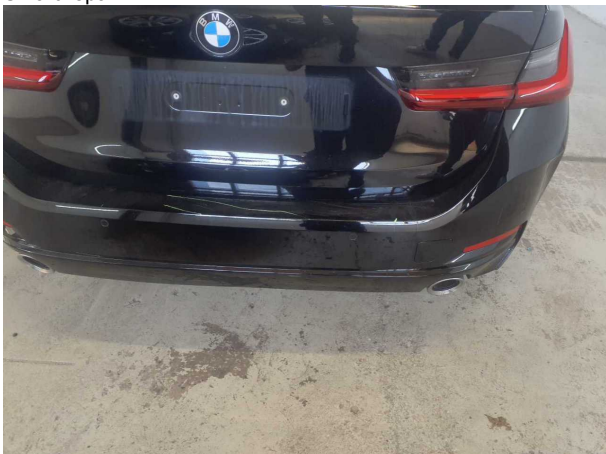
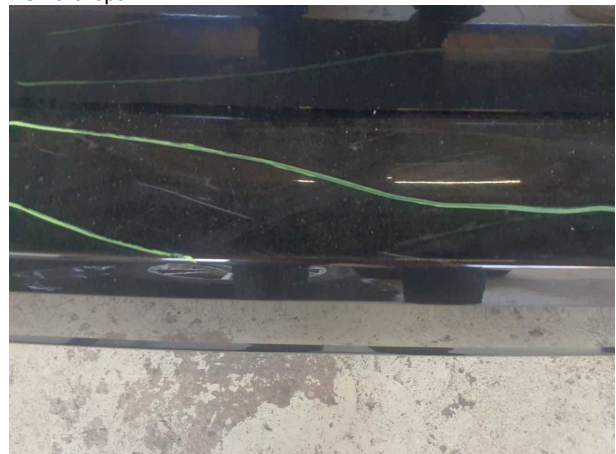
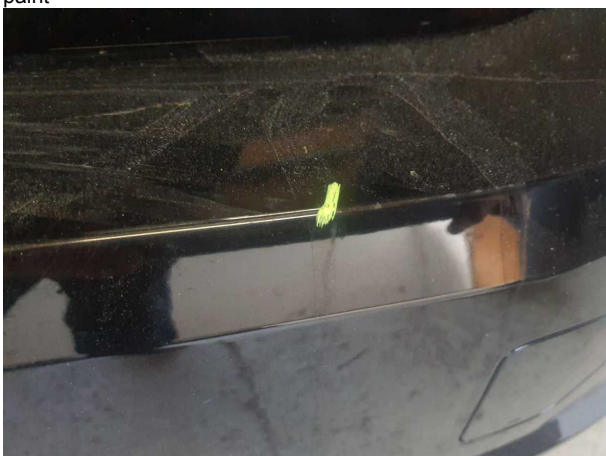
| No. | Component group | Description |
|---|---|---|
| 2 | Rear bumper | Rear bumper - Scratched - Repair and paint |

**Damage #2:** Rear bumper: Rear bumper - Scratched - Repair and paint

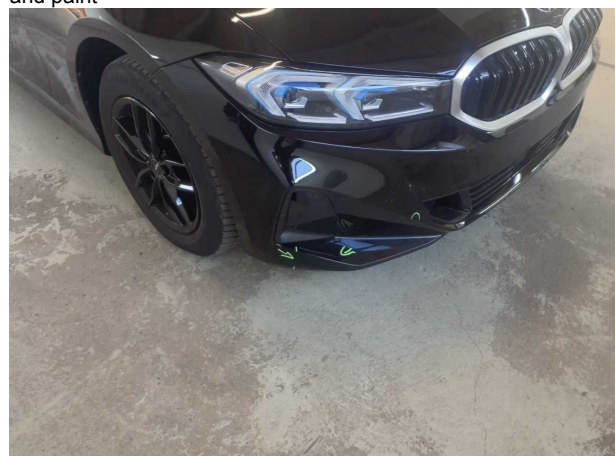
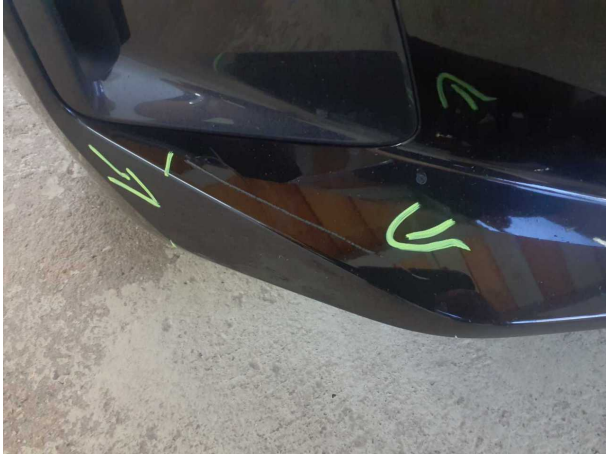
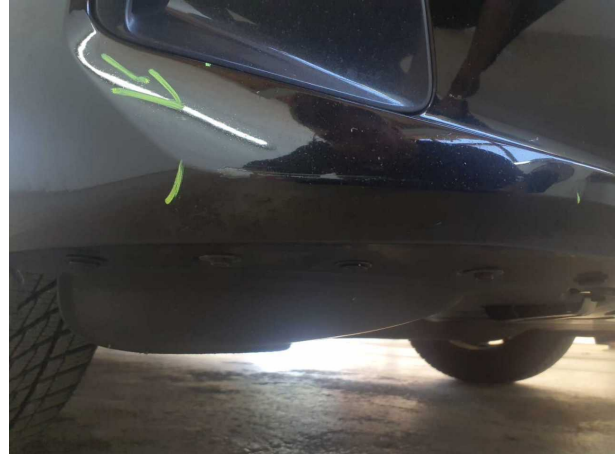
| No. | Component group | Description |
|---|---|---|
| 3 | Front bumper | Front bumper - Scratched - Repair and paint |

**Damage #3:** Front bumper: Front bumper - Scratched - Repair and paint

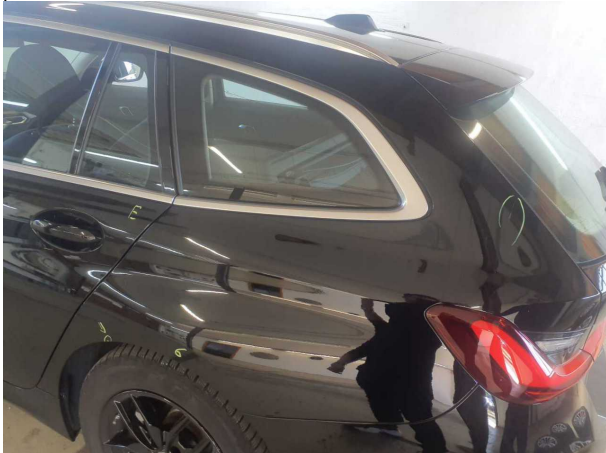
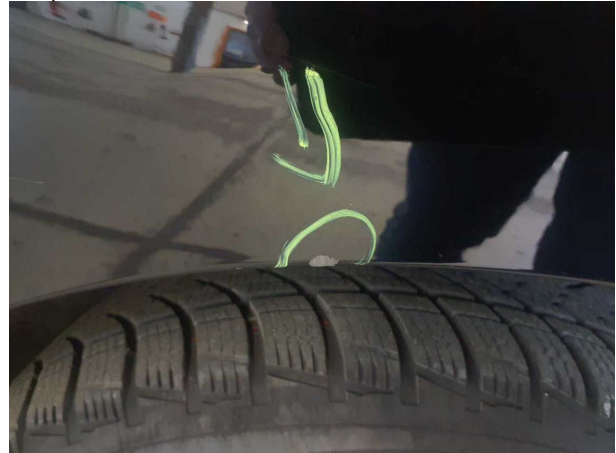
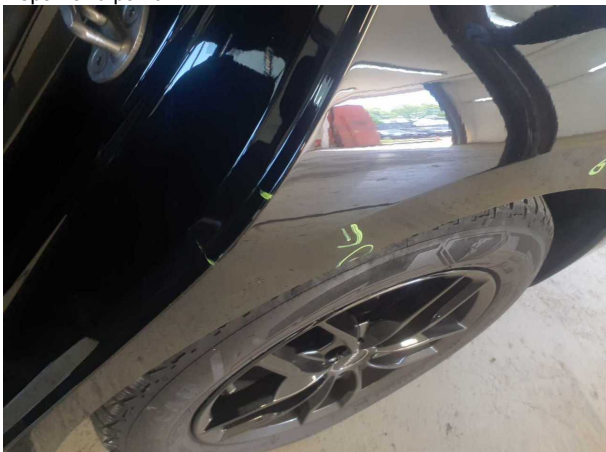
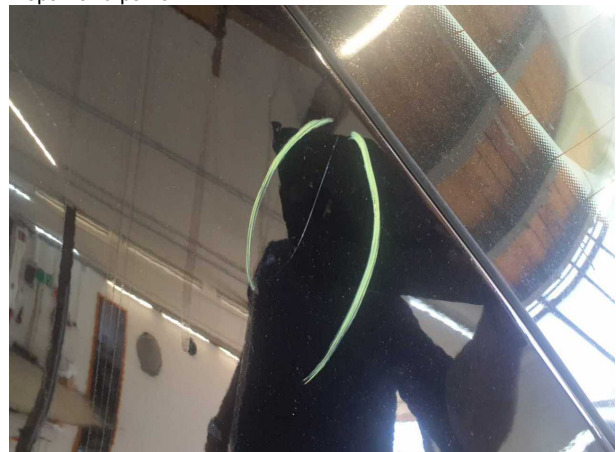
| No. | Component group | Description |
|---|---|---|
| 4 | Side panel - rear left side | Side panel - Scratched - Repair and paint |

**Damage #4:** Side panel - rear left side: Side panel - Scratched - Repair and paint
