**WBA5P51000FN09142**

## Zustandsbericht

Inspection date: 24 Apr 2025  
**Protocol number:** 39444681  
Delivery date: 24 Apr 2025

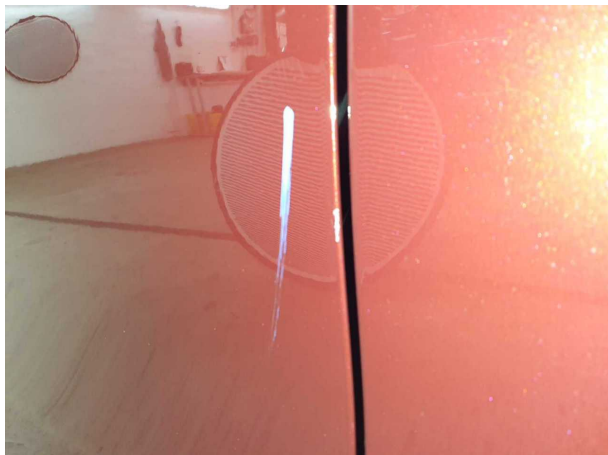
| No. | Component group | Description |
|---|---|---|
| 1 | Door - front left side | Door edge - Scratched - No deduction |

**Damage #1:** Door - front left side: Door edge - Scratched - No deduction

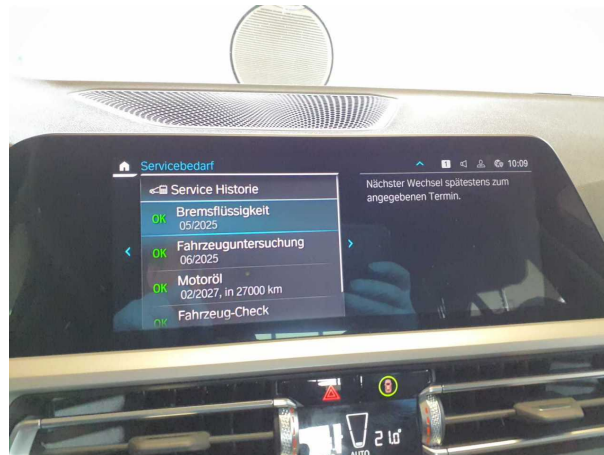
| No. | Component group | Description |
|---|---|---|
| 2 | Braking system | Brake fluid - Due - Replace |

**Damage #2:** Braking system: Brake fluid - Due - Replace

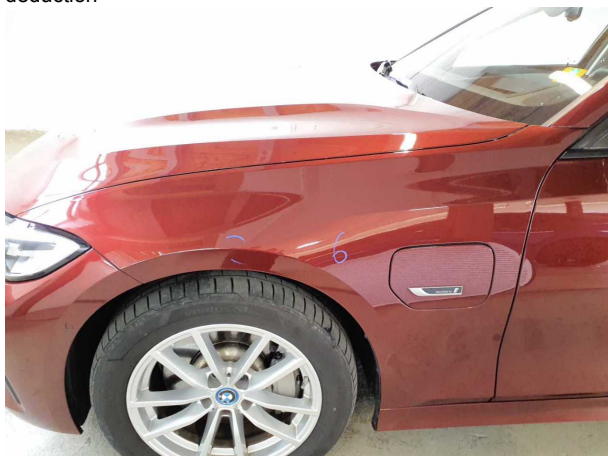
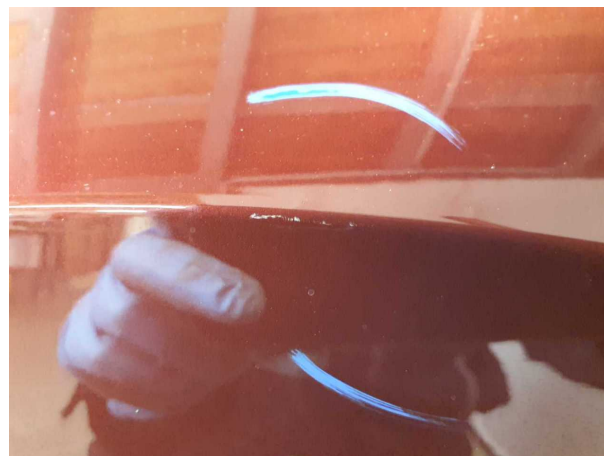
| No. | Component group | Description |
|---|---|---|
| 3 | Mudguard - left side | Mudguard - left side - Scratch(es) - Smart repair |

**Damage #3:** Mudguard - left side: Mudguard - left side - Scratch(es) - Smart repair

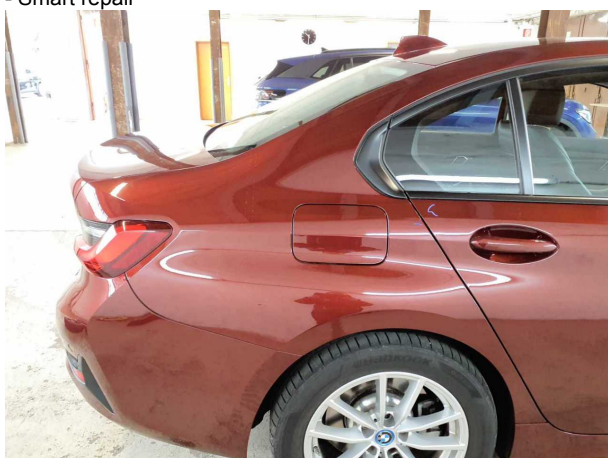
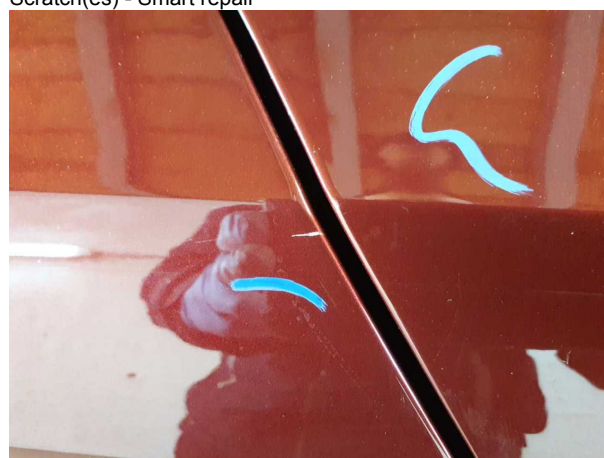
| No. | Component group | Description |
|---|---|---|
| 4 | Side panel - rear right side | Side panel - Scratch(es) - Smart repair |

**Damage #4:** Side panel - rear right side: Side panel - Scratch(es) - Smart repair

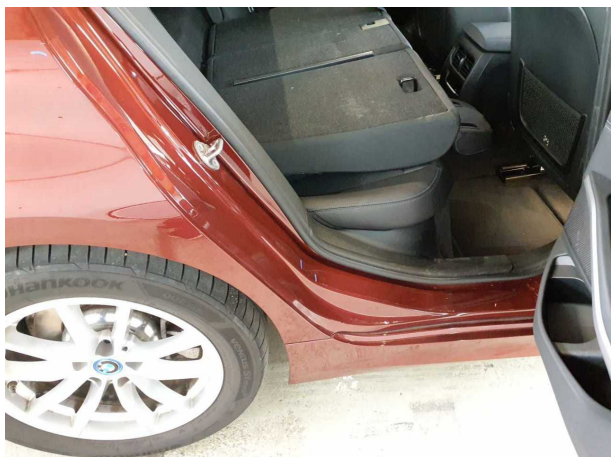
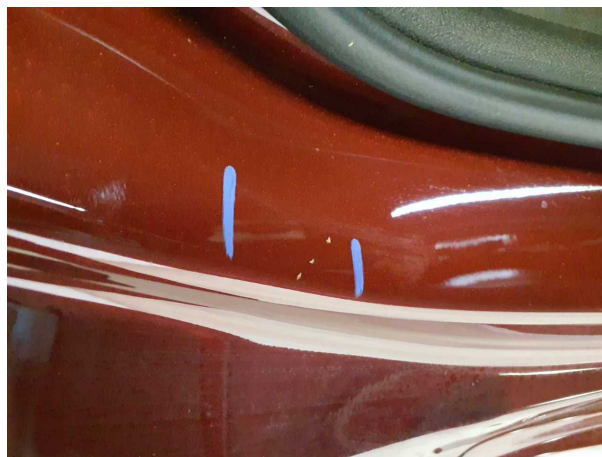
| No. | Component group | Description |
|---|---|---|
| 5 | Side panel - rear right side | Sill - Scratch(es) - Smart repair |

**Damage #5:** Side panel - rear right side: Sill - Scratch(es) - Smart repair

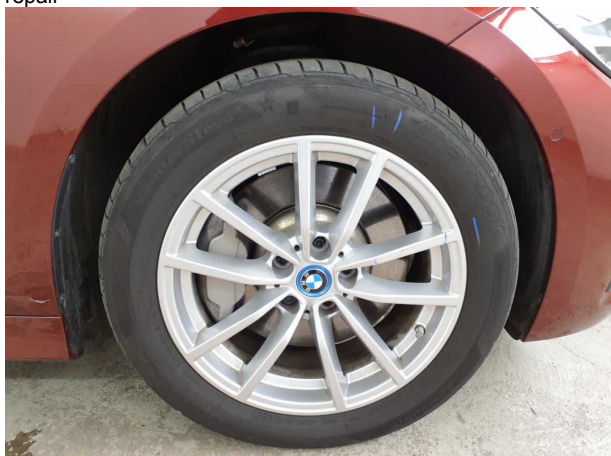
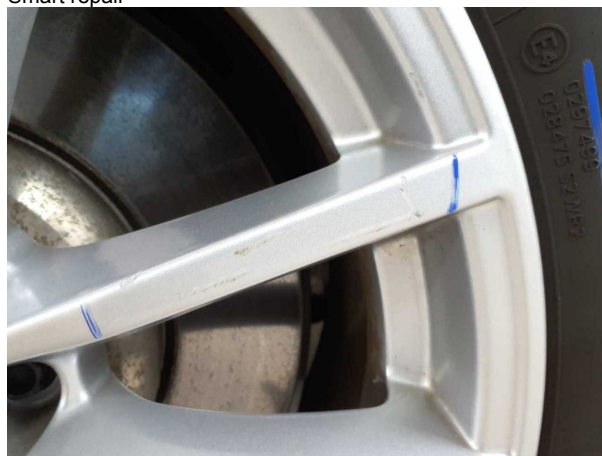
| No. | Component group | Description |
|---|---|---|
| 6 | Wheel / tyres | Alloy rim - front right side - Scratched - Loss in value |

**Damage #6:** Wheel / tyres: Alloy rim - front right side - Scratched - Loss in value

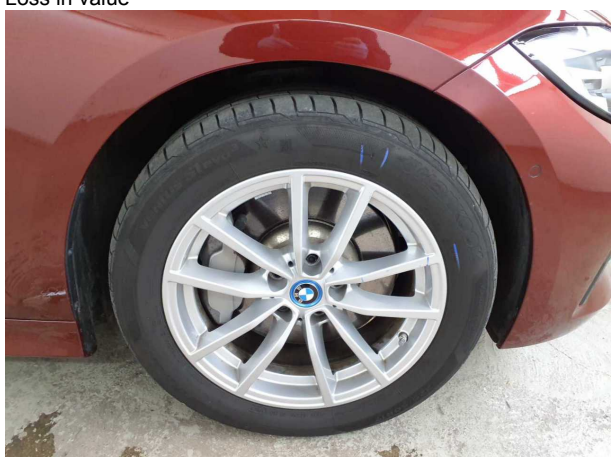
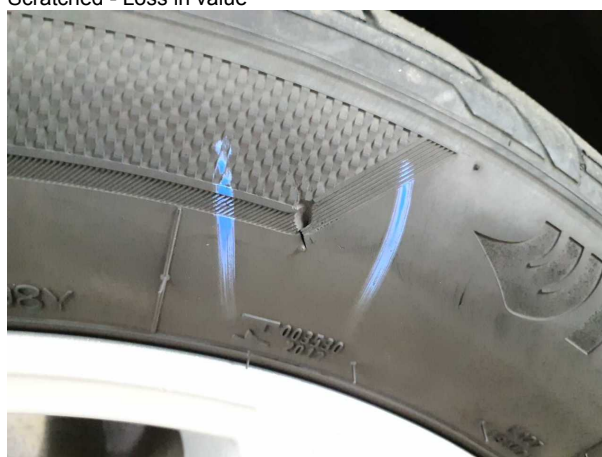
| No. | Component group | Description |
|---|---|---|
| 7 | Wheel / tyres | Tyre - front right side - Damaged - Replace |

| Axle | Tyre size | Manufacturer | Type of tyre | Tread depth | Roadworthy | Permissibility |
|---|---|---|---|---|---|---|
| 1 | 225/50 R17 98Y | Hankook | Summer tyres | 6mm - 6mm | Not o.k. | |

**Damage #7:** Wheel / tyres: Tyre - front right side - Damaged - Replace

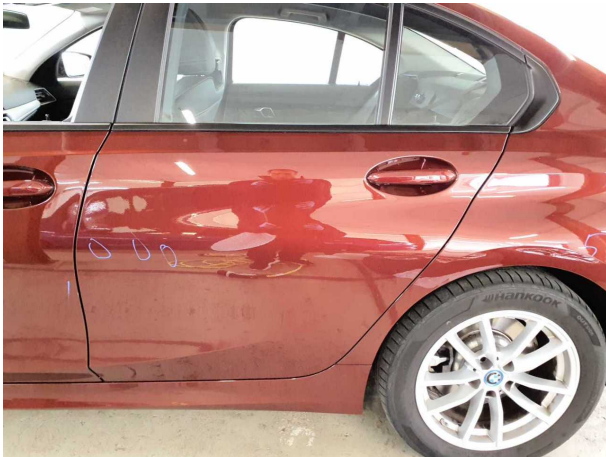
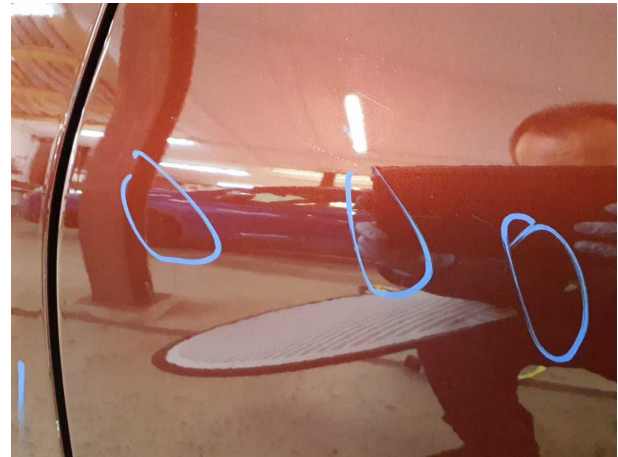
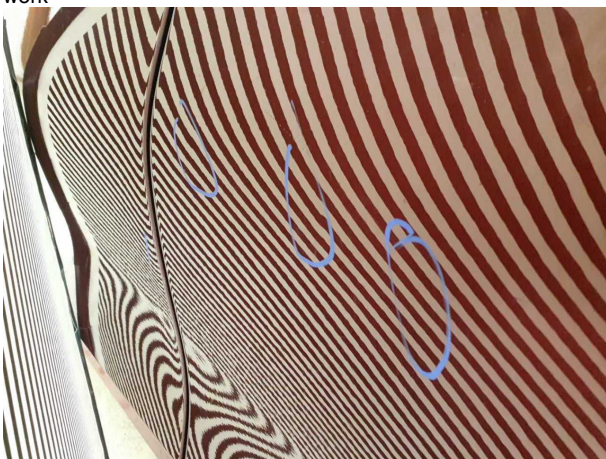
| No. | Component group | Description |
|---|---|---|
| 8 | Door - rear left side | Door - dent(s) - Smooth repair work |

**Damage #8:** Door - rear left side: Door - dent(s) - Smooth repair work

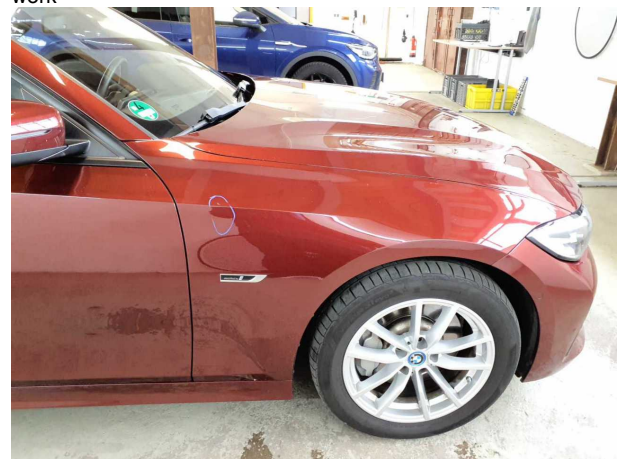
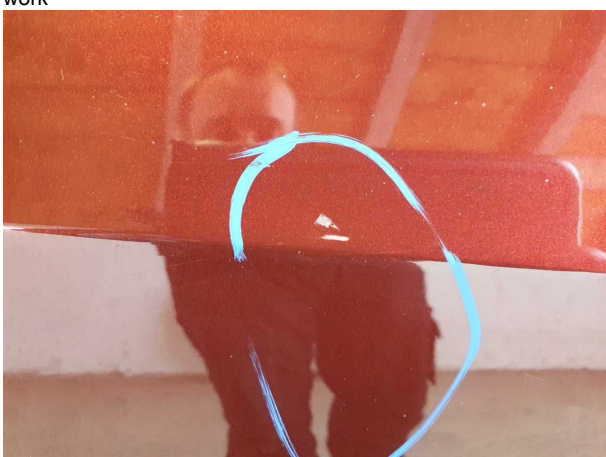
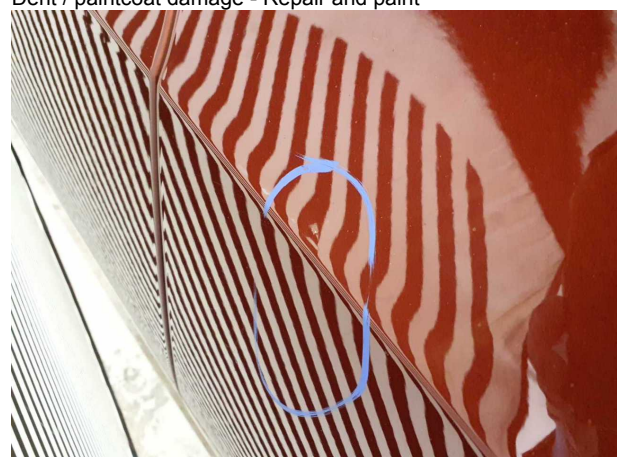
| No. | Component group | Description |
|---|---|---|
| 9 | Mudguard - right side | Mudguard - right side - Dent / paintcoat damage - Repair and paint |

**Damage #9:** Mudguard - right side: Mudguard - right side - Dent / paintcoat damage - Repair and paint

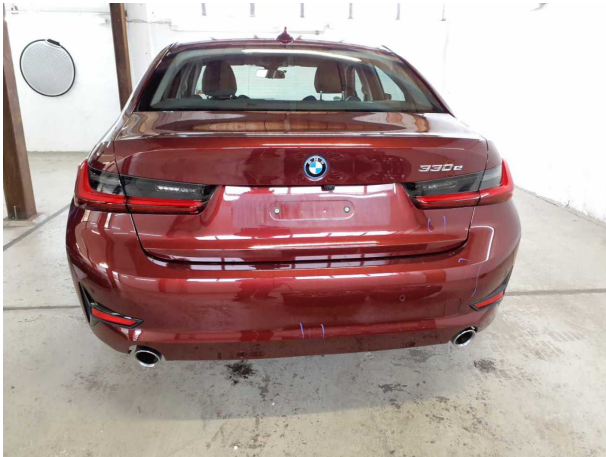
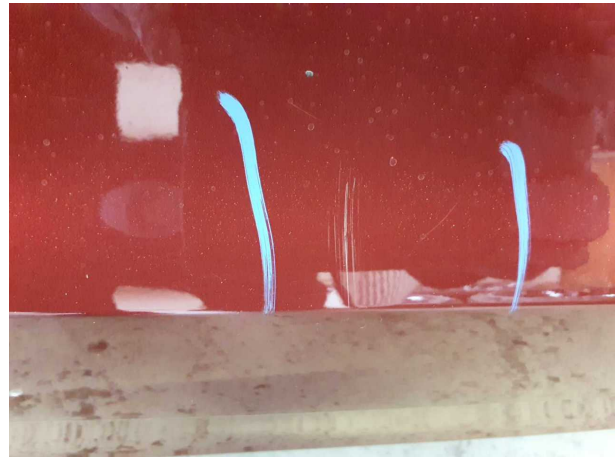
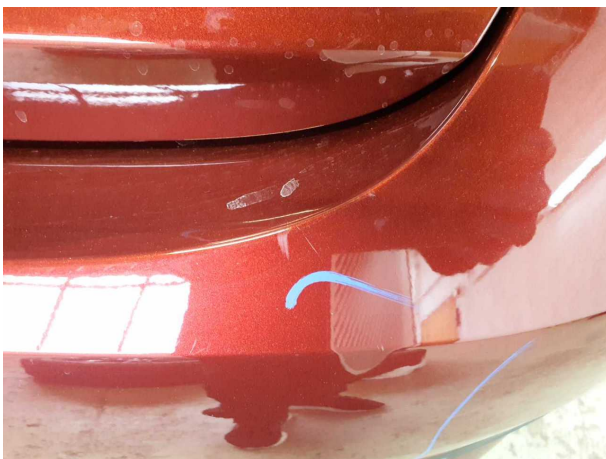
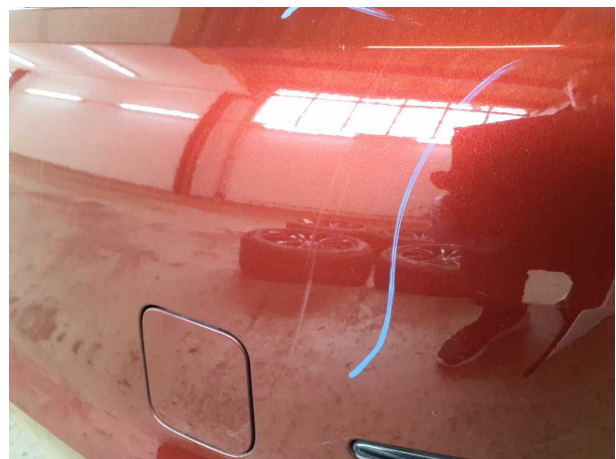
| No. | Component group | Description |
|---|---|---|
| 10 | Rear bumper | Rear bumper - Scratch(es) - Paint |

**Damage #10:** Rear bumper: Rear bumper - Scratch(es) - Paint

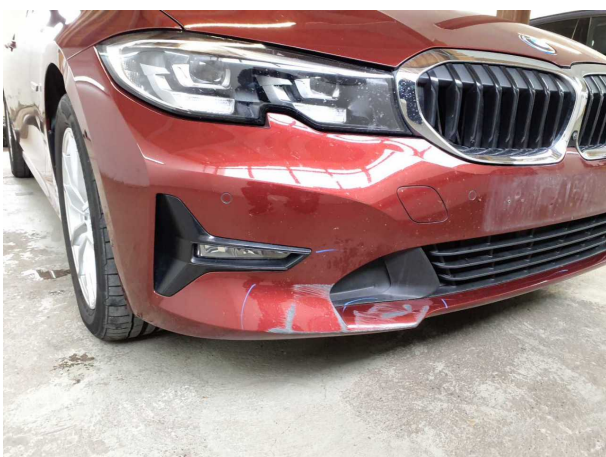
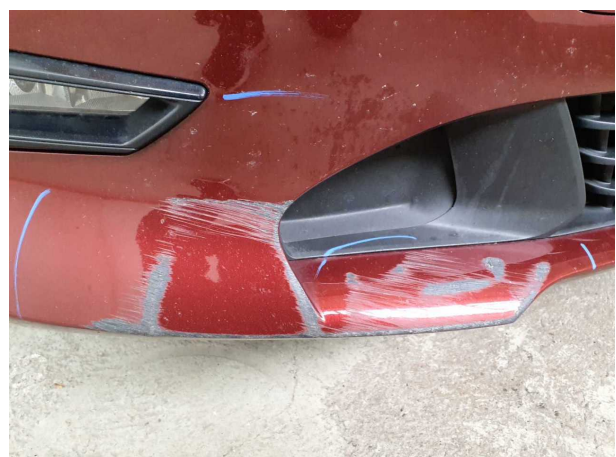
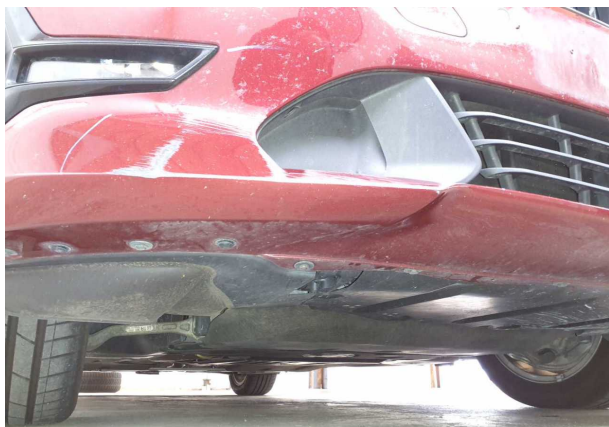
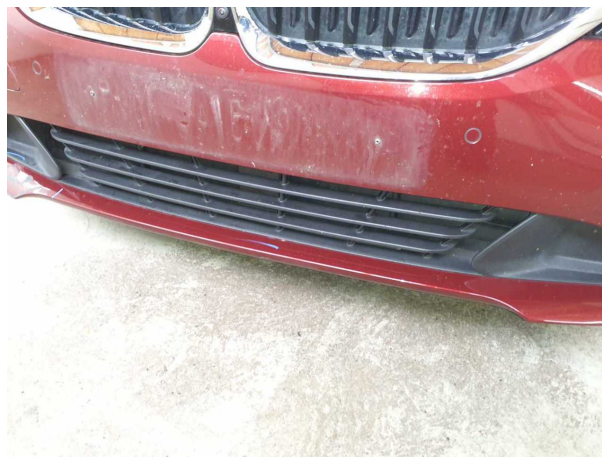
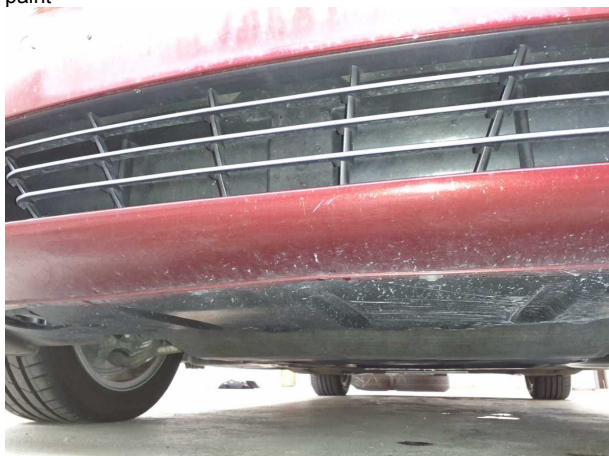
| No. | Component group | Description |
|---|---|---|
| 11 | Front bumper | Front bumper - Scratched - Repair and paint |

**Damage #11:** Front bumper: Front bumper - Scratched - Repair a...  
paint

**Damage #11:** Front bumper: Front bumper - Scratched - Rep...  
and paint

**Damage #11:** Front bumper: Front bumper - Scratched - Repair and paint

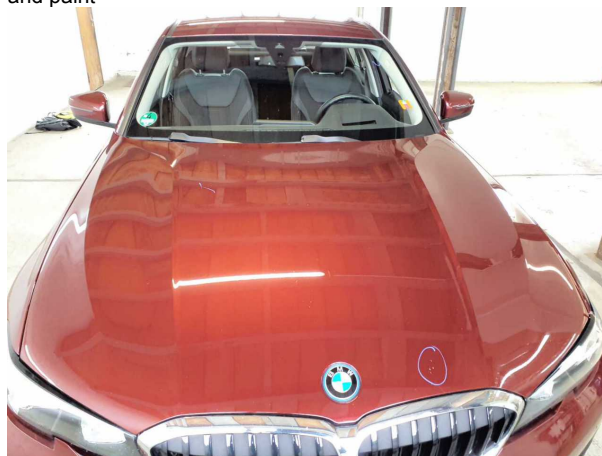
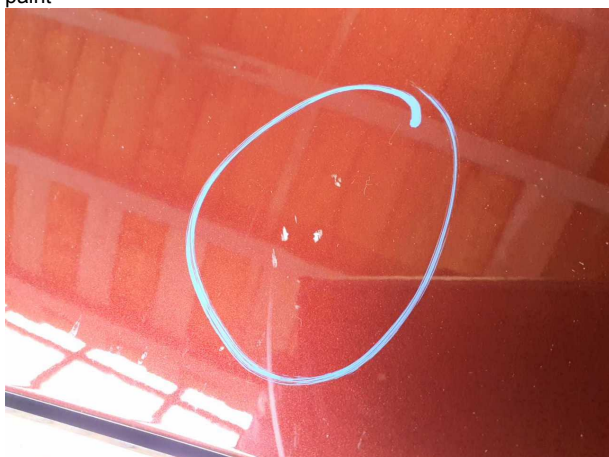
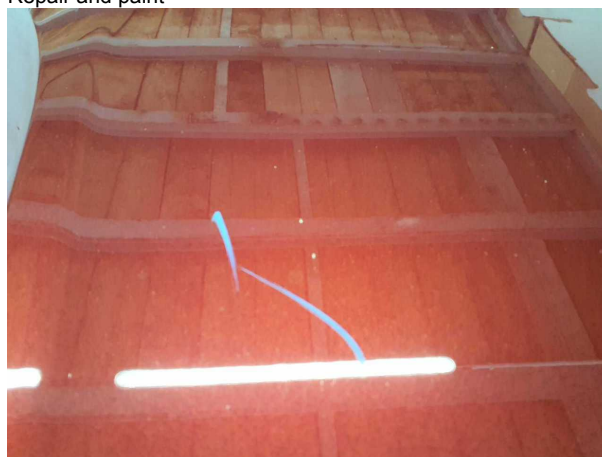
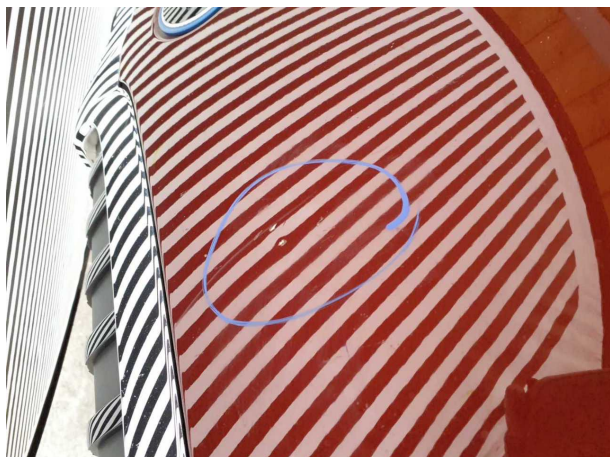
| No. | Component group | Description |
|---|---|---|
| 12 | Bonnet | Bonnet - Dent / paintcoat damage - Repair and paint |

**Damage #12:** Bonnet: Bonnet - Dent / paintcoat damage - Repair and paint
