**WBA6N31040FL07144**

## Zustandsbericht

Inspection date: 28 Apr 2025  
**Protocol number: 39513267**

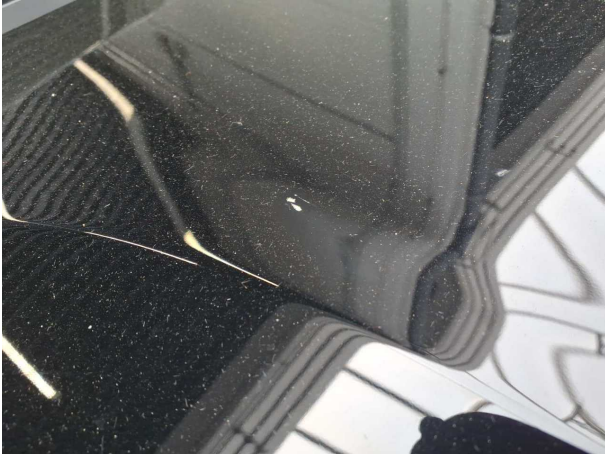
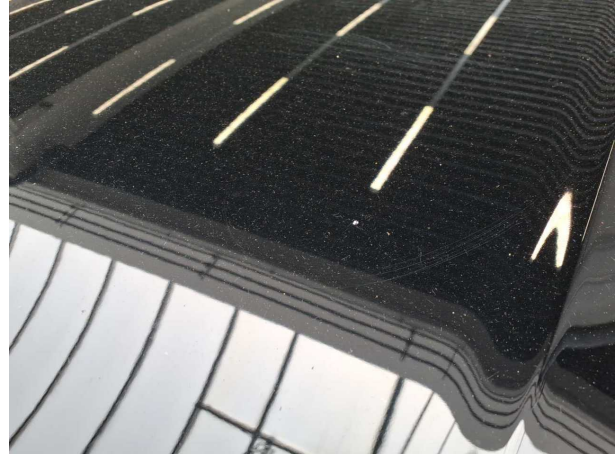
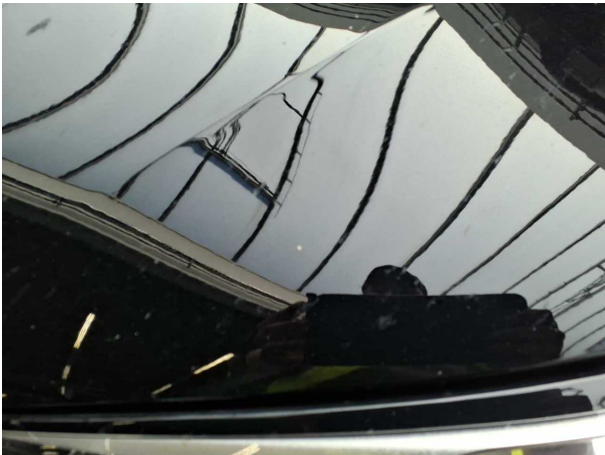
| No. | Component group | Description |
|---|---|---|
| 2 | Bonnet | Bonnet - Stone chips - Repair and paint |

**Damage #2:** Bonnet: Bonnet - Stone chips - Repair and paint
