WBA6K51020FL20513

## Vehicle details

## Zustandsbericht

Inspection date: 29 Apr 2025  
**Protocol number:** 39511423  
Delivery date: 29 Apr 2025

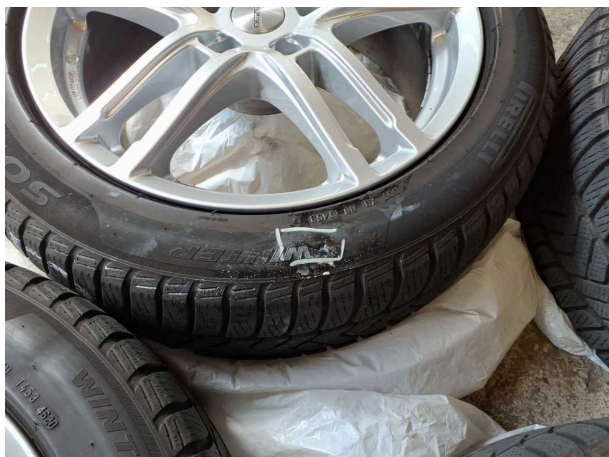
| No. | Component group | Description |
|---|---|---|
| 1 | 2nd wheel set | 1 tyre - Damaged - No deduction |

**Damage #1:** 2nd wheel set: 1 tyre - Damaged - No deduction

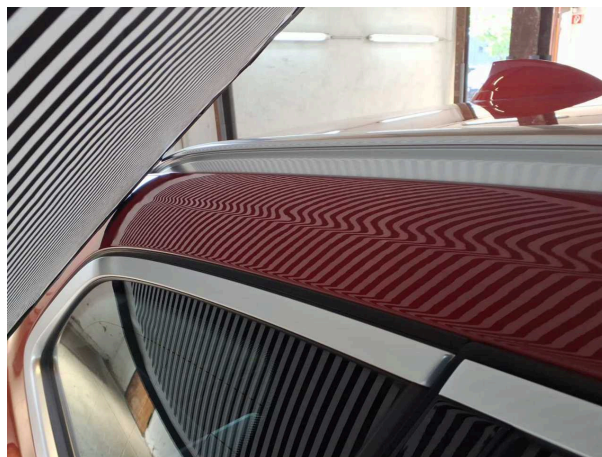
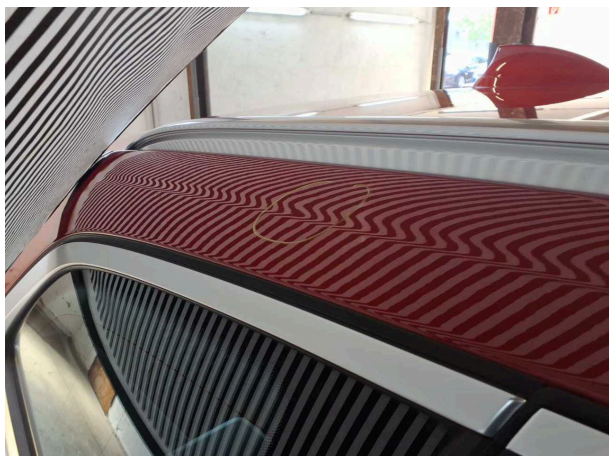
| No. | Component group | Description |
|---|---|---|
| 2 | Roof | Roof rail - right side - dent(s) - Smooth repair work |

**Damage #2:** Roof: Roof rail - right side - dent(s) - Smooth repair work

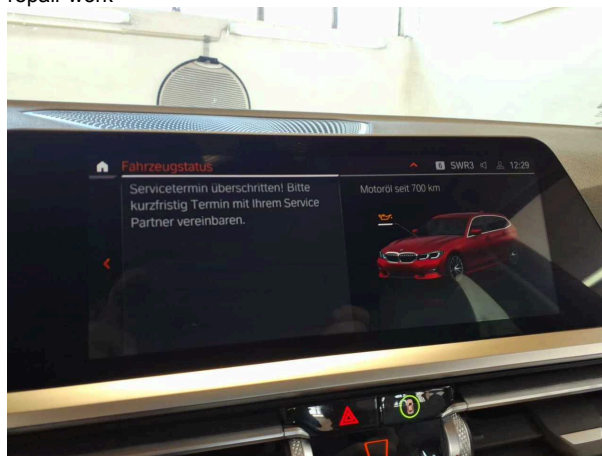
| No. | Component group | Description |
|---|---|---|
| 3 | Misc. | Inspection / maintenance - Due - Perform |

**Damage #3:** Misc.: Inspection / maintenance - Due - Perform

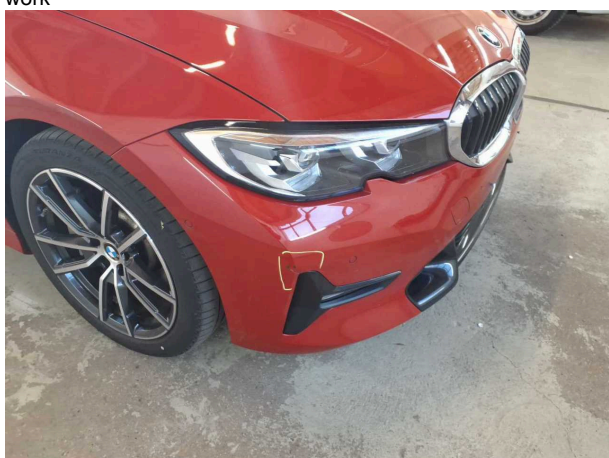
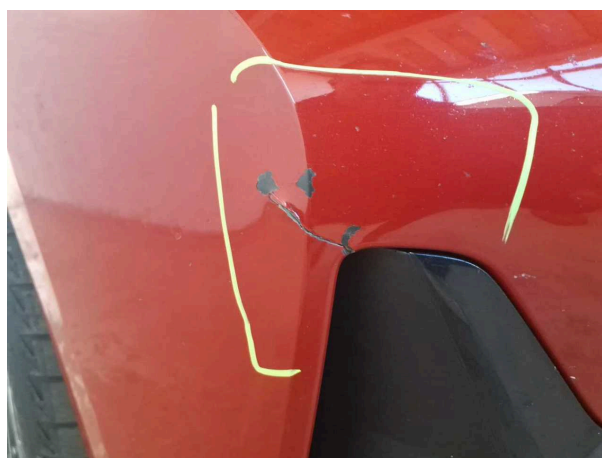
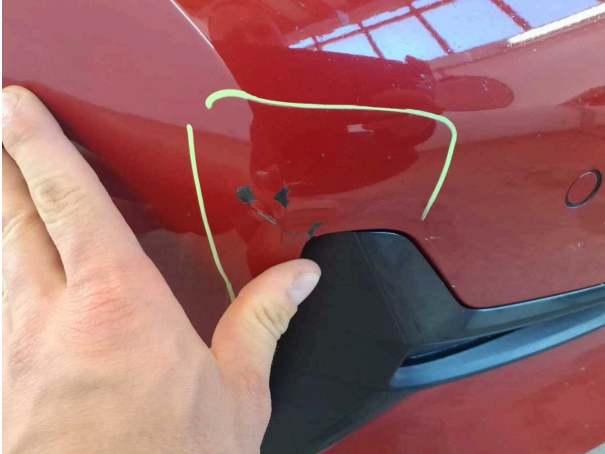
| No. | Component group | Description |
|---|---|---|
| 4 | Front bumper | Front bumper (Gebrochen) - Damaged - Replace |

**Damage #4:** Front bumper: Front bumper (Gebrochen) - Damaged - Replace

**Damage #4:** Front bumper: Front bumper (Gebrochen) - Damaged  
- Replace
