**WBA5P51060FK96844**

## Zustandsbericht

Inspection date: 1 Apr 2025  
**Protocol number: 39334131**

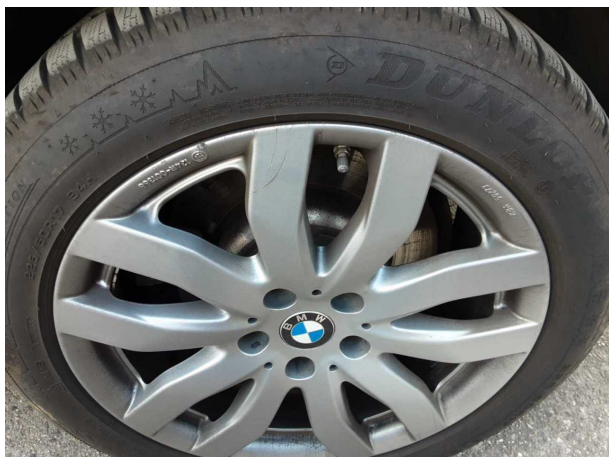
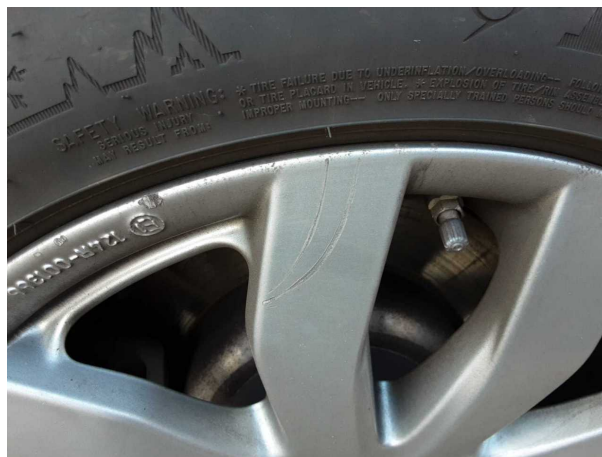
| No. | Component group | Description |
|---|---|---|
| 1 | Wheel / tyres | Alloy rim - rear left side - Scratch(es) - Smart repair |

**Damage #1:** Wheel / tyres: Alloy rim - rear left side - Scratch(es) - Smart repair

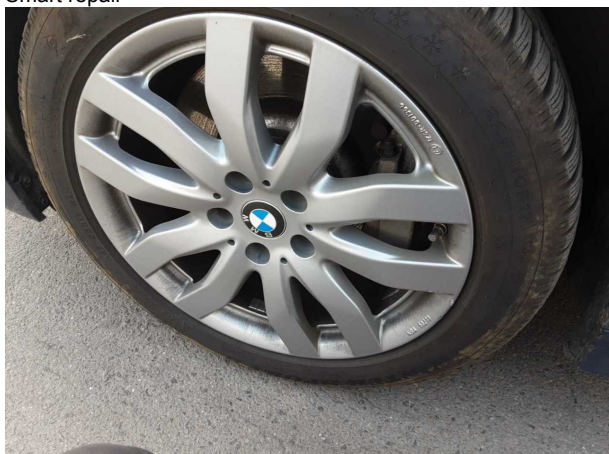
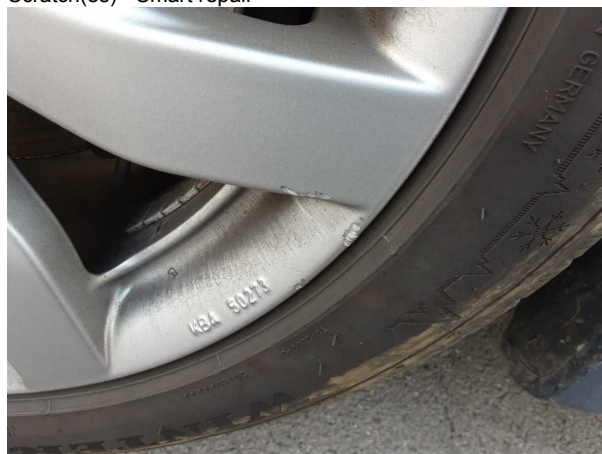
| No. | Component group | Description |
|---|---|---|
| 2 | Wheel / tyres | Alloy rim - front left side - Scratch(es) - Smart repair |

**Damage #2:** Wheel / tyres: Alloy rim - front left side - Scratch(es) - Smart repair

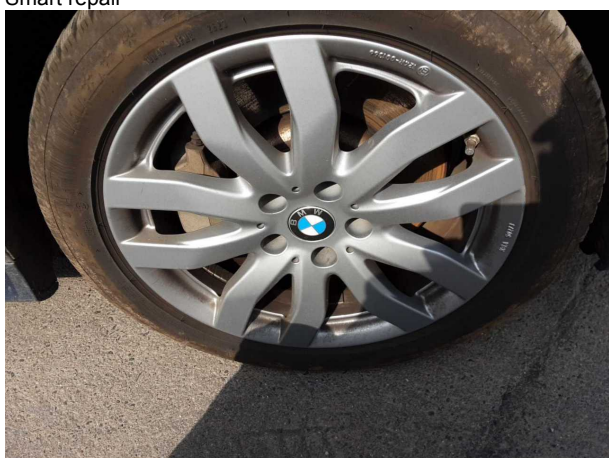
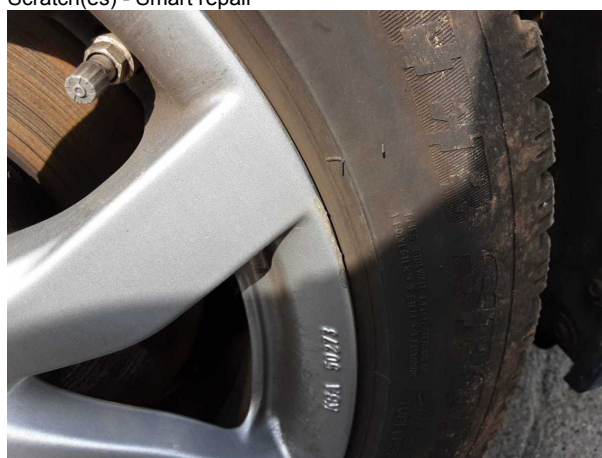
| No. | Component group | Description |
|---|---|---|
| 3 | Wheel / tyres | Alloy rim - front right side - Scratch(es) - Smart repair |

**Damage #3:** Wheel / tyres: Alloy rim - front right side - Scratch(es) - Smart repair

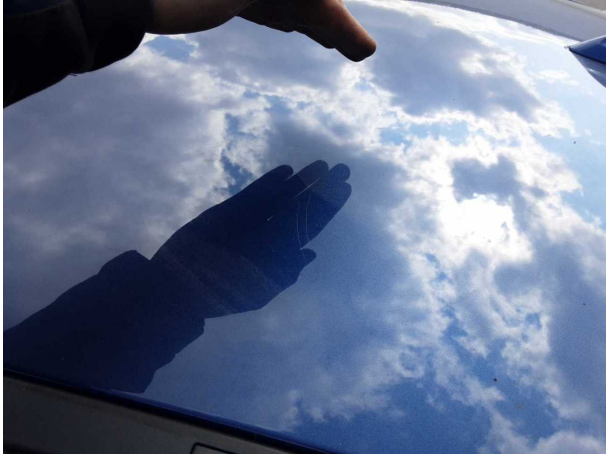
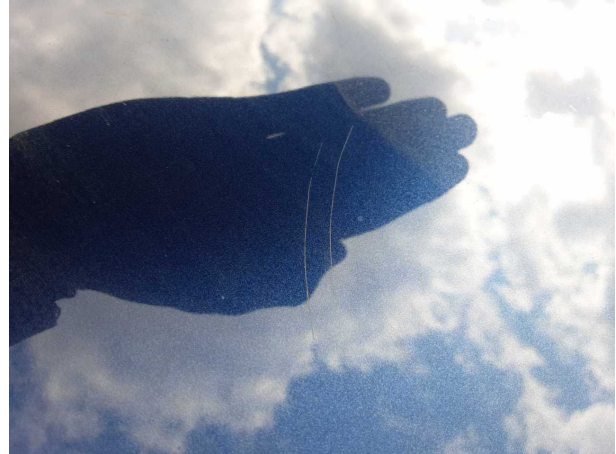
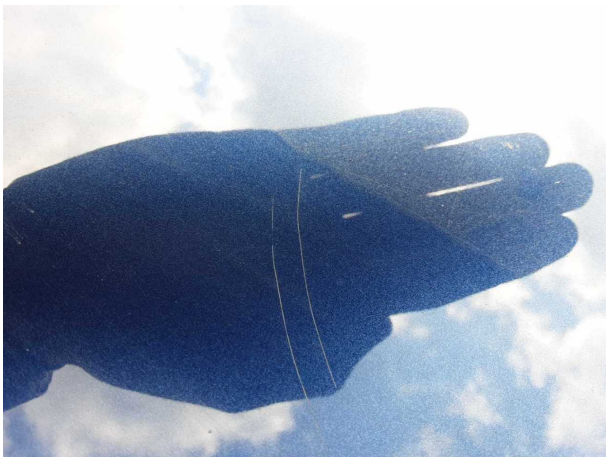
| No. | Component group | Description |
|---|---|---|
| 4 | Roof | Roof - Scratch(es) - Smart repair |

**Damage #4:** Roof: Roof - Scratch(es) - Smart repair

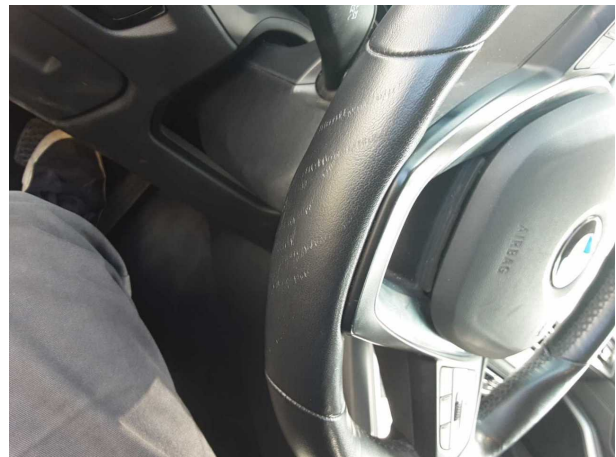
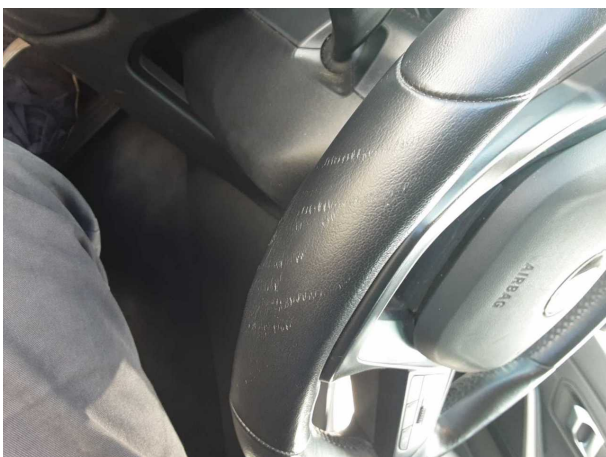
| No. | Component group | Description |
|---|---|---|
| 5 | Steering system | Steering wheel - Scratch(es) - Smart repair |

**Damage #5:** Steering system: Steering wheel - Scratch(es) - Smart repair

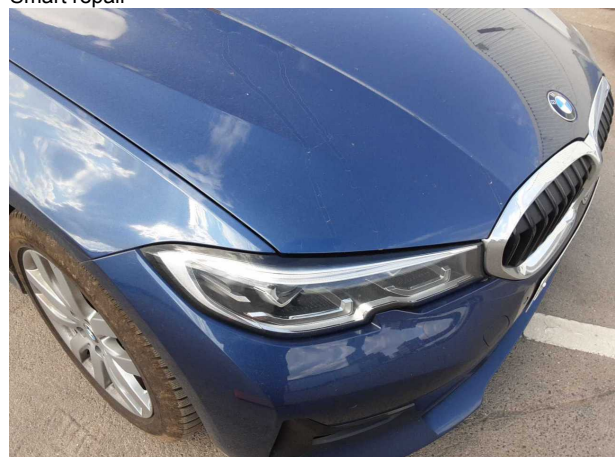
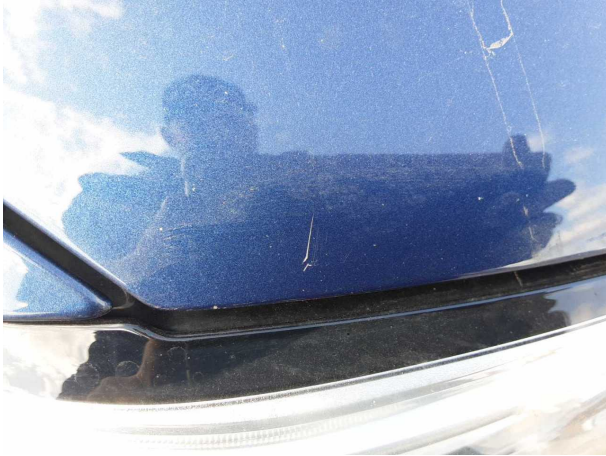
| No. | Component group | Description |
|---|---|---|
| 6 | Bonnet | Bonnet - Scratch(es) - Smart repair |

**Damage #6:** Bonnet: Bonnet - Scratch(es) - Smart repair

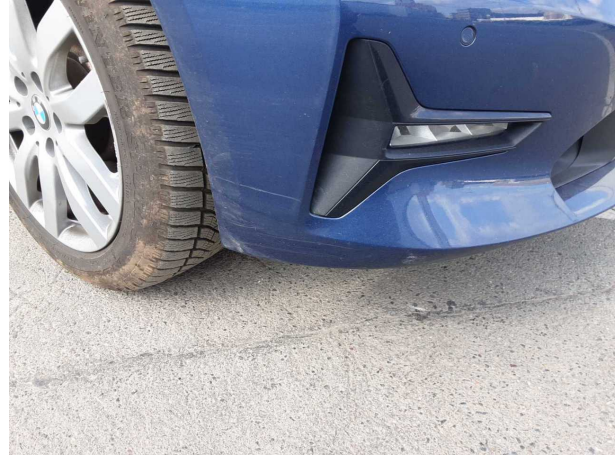
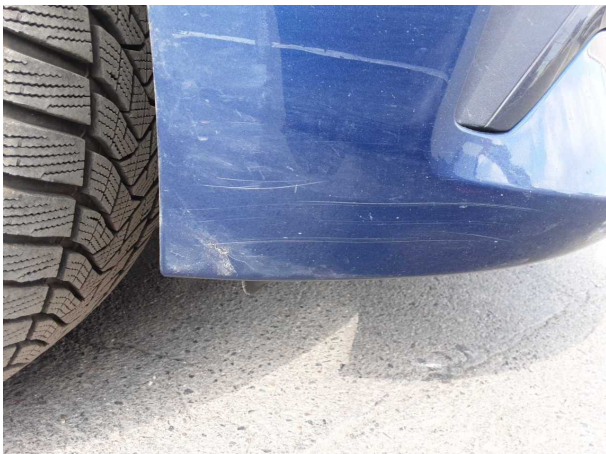
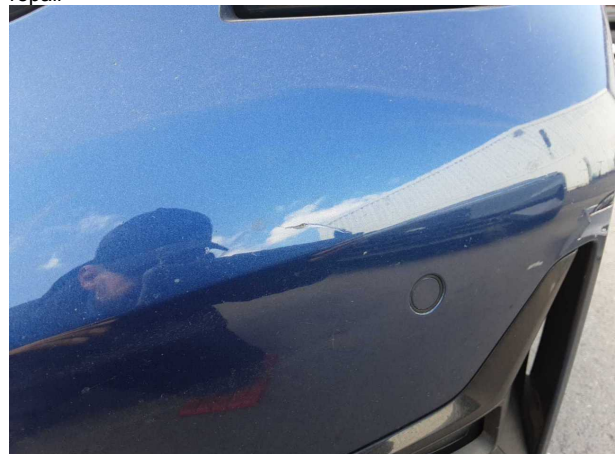
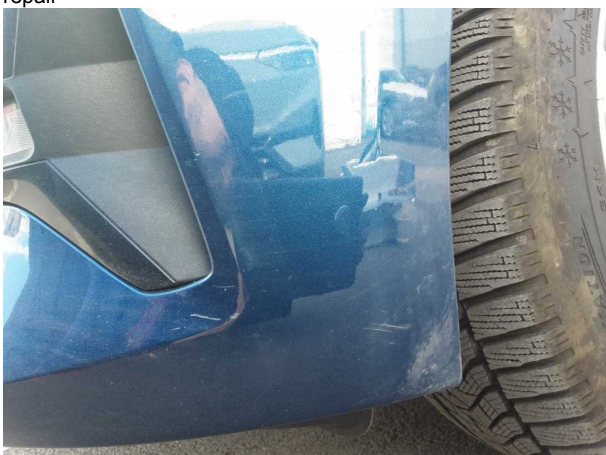
| No. | Component group | Description |
|---|---|---|
| 7 | Front bumper | Front bumper - Scratch(es) - Smart repair |

**Damage #7:** Front bumper: Front bumper - Scratch(es) - Smart repair

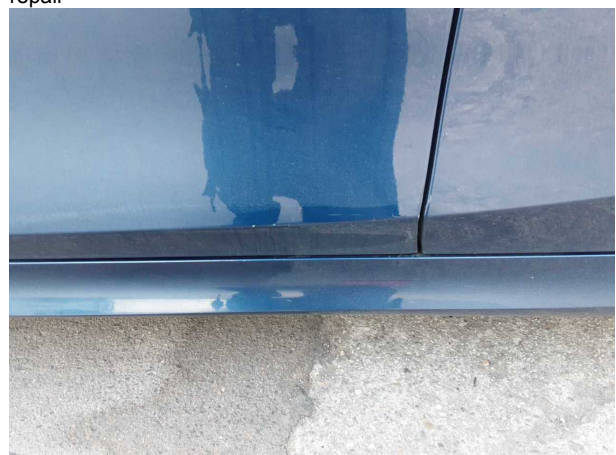
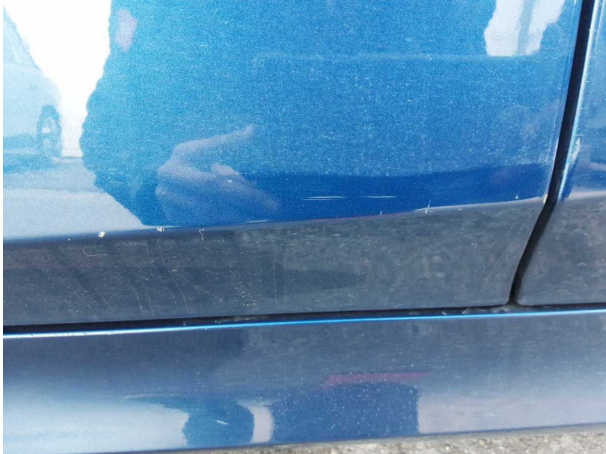
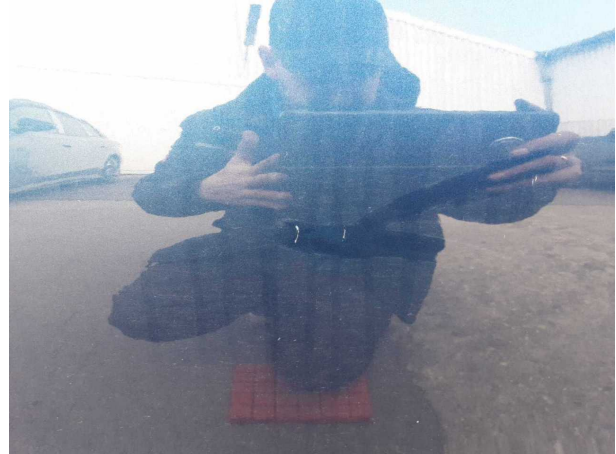
| No. | Component group | Description |
|---|---|---|
| 8 | Door - front left side | Door - Scratch(es) - Smart repair |

**Damage #8:** Door - front left side: Door - Scratch(es) - Smart repair

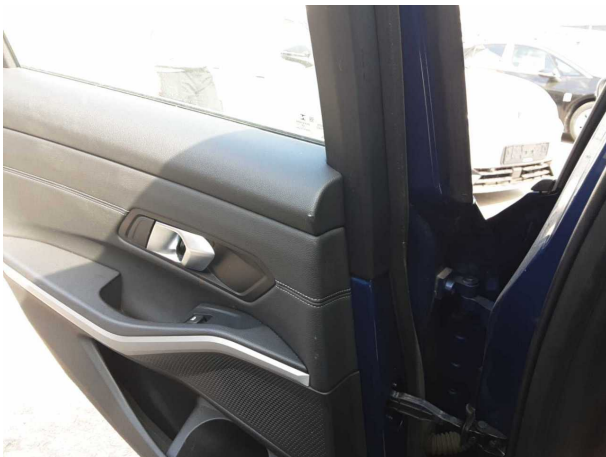
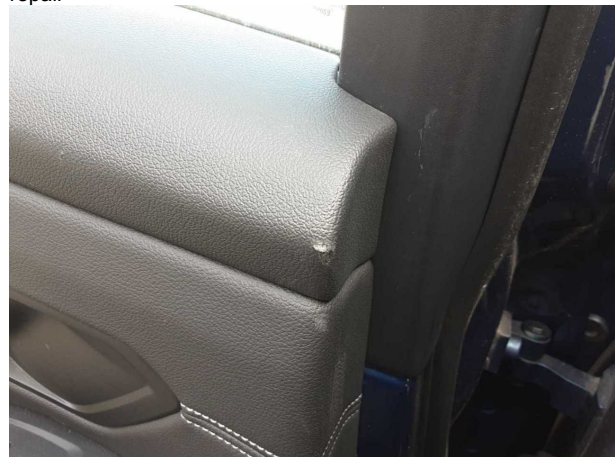
| No. | Component group | Description |
|---|---|---|
| 9 | Trim / covers | Door trim - rear left side - Scratch(es) - Smart repair |

**Damage #9:** Trim / covers: Door trim - rear left side - Scratch(es) - Smart repair

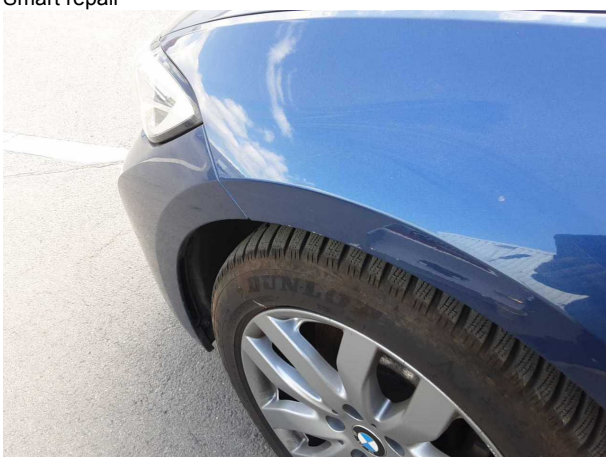
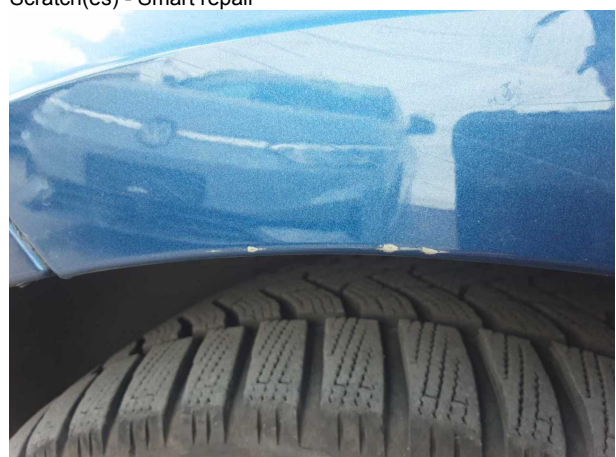
| No. | Component group | Description |
|---|---|---|
| 10 | Mudguard - left side | Mudguard - left side - Scratch(es) - Paint |

**Damage #10:** Mudguard - left side: Mudguard - left side - Scratch(es) - Paint

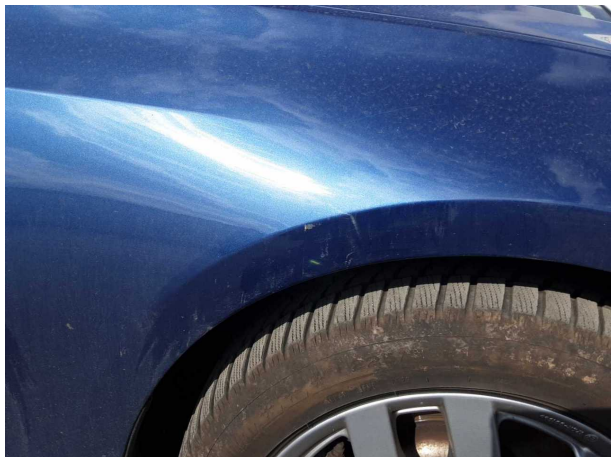
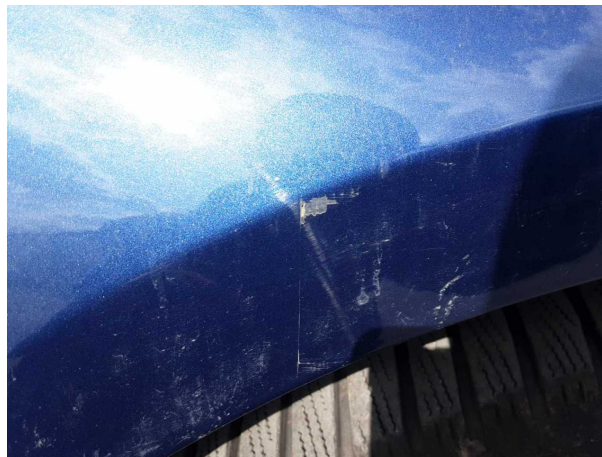
| No. | Component group | Description |
|---|---|---|
| 11 | Mudguard - right side | Mudguard - right side - Scratch(es) - Paint |

| No. | Location |
|---|---|
| 1 | Mudguard - right side, Professionally carried out, Invoice of repair done Non-existent |

**Damage #11:** Mudguard - right side: Mudguard - right side - Scratch(es) - Paint

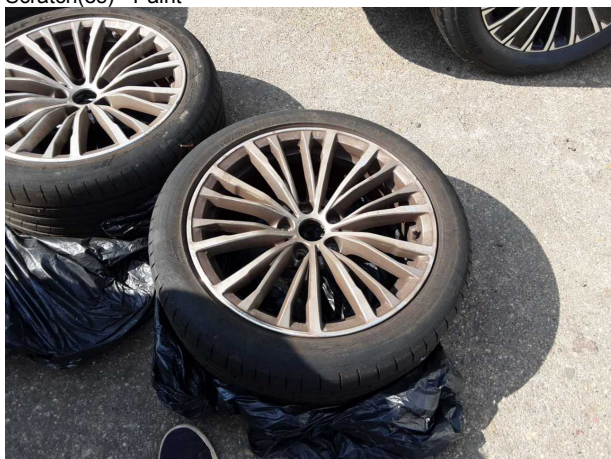
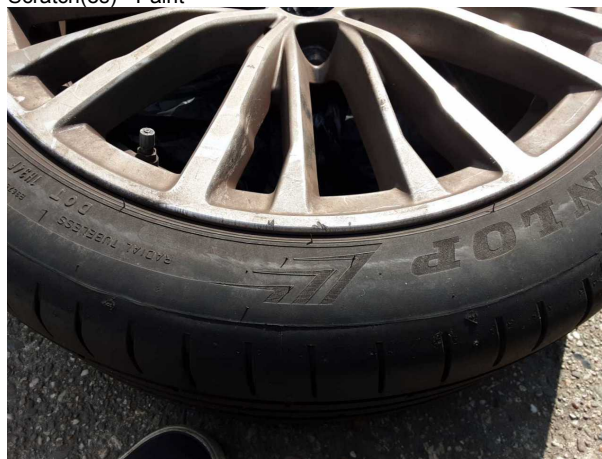
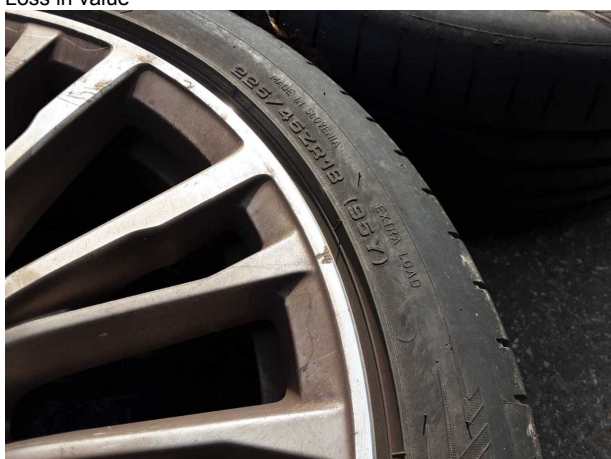
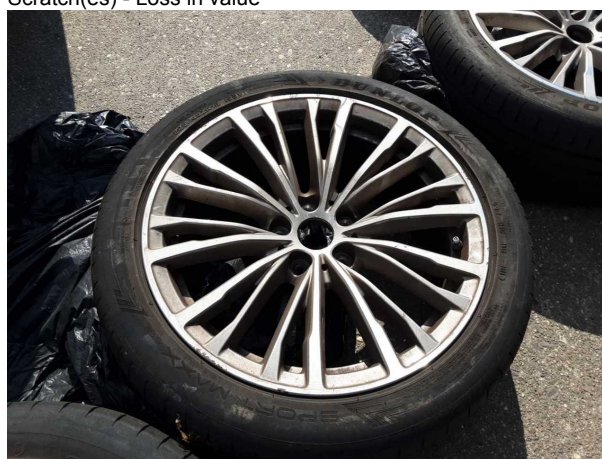
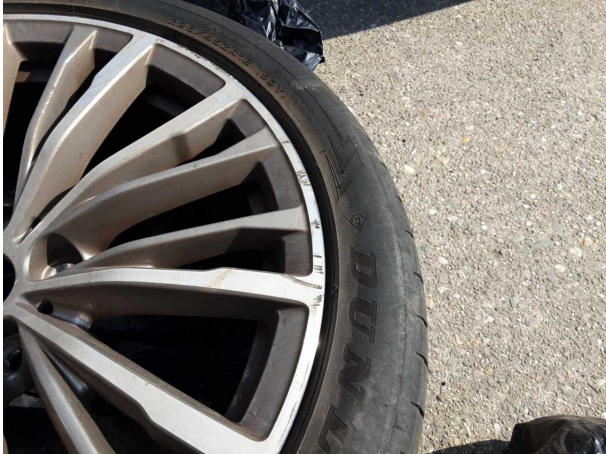
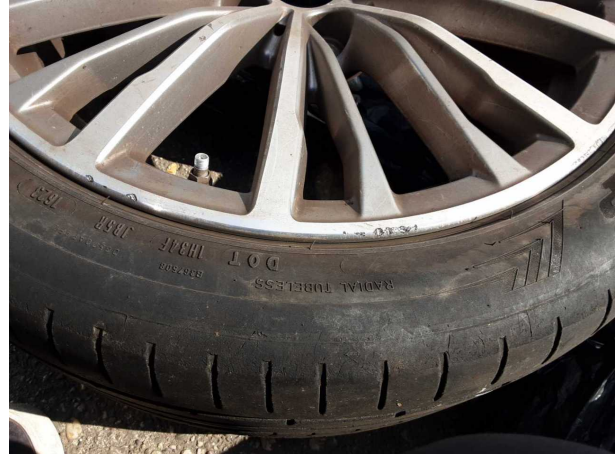
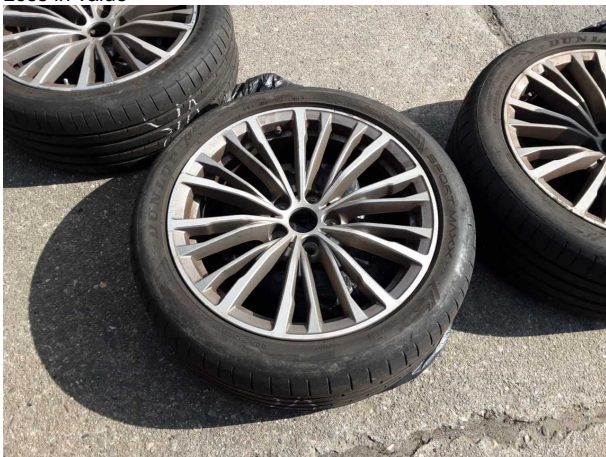
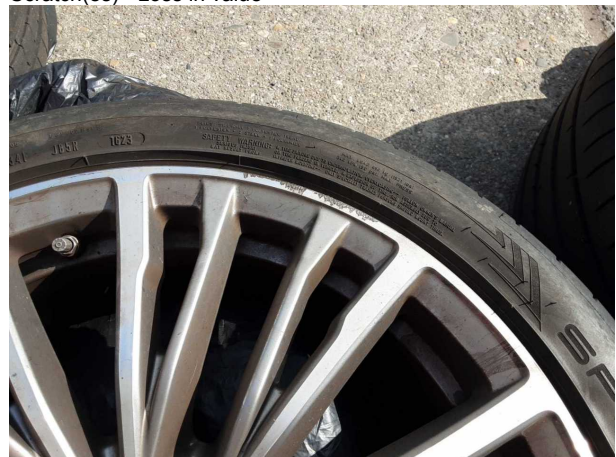
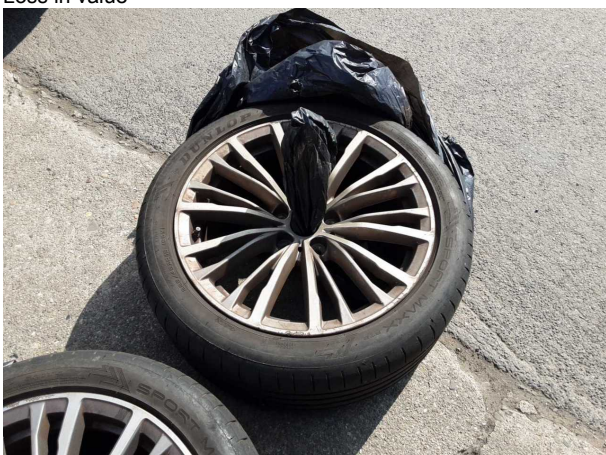
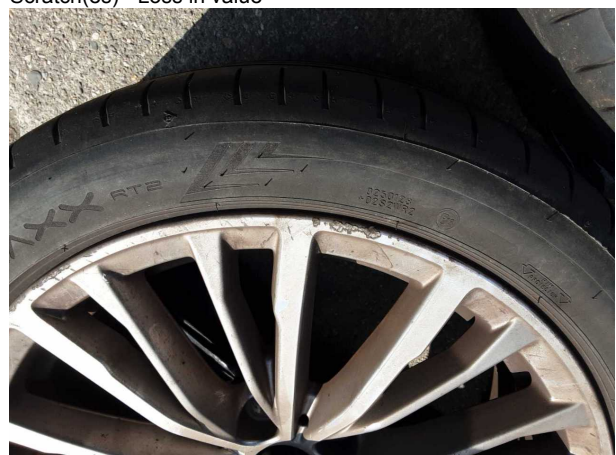
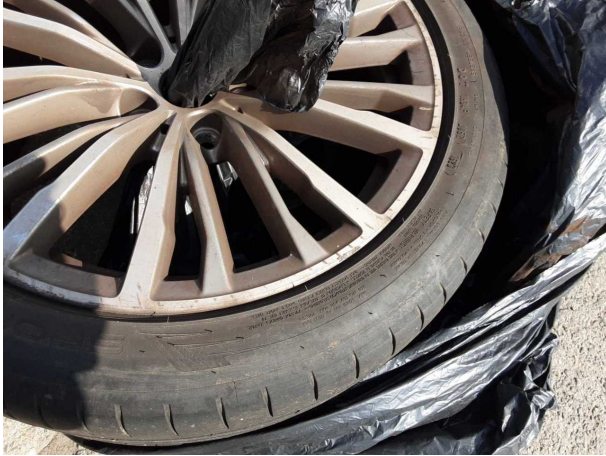
| No. | Component group | Description |
|---|---|---|
| 12 | 2nd wheel set | Alloy rim set - complete - Scratch(es) - Loss in value |

**Damage #12:** 2nd wheel set: Alloy rim set - complete - Scratch(es) - Loss in value

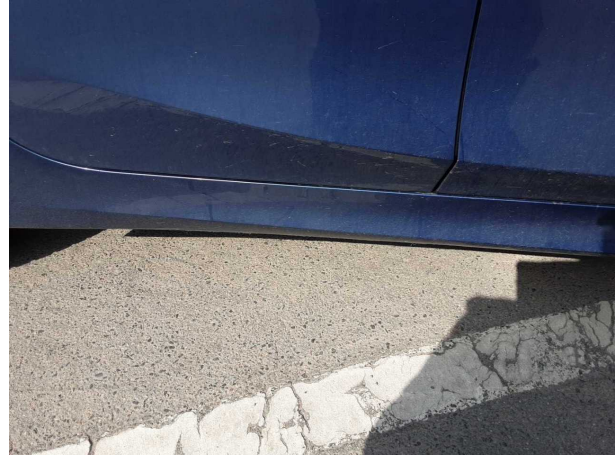
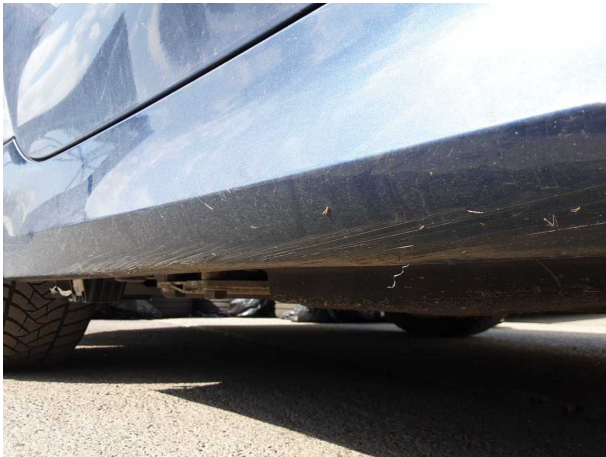
| No. | Component group | Description |
|---|---|---|
| 13 | Sill - right side | Sill - Scratch(es) - Paint |

**Damage #13:** Sill - right side: Sill - Scratch(es) - Paint

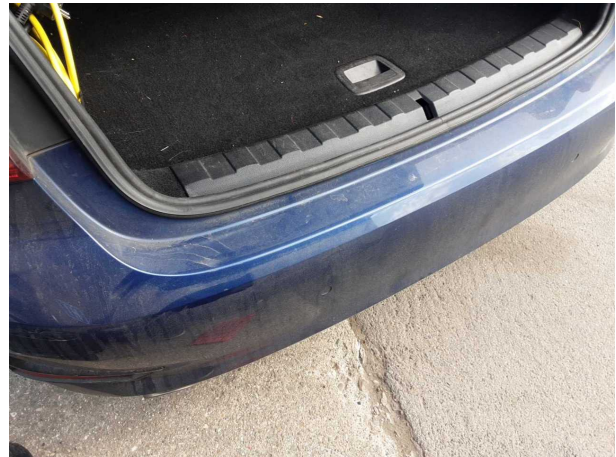
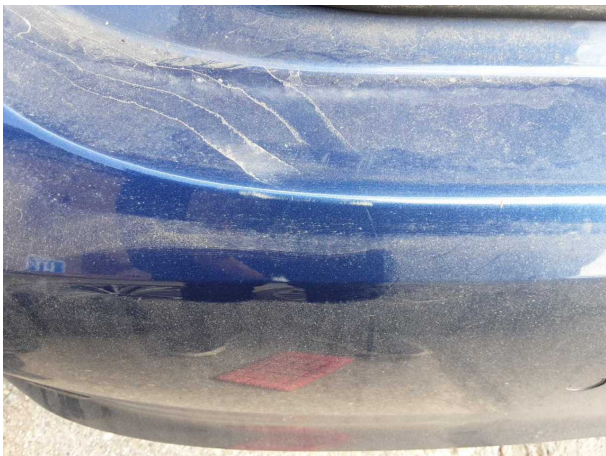
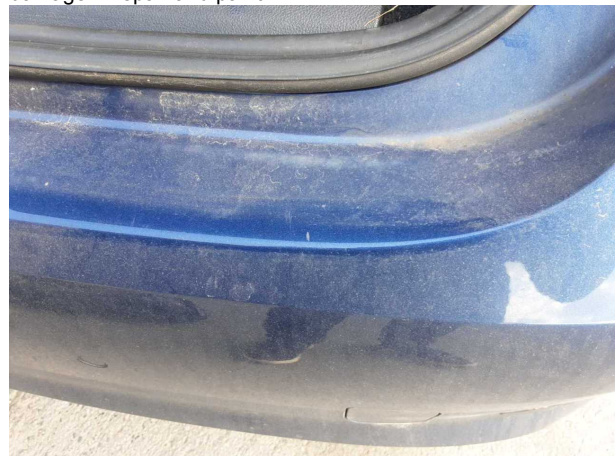
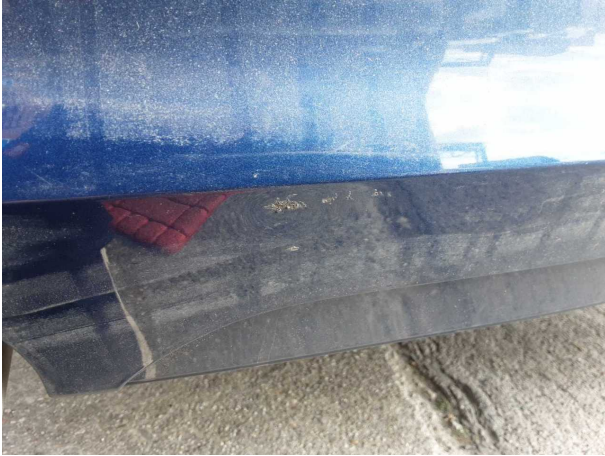
| No. | Component group | Description |
|---|---|---|
| 14 | Rear bumper | Rear bumper - Dent / paintcoat damage - Repair and paint |

**Damage #14:** Rear bumper: Rear bumper - Dent / paintcoat damage - Repair and paint
