WBA6N310X0FK89720

## Zustandsbericht

Inspection date: 28 Apr 2025

**Protocol number:** 39500040

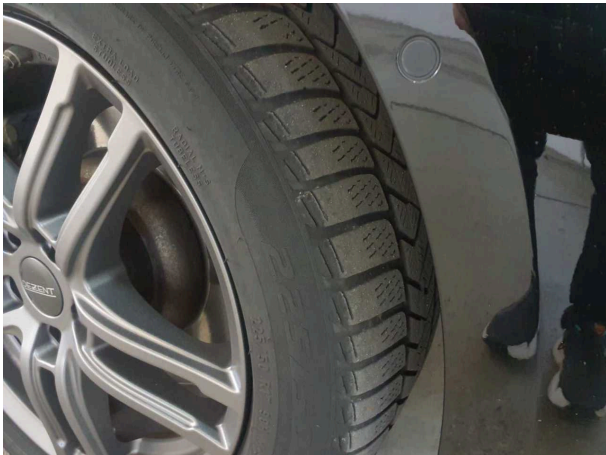
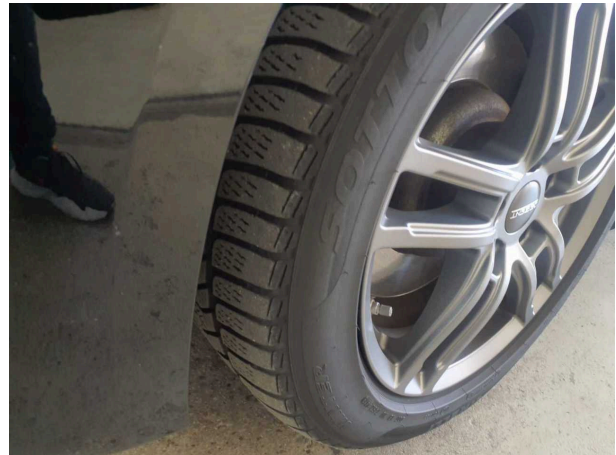
| No. | Component group | Description |
|---|---|---|
| 1 | Wheel / tyres | Tyre - front - Worn - No deduction |

| Axle | Tyre size | Manufacturer | Type of tyre | Tread depth | Roadworthy | Permissibility |
|---|---|---|---|---|---|---|
| 1 | 225/50 R17 98H | Goodyear | Winter tyres | 2mm - 2mm | Not o.k. | |

**Damage #1:** Wheel / tyres: Tyre - front - Worn - No deduction

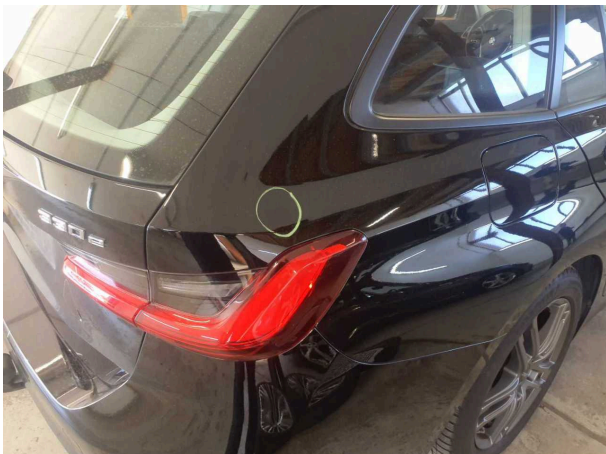
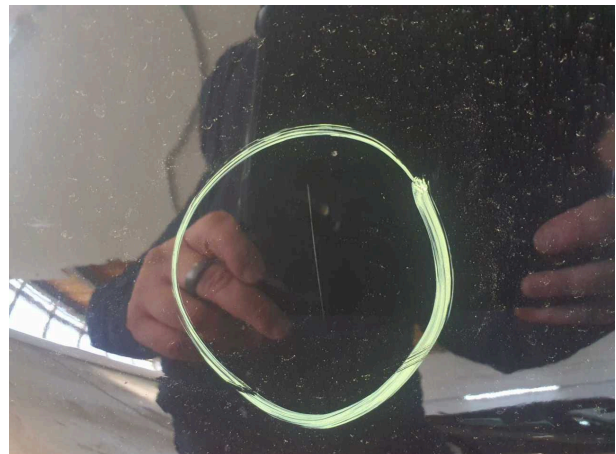
| No. | Component group | Description |
|---|---|---|
| 2 | Side panel - rear right side | Side panel - Scratch(es) - Cover / polish |

**Damage #2:** Side panel - rear right side: Side panel - Scratch(es) - Cover / polish

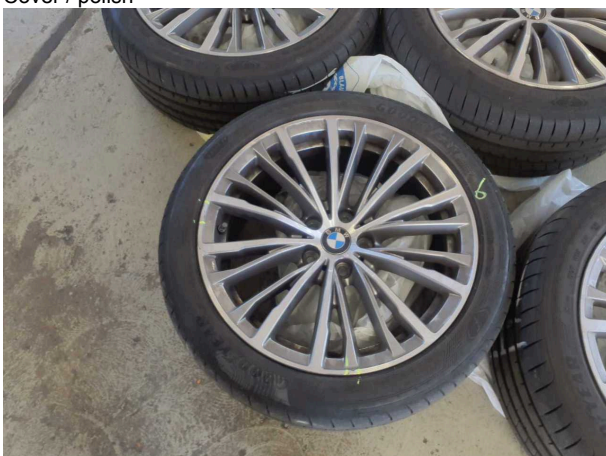
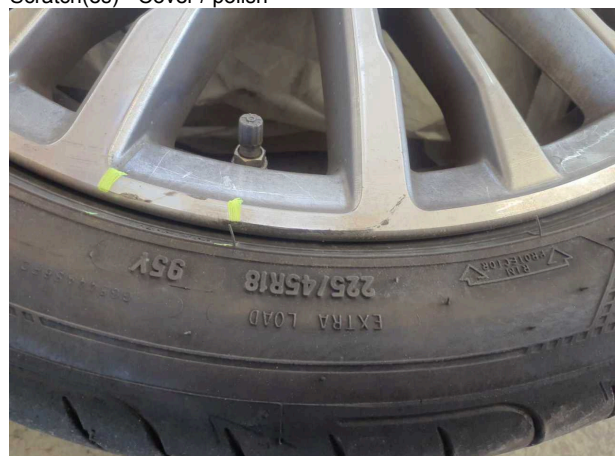
| No. | Component group | Description |
|---|---|---|
| 3 | 2nd wheel set | 1 alloy rim - Scratched - Loss in value |

**Damage #3:** 2nd wheel set: 1 alloy rim - Scratched - Loss in value

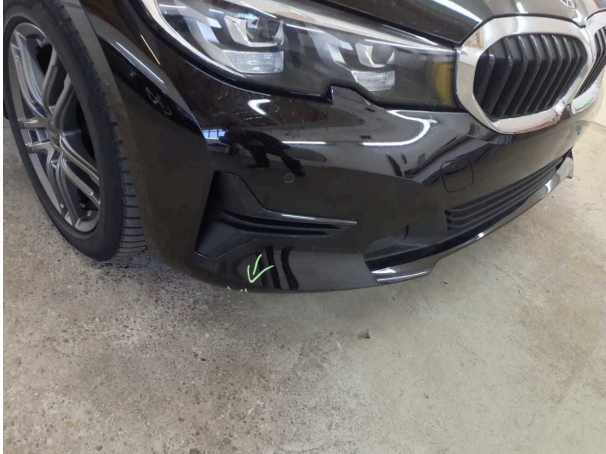
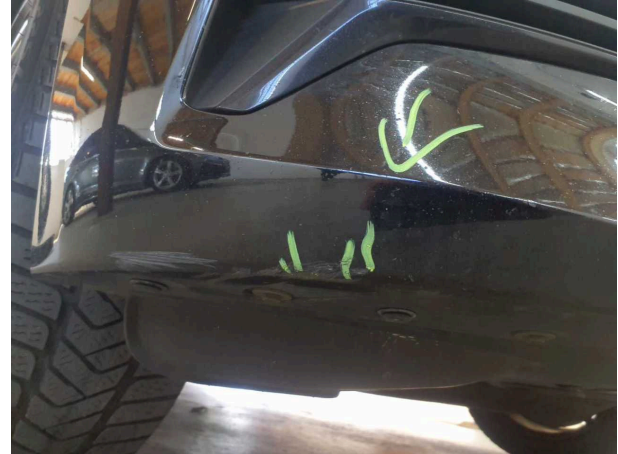
| No. | Component group | Description |
|---|---|---|
| 4 | Front bumper | Front bumper - Scratched - Smart repair |

**Damage #4:** Front bumper: Front bumper - Scratched - Smart repair

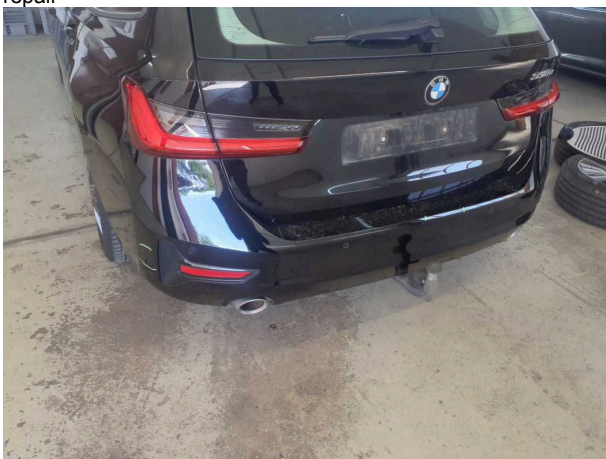
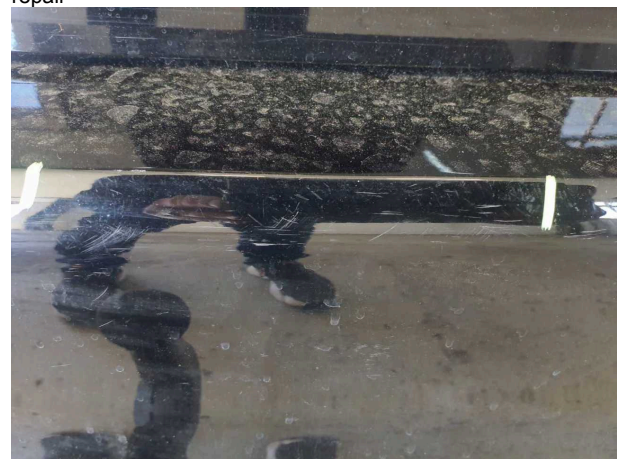
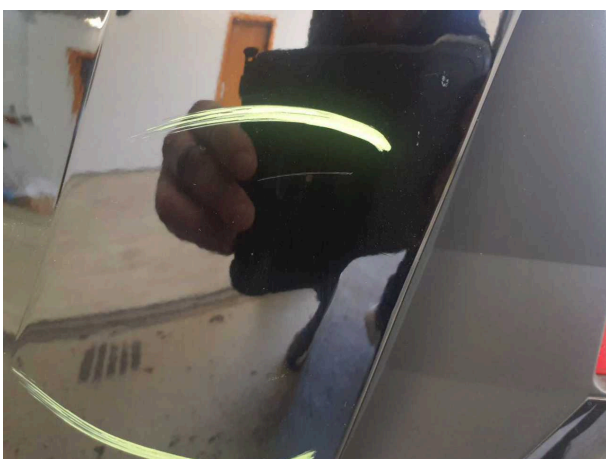
| No. | Component group | Description |
|---|---|---|
| 6 | Rear bumper | Rear bumper - Scratched - Paint |

**Damage #6:** Rear bumper: Rear bumper - Scratched - Paint

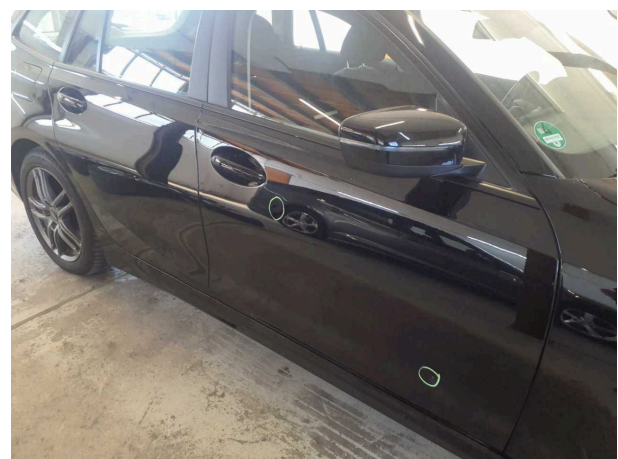
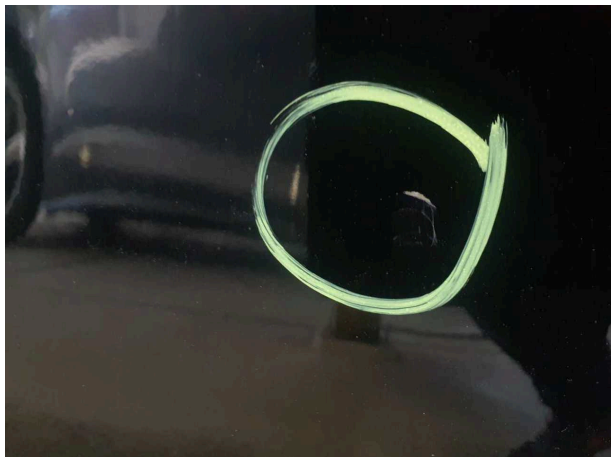
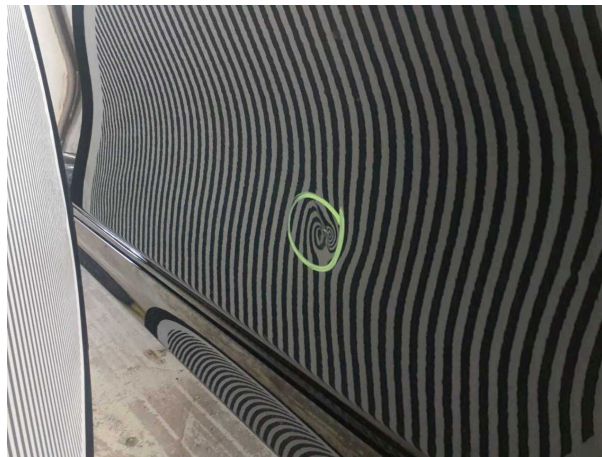
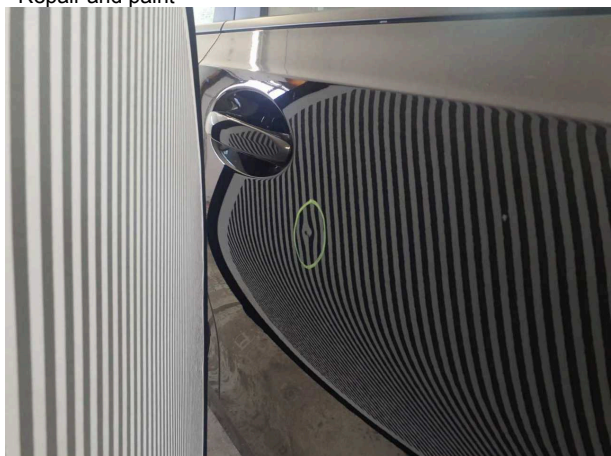
| No. | Component group | Description |
|---|---|---|
| 7 | Door - front right side | Door - Dent / paintcoat damage - Repair and paint |

**Damage #7:** Door - front right side: Door - Dent / paintcoat damage - Repair and paint

**Damage #7:** Door - front right side: Door - Dent / paintcoat damage  
- Repair and paint

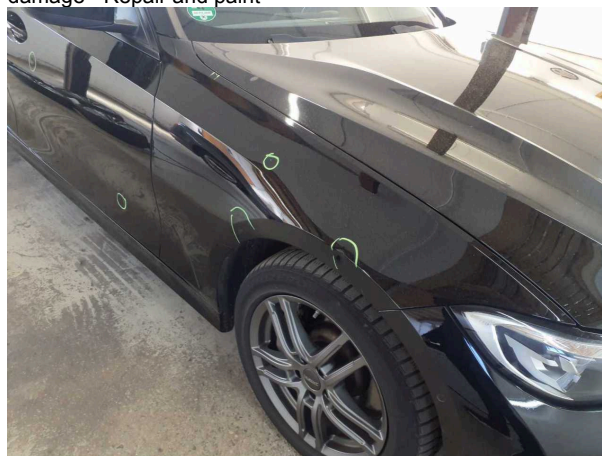
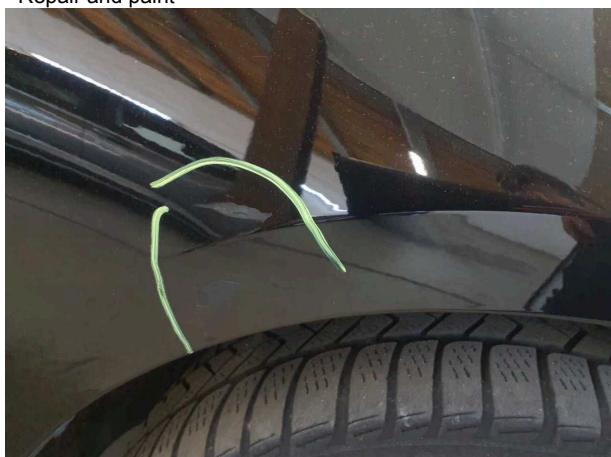
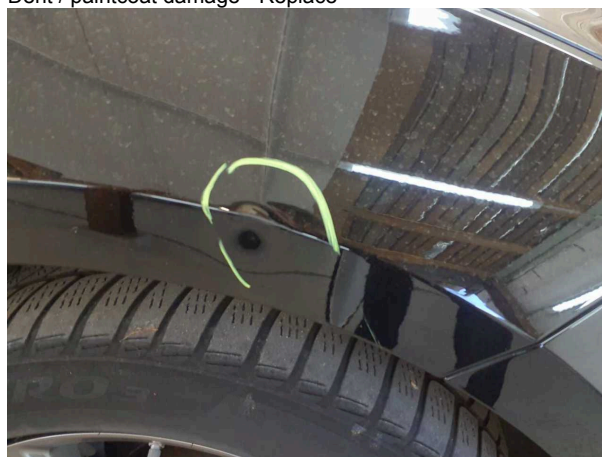
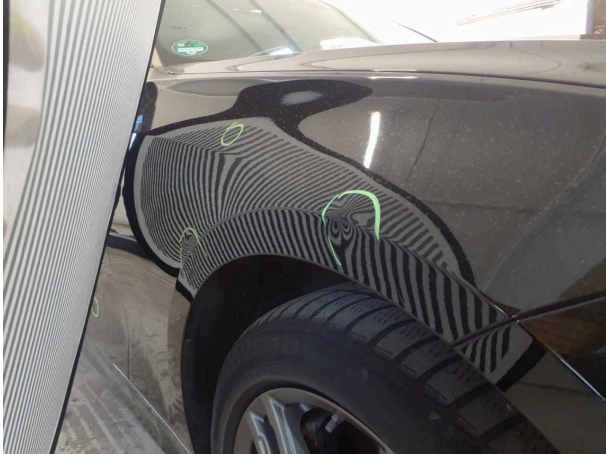
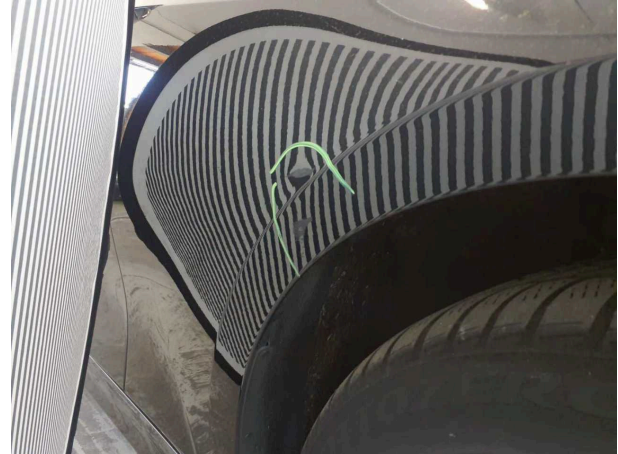
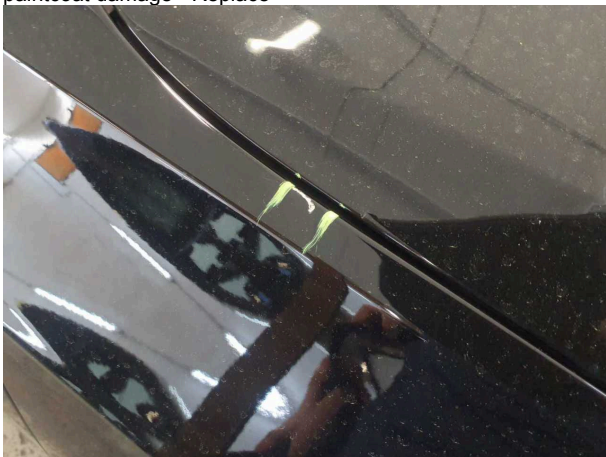
| No. | Component group | Description |
|---|---|---|
| 8 | Mudguard - right side | Mudguard - right side - Dent / paintcoat damage - Replace |

**Damage #8:** Mudguard - right side: Mudguard - right side -  
Dent / paintcoat damage - Replace

**Damage #8:** Mudguard - right side: Mudguard - right side - Dent /  
paintcoat damage - Replace

**Damage #8:** Mudguard - right side: Mudguard - right side - Dent / paintcoat damage - Replace
