WBA5F31020FL17390

## Zustandsbericht

Inspection date: 9 May 2025

**Protocol number:** 39651431

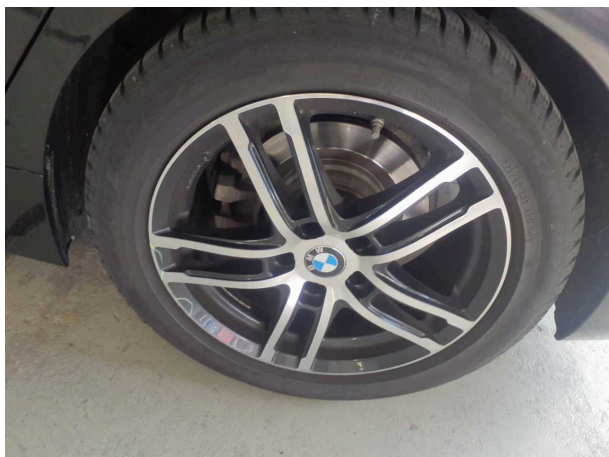
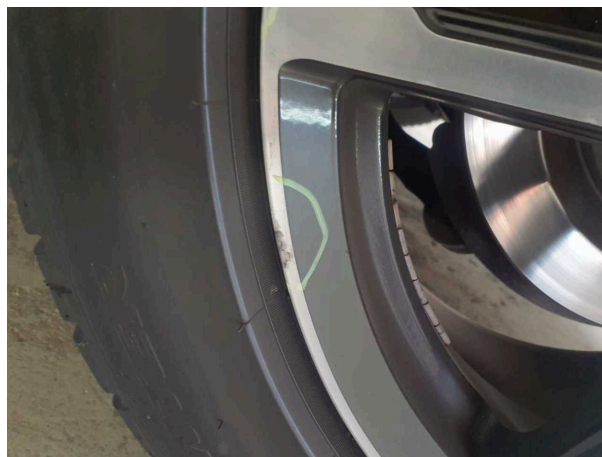
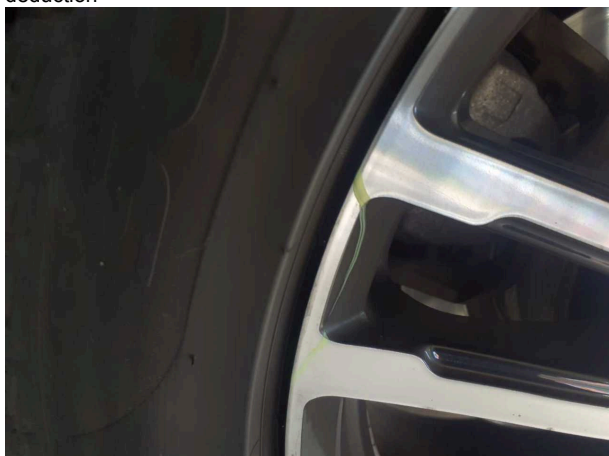
| No. | Component group | Description |
|---|---|---|
| 1 | Wheel / tyres | Alloy rim - rear left side - Scratched - No deduction |

**Damage #1:** Wheel / tyres: Alloy rim - rear left side - Scratched - ... deduction

**Damage #1:** Wheel / tyres: Alloy rim - rear left side - Scratched - No deduction

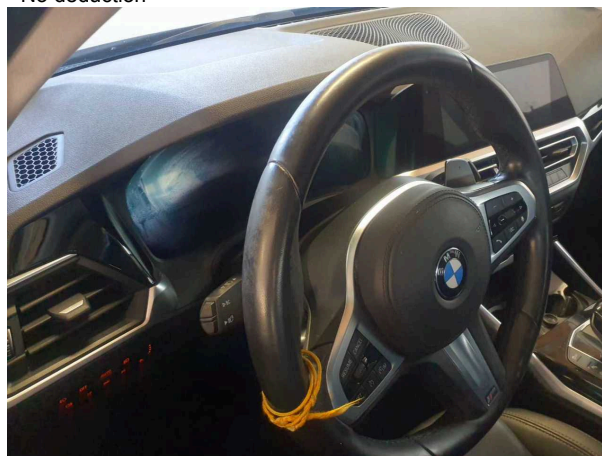
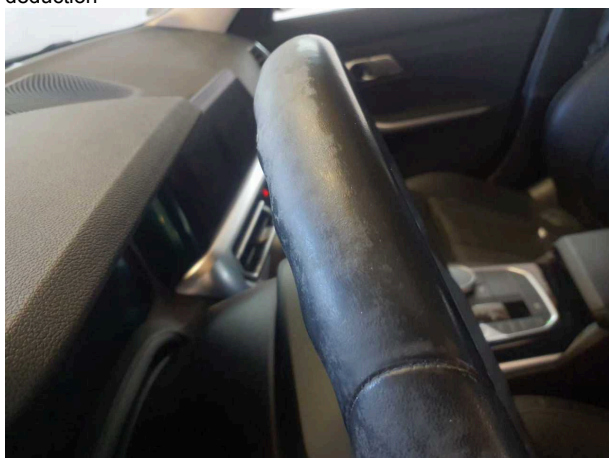
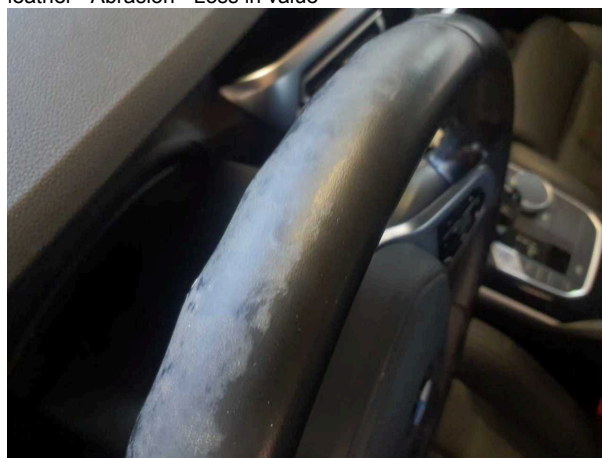
| No. | Component group | Description |
|---|---|---|
| 2 | Steering system | Multi-function steering wheel - leather - Abrasion - Loss in value |

**Damage #2:** Steering system: Multi-function steering wheel - leather - Abrasion - Loss in value

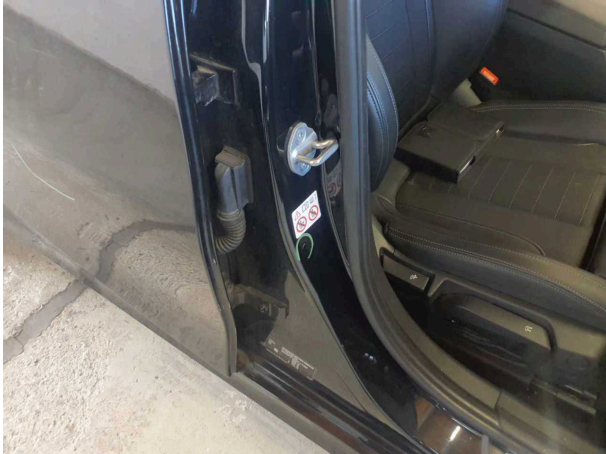
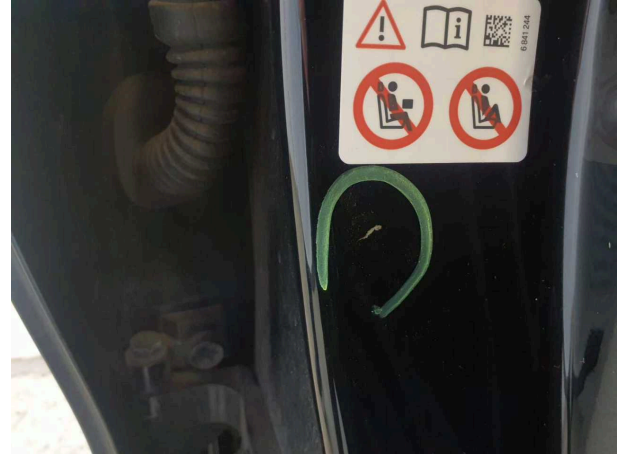
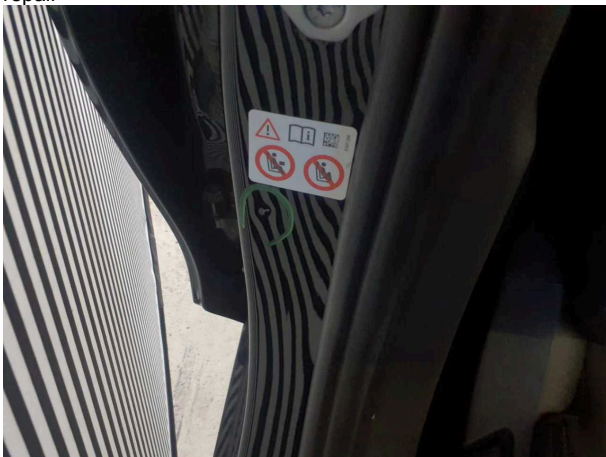
| No. | Component group | Description |
|---|---|---|
| 3 | Sill - right side | Sill - Dent / paintcoat damage - Smart repair |

**Damage #3:** Sill - right side: Sill - Dent / paintcoat damage - Smart repair

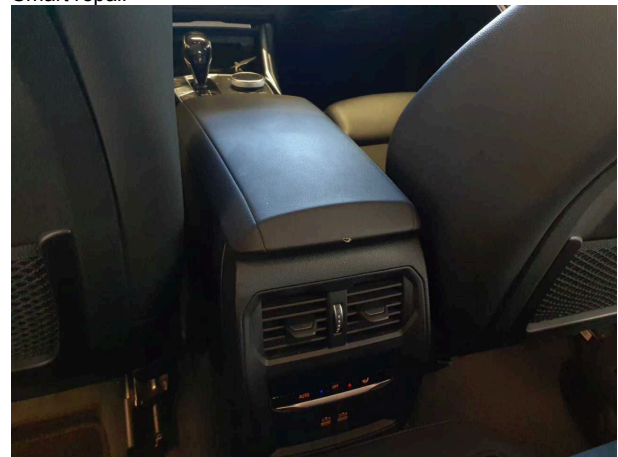
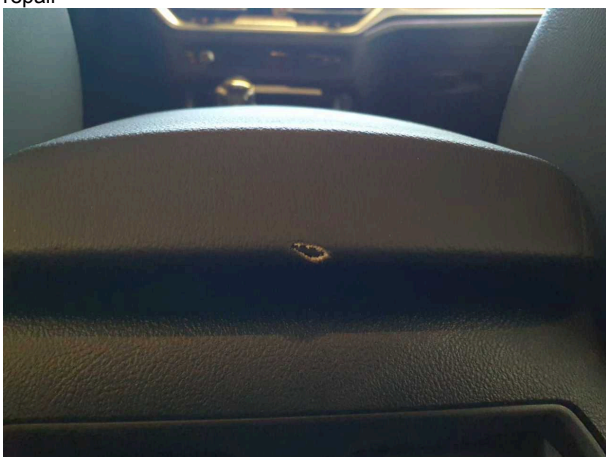
| No. | Component group | Description |
|---|---|---|
| 4 | Seat - rear | Armrest - centre - Broken / torn - Replace |

**Damage #4:** Seat - rear: Armrest - centre - Broken / torn - Replace

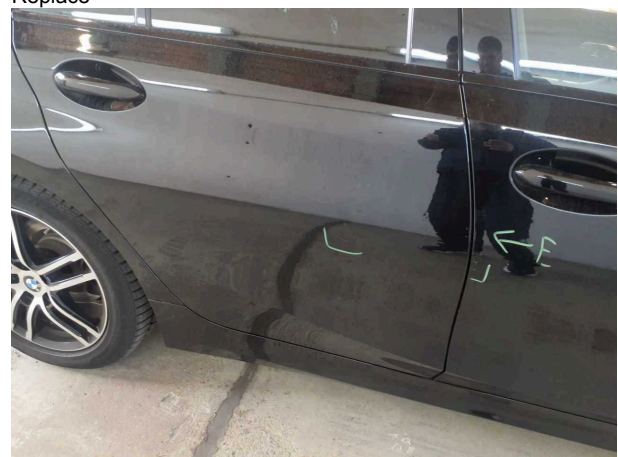
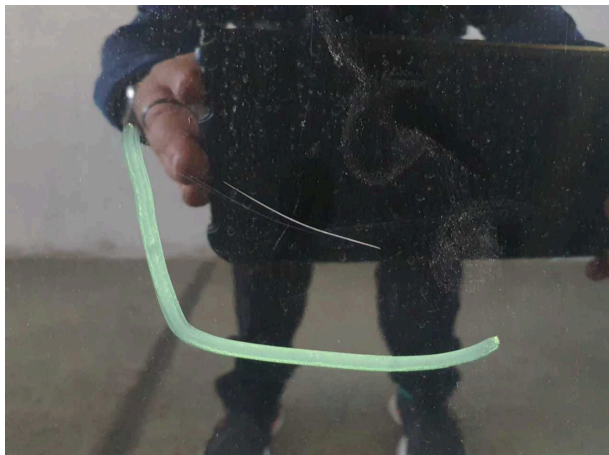
| No. | Component group | Description |
|---|---|---|
| 5 | Door - rear right side | Door - Scratch(es) - Paint |

**Damage #5:** Door - rear right side: Door - Scratch(es) - Paint

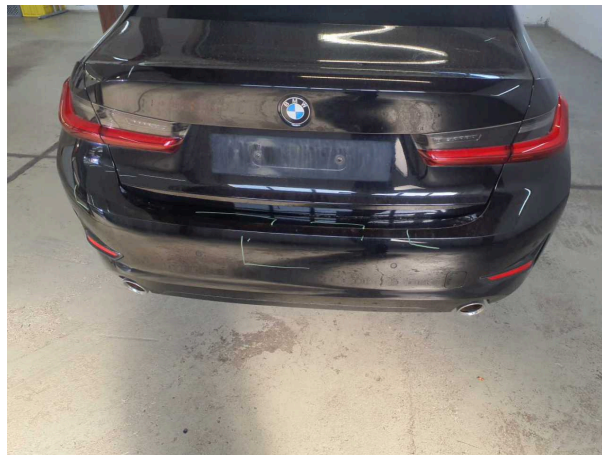
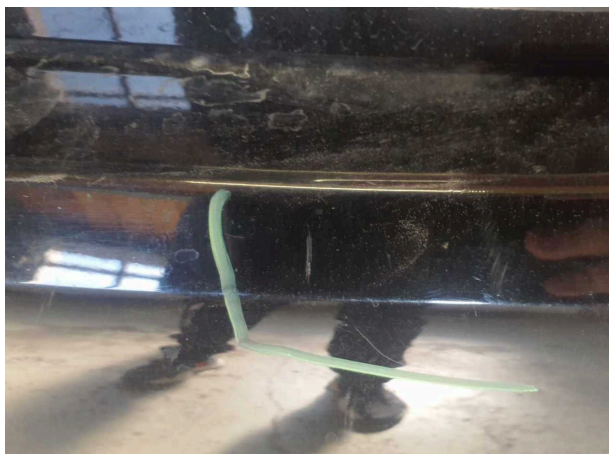
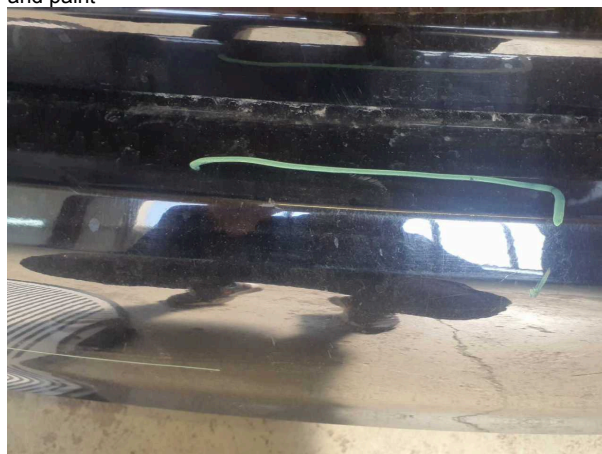
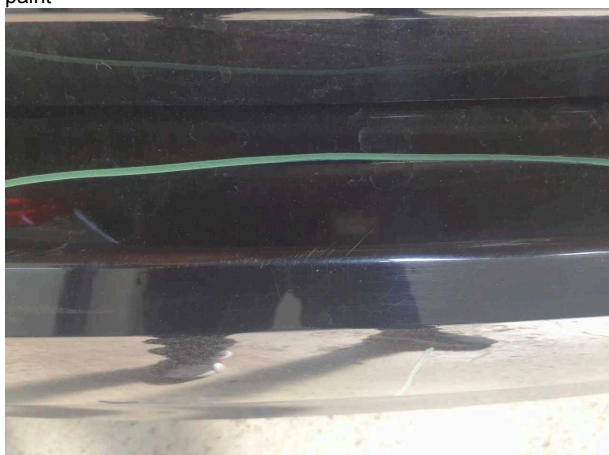
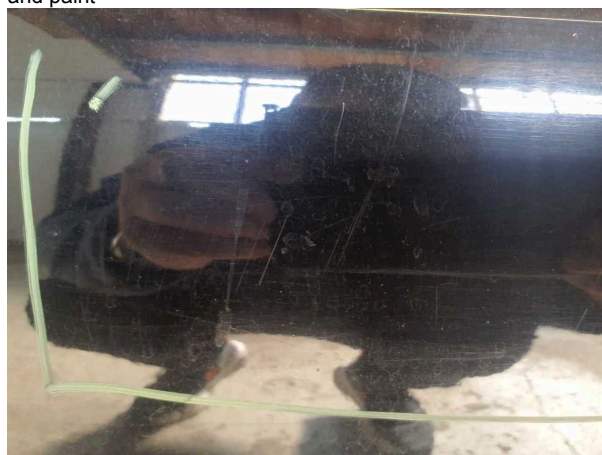
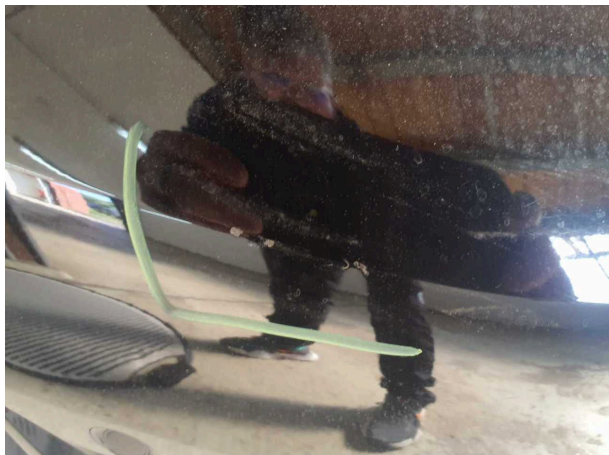
| No. | Component group | Description |
|---|---|---|
| 6 | Rear bumper | Rear bumper - Scratched - Repair and paint |

**Damage #6:** Rear bumper: Rear bumper - Scratched - Repair and paint

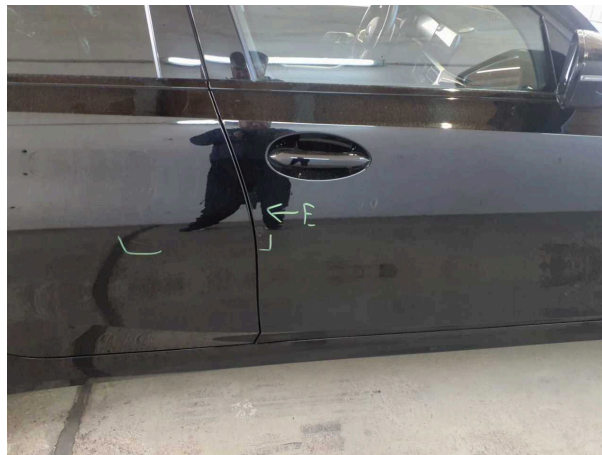
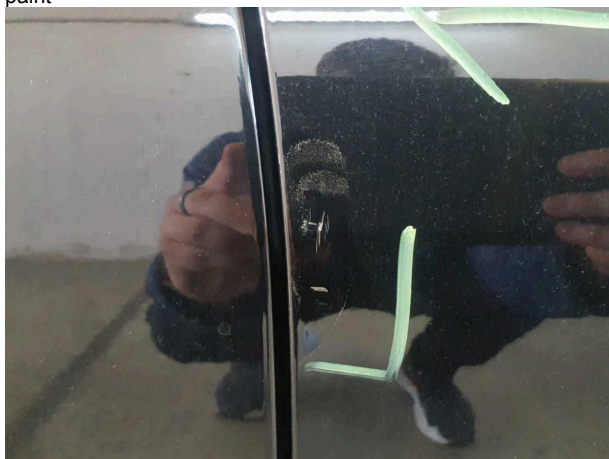
| No. | Component group | Description |
|---|---|---|
| 7 | Door - front right side | Door - Scratched - Paint |

**Damage #7:** Door - front right side: Door - Scratched - Paint

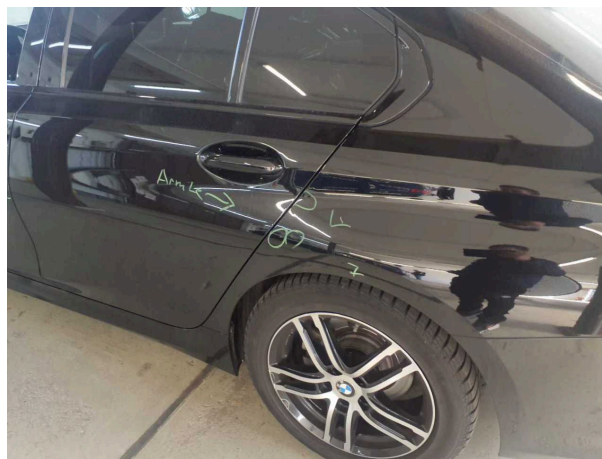
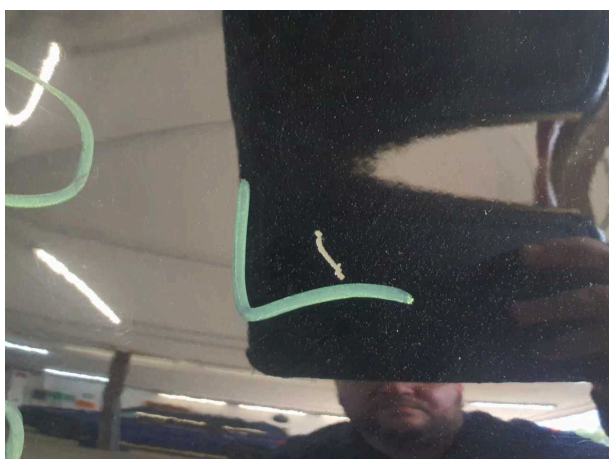
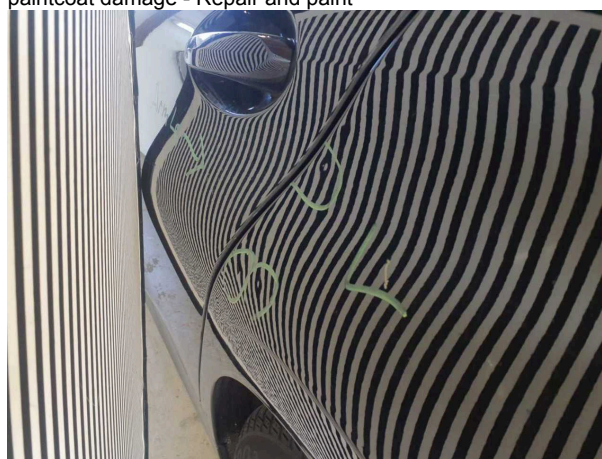
| No. | Component group | Description |
|---|---|---|
| 8 | Side panel - rear left side | Side panel - Dent / paintcoat damage - Repair and paint |

**Damage #8:** Side panel - rear left side: Side panel - Dent / paintcoat damage - Repair and paint

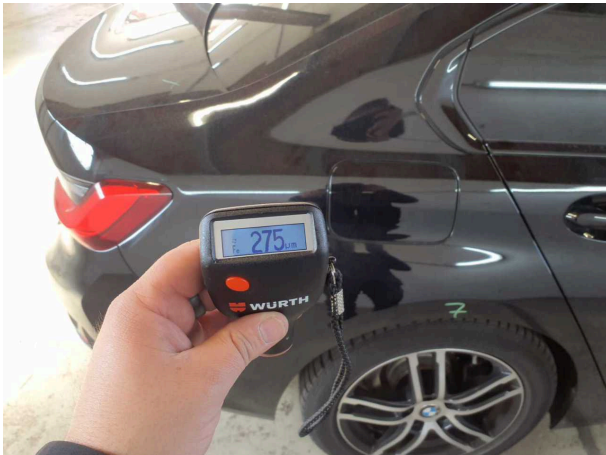
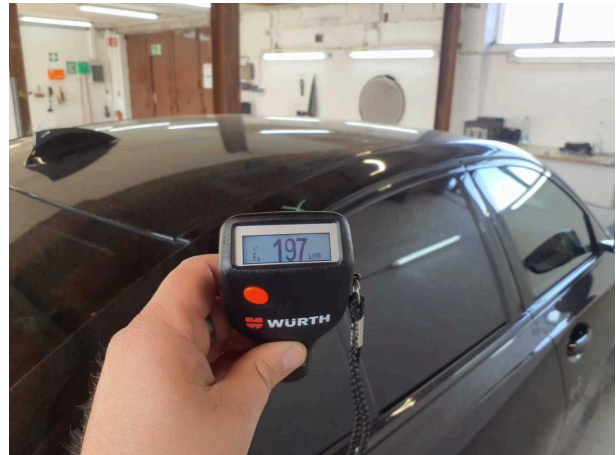
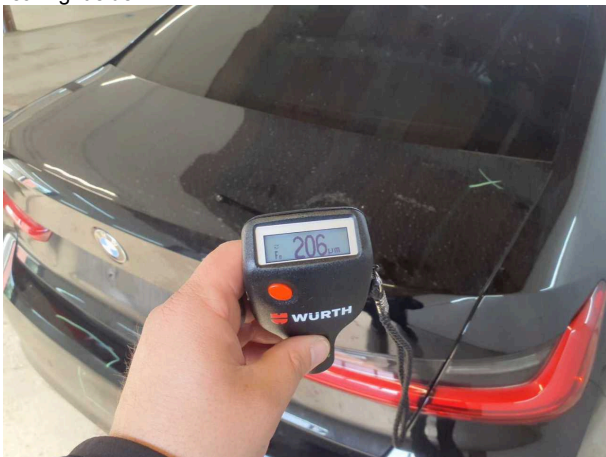
| No. | Location |
|---|---|
| 1 | Roof rail - right side, Boot lid / rear door, Side panel - rear right side, Professionally carried out |

**Repainting 1:** Roof rail - right side, Boot lid / rear door, Side pane... rear right side

**Repainting 1:** Roof rail - right side, Boot lid / rear door, Side panel - rear right side
