WBA6N31060FL23653

## Zustandsbericht

**TÜV SÜD Auto Partner GmbH**  
Gutenbergstr. 13  
70771 Leinfelden-Echterdingen

Inspection date: 20 May 2025  
**Protocol number: 39797824**  
Delivery date: 20 May 2025

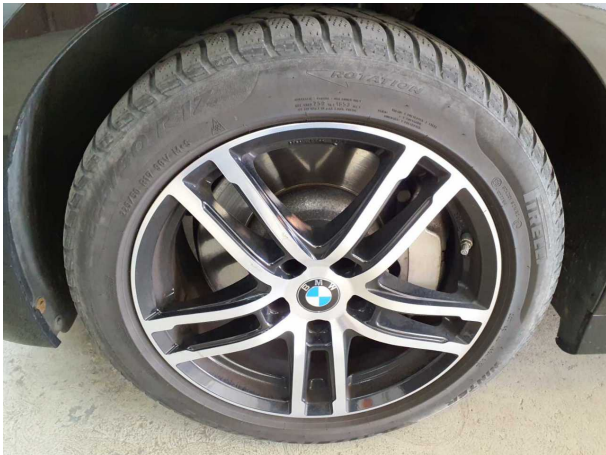
| No. | Component group | Description |
|---|---|---|
| 1 | Wheel / tyres | Tyre - front - Worn - No deduction |

**Damage #1:** Wheel / tyres: Tyre - front - Worn - No deduction

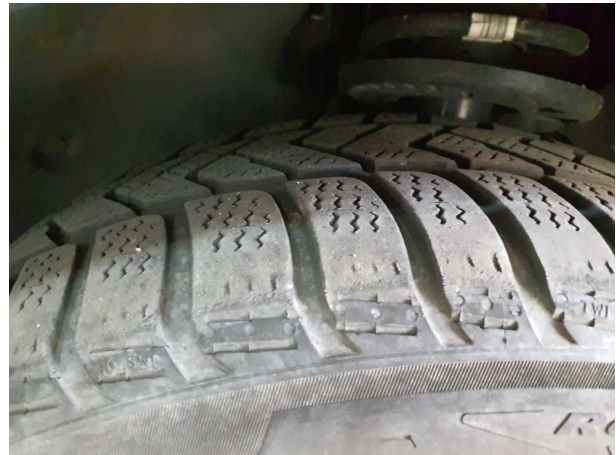
**Damage #1:** Wheel / tyres: Tyre - front - Worn - No deduction

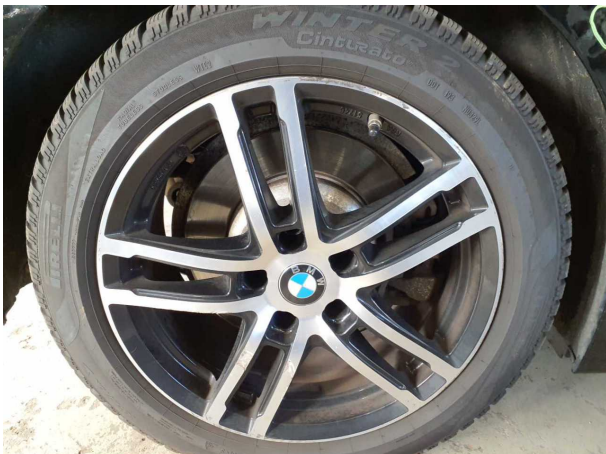
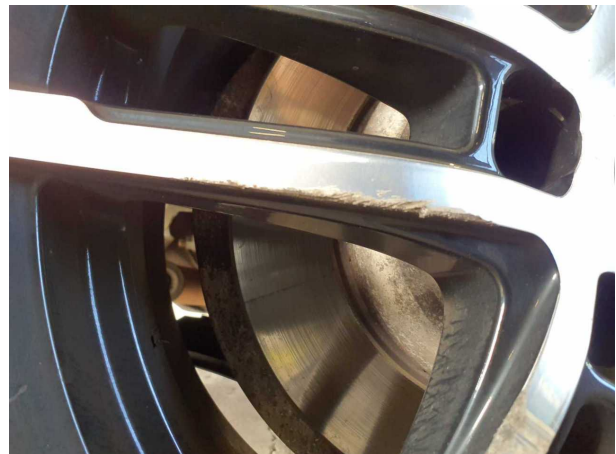
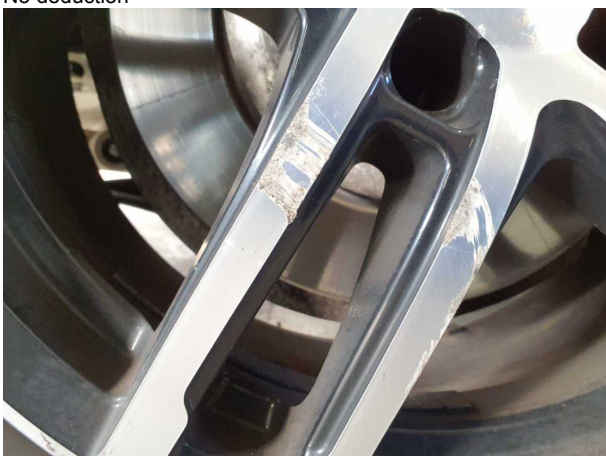
| No. | Component group | Description |
|---|---|---|
| 2 | Wheel / tyres | Alloy rim - rear right side - Scratched - No deduction |

**Damage #2:** Wheel / tyres: Alloy rim - rear right side - Scratched - No deduction

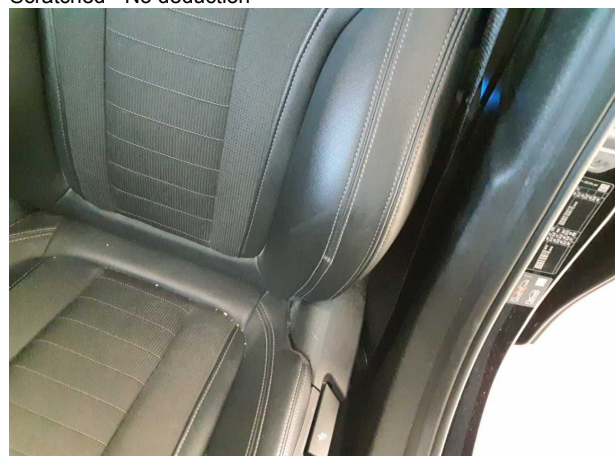
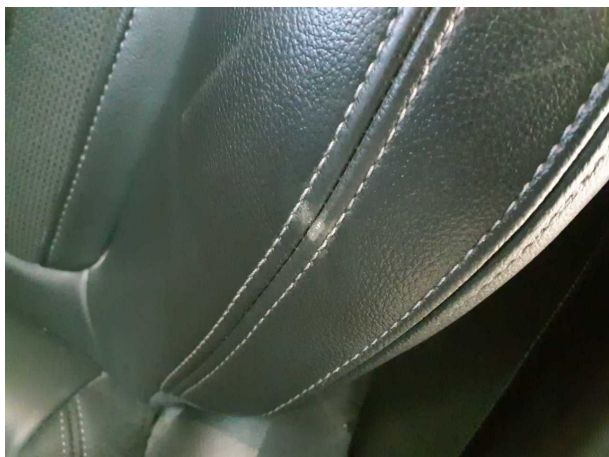
| No. | Component group | Description |
|---|---|---|
| 3 | Seat - front | Seat cover - left side - Abrasion - Loss in value |

**Damage #3:** Seat - front: Seat cover - left side - Abrasion - Low in value

**Damage #3:** Seat - front: Seat cover - left side - Abrasion - Loss in value

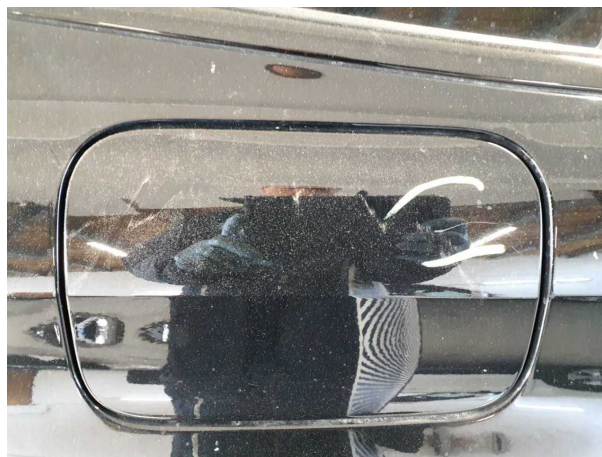
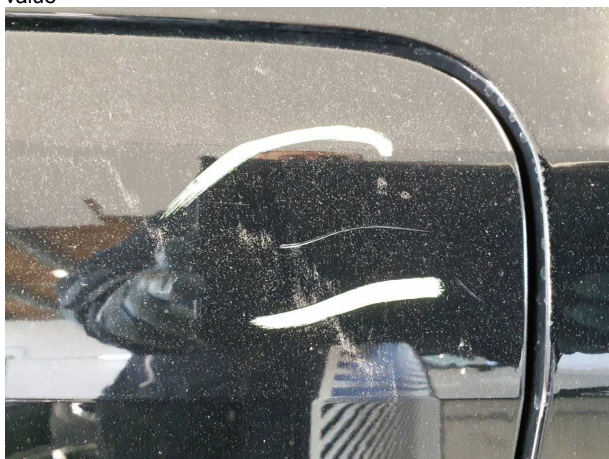
| No. | Component group | Description |
|---|---|---|
| 4 | Fuel system | Tank cap - Scratch(es) - Smart repair |

**Damage #4:** Fuel system: Tank cap - Scratch(es) - Smart repair

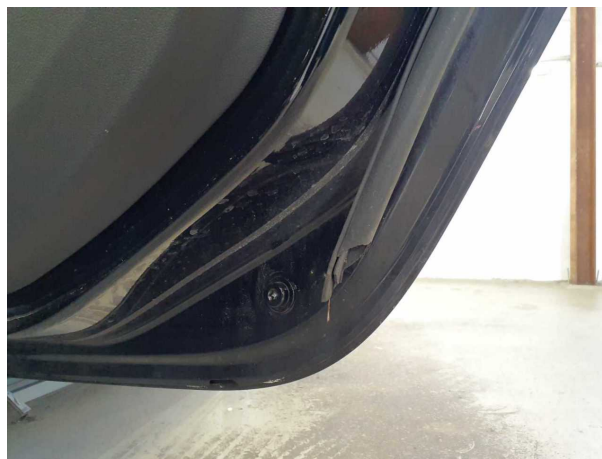
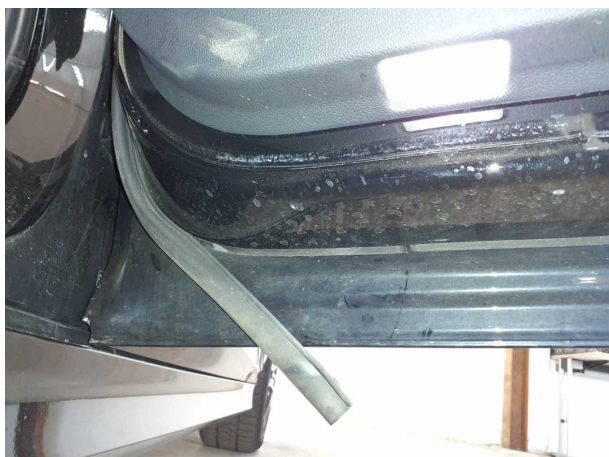
| No. | Component group | Description |
|---|---|---|
| 5 | Door - rear right side | Door seal - Damaged - Replace |

**Damage #5:** Door - rear right side: Door seal - Damaged - Replace

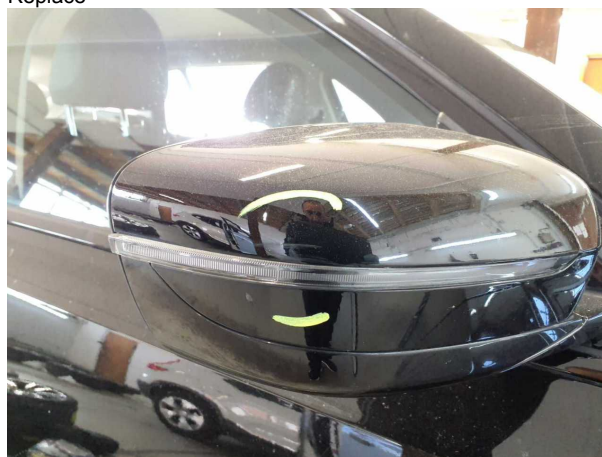
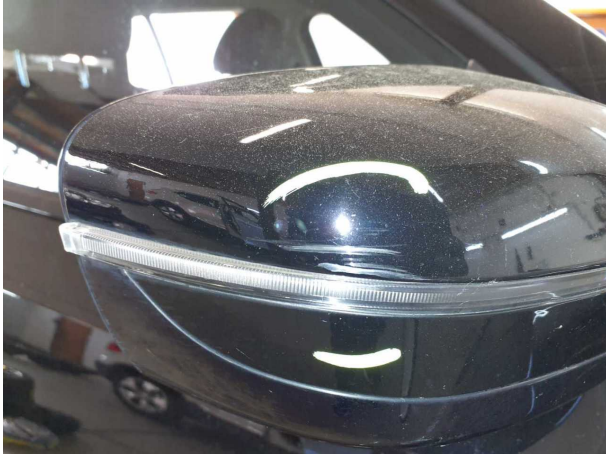
| No. | Component group | Description |
|---|---|---|
| 6 | Wing mirror - right side | Cap - Scratched - Smart repair |

**Damage #6:** Wing mirror - right side: Cap - Scratched - Smart repair

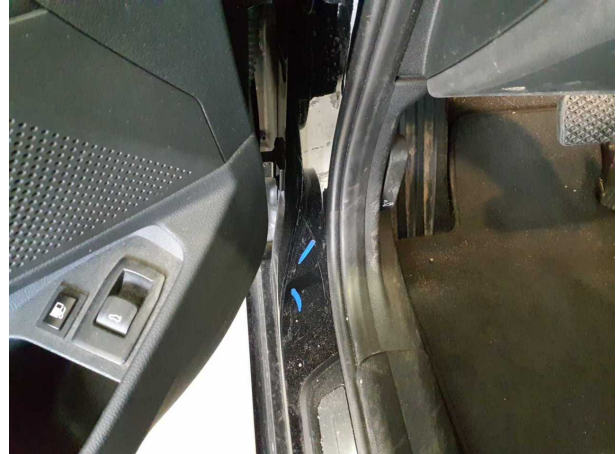
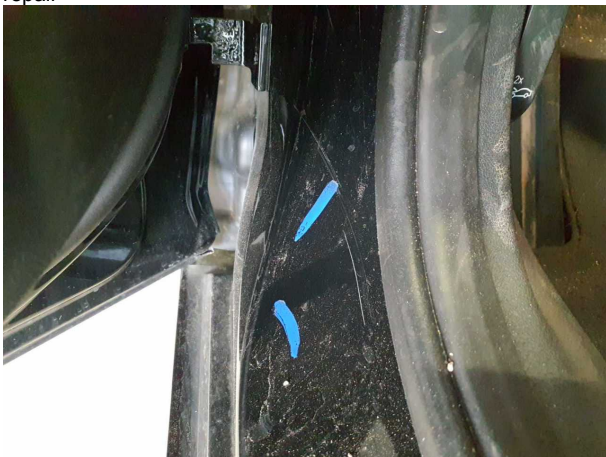
| No. | Component group | Description |
|---|---|---|
| 7 | Sill - left side | Sill - Scratch(es) - Smart repair |

**Damage #7:** Sill - left side: Sill - Scratch(es) - Smart repair

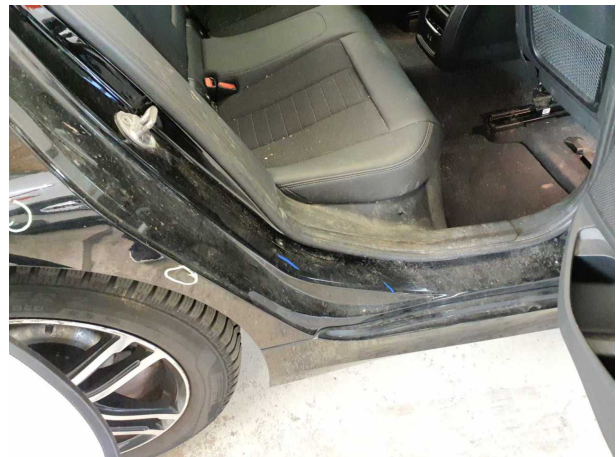
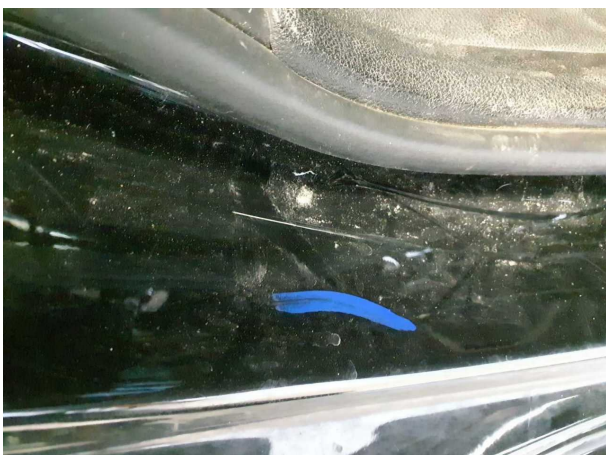
| No. | Component group | Description |
|---|---|---|
| 8 | Side panel - rear right side | Sill - Scratch(es) - Smart repair |

**Damage #8:** Side panel - rear right side: Sill - Scratch(es) - Smart repair

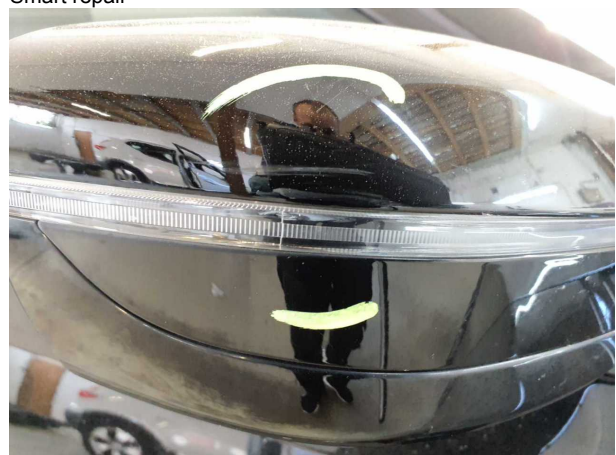
| No. | Component group | Description |
|---|---|---|
| 9 | Indicator - front | Mirror - right side - Scratched - Replace |

**Damage #9:** Indicator - front: Mirror - right side - Scratched - Replace

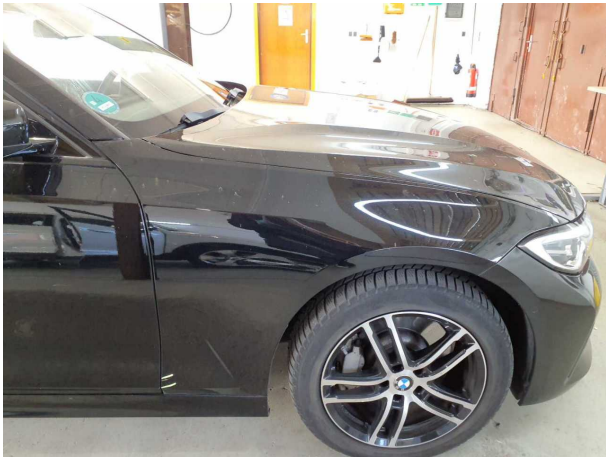
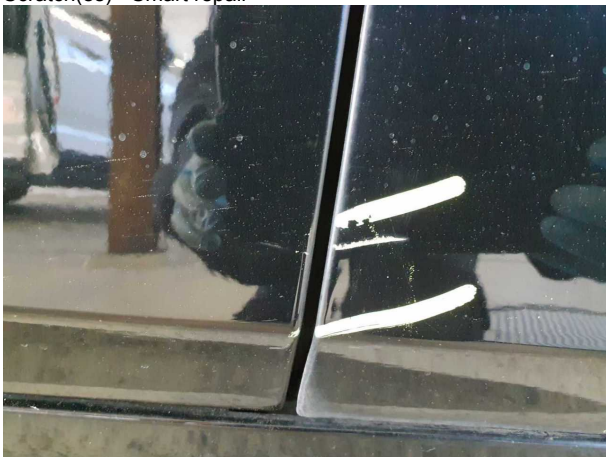
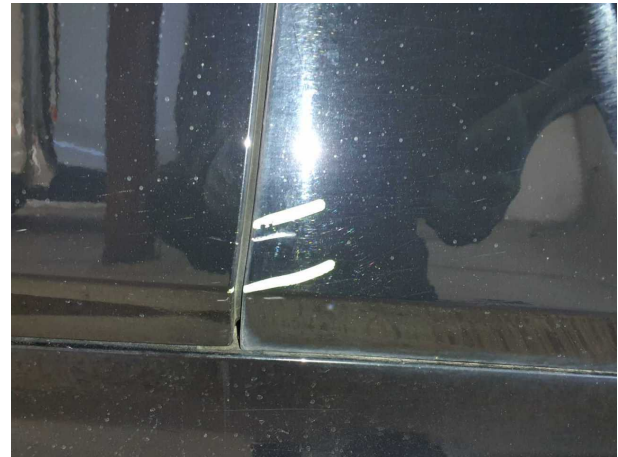
| No. | Component group | Description |
|---|---|---|
| 10 | Mudguard - right side | Mudguard - right side - Scratch(es) - Smart repair |

**Damage #10:** Mudguard - right side: Mudguard - right side - Scratch(es) - Smart repair

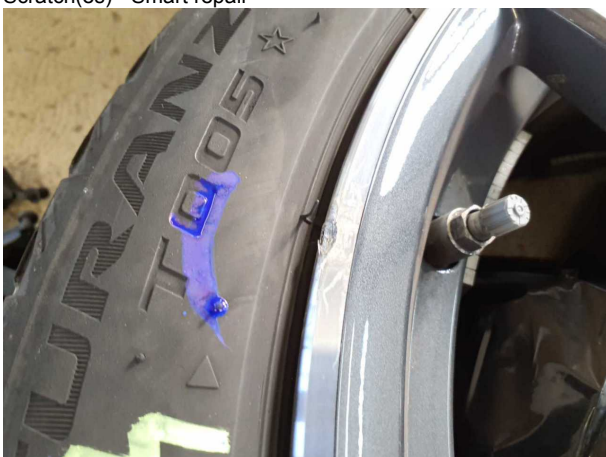
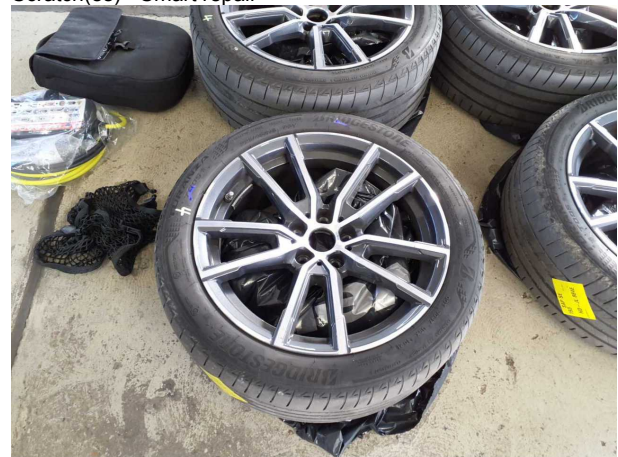
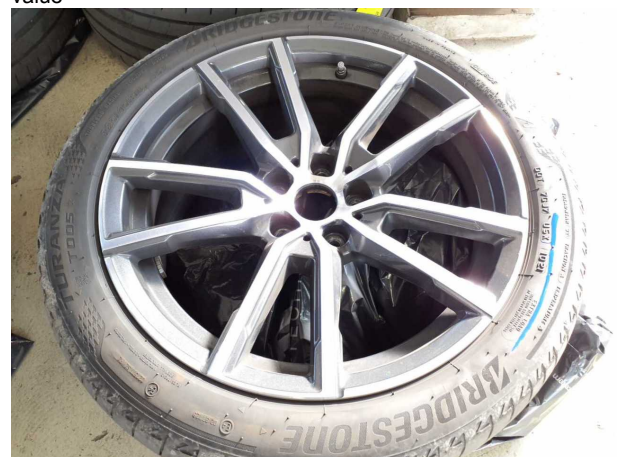
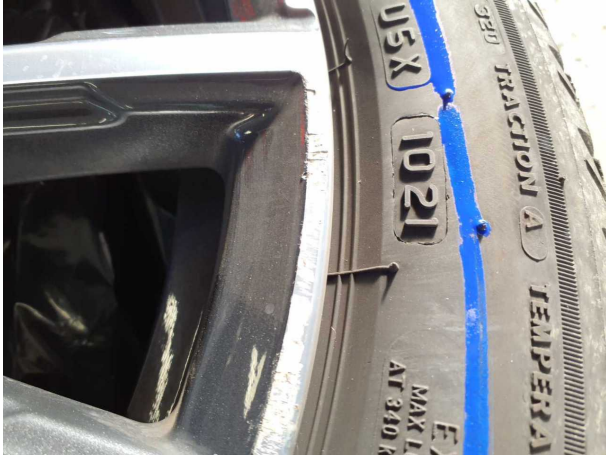
| No. | Component group | Description |
|---|---|---|
| 12 | 2nd wheel set | 2 alloy rims - Scratched - Loss in value |

**Damage #12:** 2nd wheel set: 2 alloy rims - Scratched - Loss in value

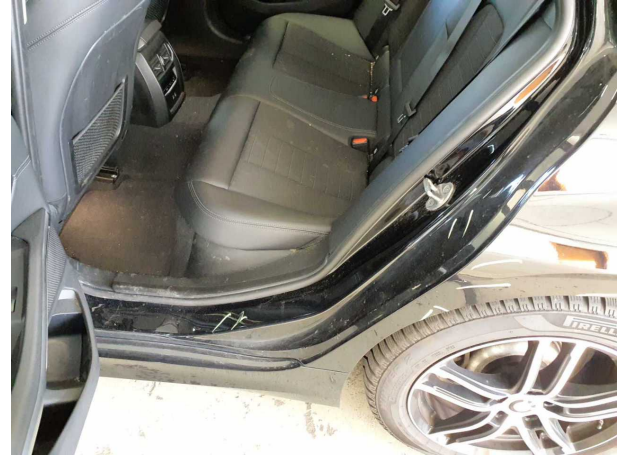
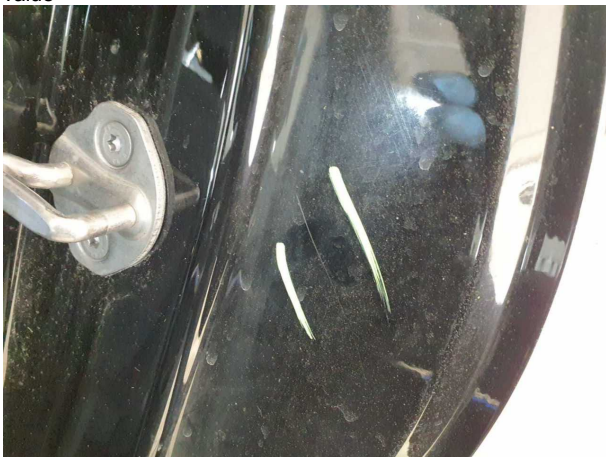
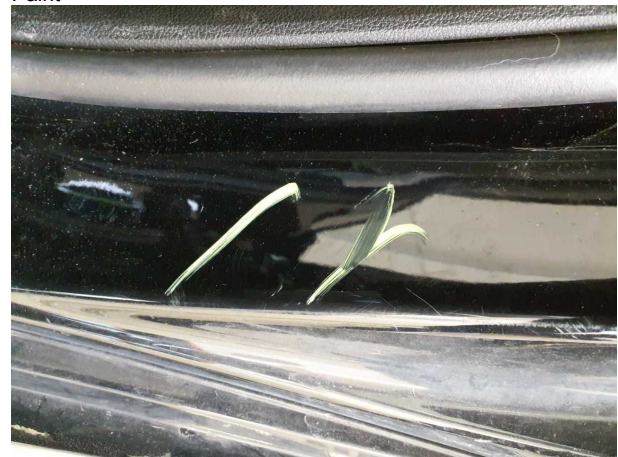
| No. | Component group | Description |
|---|---|---|
| 13 | Side panel - rear left side | Sill - Scratch(es) - Paint |

**Damage #13:** Side panel - rear left side: Sill - Scratch(es) - Paint

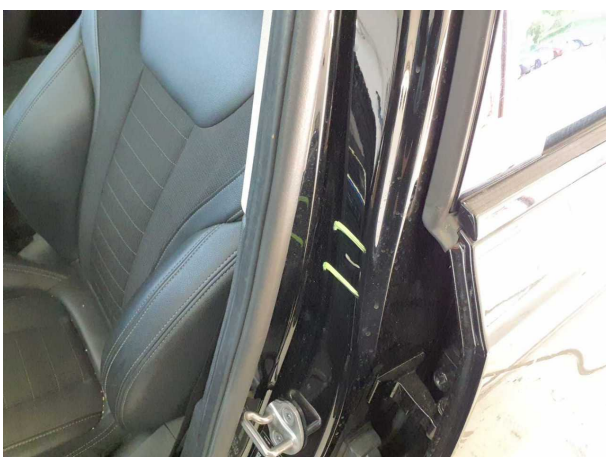
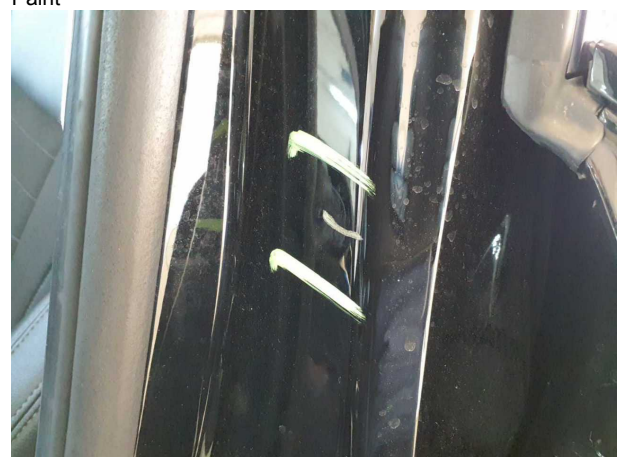
| No. | Component group | Description |
|---|---|---|
| 14 | Body | B-pillar - left side - Scratched - Repair and paint |

**Damage #14:** Body: B-pillar - left side - Scratched - Repair and paint

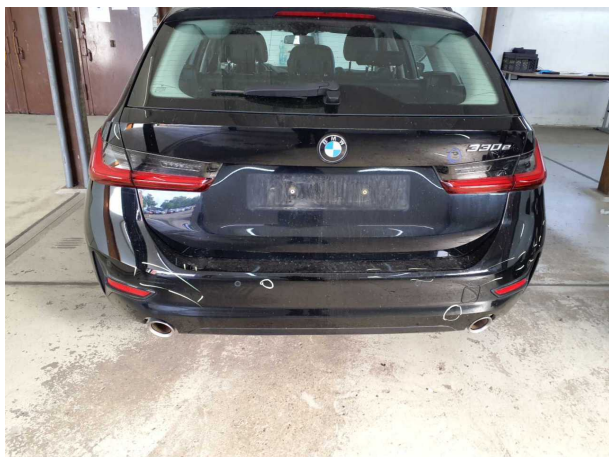
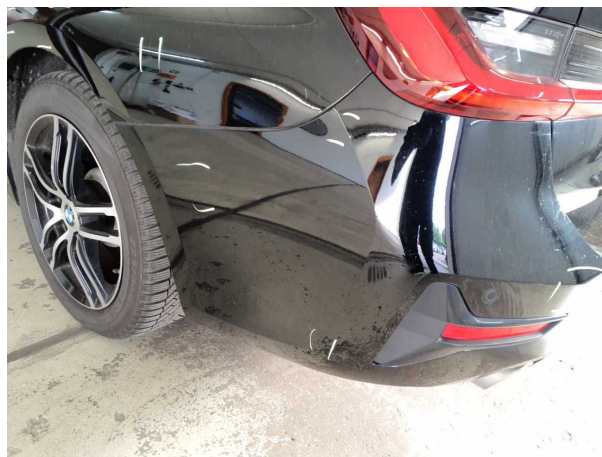
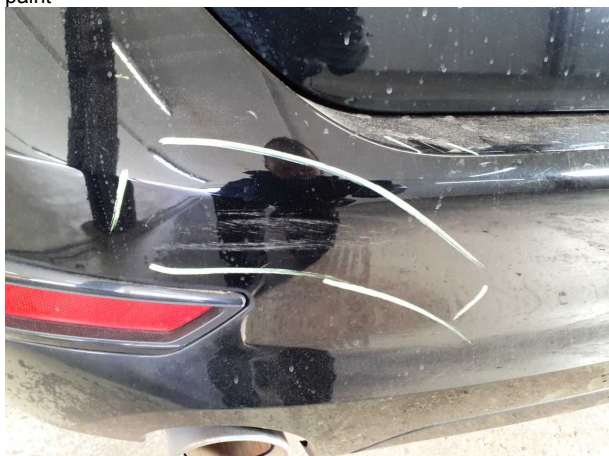
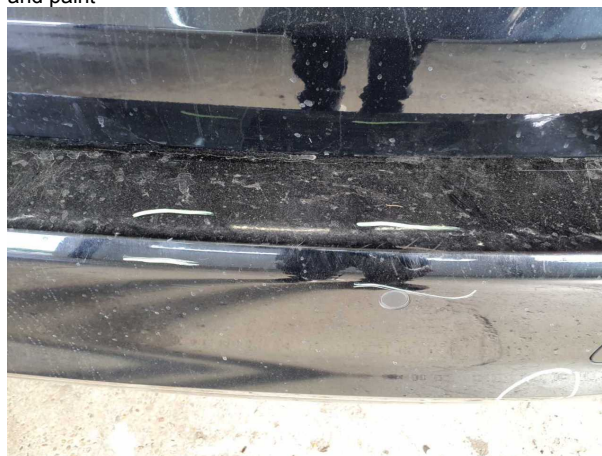
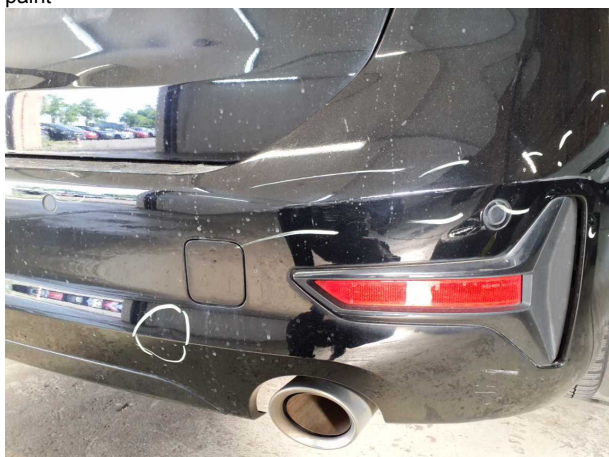
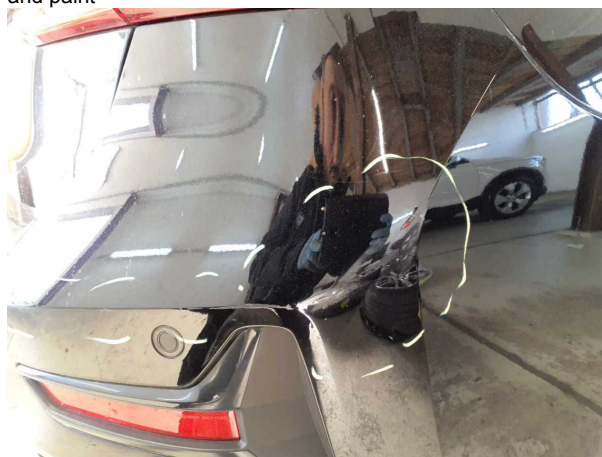
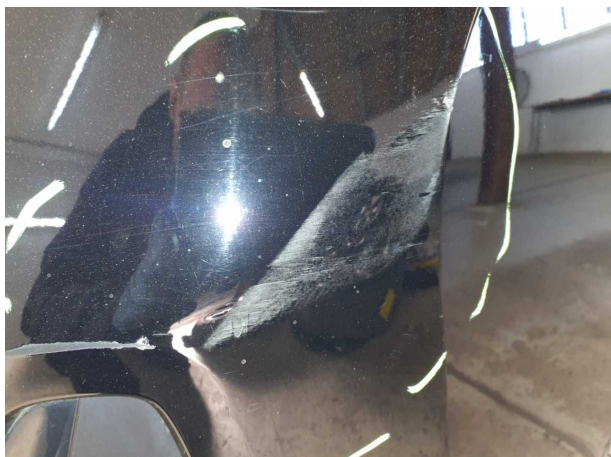
| No. | Component group | Description |
|---|---|---|
| 15 | Rear bumper | Rear bumper - Scratched - Repair and paint |

**Damage #15:** Rear bumper: Rear bumper - Scratched - Repair and paint

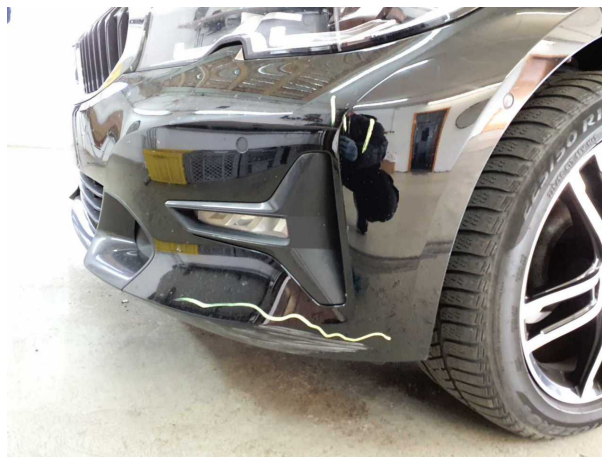
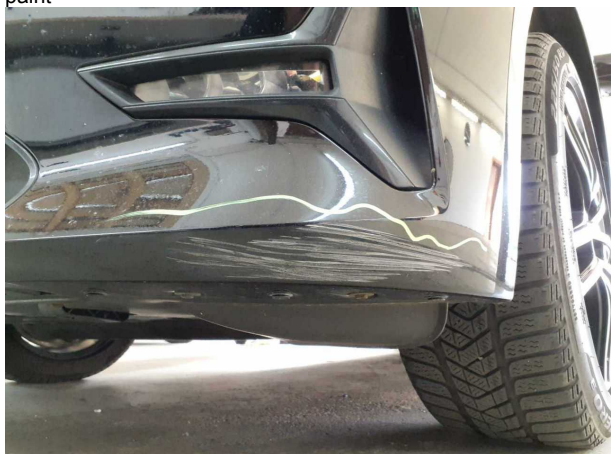
| No. | Component group | Description |
|---|---|---|
| 16 | Front bumper | Front bumper - Scratched - Repair and paint |

**Damage #16:** Front bumper: Front bumper - Scratched - Rep... and paint

**Damage #16:** Front bumper: Front bumper - Scratched - Repair and paint

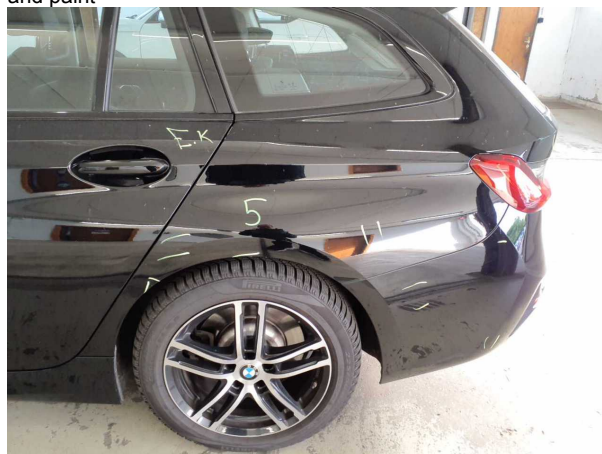
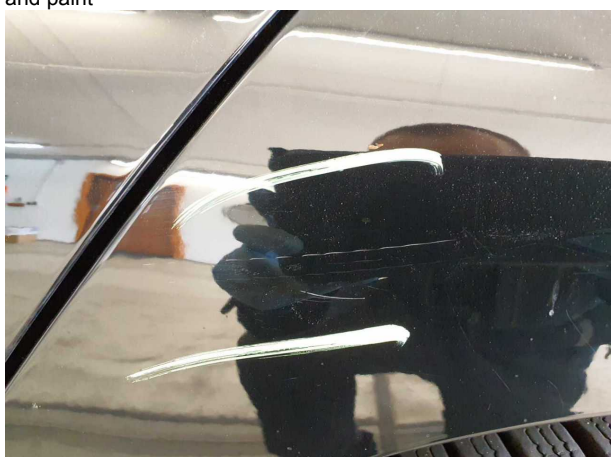
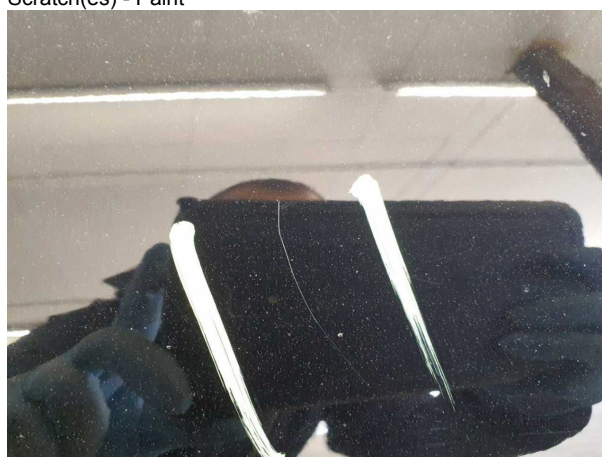
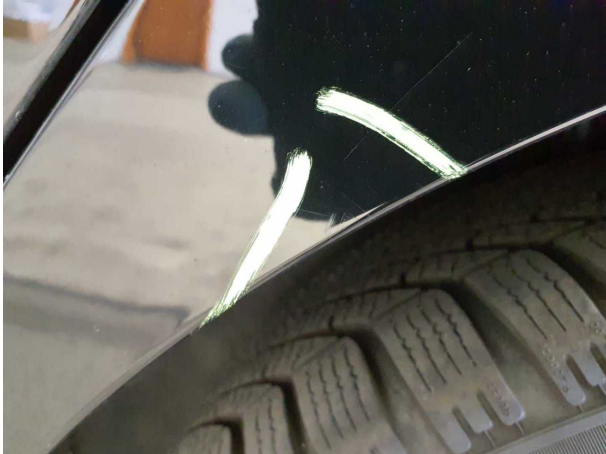
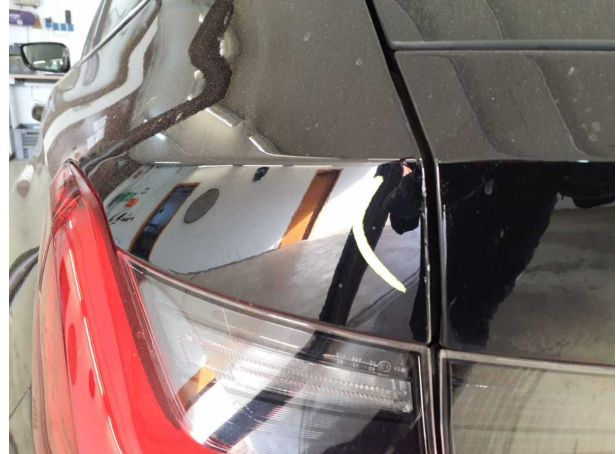
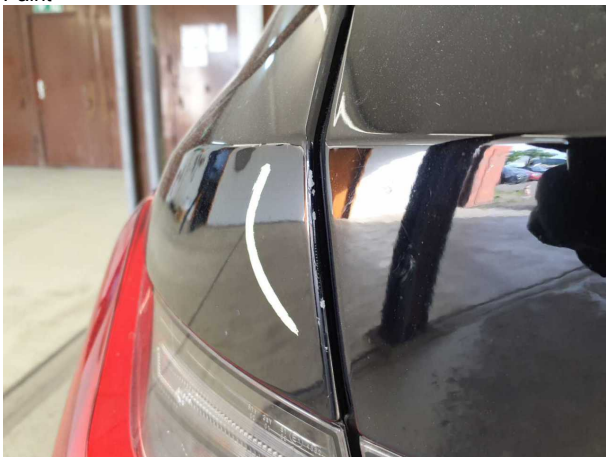
| No. | Component group | Description |
|---|---|---|
| 17 | Side panel - rear left side | Side panel - Scratch(es) - Paint |

**Damage #17:** Side panel - rear left side: Side panel - Scratch(es) - Paint

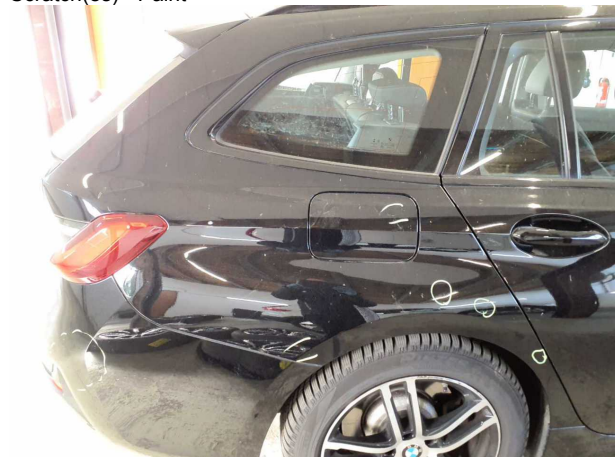
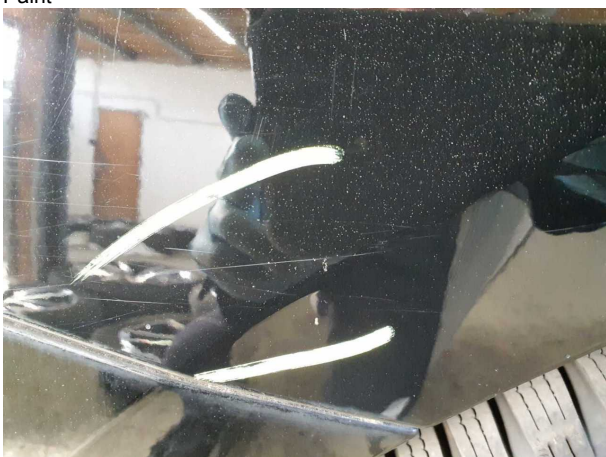
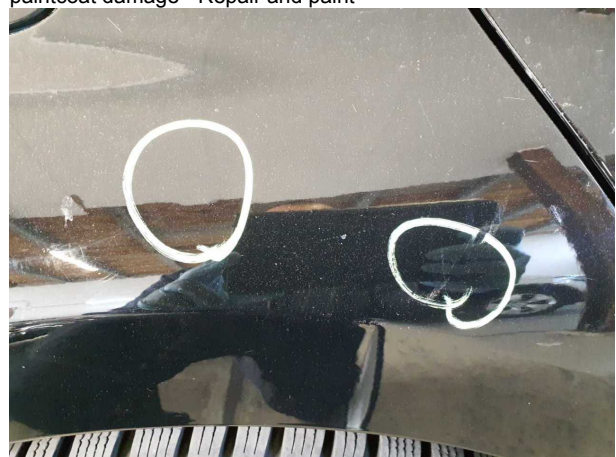
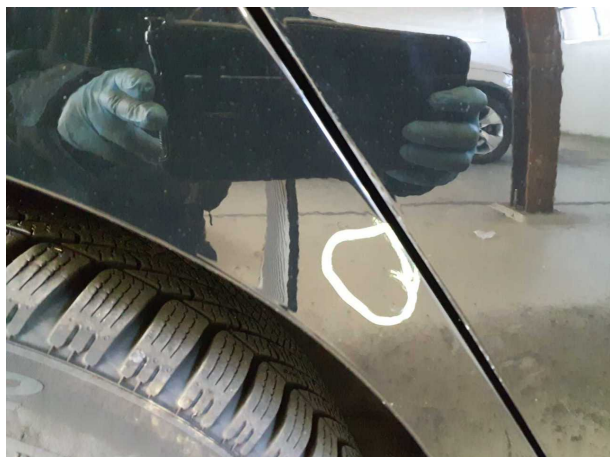
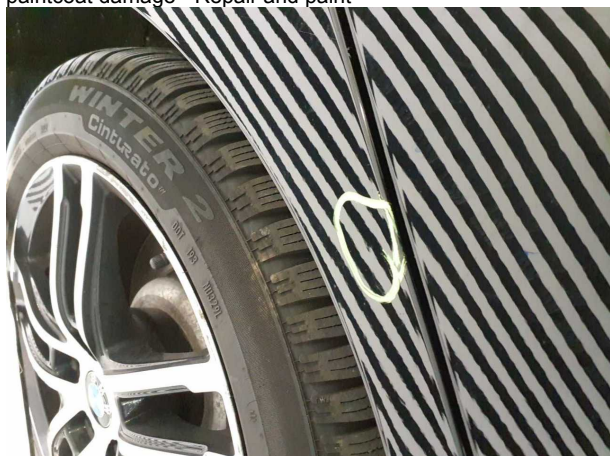
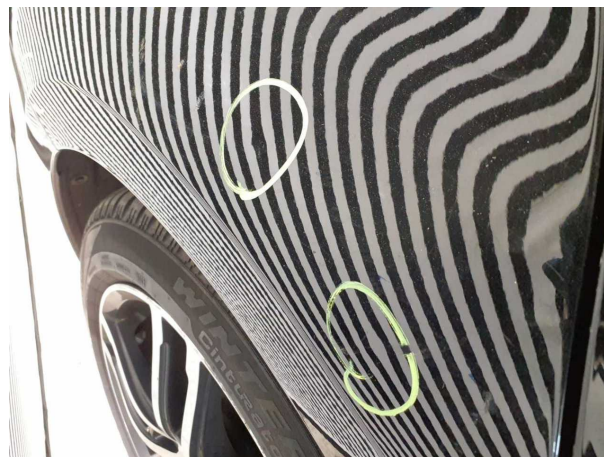
| No. | Component group | Description |
|---|---|---|
| 18 | Side panel - rear right side | Side panel - Dent / paintcoat damage - Repair and paint |

**Damage #18:** Side panel - rear right side: Side panel - Dent / paintcoat damage - Repair and paint

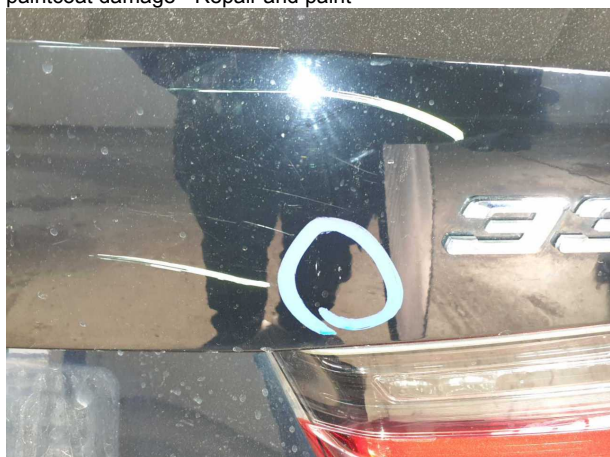
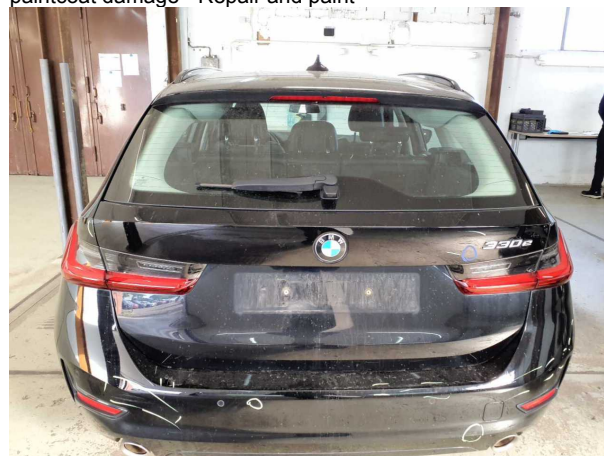
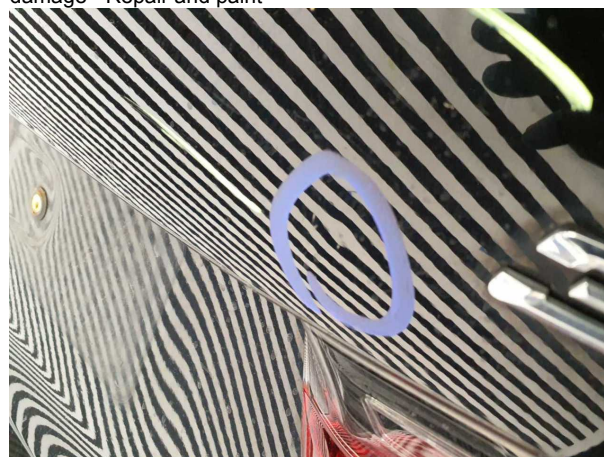
| No. | Component group | Description |
|---|---|---|
| 19 | Boot lid / rear door | Boot lid - Dent / paintcoat damage - Repair and paint |

**Damage #19:** Boot lid / rear door: Boot lid - Dent / paintcoat damage - Repair and paint

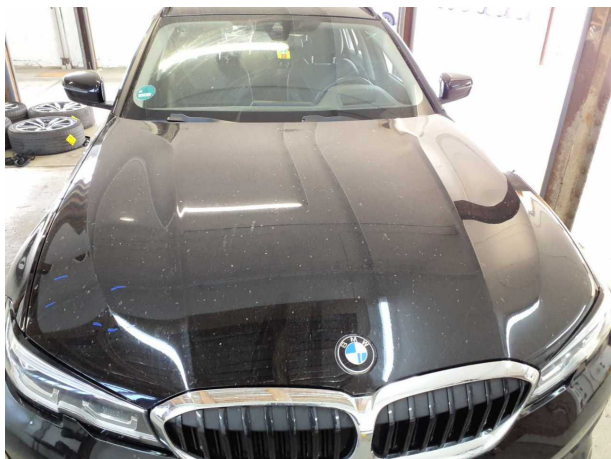
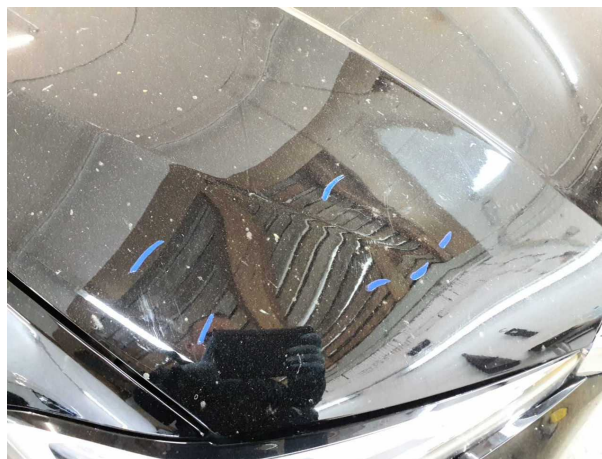
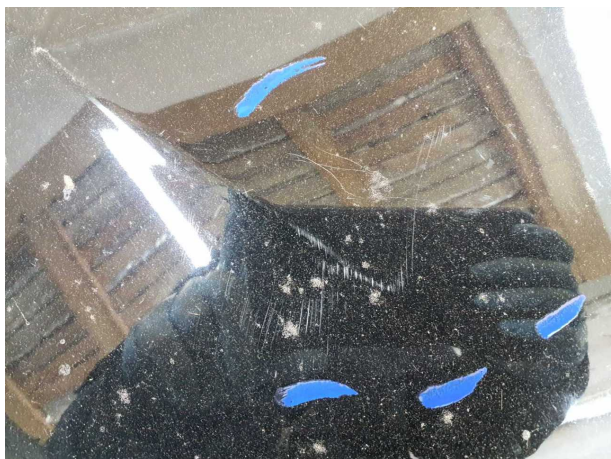
| No. | Component group | Description |
|---|---|---|
| 20 | Bonnet | Bonnet - Scratch(es) - Paint |

**Damage #20:** Bonnet: Bonnet - Scratch(es) - Paint

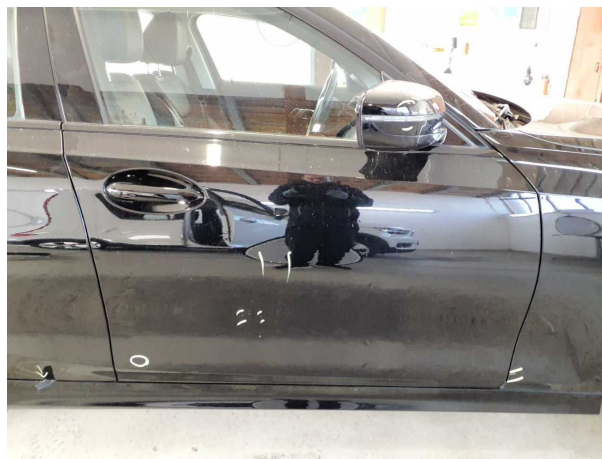
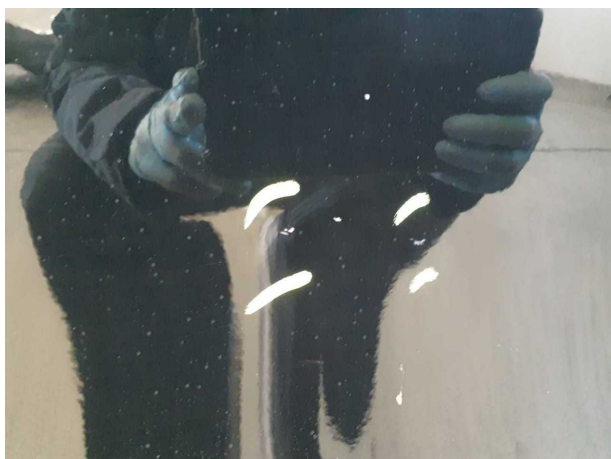
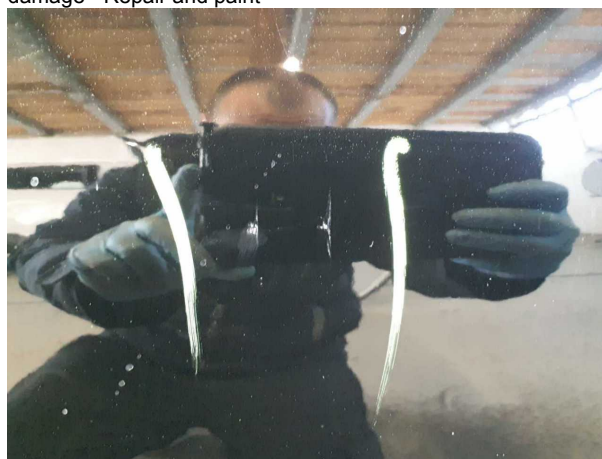
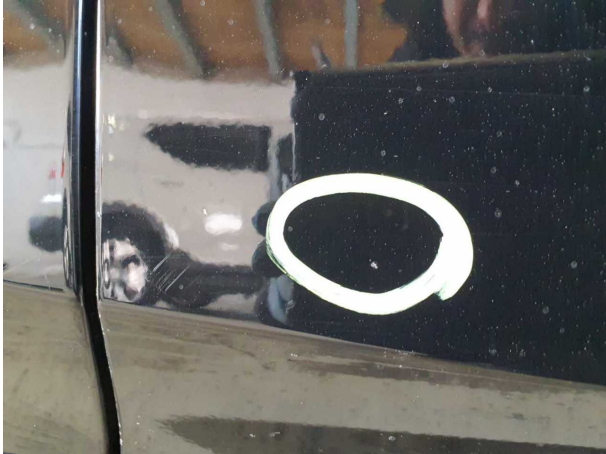
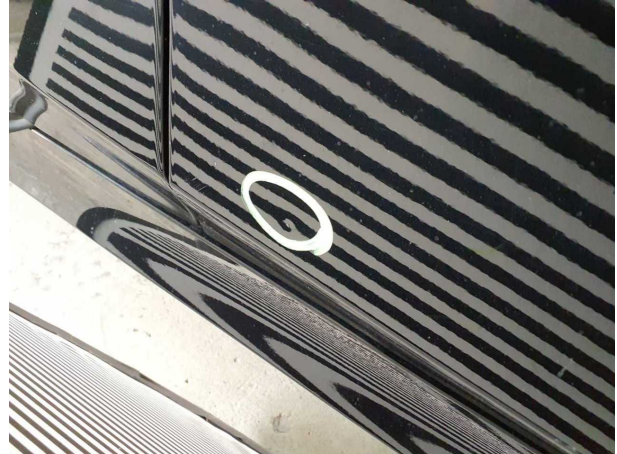
| No. | Component group | Description |
|---|---|---|
| 21 | Door - front right side | Door - Dent / paintcoat damage - Repair and paint |

**Damage #21:** Door - front right side: Door - Dent / paintcoat damage - Repair and paint
