**WBA6N31080FL14775**

## Zustandsbericht

**TÜV SÜD Auto Partner GmbH**  
Gutenbergstr. 13  
70771 Leinfelden-Echterdingen

Inspection date: 28 May 2025  
**Protocol number: 40022124**

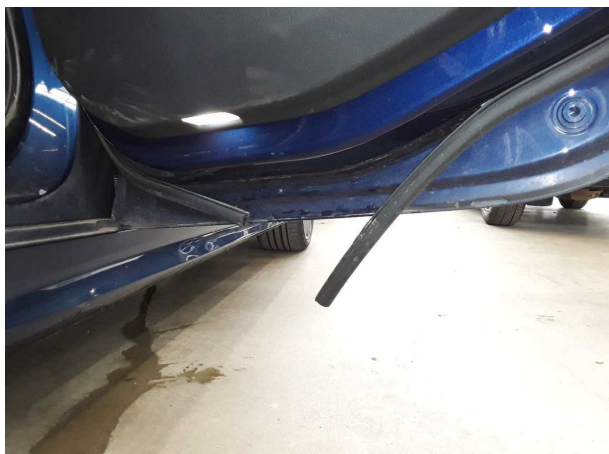
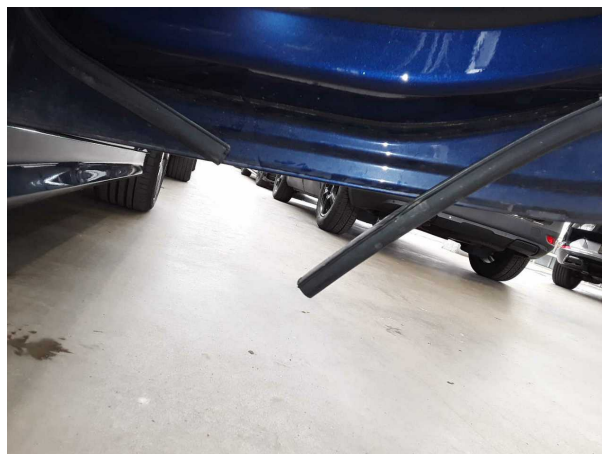
| No. | Component group | Description |
|---|---|---|
| 1 | Door - rear right side | Door seal - Differs from the original configuration - Replace |

**Damage #1:** Door - rear right side: Door seal - Differs from the original configuration - Replace

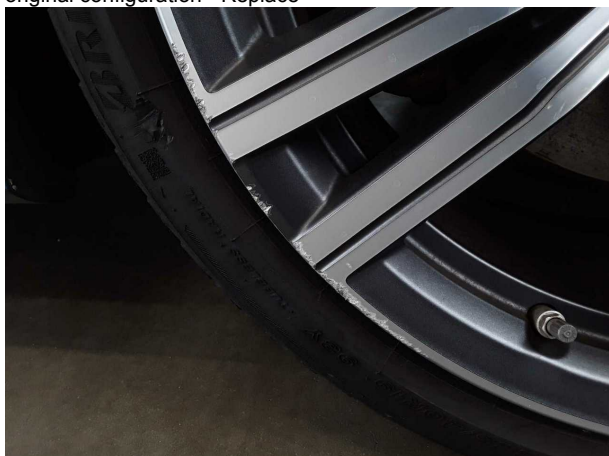
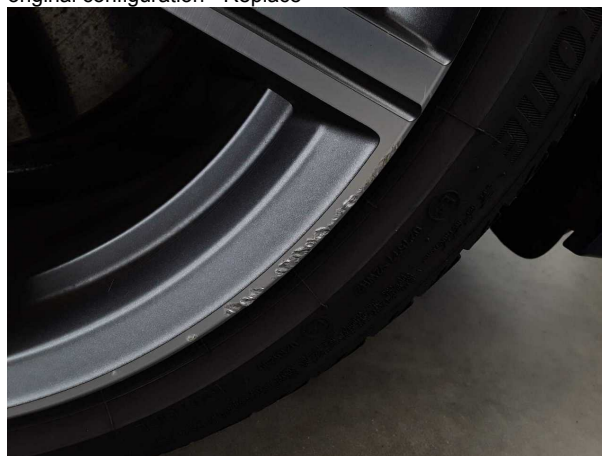
| No. | Component group | Description |
|---|---|---|
| 2 | Wheel / tyres | Alloy rim - front right side (Materialabtrag optisch gering) - Scratched - Loss in value |

**Damage #2:** Wheel / tyres: Alloy rim - front right side (Materialabtrag optisch gering) - Scratched - Loss in value

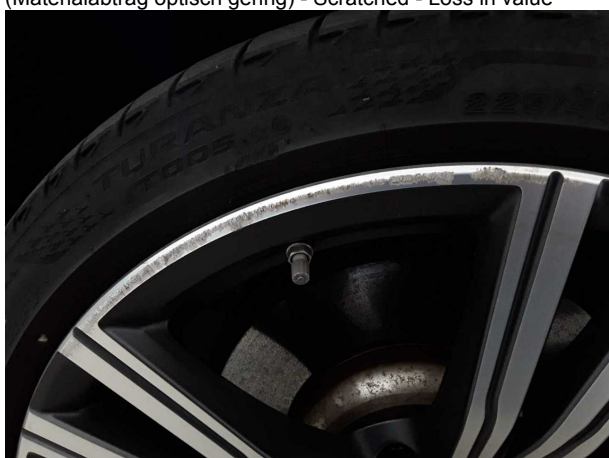
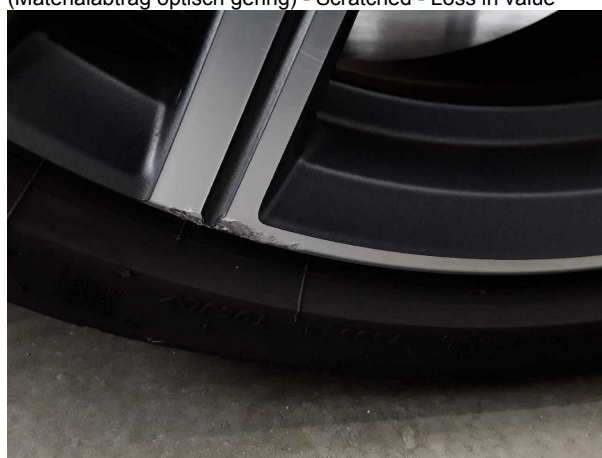
| No. | Component group | Description |
|---|---|---|
| 3 | Wheel / tyres | Alloy rim - front left side (Materialabtrag optisch gering) - Scratched - Loss in value |

**Damage #3:** Wheel / tyres: Alloy rim - front left side (Materialabtrag optisch gering) - Scratched - Loss in value

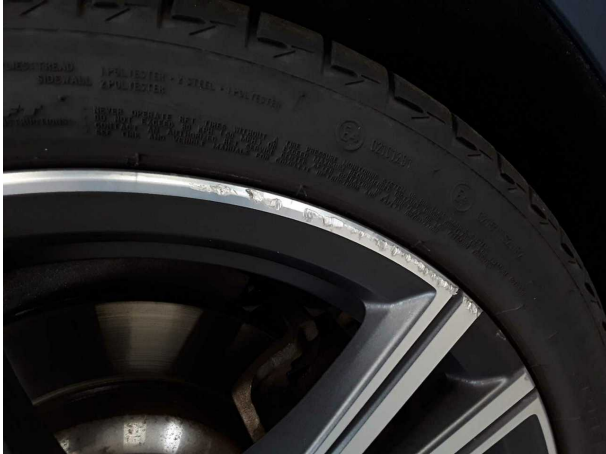
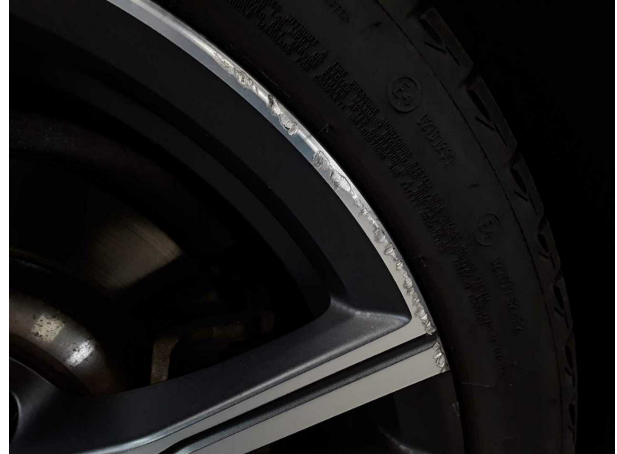
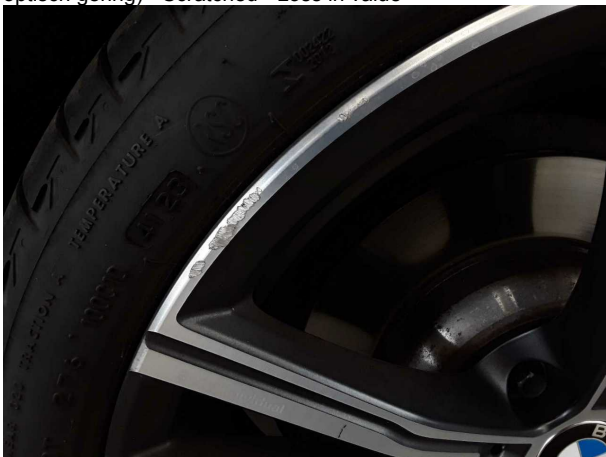
| No. | Component group | Description |
|---|---|---|
| 4 | Wheel / tyres | Alloy rim - rear right side (Materialabtrag optisch gering) - Scratched - Loss in value |

**Damage #4:** Wheel / tyres: Alloy rim - rear right side (Materialabtr... optisch gering) - Scratched - Loss in value

**Damage #4:** Wheel / tyres: Alloy rim - rear right side (Materialabtrag optisch gering) - Scratched - Loss in value

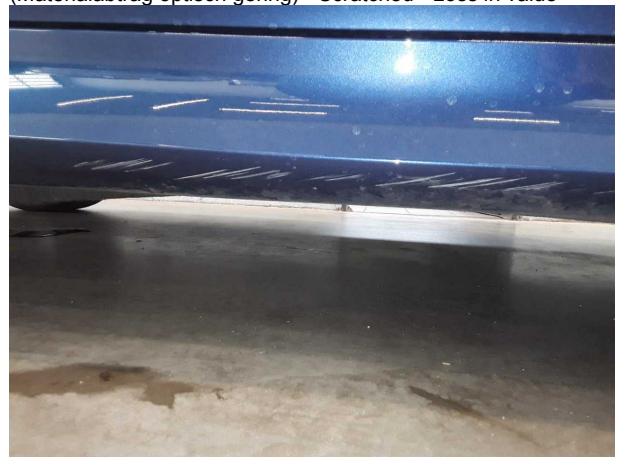
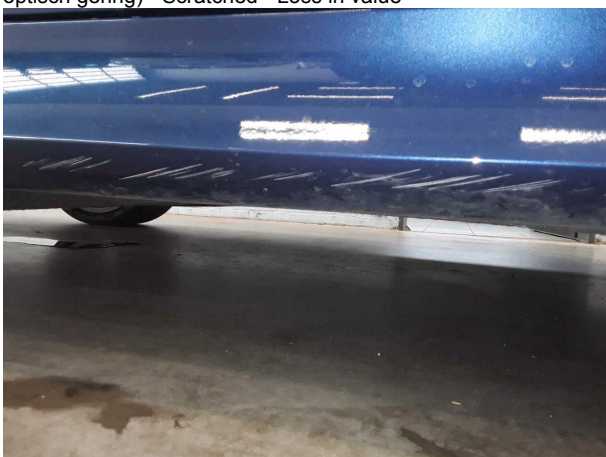
| No. | Component group | Description |
|---|---|---|
| 5 | Sill - right side | Trim - Scratched - Repair and paint |

**Damage #5:** Sill - right side: Trim - Scratched - Repair and paint

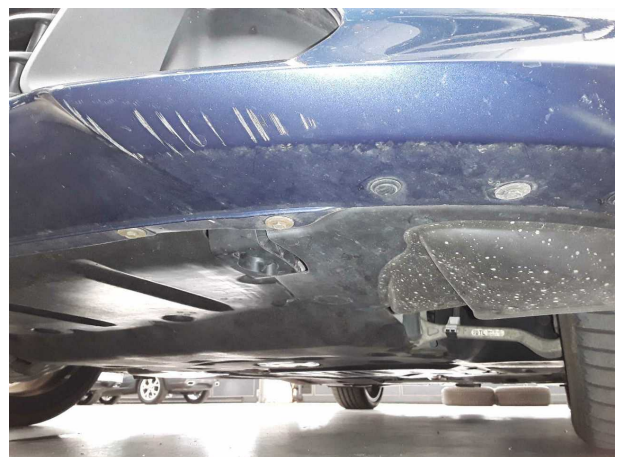
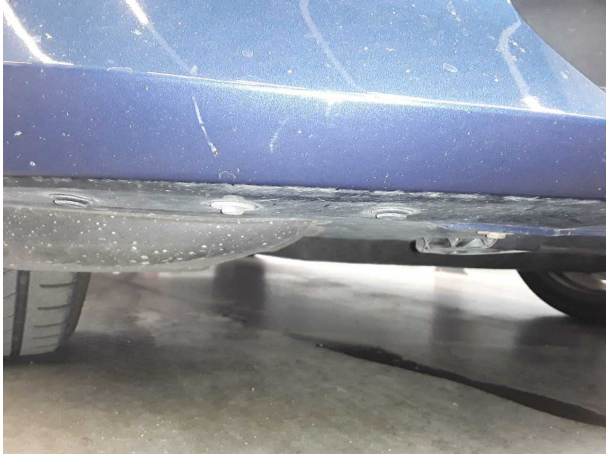
| No. | Component group | Description |
|---|---|---|
| 6 | Front bumper | Front bumper - Scratched - Repair and paint |

**Damage #6:** Front bumper: Front bumper - Scratched - Repair and paint

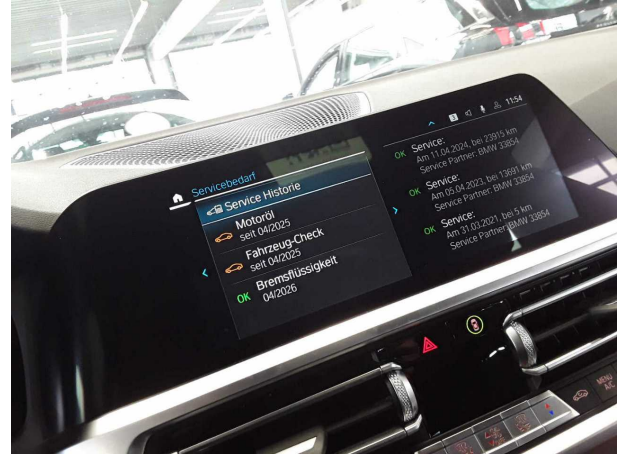
| No. | Component group | Description |
|---|---|---|
| 7 | Misc. | Inspection / maintenance - Due - Replace |

**Damage #7:** Misc.: Inspection / maintenance - Due - Replace
