WBA11DZ000FK51395

## Zustandsbericht

**TÜV SÜD Auto Partner GmbH**  
Gutenbergstr. 13  
70771 Leinfelden-Echterdingen

**Protocol number:** 39796669

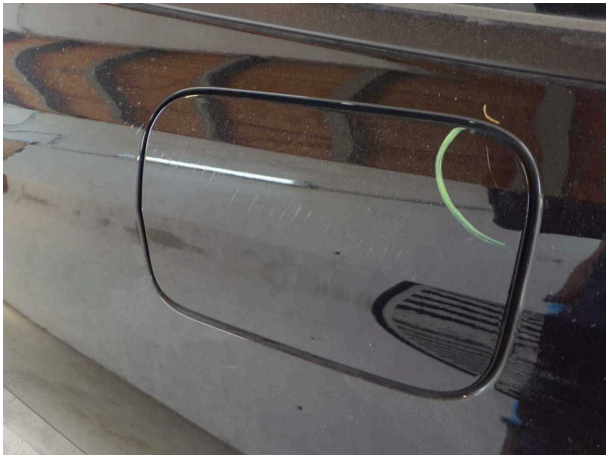
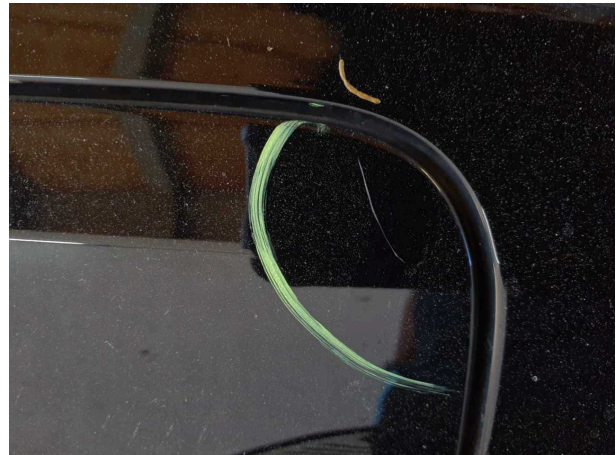
| No. | Component group | Description |
|---|---|---|
| 1 | Fuel system | Tank cap - Scratched - Smart repair |

**Damage #1:** Fuel system: Tank cap - Scratched - Smart repair

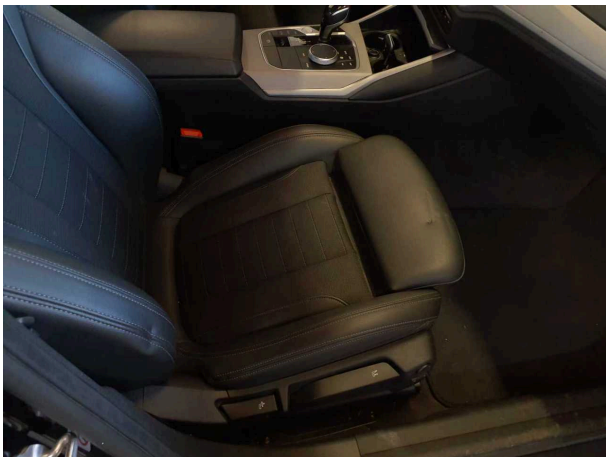
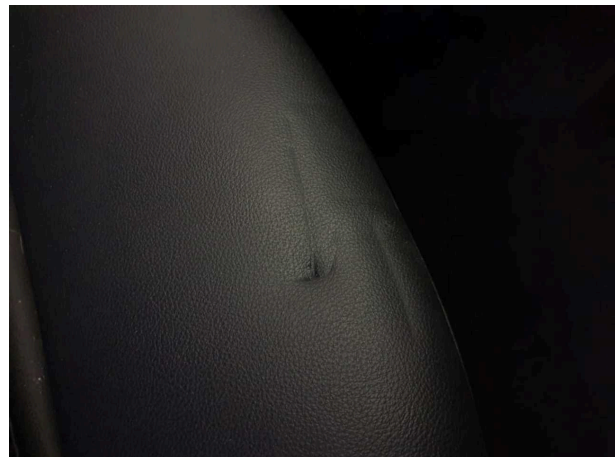
| No. | Component group | Description |
|---|---|---|
| 2 | Seat - front | Seat - right side - Scratched - Loss in value |

**Damage #2:** Seat - front: Seat - right side - Scratched - Loss in value

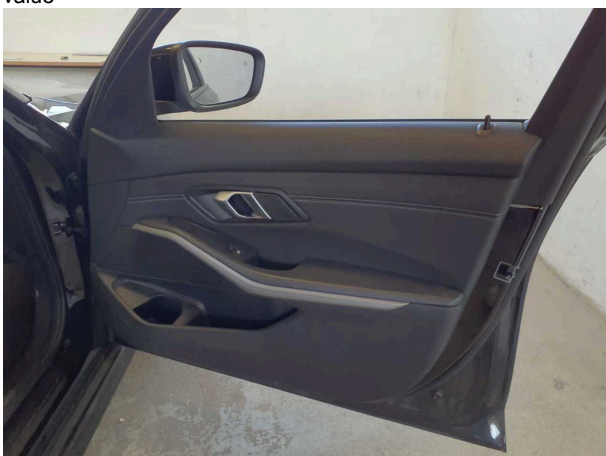
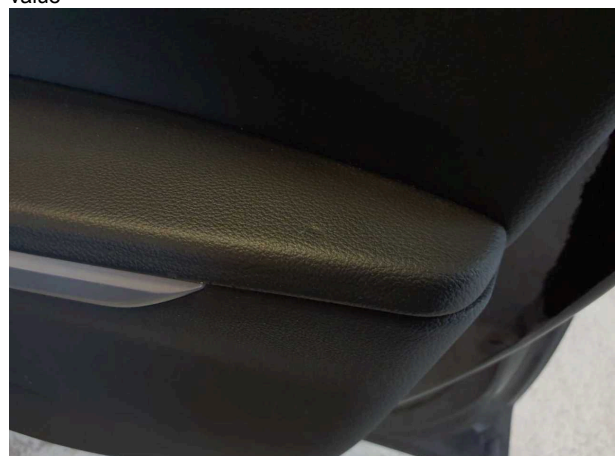
| No. | Component group | Description |
|---|---|---|
| 3 | Trim / covers | Door trim - front right side - Scratched - Loss in value |

**Damage #3:** Trim / covers: Door trim - front right side - Scratched - Loss in value

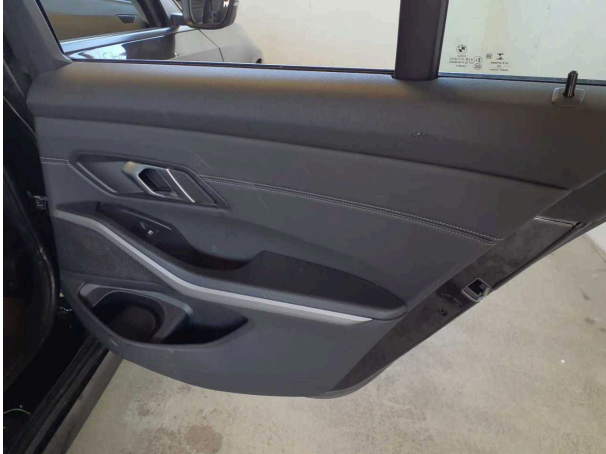
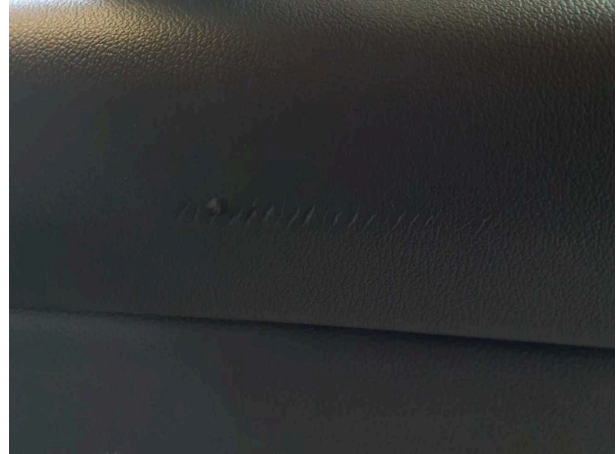
| No. | Component group | Description |
|---|---|---|
| 4 | Trim / covers | Door trim - rear right side - Scratched - Loss in value |

**Damage #4:** Trim / covers: Door trim - rear right side - Scratched - Loss in value

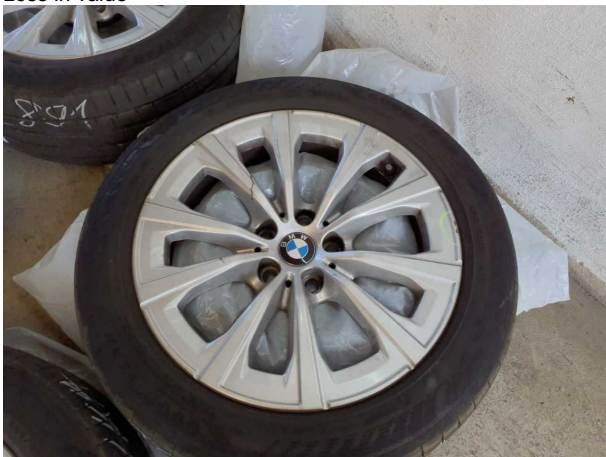
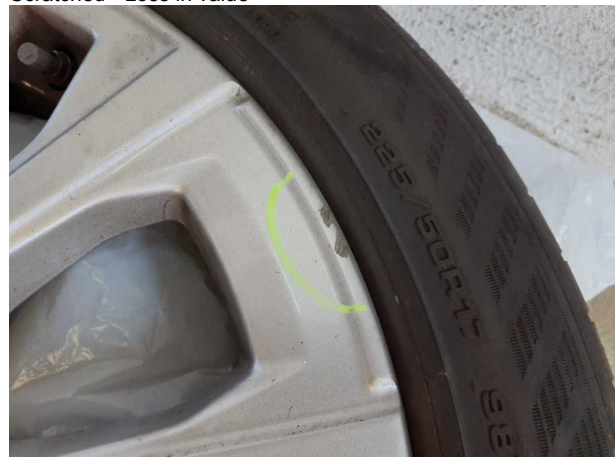
| No. | Component group | Description |
|---|---|---|
| 5 | 2nd wheel set | 1 alloy rim - Scratched - Loss in value |

**Damage #5:** 2nd wheel set: 1 alloy rim - Scratched - Loss in value

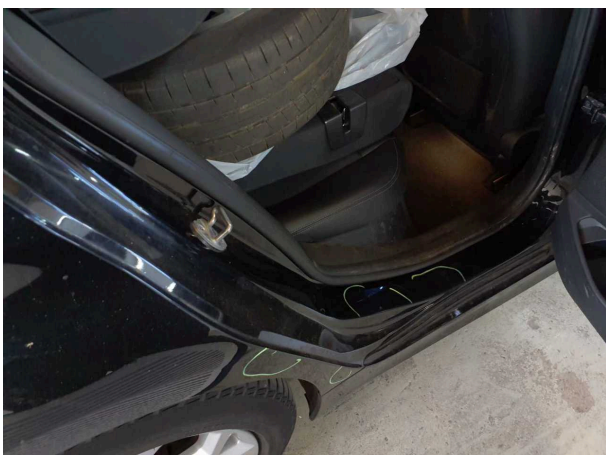
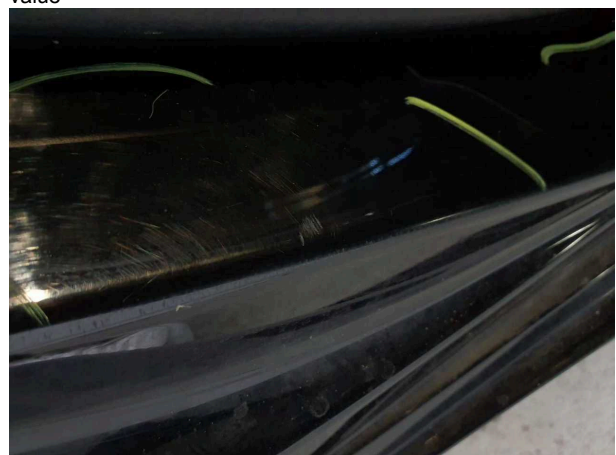
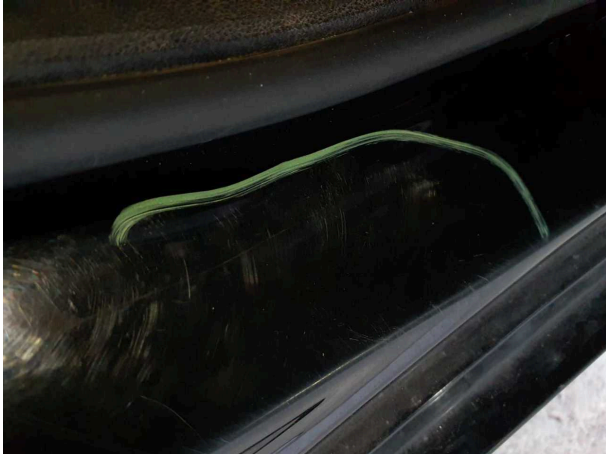
| No. | Component group | Description |
|---|---|---|
| 6 | Side panel - rear right side | Sill - Scratched - Smart repair |

**Damage #6:** Side panel - rear right side: Sill - Scratched - Smart repair

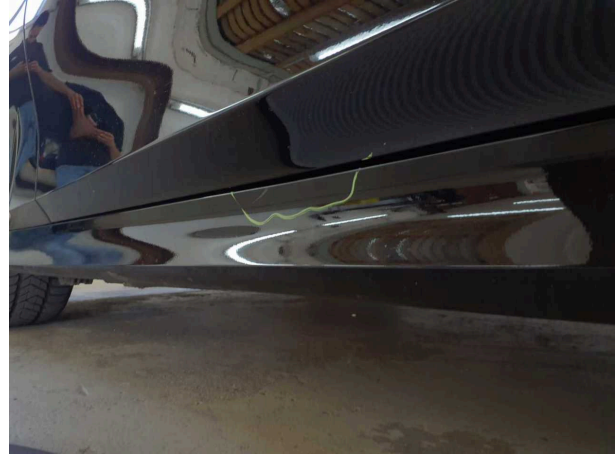
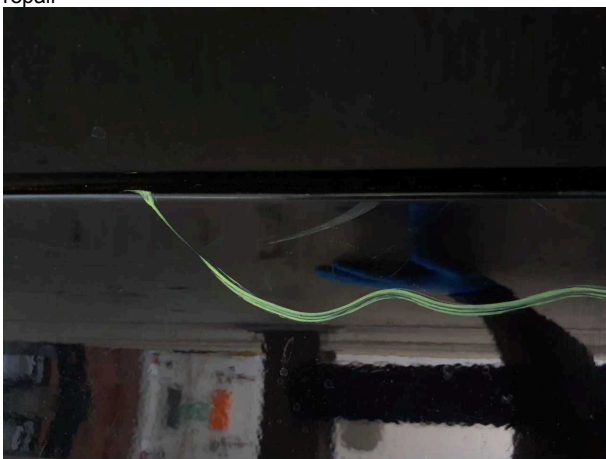
| No. | Component group | Description |
|---|---|---|
| 7 | Sill - left side | Trim - Scratched - Paint |

**Damage #7:** Sill - left side: Trim - Scratched - Paint

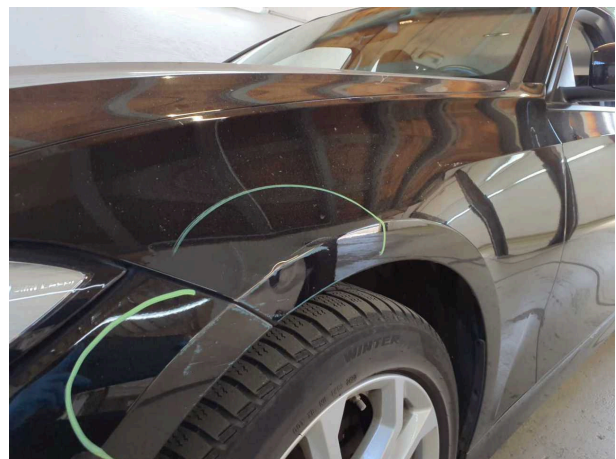
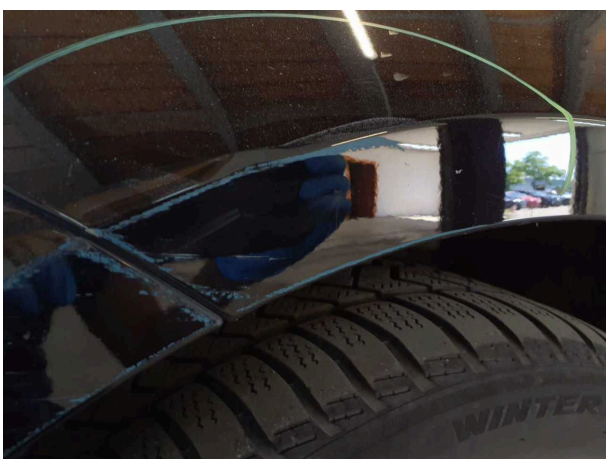
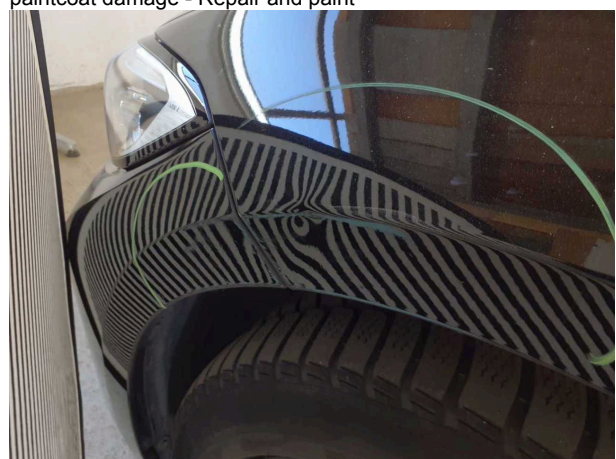
| No. | Component group | Description |
|---|---|---|
| 8 | Mudguard - left side | Mudguard - left side - Dent / paintcoat damage - Repair and paint |

**Damage #8:** Mudguard - left side: Mudguard - left side - Dent / paintcoat damage - Repair and paint

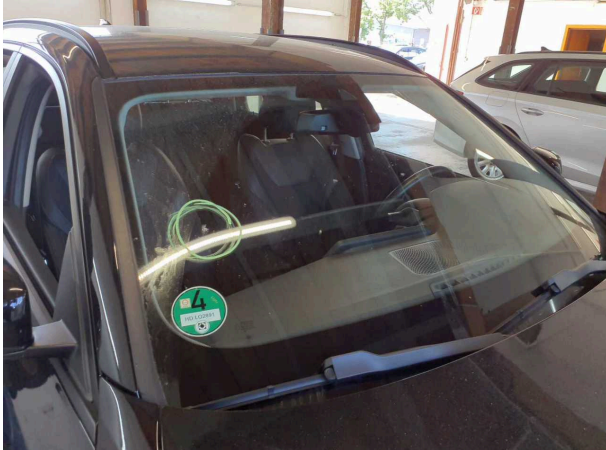
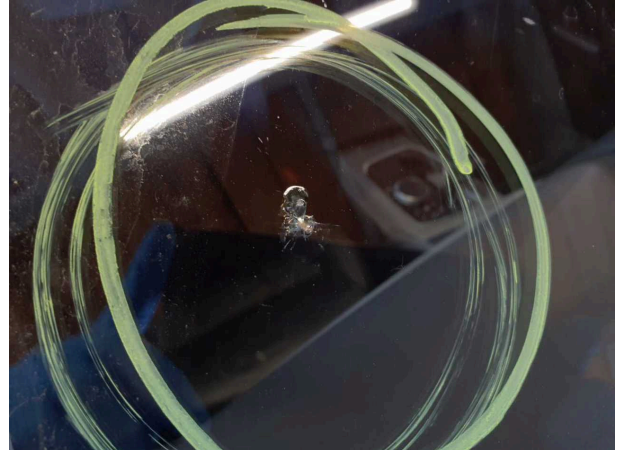
| No. | Component group | Description |
|---|---|---|
| 9 | Vehicle glazing | Windscreen - Stone chips - Replace |

**Damage #9:** Vehicle glazing: Windscreen - Stone chips - Replace

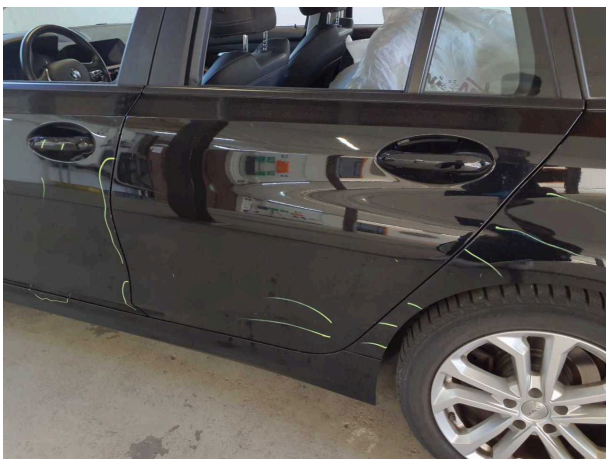
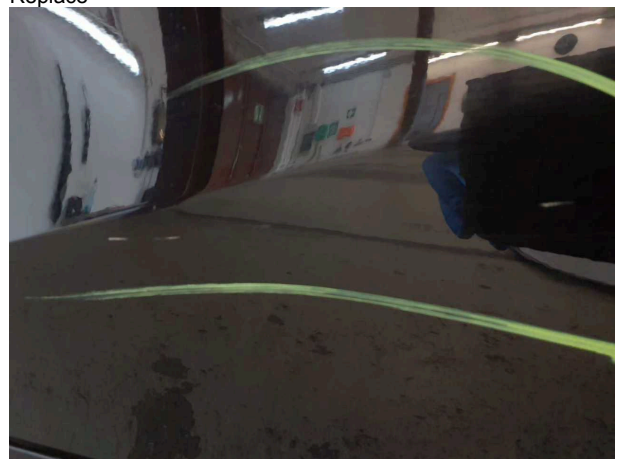
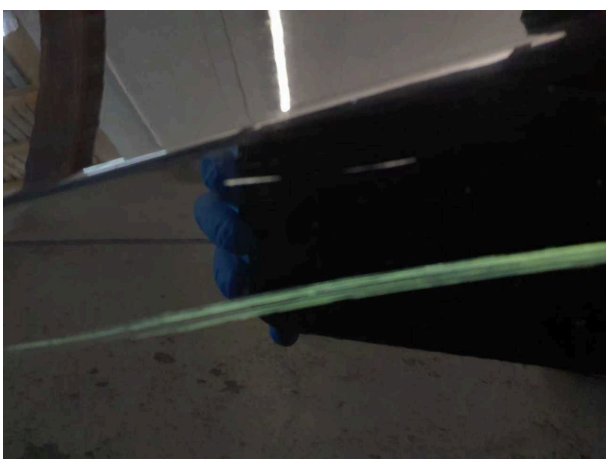
| No. | Component group | Description |
|---|---|---|
| 10 | Door - rear left side | Door - Scratched - Paint |

**Damage #10:** Door - rear left side: Door - Scratched - Paint

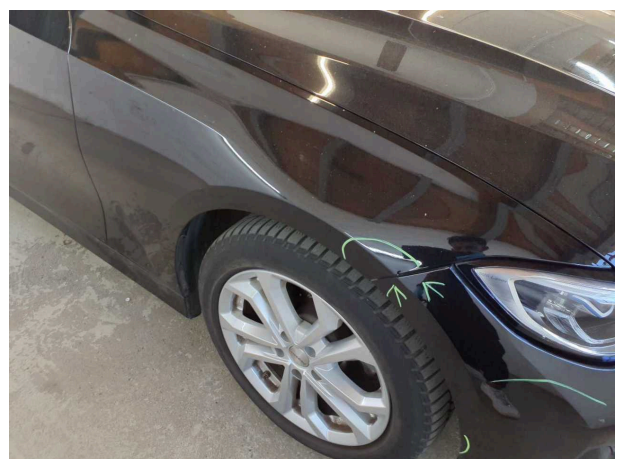
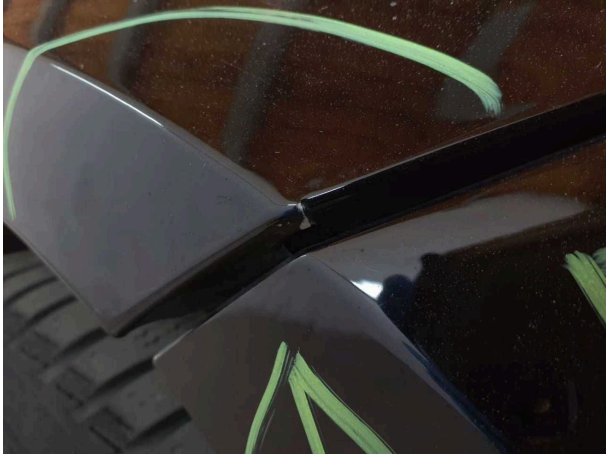
| No. | Component group | Description |
|---|---|---|
| 11 | Mudguard - right side | Mudguard - right side - Broken / torn - Replace |

**Damage #11:** Mudguard - right side: Mudguard - right side - Broken / torn - Replace

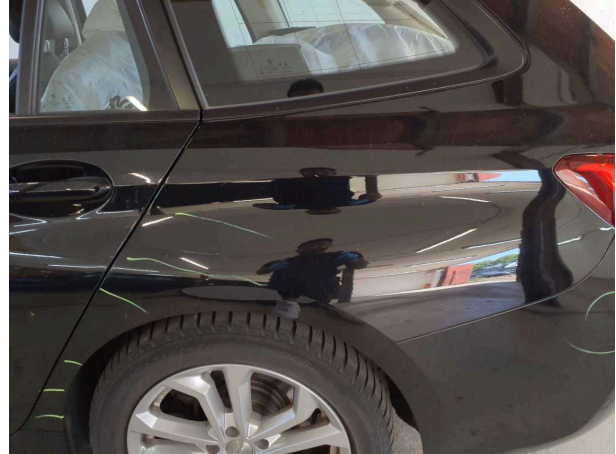
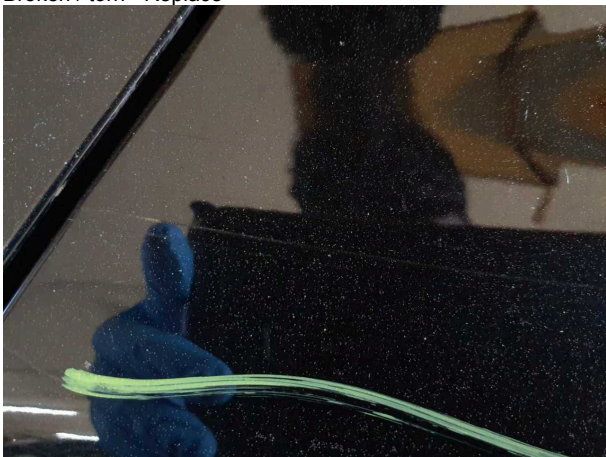
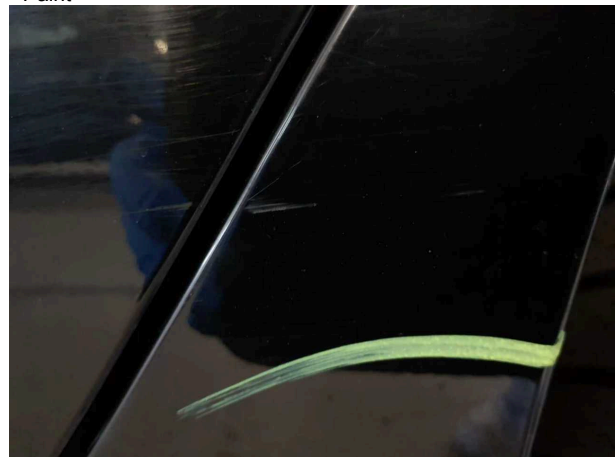
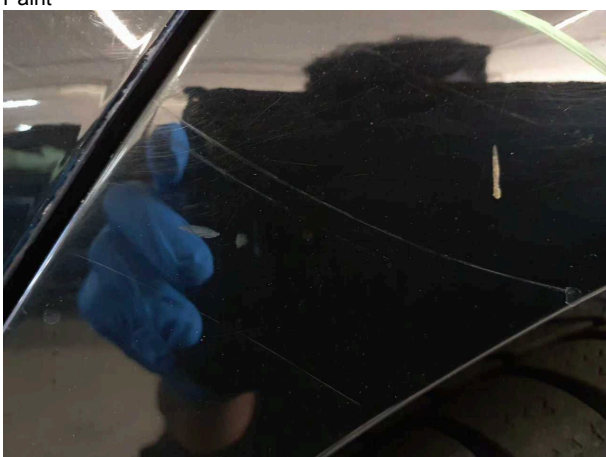
| No. | Component group | Description |
|---|---|---|
| 12 | Side panel - rear left side | Side panel - Scratched - Paint |

**Damage #12:** Side panel - rear left side: Side panel - Scratch... - Paint

**Damage #12:** Side panel - rear left side: Side panel - Scratched - Paint

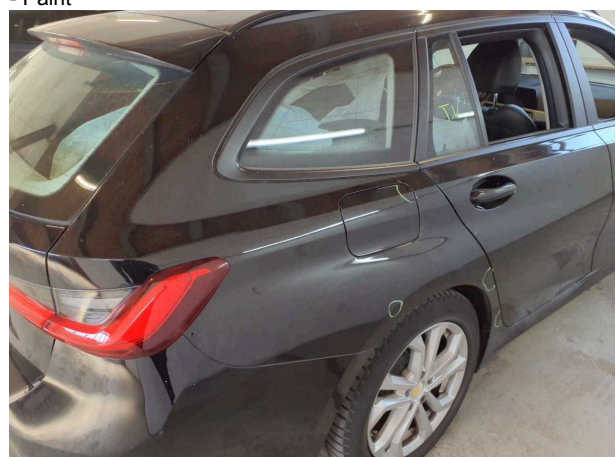
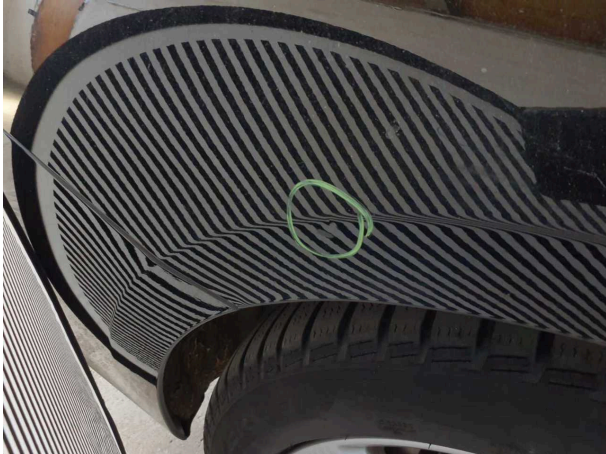
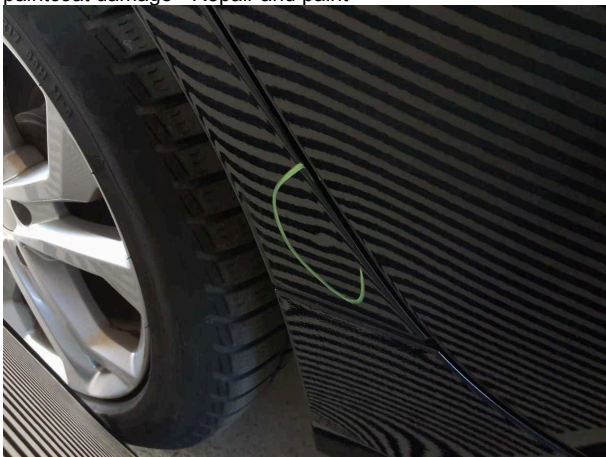
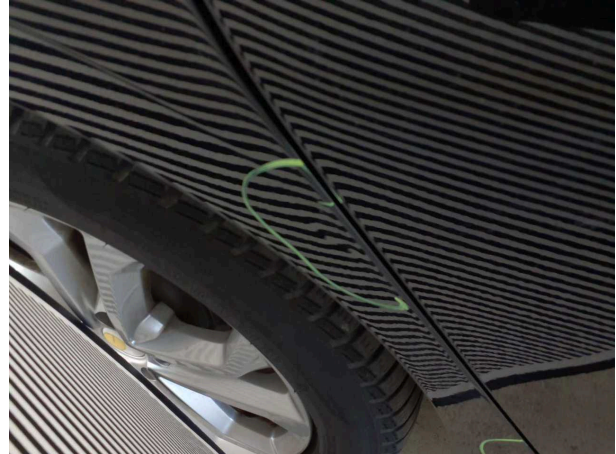
| No. | Component group | Description |
|---|---|---|
| 13 | Side panel - rear right side | Side panel - Dent / paintcoat damage - Repair and paint |

**Damage #13:** Side panel - rear right side: Side panel - Dent / paintcoat damage - Repair and paint

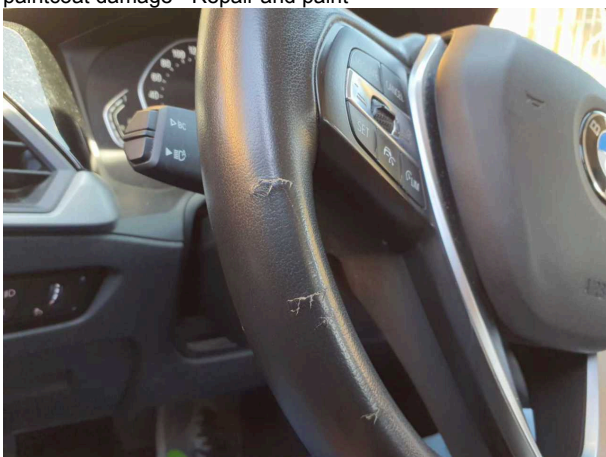
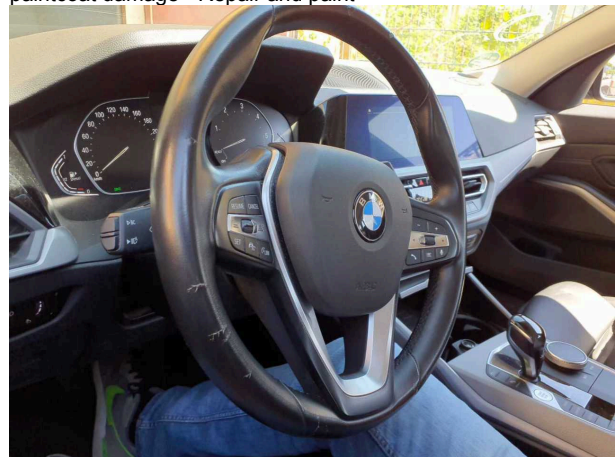
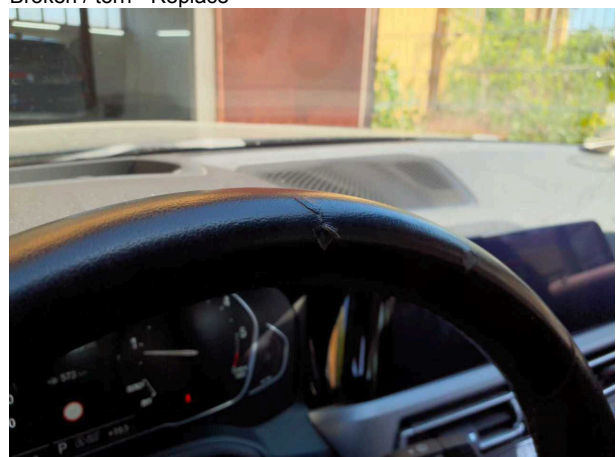
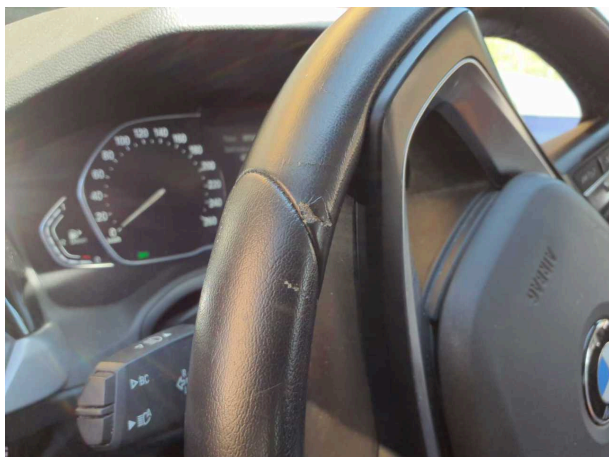
| No. | Component group | Description |
|---|---|---|
| 14 | Steering system | Steering wheel sheath - Broken / torn - Replace |

**Damage #14:** Steering system: Steering wheel sheath - Broken / torn - Replace

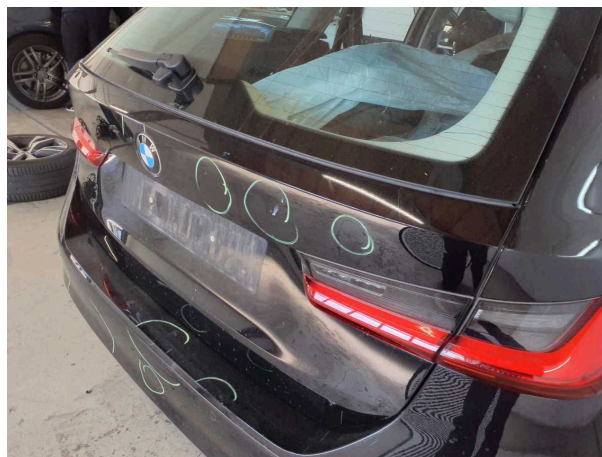
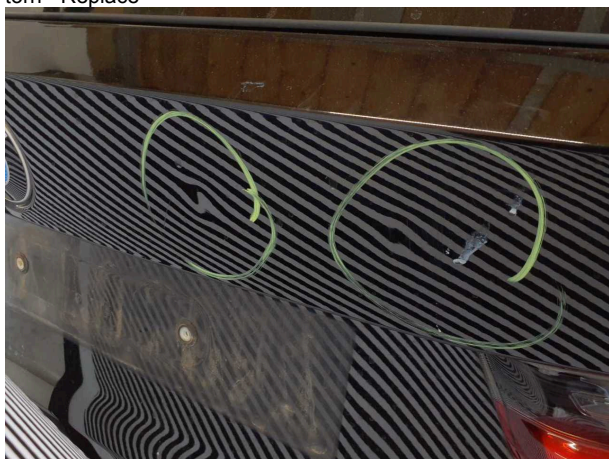
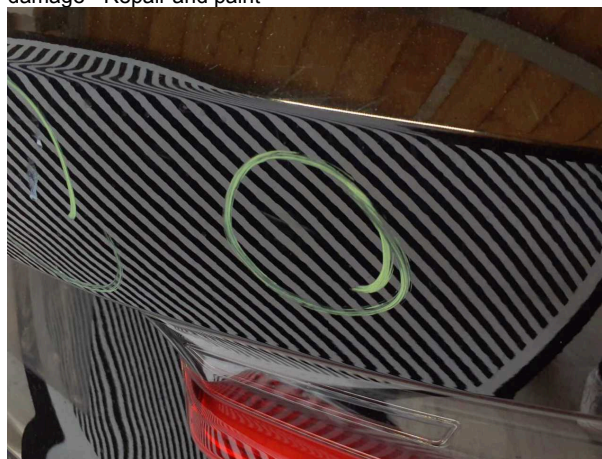
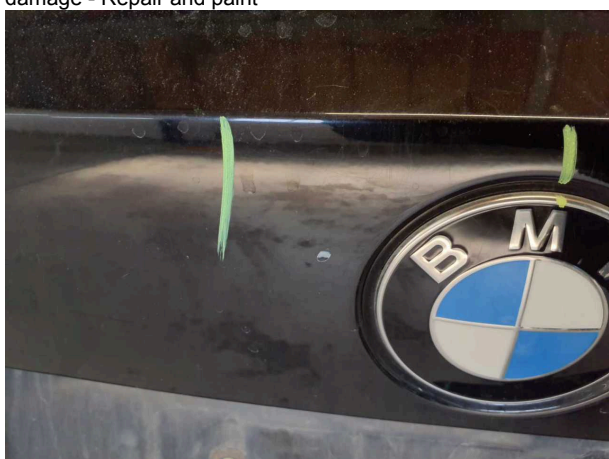
| No. | Component group | Description |
|---|---|---|
| 15 | Boot lid / rear door | Boot lid - Dent / paintcoat damage - Repair and paint |

**Damage #15:** Boot lid / rear door: Boot lid - Dent / paintcoat damage - Repair and paint

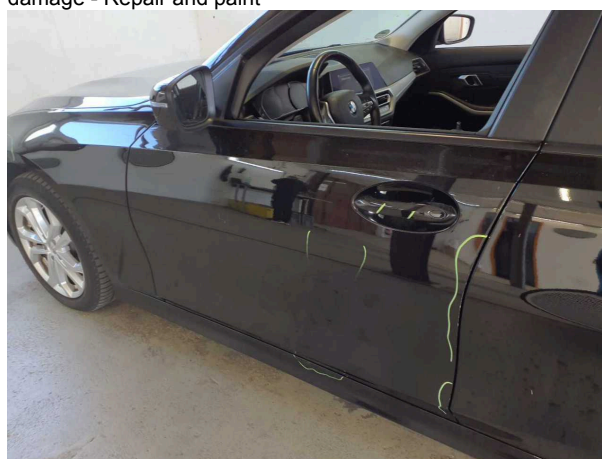
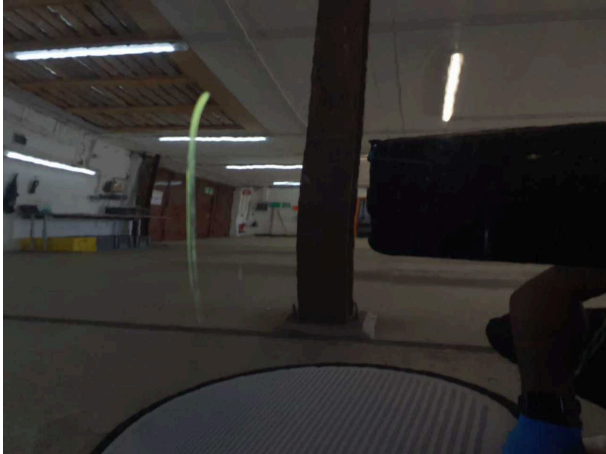
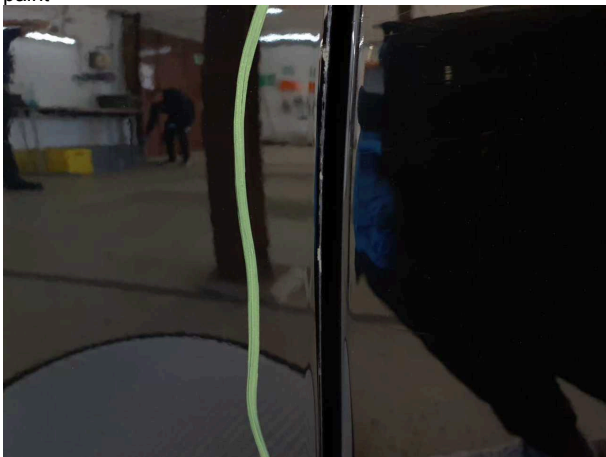
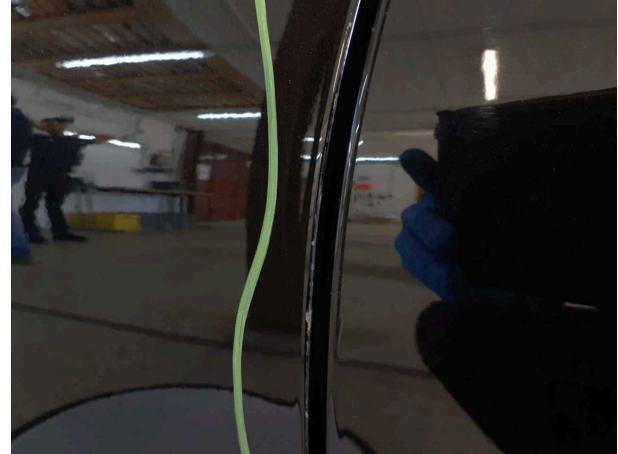
| No. | Component group | Description |
|---|---|---|
| 16 | Door - front left side | Door - Scratched - Repair and paint |

**Damage #16:** Door - front left side: Door - Scratched - Repair and paint

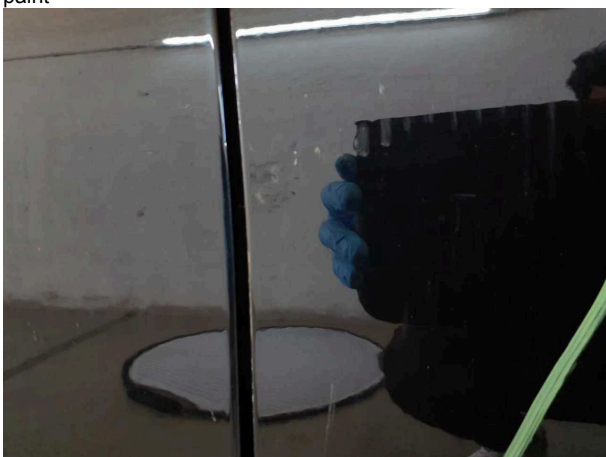
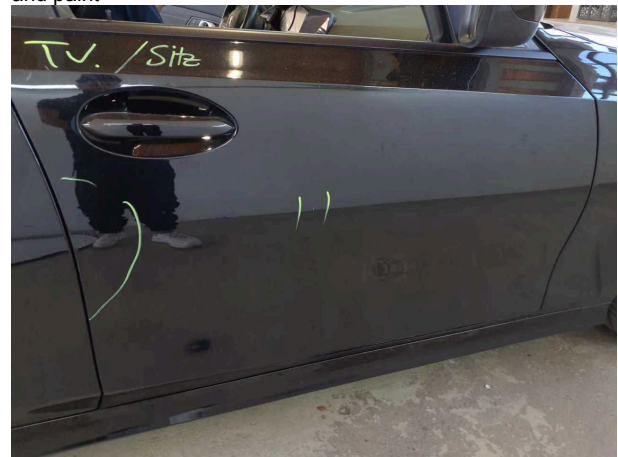
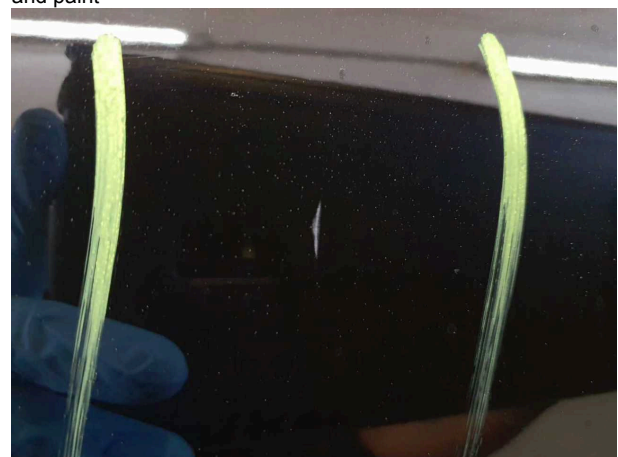
| No. | Component group | Description |
|---|---|---|
| 17 | Door - front right side | Door - Scratched - Repair and paint |

**Damage #17:** Door - front right side: Door - Scratched - Repair and paint

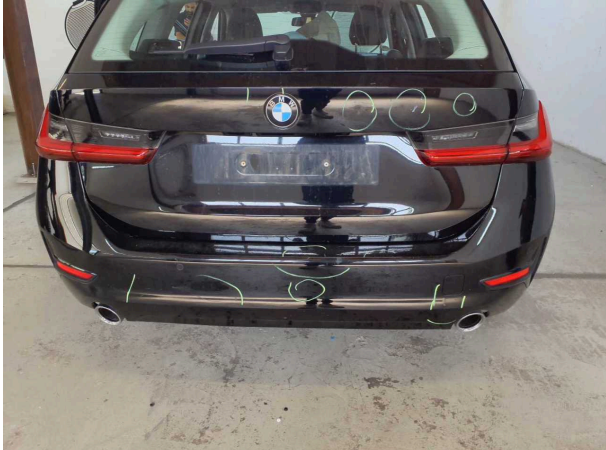
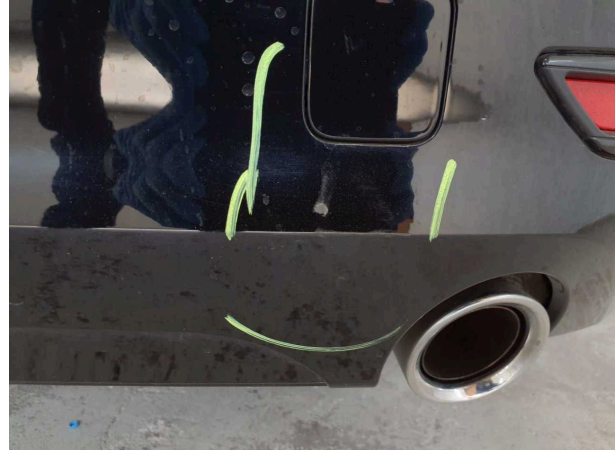
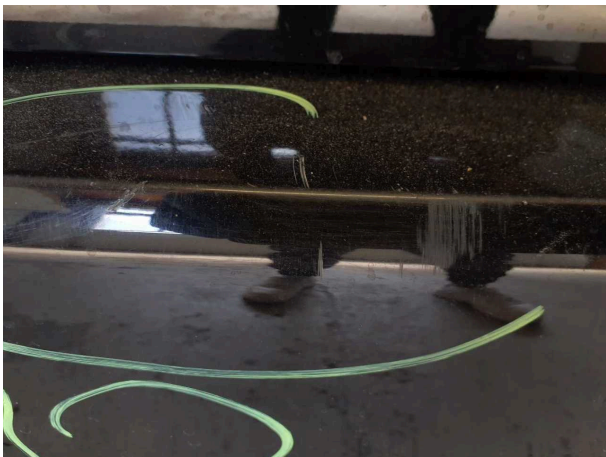
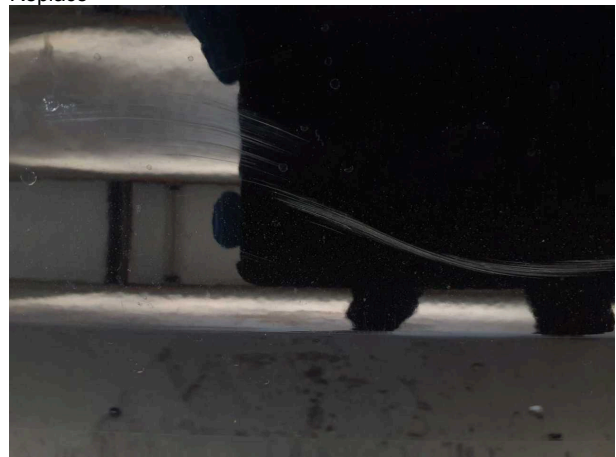
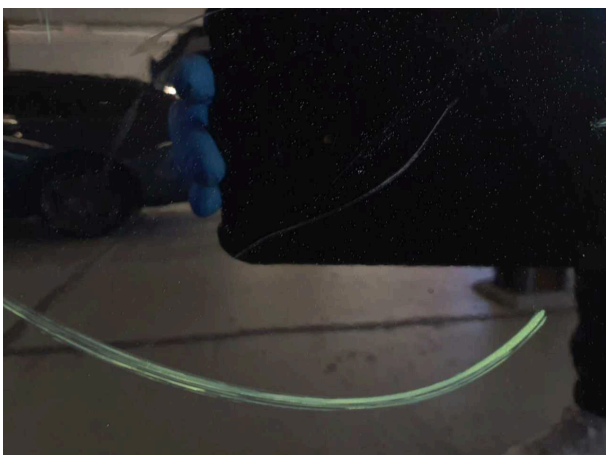
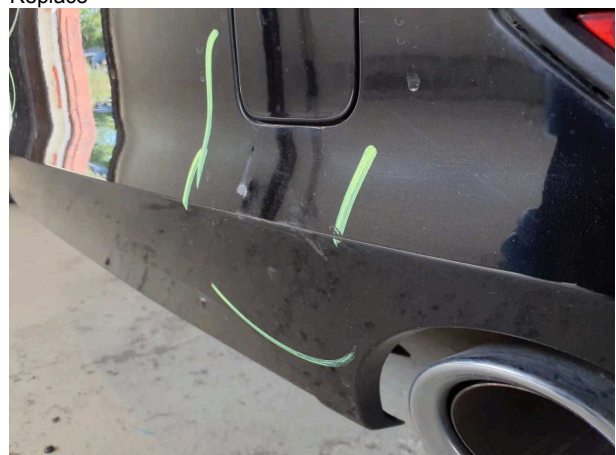
| No. | Component group | Description |
|---|---|---|
| 18 | Rear bumper | Rear bumper - Damaged - Replace |

| No. | Location |
|---|---|
| 1 | Bumper rear, Professionally carried out |

**Damage #18:** Rear bumper: Rear bumper - Damaged - Replace

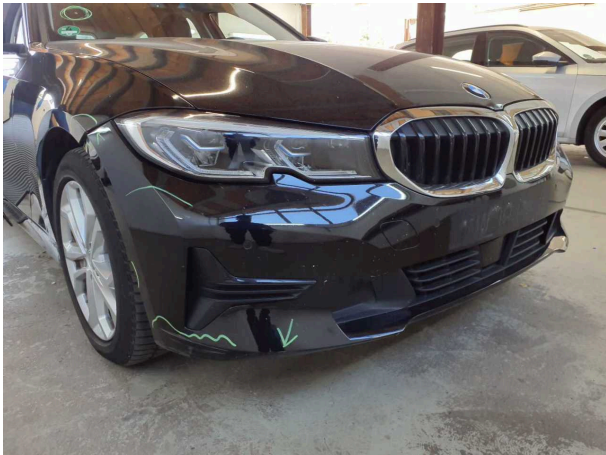
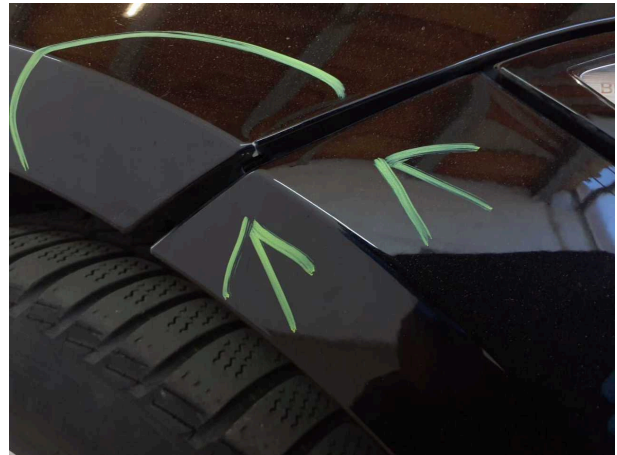
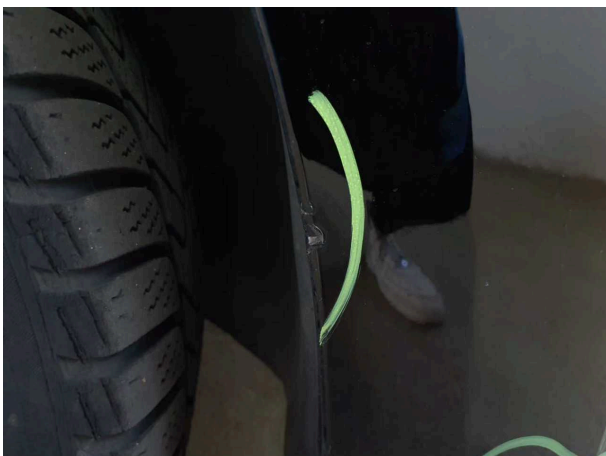
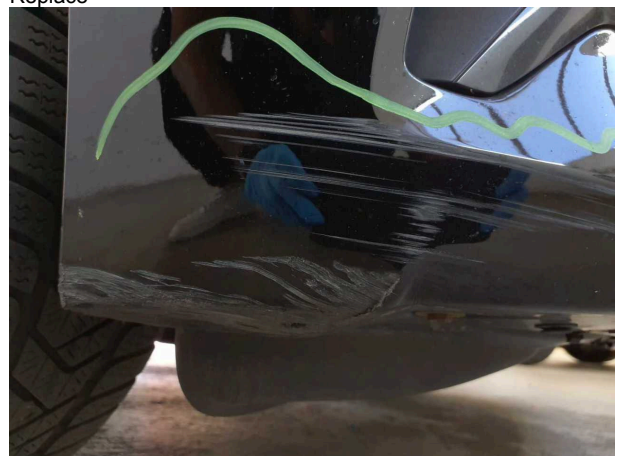
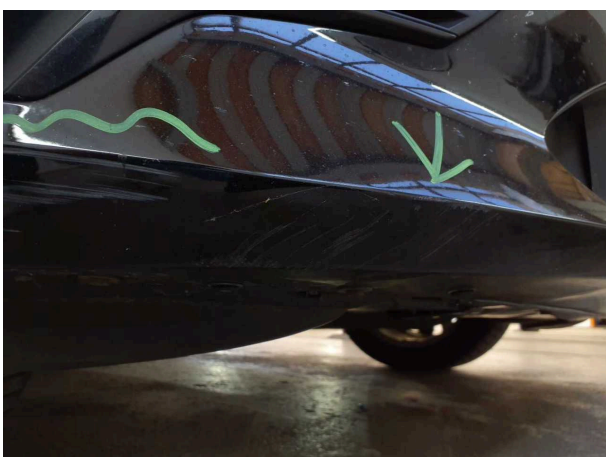
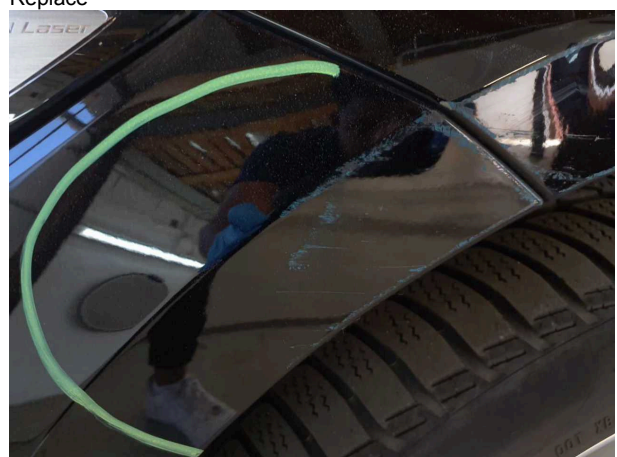
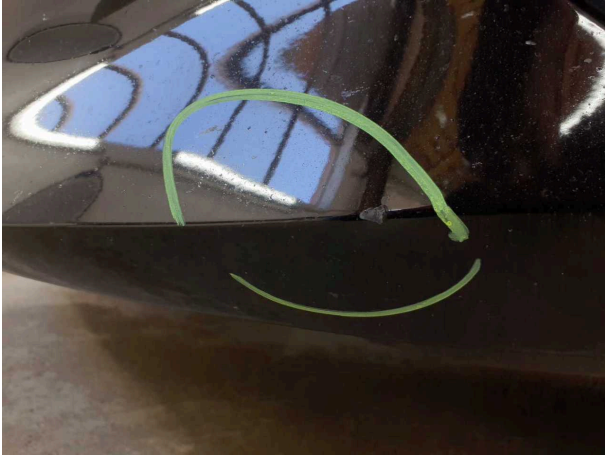
| No. | Component group | Description |
|---|---|---|
| 19 | Front bumper | Front bumper - Damaged - Replace |

**Damage #19:** Front bumper: Front bumper - Damaged - Replace
