Operator		Inspection condition	conditional: light/moisture/dirt
License number		Mileage (Read)	145,814 km
Manufacturer	BMW	Next maintenance in	20,000 km
Type / Model	330i Touring Aut. Sport Line	Main inspection	
Vehicle Identification number	WBA6K510X0FJ04263	Power / Engine displacement	190 kW / 1,998 ccm
First registration	12 Nov 2019	Upholstery/Colour	Cloth / leather combination / Black
Last maintenance		Paintwork	Red
Fuel type	Petrol	Gearbox	Automatic

Zustandsbericht

Inspection date: 15 Jan 2025
Protocol number: 37995861

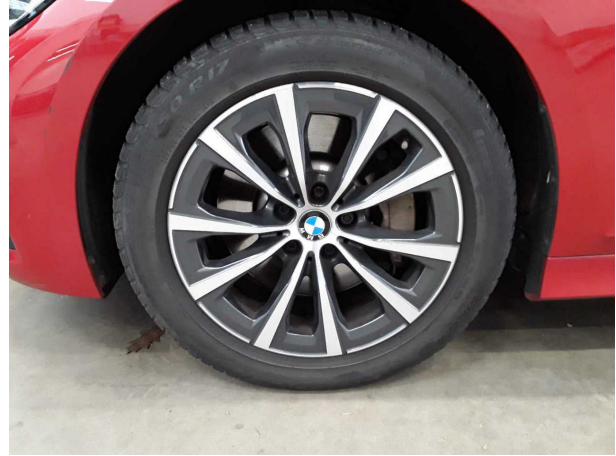
Axle	Tyre size	Manufacturer	Type of tyre	Tread depth	Roadworthy	Permissibility
1	225/50 R17 98H	Pirelli	Winter tyres	4mm - 4mm	o.k.	Not o.k.
2	225/50 R17 98H	Pirelli	Winter tyres	5mm - 5mm	o.k.	Not o.k.

Figure 20: Mounted tyres

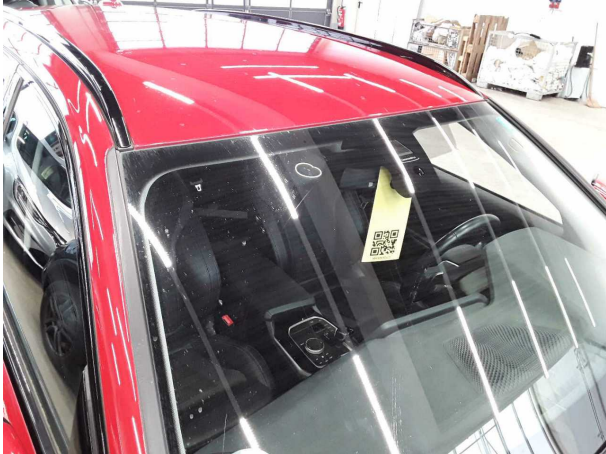
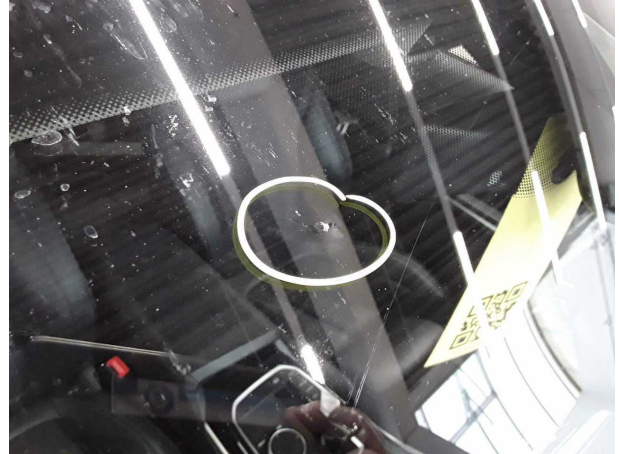
No.	Component group	Description
1	Vehicle glazing	Windscreen with lane departure assistant (mit Rissbildung zu nah am Rand) - Stone chips - Replace
2	Front bumper	Front bumper - Scratched - Paint

Damage #1: Vehicle glazing: Windscreen with lane departure assistant (mit Rissbildung zu nah am Rand) - Stone chips - Replace

Damage #1: Vehicle glazing: Windscreen with lane departure assistant (mit Rissbildung zu nah am Rand) - Stone chips -

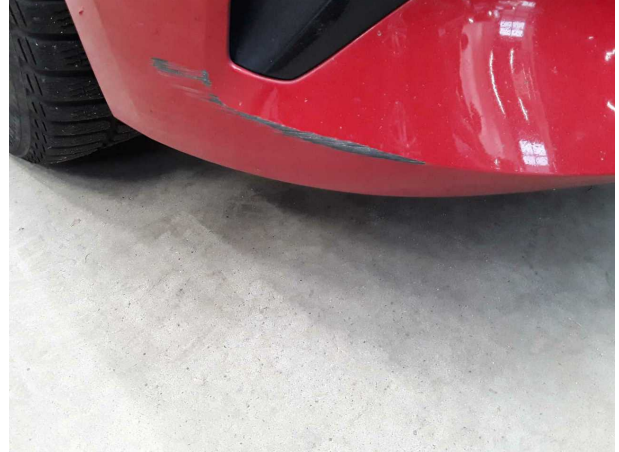
Damage #2: Front bumper: Front bumper - Scratched - Paint
