WAUZZZF32R1050034

Zustandsbericht

Inspection date: 30 Dec 2024
Protocol number: 37715796
Delivery date: 30 Dec 2024

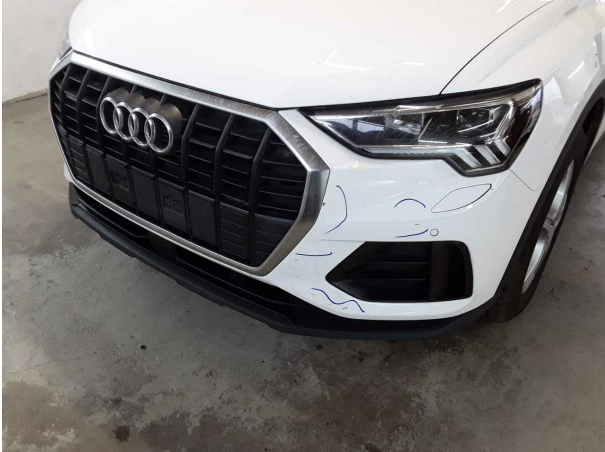
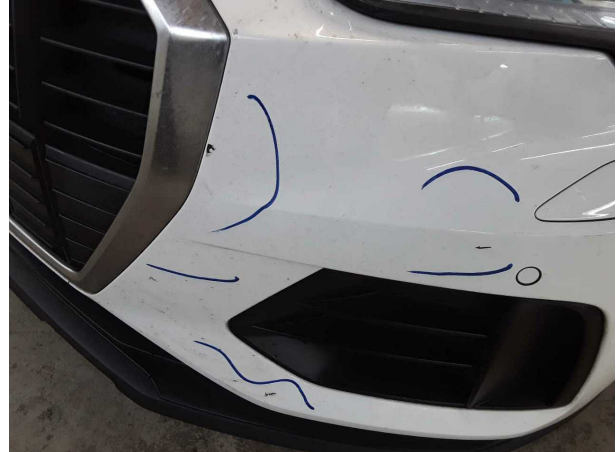
Damage #2: Front bumper: Front bumper - Scratched - Repair and paint

No.	Component group	Description
1	Documents	Service book (Wartungsnachweise fehlen) - No deduction
2	Front bumper	Front bumper - Scratched - Repair and paint
3	Rear bumper	Rear bumper (Stark verkratzt) - Deformed - Replace

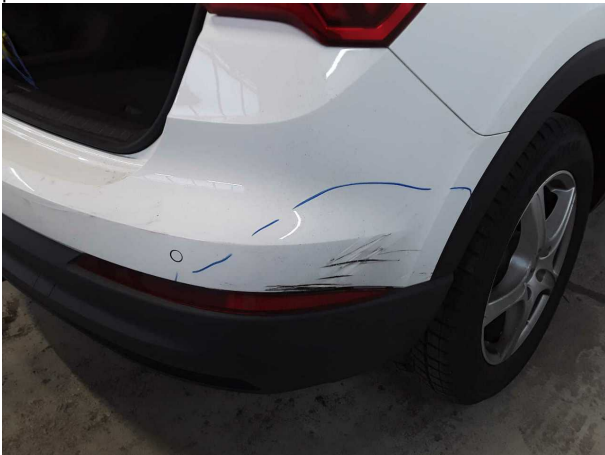
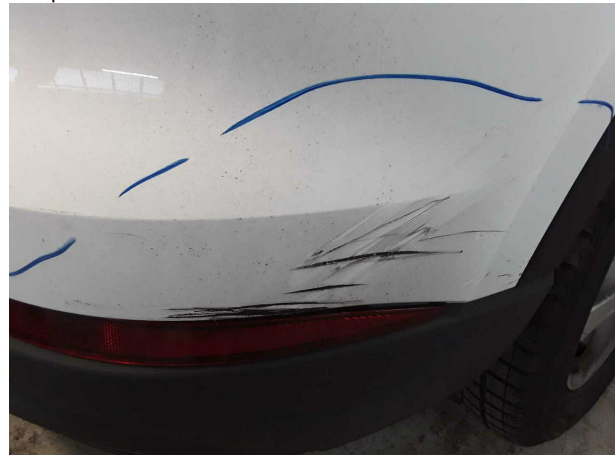
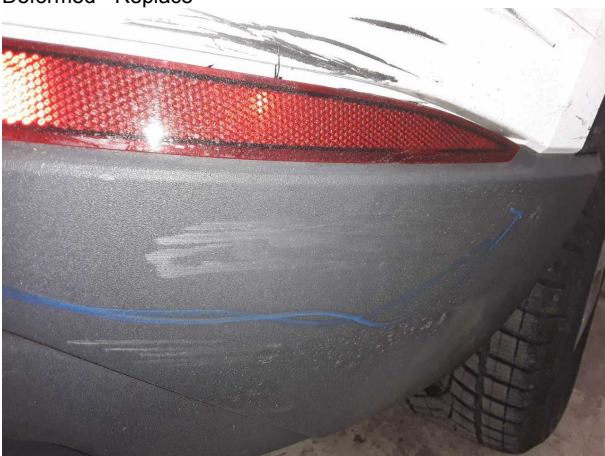
Damage #3: Rear bumper: Rear bumper (Stark verkratzt) - Deformed - Replace
