**WAUZZZGB6LR040511**

## Zustandsbericht

Inspection date: 25 Feb 2025  
**Protocol number: 38566199**  
Delivery date: 25 Feb 2025

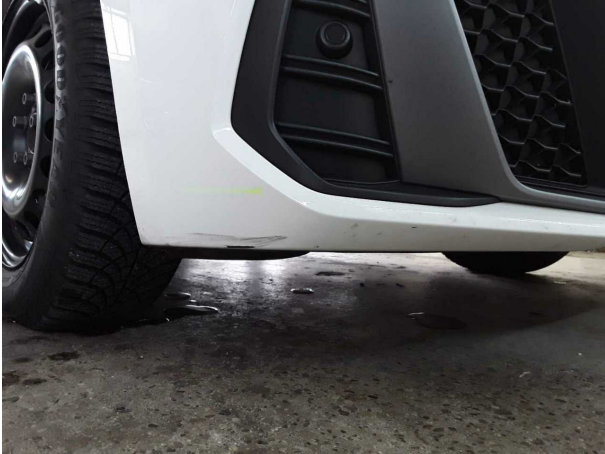
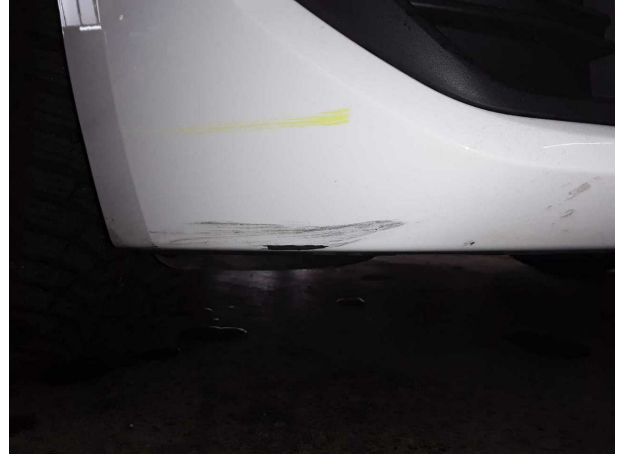
**Damage #2:** Front bumper: Front bumper - Scratch(es) - Smart repair

No.	Component group	Description
1	Documents	Service book - No evidence
2	Front bumper	Front bumper - Scratch(es) - Smart repair
3	Equipment	Vehicle key (1 von 2 fehlt) - Replace
4	2nd wheel set	Tyres - complete set (Sommerradsatz fehlt) - Replace
