WAUZZZF26MN052345

Zustandsbericht

Inspection date: 26 Feb 2025
Protocol number: 38597071
Delivery date: 26 Feb 2025

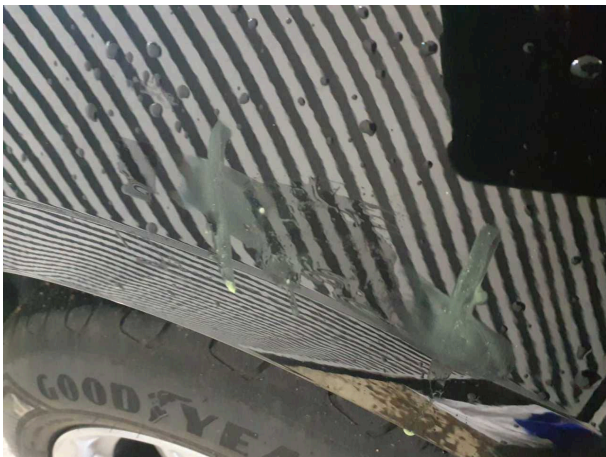
Damage #2: Side panel - rear right side: Side panel - Scratch...
- Paint

Damage #2: Side panel - rear right side: Side panel - Scratched -
Paint

No.	Component group	Description
1	Misc.	Inspection / maintenance - Due - Replace
2	Side panel - rear right side	Side panel - Scratched - Paint
3	Front bumper	Front bumper - Scratched - Repair and paint
4	Door - front left side	Door - Dent / paintcoat damage - Repair and paint

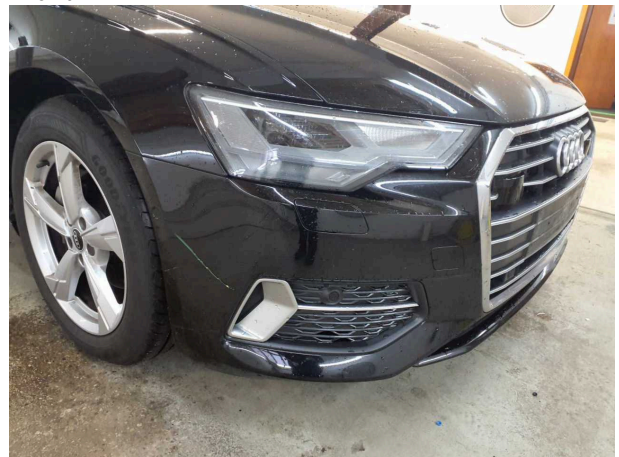
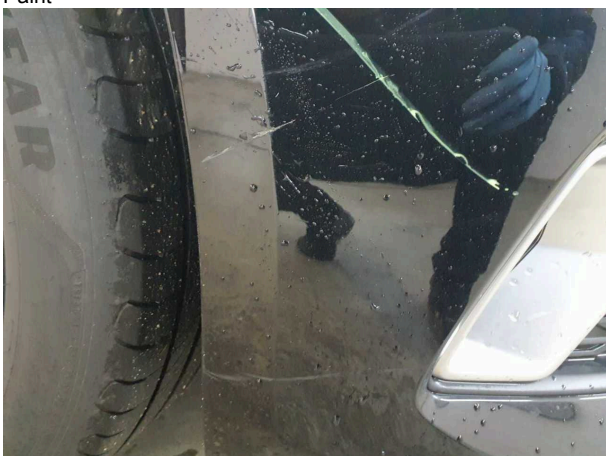
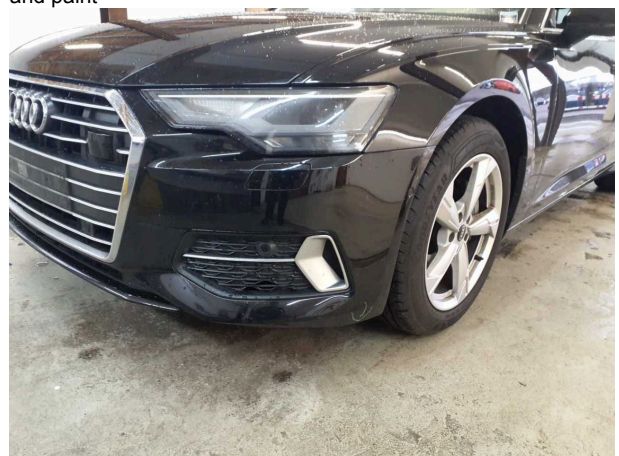
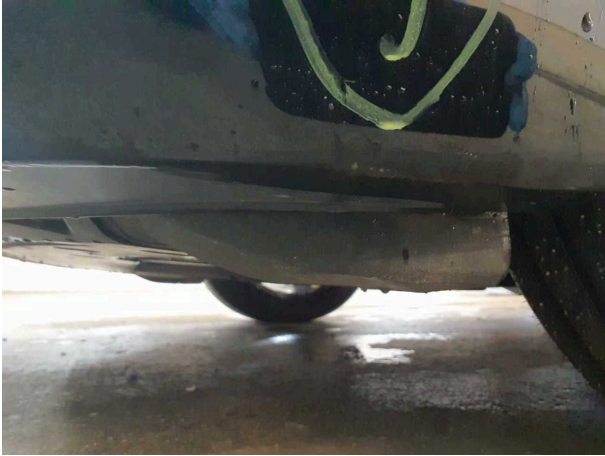
Damage #3: Front bumper: Front bumper - Scratched - Repair
and paint

Damage #3: Front bumper: Front bumper - Scratched - Repair and paint

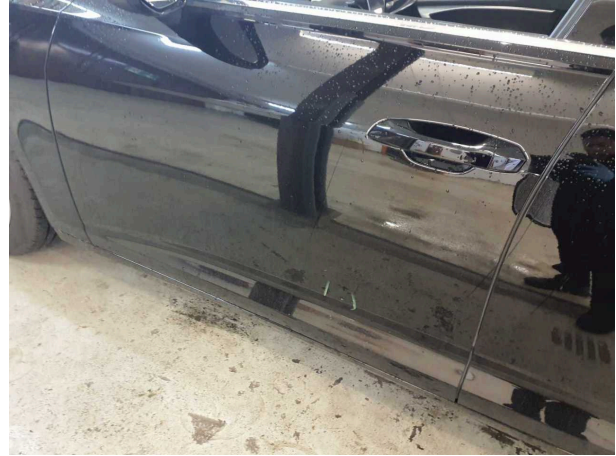
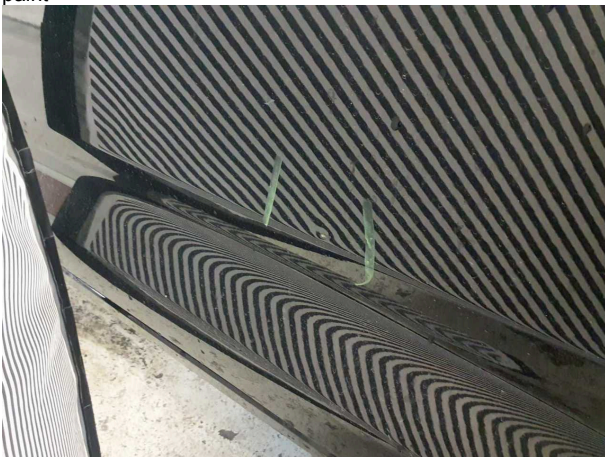
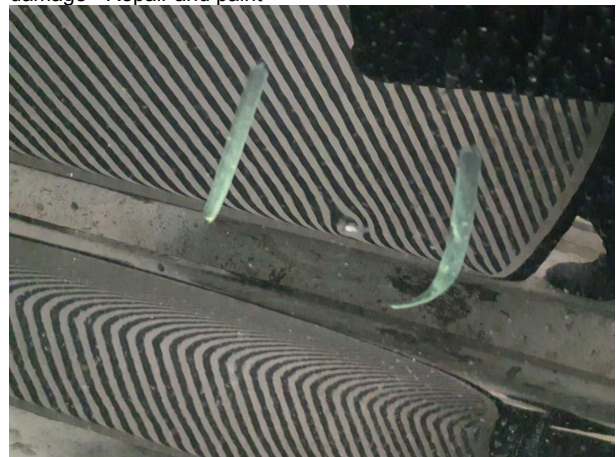
Damage #4: Door - front left side: Door - Dent / paintcoat damage - Repair and paint
