Operator		Inspection condition	conditional: light/moisture/dirt
License number		Mileage (Read)	89,529 km
Manufacturer	Audi	Next maintenance in	531 Tag(e)
Type / Model	Q5 50 TFSI e	Main inspection (Read from ZBI)	12/2025
Vehicle Identification number	WAUZZZFY0L2113628	Power / Engine displacement	185 kW / 1,984 ccm
First registration	29 Oct 2020	Upholstery/Colour	/
Last maintenance		Paintwork	
Fuel type	Hybr.B/E ext. edition	Gearbox	Automatic

Zustandsbericht

Inspection date: 26 Feb 2025
Protocol number: 38585259
Delivery date: 26 Feb 2025

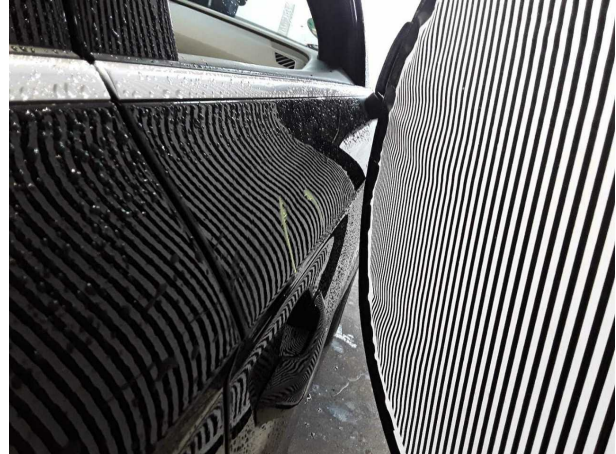
No.	Component group	Description
1	Documents	Service book - No evidence
2	Door - front right side	Door - dent(s) - Smooth repair work
3	Instrument panel	Glove box lid (Schwergängig) - Un- / install

Damage #2: Door - front right side: Door - dent(s) - Smooth repair work
