**WBA81CY030FN56576**

## Vehicle details

## Zustandsbericht

Inspection date: 31 Jan 2024  
**Protocol number: 38875210**  
Delivery date: 17 Mar 2025

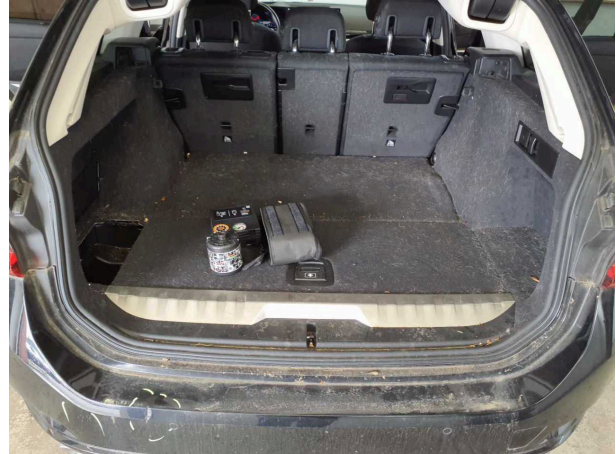
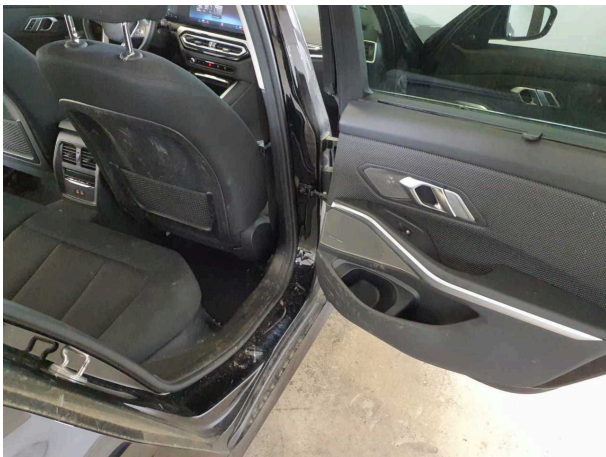
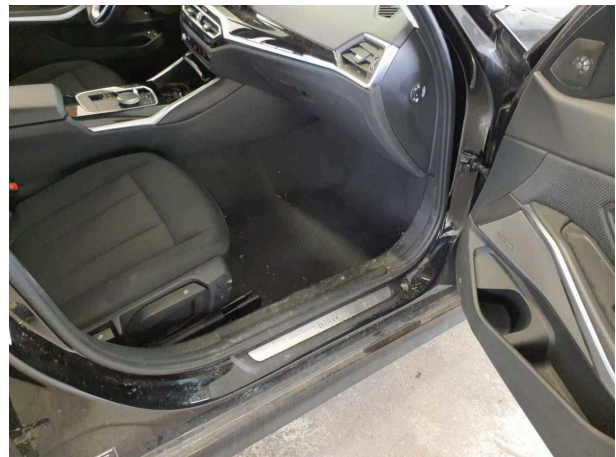
Damage #3: Interior: Interior - Soiled - Clean

| No. | Component group | Description |
|---|---|--|
| 3 | Interior | Interior - Soiled - Clean |

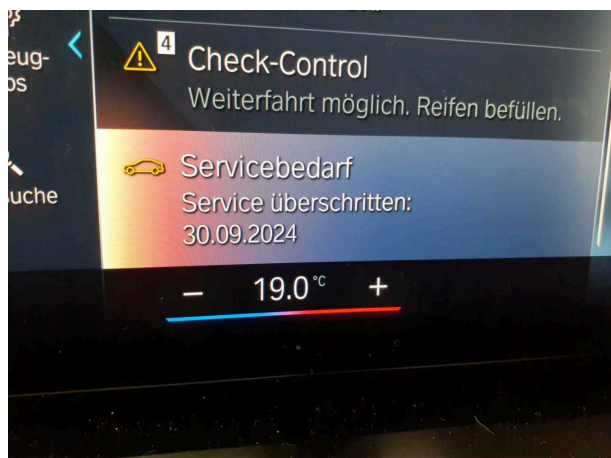
Damage #4: Misc.: Inspection / maintenance - Due - Perform

| No. | Component group | Description |
|---|---|--|
| 4 | Misc. | Inspection / maintenance - Due - Perform |

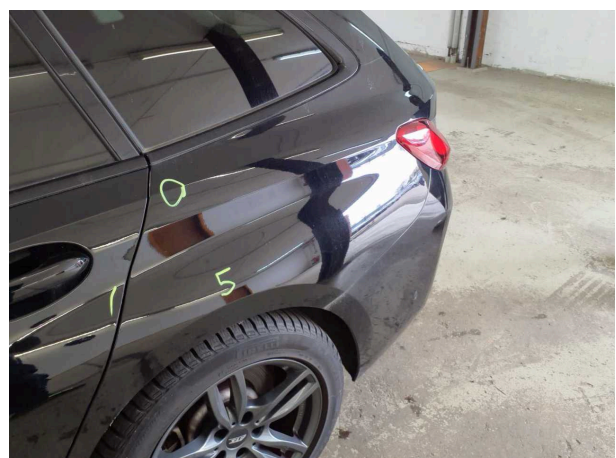
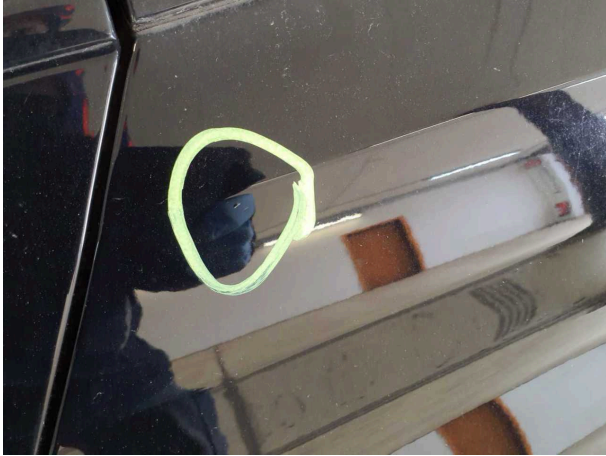
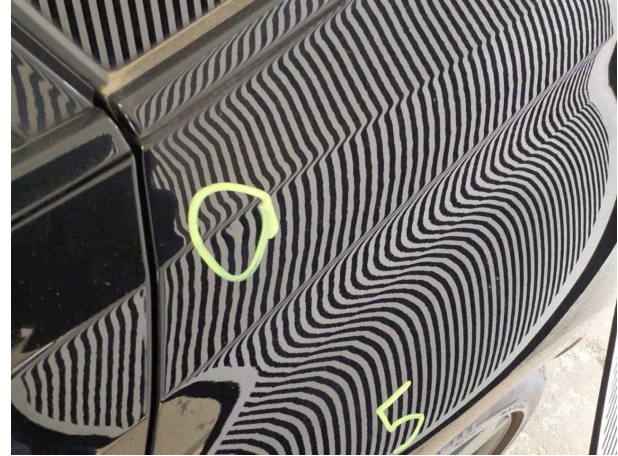
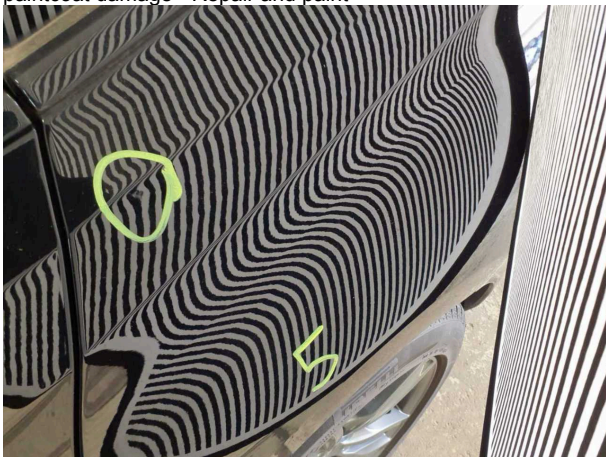
Damage #5: Side panel - rear left side: Side panel - Dent / paintcoat damage - Repair and paint

**Damage #5:** Side panel - rear left side: Side panel - Dent / paintcoat damage - Repair and paint

| No. | Component group | Description |
|---|---|--|
| 5 | Side panel - rear left side | Side panel - Dent / paintcoat damage - Repair and paint |

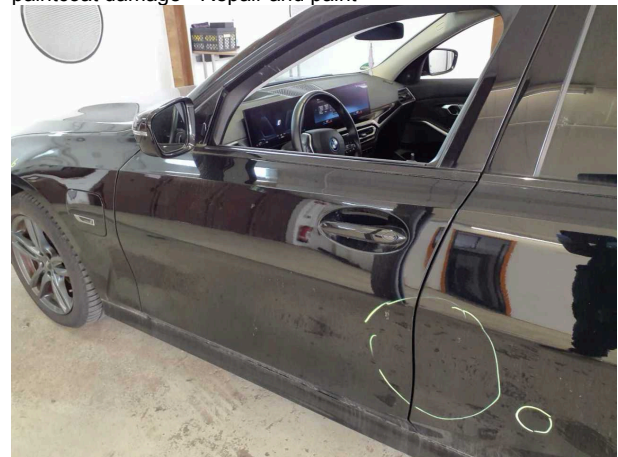
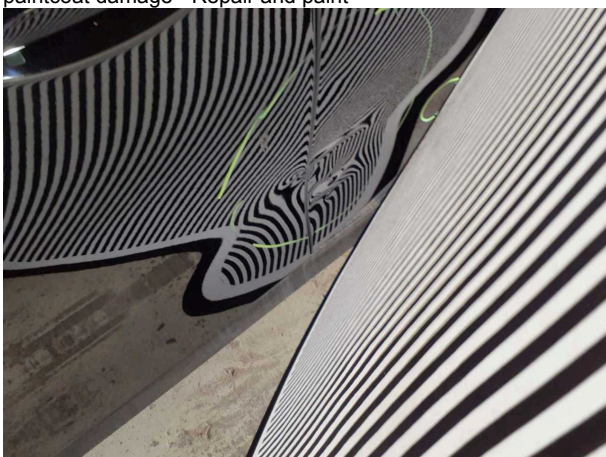
**Damage #6:** Door - front left side: Door - Dent / paintcoat damage - Repair and paint

| No. | Component group | Description |
|---|---|--|
| 6 | Door - front left side | Door - Dent / paintcoat damage - Repair and paint |

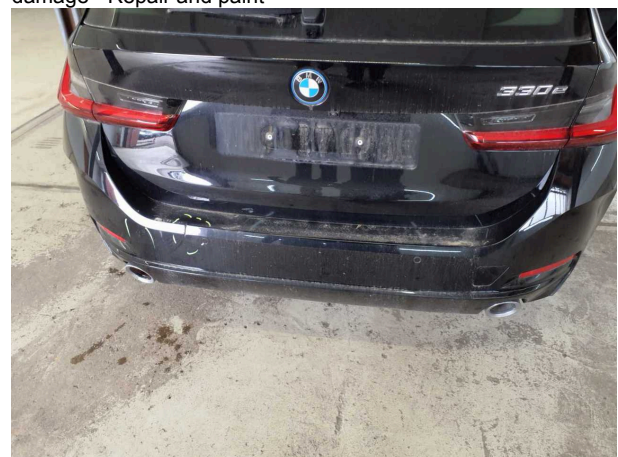
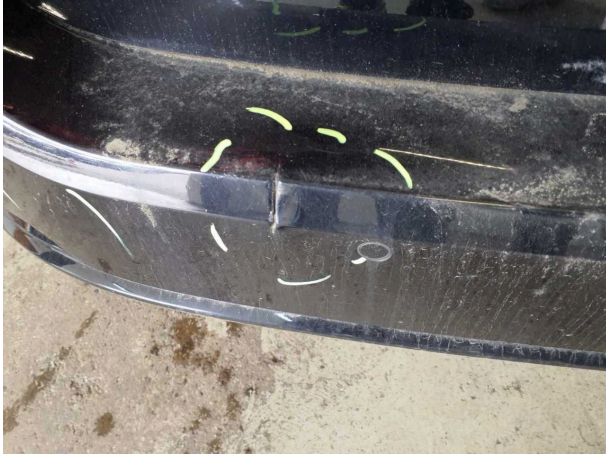
**Damage #7:** Rear bumper: Rear bumper - Dent / paintcoat damage - Replace

**Damage #7:** Rear bumper: Rear bumper - Dent / paintcoat dama...  
- Replace

| No. | Component group | Description |
|---|---|--|
| 7 | Rear bumper | Rear bumper - Dent / paintcoat damage - Replace |

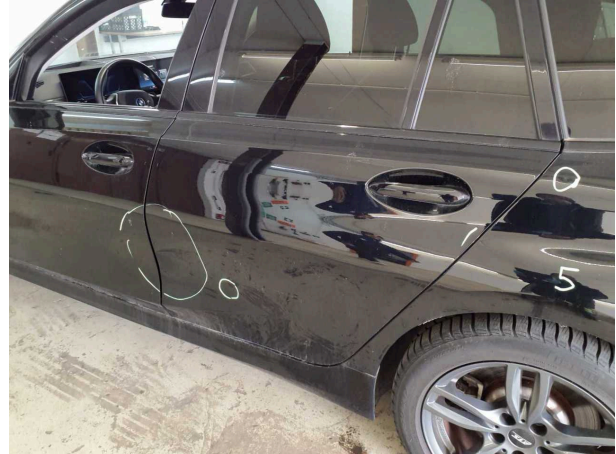
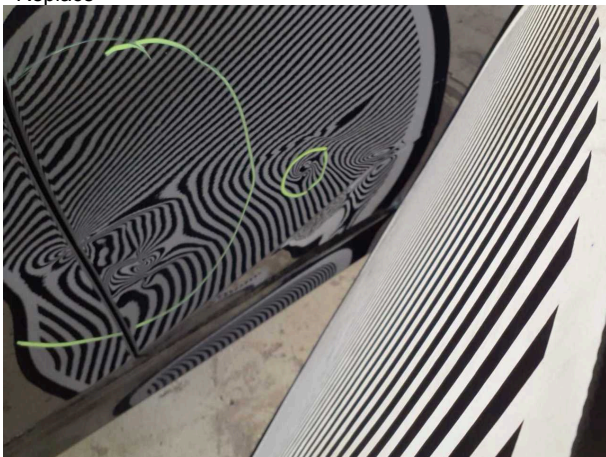
**Damage #8:** Door - rear left side: Door - Deformed - Replace

| No. | Component group | Description |
|---|---|--|
| 8 | Door - rear left side | Door - Deformed - Replace |
