Operator		Inspection condition	Sufficient
License number		Mileage (Read)	11,494 km
Manufacturer	Audi	Next maintenance in	16 Monat(e)
Type / Model	Q4 45 e-tron	Main inspection (Read from ZBI)	08/2027
Vehicle Identification number	WAUZZZFZ2RP087893	Power / Engine displacement	89 kW
First registration	7 Aug 2024	Upholstery/Colour	/
Last maintenance		Paintwork	
Fuel type	Electric	Gearbox	Automatic

Zustandsbericht

Inspection date: 17 Mar 2025
Protocol number: 38890309
Delivery date: 17 Mar 2025

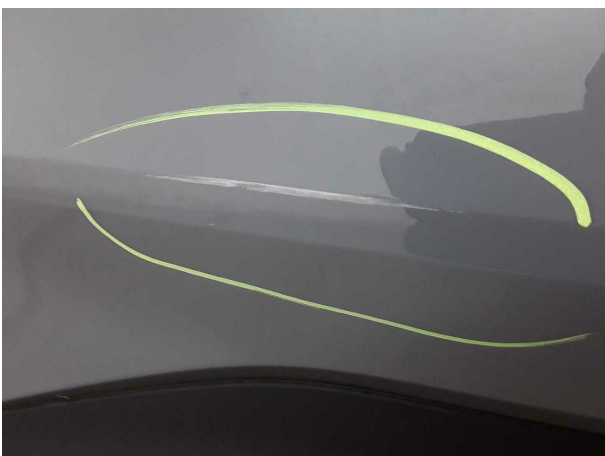
Damage #3: Door - rear right side: Door - Scratched - Paint

No.	Component group	Description
1	Interior	Office bag (Fehlt) - Replace
2	Front bumper	Front bumper - Scratched - Paint
3	Door - rear right side	Door - Scratched - Paint
