**WBA35BG080N080647**

## Zustandsbericht

**TÜV SÜD Auto Plus GmbH**  
Gutenbergstr. 13  
70771 Leinfelden-Echterdingen

**Protocol number:** 38801337

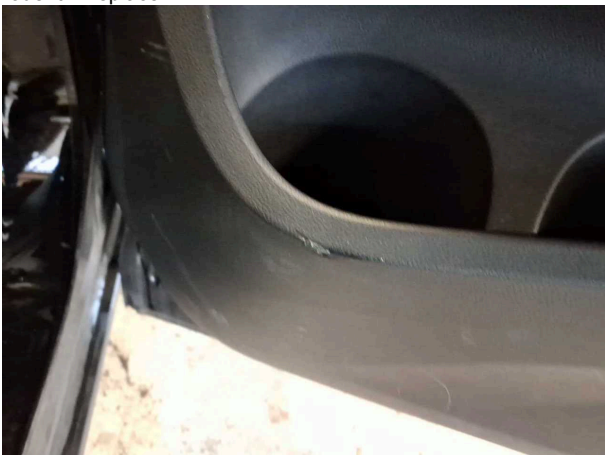
**Damage #3:** Trim / covers: Door trim - rear right side -  
Scratched - Loss in value

**Damage #3:** Trim / covers: Door trim - rear right side - Scratched -  
Loss in value

No.	Component group	Description
1	Door - front right side	Door - Scratch(es) - Cover / polish
2	Bonnet	Insulation lining - Damage caused by marten / rodent - Replace
3	Trim / covers	Door trim - rear right side - Scratched - Loss in value
