WBAJX21050BU93296

## Zustandsbericht

Inspection date: 28 Jun 2024

**Protocol number:** 34599455

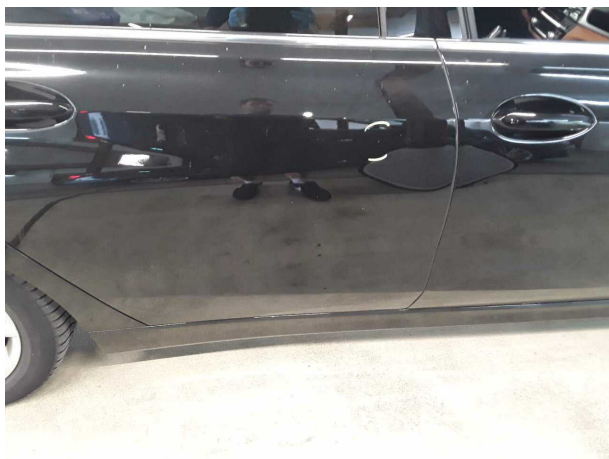
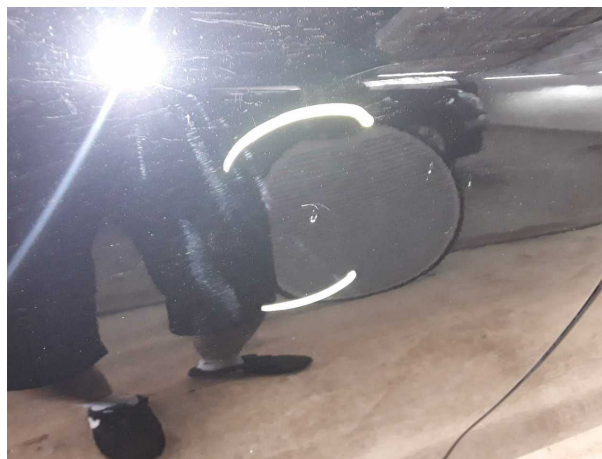
| No. | Component group | Description |
|---|---|---|
| 1 | Door - rear right side | Door - Scratch(es) - Cover / polish |

**Damage #1:** Door - rear right side: Door - Scratch(es) - Cover / polish

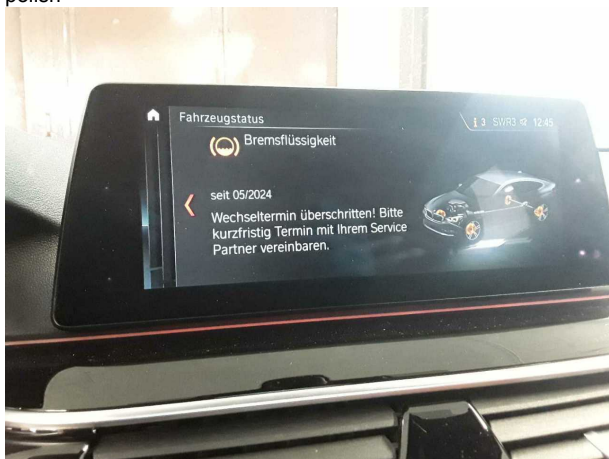
| No. | Component group | Description |
|---|---|---|
| 2 | Braking system | Brake fluid - Due - Replace |

**Damage #2:** Braking system: Brake fluid - Due - Replace

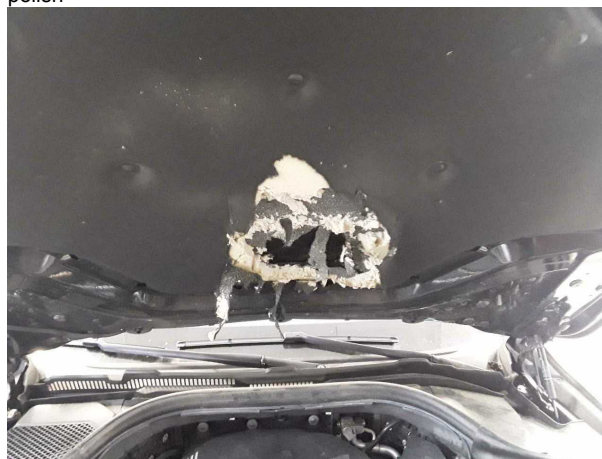
| No. | Component group | Description |
|---|---|---|
| 4 | Bonnet | Insulation lining - Damage caused by marten / rodent - Replace |

**Damage #4:** Bonnet: Insulation lining - Damage caused by marten / rodent - Replace

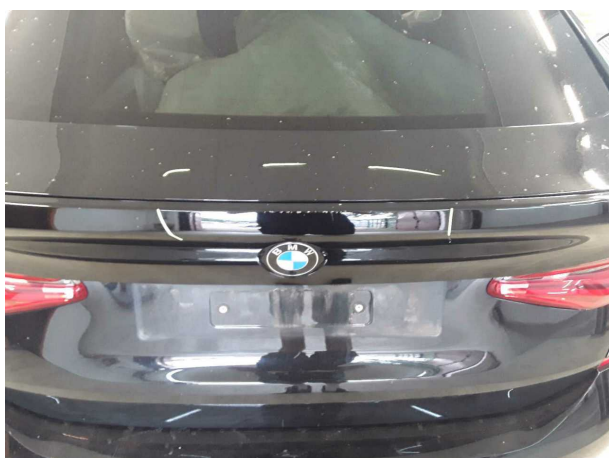
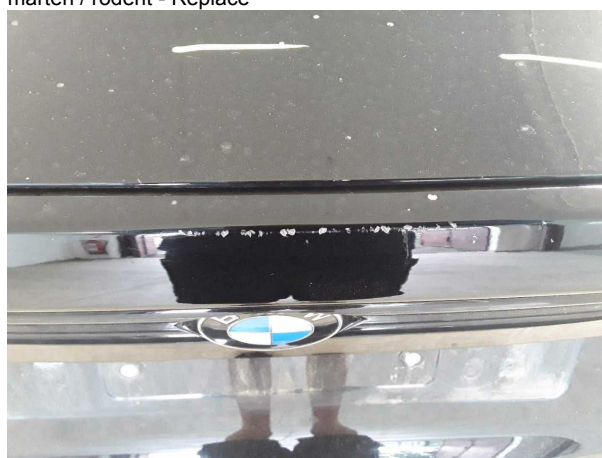
| No. | Component group | Description |
|---|---|---|
| 5 | Boot lid / rear door | Boot lid - Scratched - Smart repair |

**Damage #5:** Boot lid / rear door: Boot lid - Scratched - Smart repair

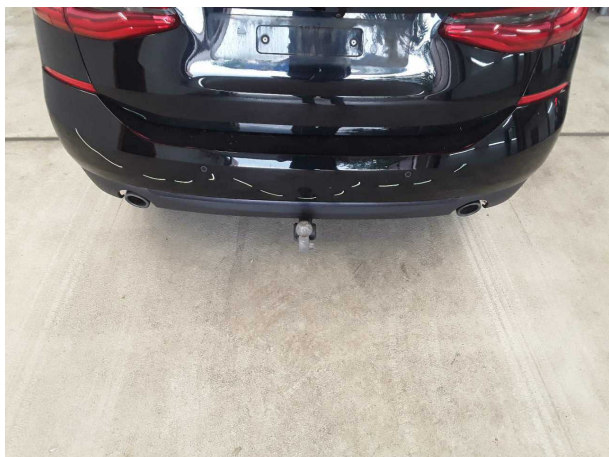
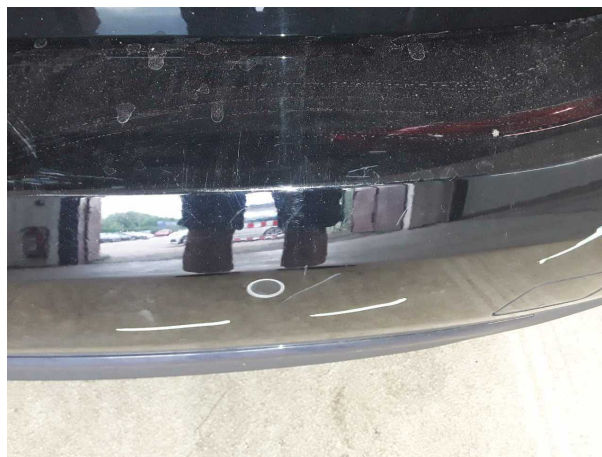
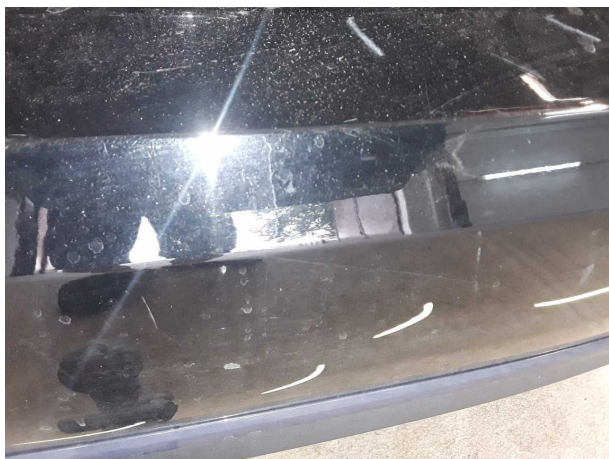
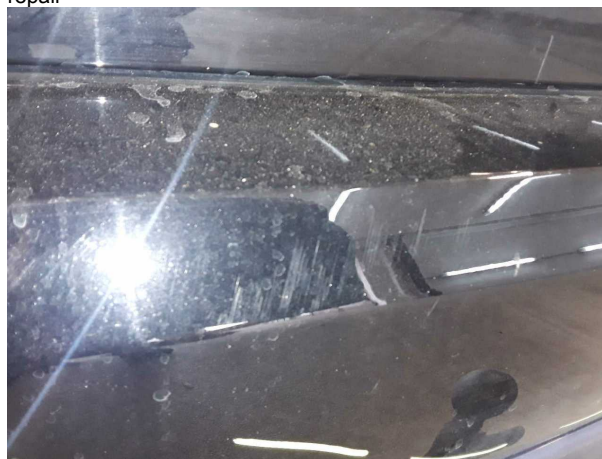
| No. | Component group | Description |
|---|---|---|
| 6 | Rear bumper | Rear bumper - Scratched - Smart repair |

**Damage #6:** Rear bumper: Rear bumper - Scratched - Smart repair

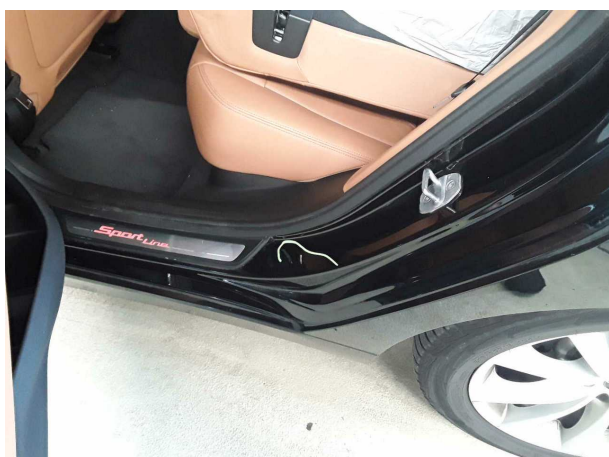
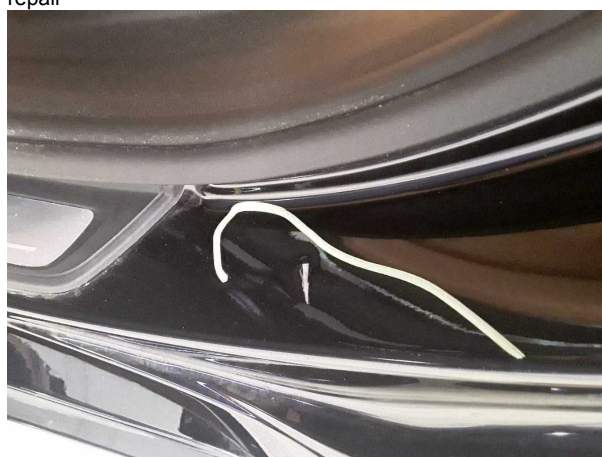
| No. | Component group | Description |
|---|---|---|
| 7 | Side panel - rear left side | Sill - Scratched - Smart repair |

**Damage #7:** Side panel - rear left side: Sill - Scratched - Smart repair

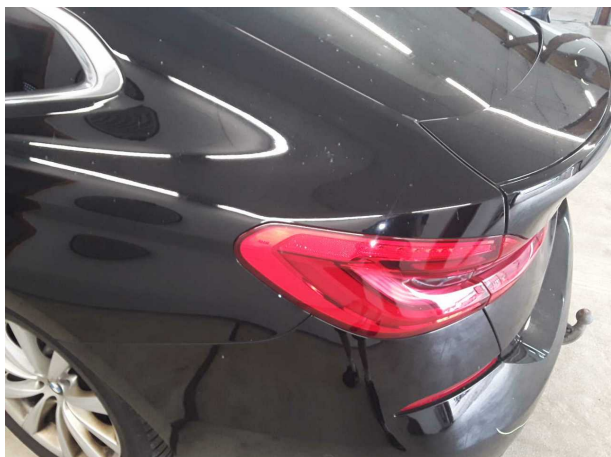
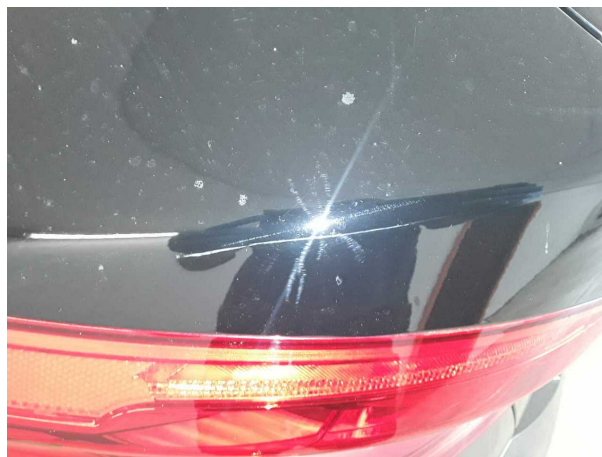
| No. | Component group | Description |
|---|---|---|
| 8 | Side panel - rear left side | Side panel - Scratch(es) - Smart repair |

**Damage #8:** Side panel - rear left side: Side panel - Scratch(es) - Smart repair

**Damage #8:** Side panel - rear left side: Side panel - Scratch(...  
- Smart repair

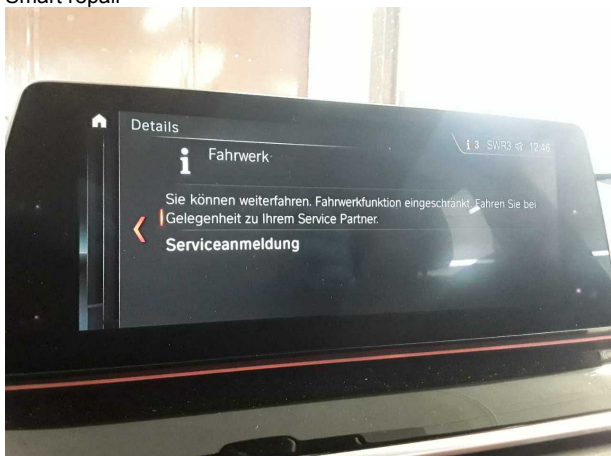
| No. | Component group | Description |
|---|---|---|
| 10 | Front axle | Air suspension compressor - Specify findings - Perform diagnosis |

**Damage #10:** Front axle: Air suspension compressor - Specify findings - Perform diagnosis

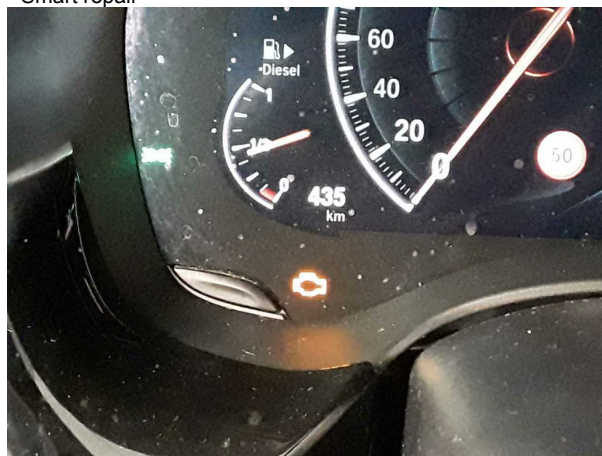
| No. | Component group | Description |
|---|---|---|
| 11 | Instrument panel | Indicator light (MIL Brennt) - Specify findings - Perform diagnosis |

**Damage #11:** Instrument panel: Indicator light (MIL Brennt) - Specify findings - Perform diagnosis

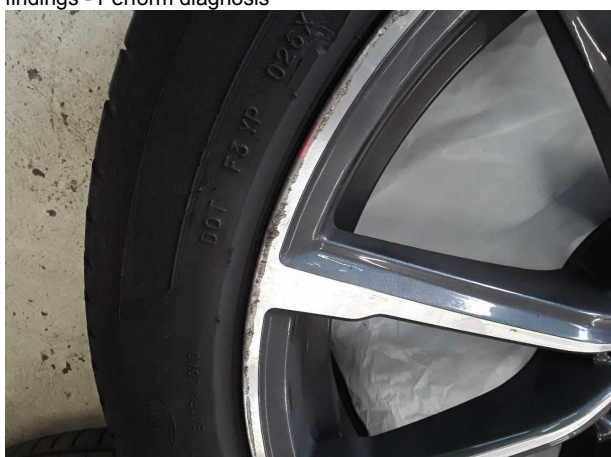
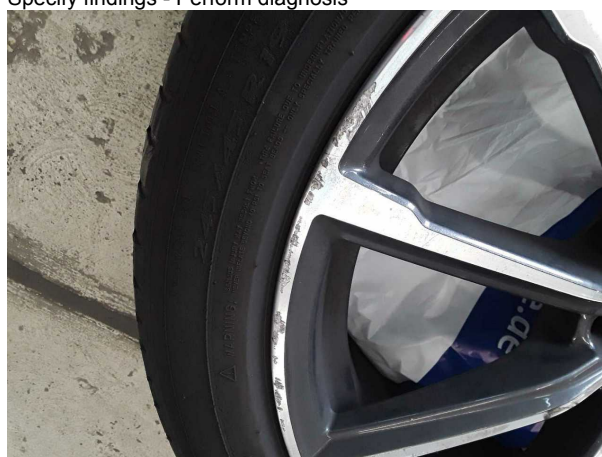
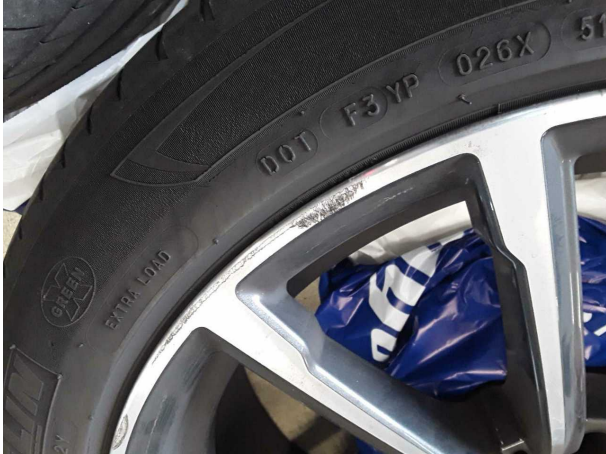
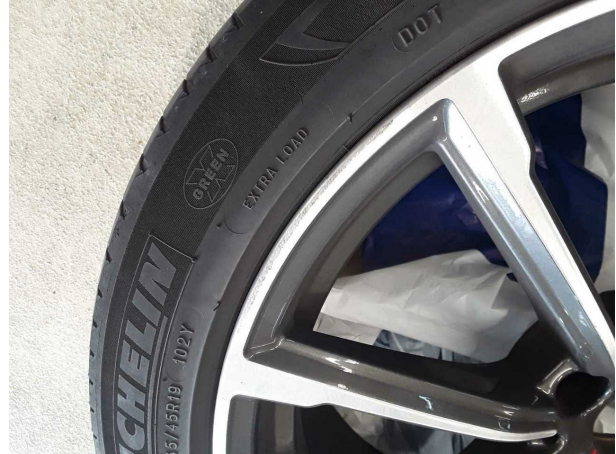
| No. | Component group | Description |
|---|---|---|
| 12 | 2nd wheel set | Alloy rim set - complete - Scratched - Loss in value |

**Damage #12:** 2nd wheel set: Alloy rim set - complete - Scratched - Loss in value
