TÜV SÜD Auto Plus GmbH  
Gutenbergstr. 13  
70771 Leinfelden-Echterdingen

Inspection date: 11 Nov 2024  
**Protocol number:** 36944128  
Created by: Gerd Bierschenk  
Mohamad Jamen  
Inspected by: Mudrek

**WBA31ED070FL89683**

## Zustandsbericht

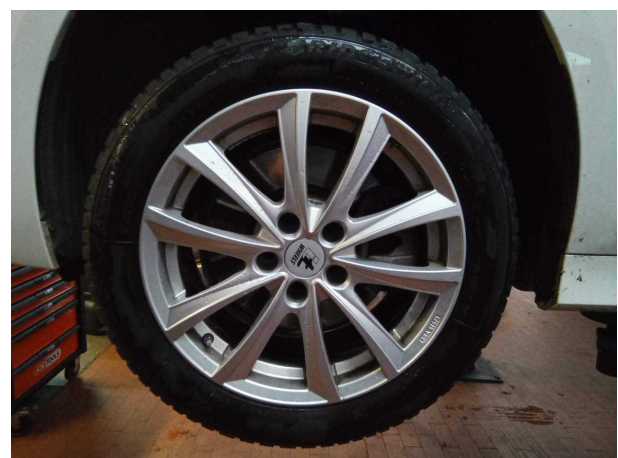
Figure 6: Mounted tyres

| Axle | Tyre size | Manufacturer | Type of tyre | Tread depth | Roadworthy | Permissibility |
|---|---|---|---|---|---|---|
| 1 | 225/50 R17 98V | Bridgestone | Winter tires (with run-flat tires) | 6mm - 6mm | o.k. | o.k. |
| 2 | 225/50 R17 98V | Bridgestone | Winter tires (with run-flat tires) | 6mm - 6mm | o.k. | o.k. |

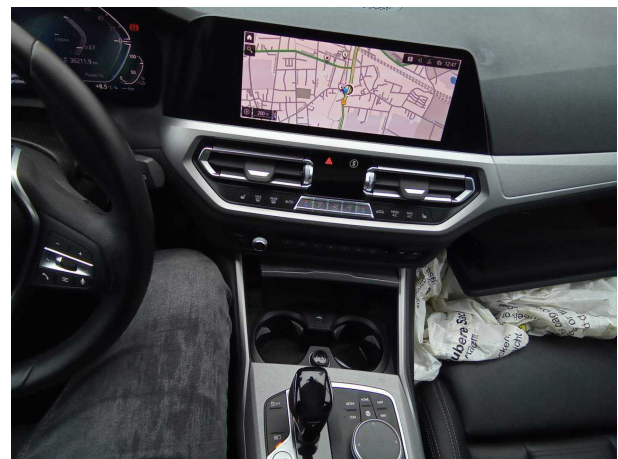
**Figure 10:** Instrument panel

| No. | Component group | Description |
|---|---|---|
| 3 | Instrument panel | Indicator light (AHK) - on - Diagnosed and repair if necessary |

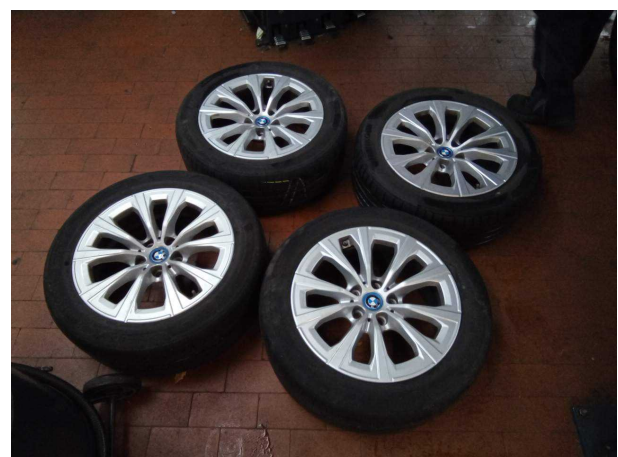
**Figure 12:** Additional tyres

| Axle | Tyre size | Manufacturer | Type of tyre | Tread depth | Roadworthy | Permissibility |
|---|---|---|---|---|---|---|
| 1 | 225/50 R17 98Y | Hankook | Summer tires (with run-flat tires) | 5mm - 5mm | o.k. | o.k. |
| 2 | 225/50 R17 98Y | Hankook | Summer tires (with run-flat tires) | 5mm - 5mm | o.k. | o.k. |

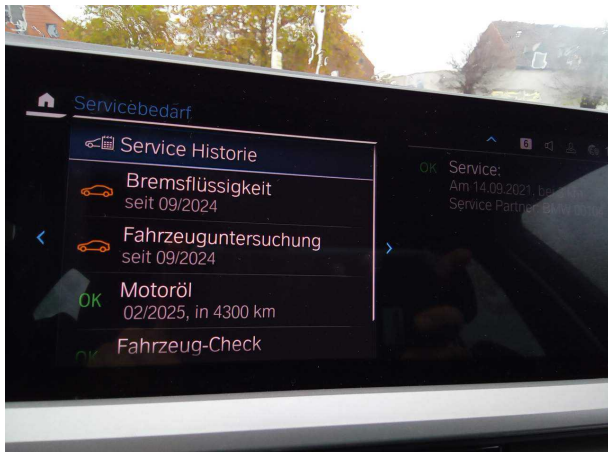
| No. | Component group | Description |
|---|---|---|
| 1 | Braking system | Brake fluid - Due - Replace |

**Damage #1:** Braking system: Brake fluid - Due - Replace

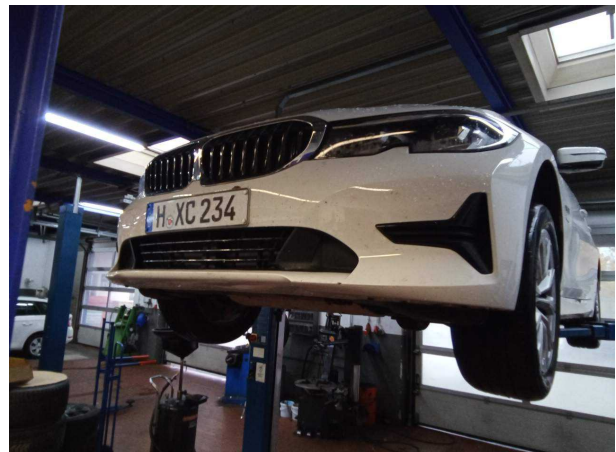
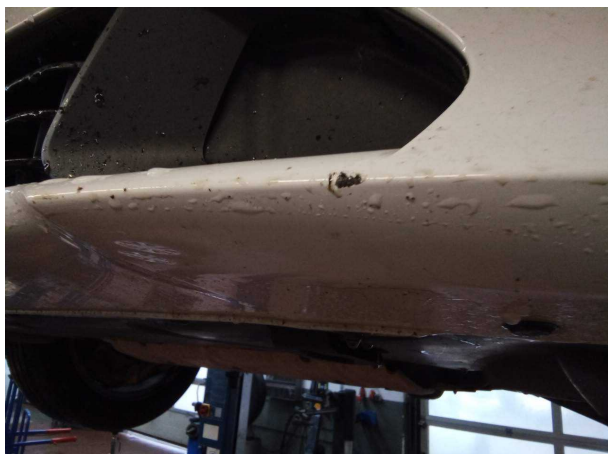
| No. | Component group | Description |
|---|---|---|
| 2 | Front bumper | Front bumper - Scratch(es) - Smart repair |

**Damage #2:** Front bumper: Front bumper - Scratch(es) - Smart repair

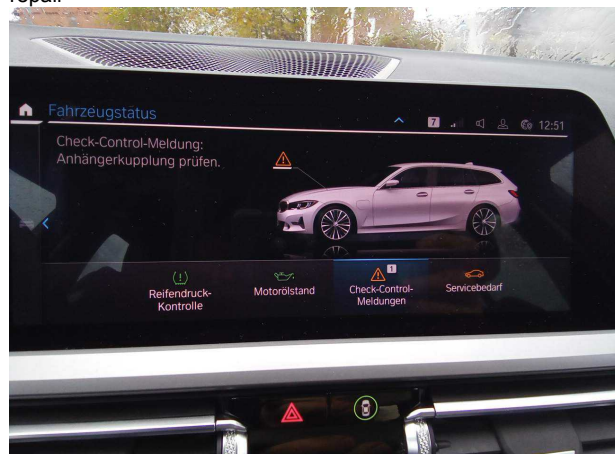
**Damage #3:** Instrument panel: Indicator light (AHK) - on - Diagnosed and repair if necessary

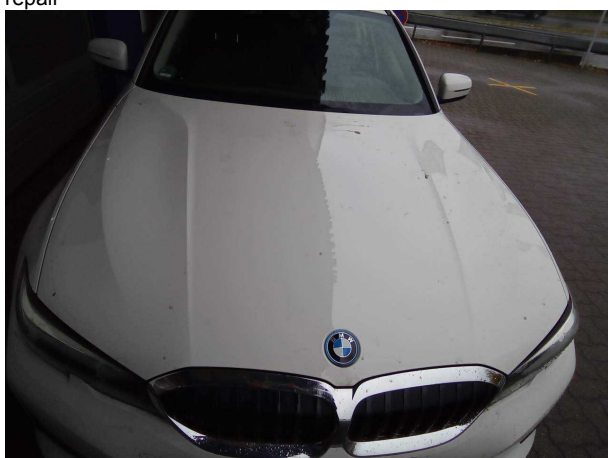
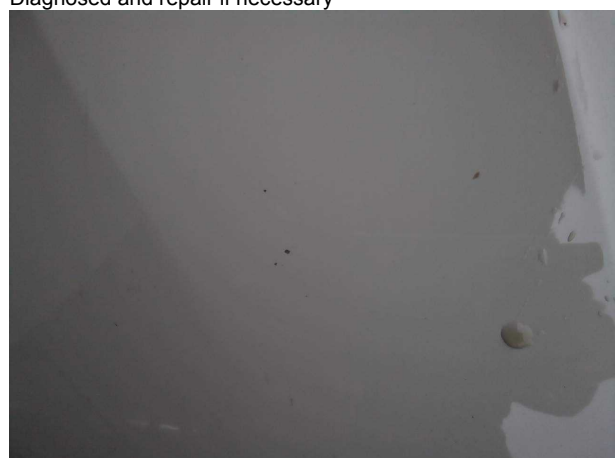
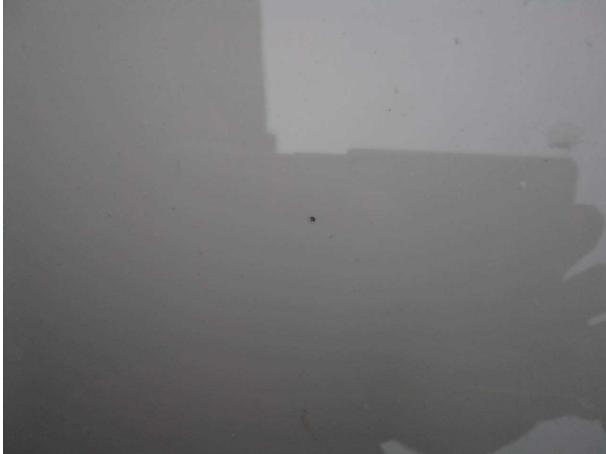
| No. | Component group | Description |
|---|---|---|
| 4 | Bonnet | Bonnet - Stone chips - Smart repair |

**Damage #4:** Bonnet: Bonnet - Stone chips - Smart repair

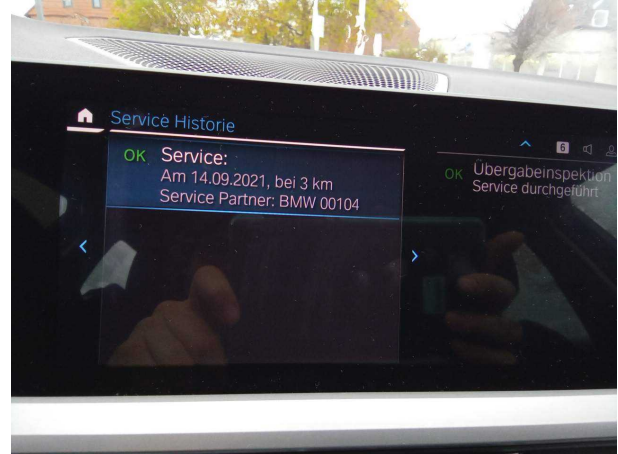
| No. | Component group | Description |
|---|---|---|
| 5 | Misc. | Inspection / maintenance (Digitale Serviceberichte fehlen, 24 Monate/30000 km) - No evidence - Loss in value |

**Damage #5:** Misc.: Inspection / maintenance (Digitale Serviceberichte fehlen, 24 Monate/30000 km) - No evidence -

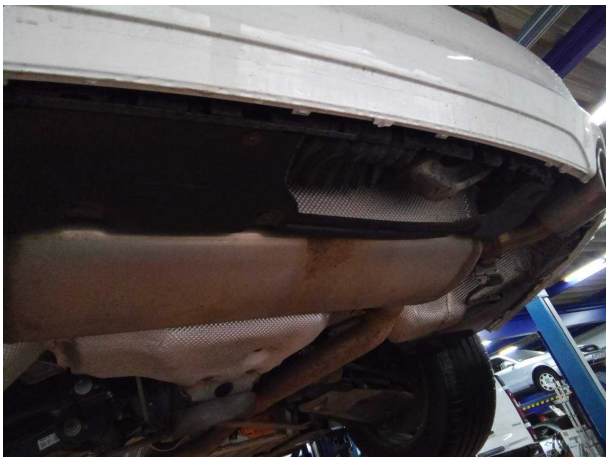
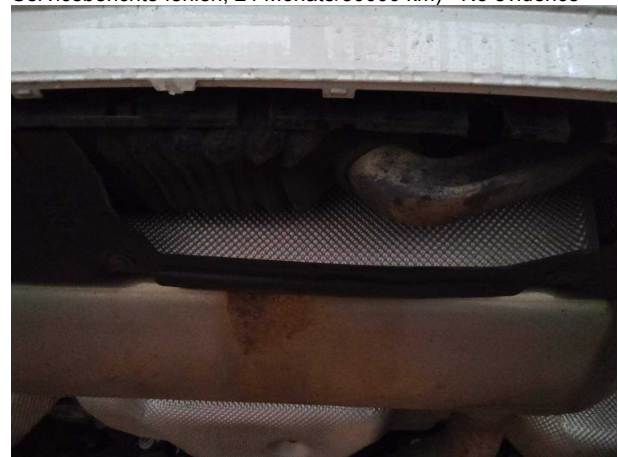
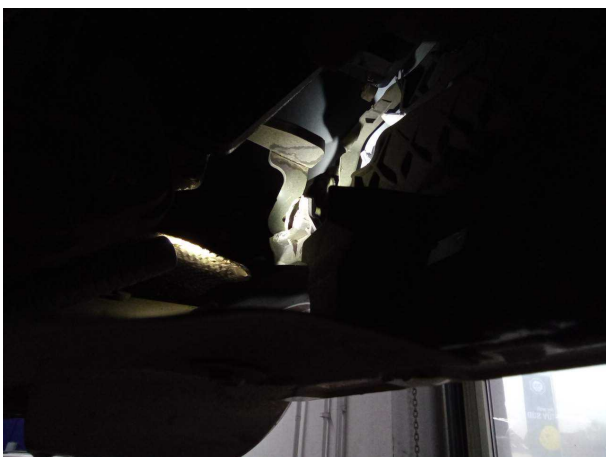
| No. | Component group | Description |
|---|---|---|
| 6 | Body | Underbody panelling - Broken / torn - Replace |

**Damage #6:** Body: Underbody panelling - Broken / torn - Replace

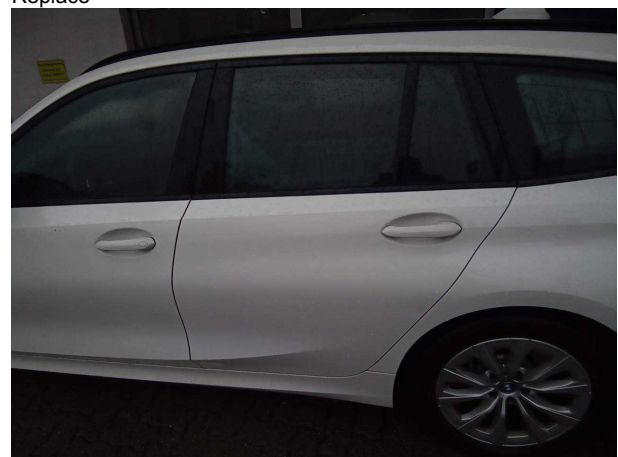
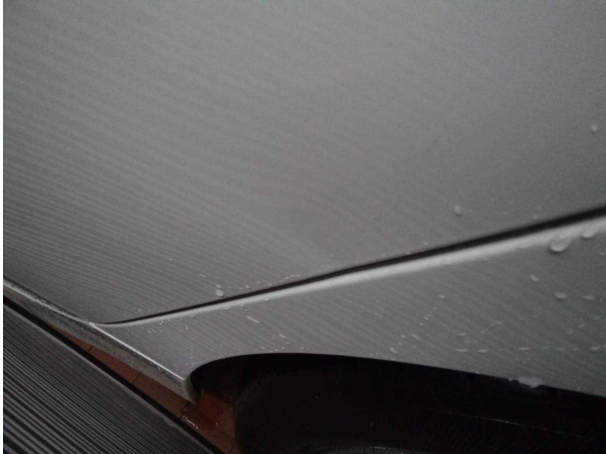
| No. | Component group | Description |
|---|---|---|
| 7 | Door - rear left side | Door - Dent / paintcoat damage - Repair and paint |

**Damage #7:** Door - rear left side: Door - Dent / paintcoat damage - Repair and paint

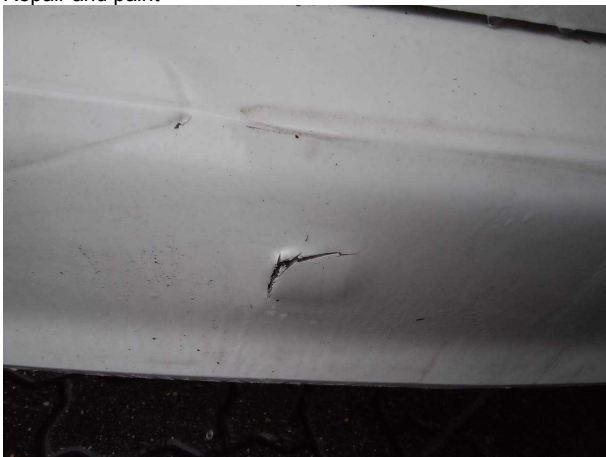
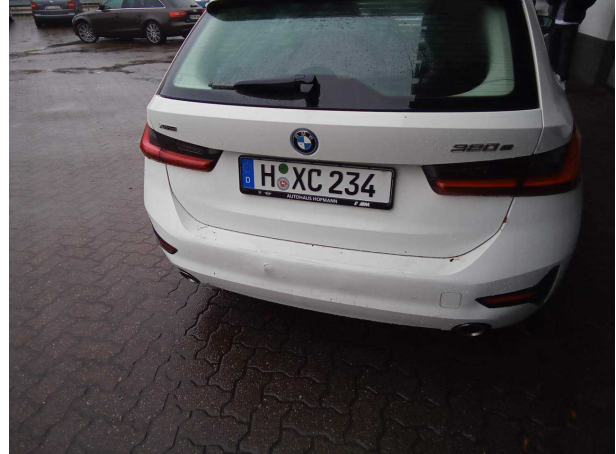
| No. | Component group | Description |
|---|---|---|
| 8 | Rear bumper | Rear bumper - Broken / torn - Replace |

**Damage #8:** Rear bumper: Rear bumper - Broken / torn - Replace
