**WAUZZZFZ5RP054743**

## Zustandsbericht

Inspection date: 19 Mar 2025  
**Protocol number: 38918057**  
Delivery date: 19 Mar 2025

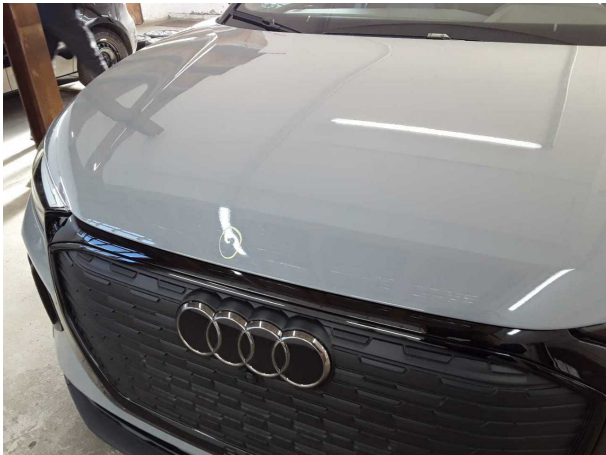
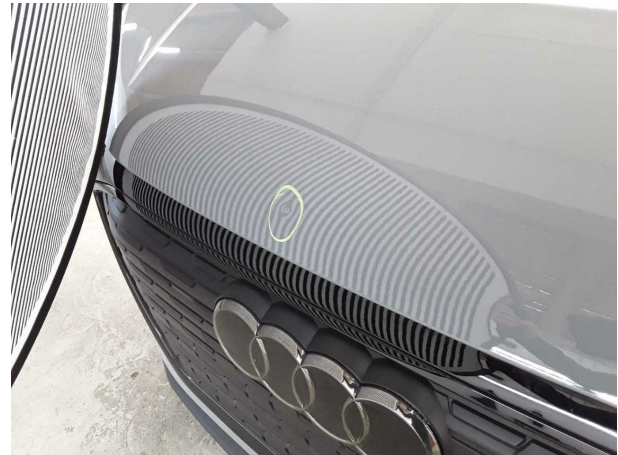
| No. | Component group | Description |
|---|---|---|
| 3 | Bonnet | Bonnet - Dent / paintcoat damage - Repair and paint |

**Damage #3:** Bonnet: Bonnet - Dent / paintcoat damage - Repair and paint
