WBA71AB0105U50061

Operator		Inspection condition	Sufficient
License number		Mileage (Read)	56,049 km
Manufacturer	BMW	Next maintenance in	5 Monat(e)
Type / Model	X1 xDrive25e Advantage Steptronic Sports Utility Vehicle5-türig 1499 ccm 220 PS / 162 KW Elektrisch 6-Gang Automatik	Main inspection	
Vehicle Identification number	WBA71AB0105U50061	Power / Engine displacement	/ 1,499 ccm
First registration	10 Dec 2021	Upholstery/Colour	Cloth / leather combination / Black-Brown
Last maintenance		Paintwork	Grey
Fuel type	Hybrid Petrol / E	Gearbox	Automatic

Zustandsbericht

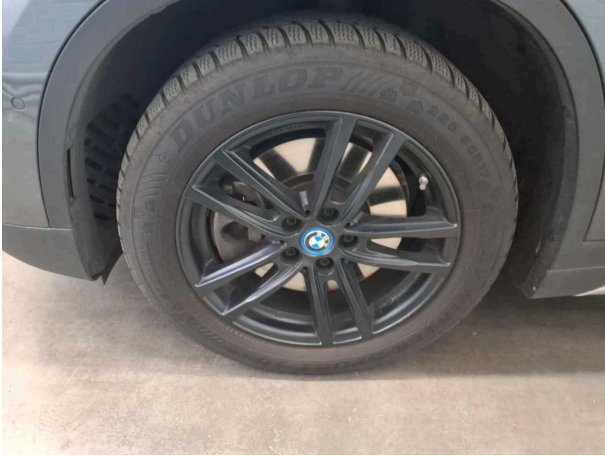
Axle	Tyre size	Manufacturer	Type of tyre	Tread depth	Roadworthy	Permissibility
1	225/55 R17 97H	Dunlop	Winter tyres	4mm - 4mm	o.k.	o.k.
2	225/55 R17 97H	Dunlop	Winter tyres	4mm - 4mm	o.k.	o.k.

Figure 19: Mounted tyres

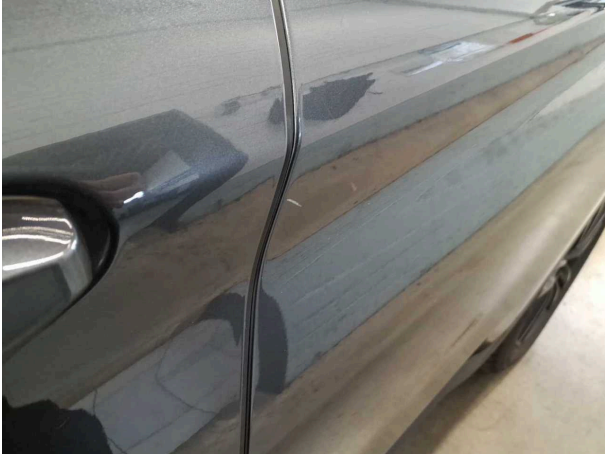
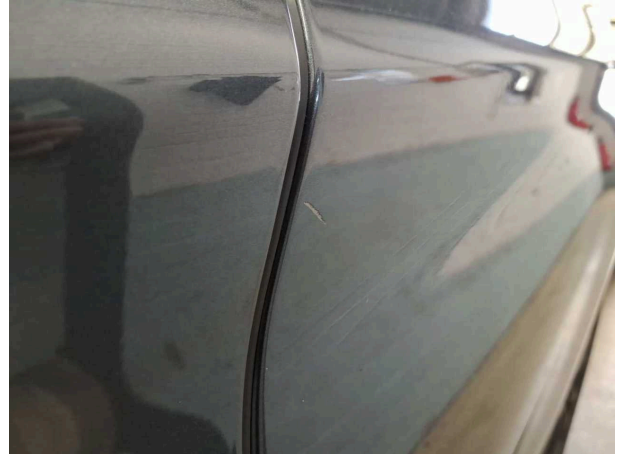
No.	Component group	Description
1	Door - rear left side	Door - Scratched - Smart repair
2	Door - front left side	Door edge - Scratched - Smart repair
3	Vehicle glazing	Windscreen - Stone chips - Replace

Damage #1: Door - rear left side: Door - Scratched - Smart repair

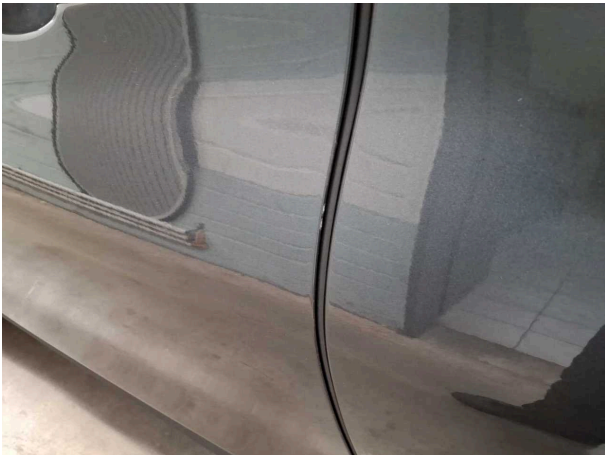
Damage #2: Door - front left side: Door edge - Scratched - Smart repair

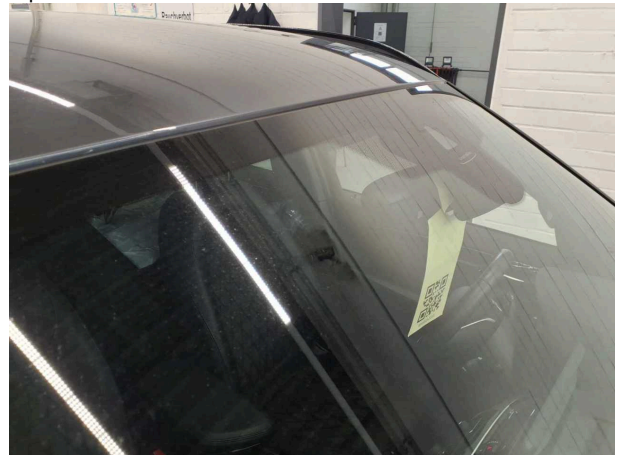
Damage #3: Vehicle glazing: Windscreen - Stone chips - Replace
