WAUZZZF44RA010448

## Zustandsbericht

Inspection date: 18 Mar 2025

**Protocol number:** 38937246

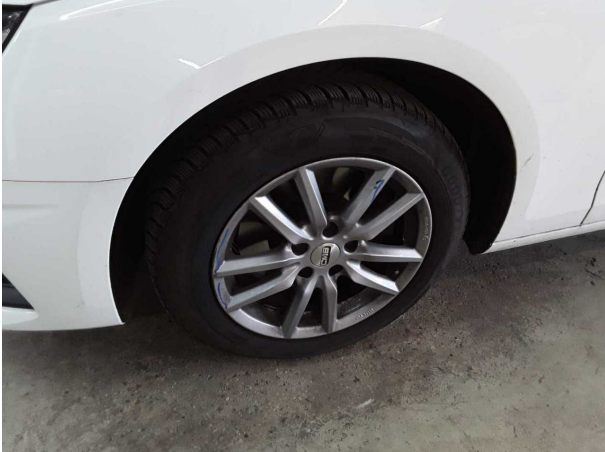
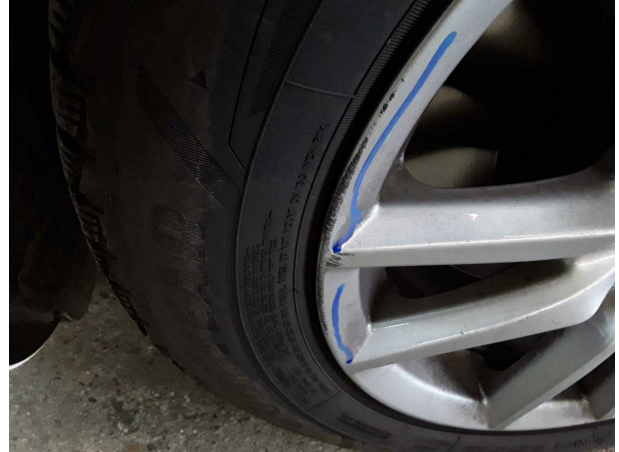
No.	Component group	Description
1	Wheel / tyres	Alloy rim - front left side - Scratched - Loss in value
2	Misc.	Inspection / maintenance - Due - Replace

**Damage #1:** Wheel / tyres: Alloy rim - front left side - Scratched - Loss in value

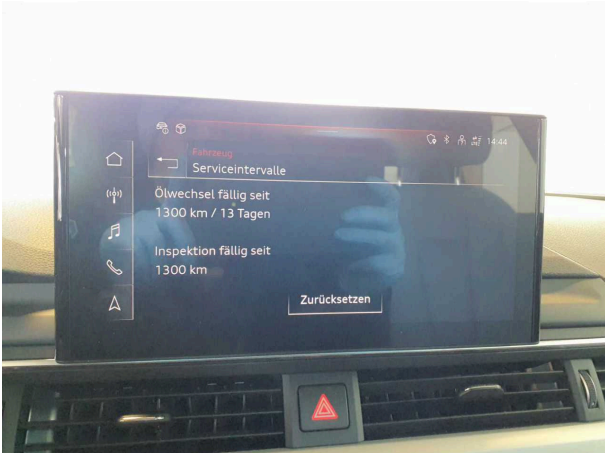
**Damage #2:** Misc.: Inspection / maintenance - Due - Replace
