**WAUZZZFY4L2125782**

## Zustandsbericht

Inspection date: 6 Mar 2025

**Protocol number:** 38771120

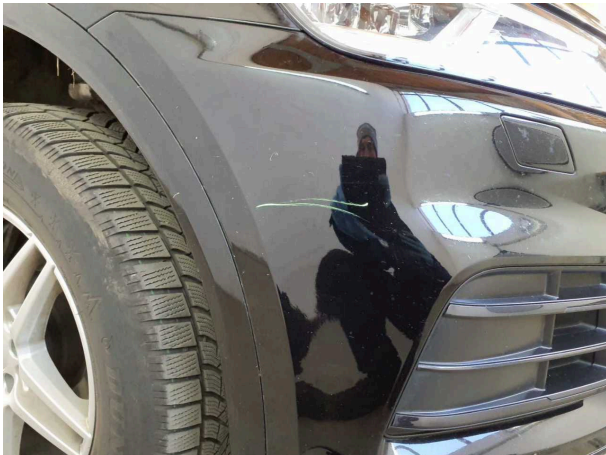
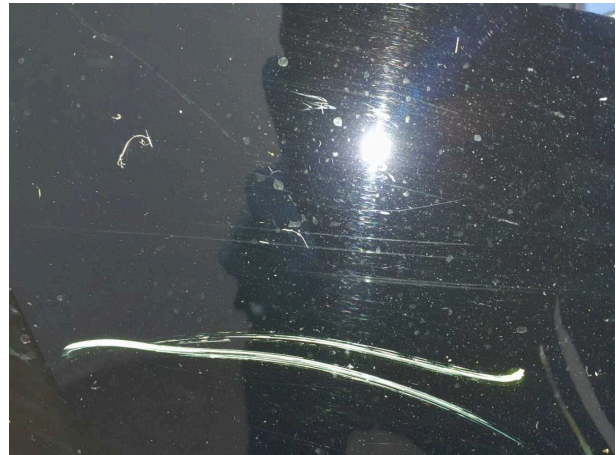
| No. | Component group | Description |
|---|---|---|
| 1 | Front bumper | Front bumper - Scratch(es) - Cover / polish |

**Damage #1:** Front bumper: Front bumper - Scratch(es) - Cover / polish

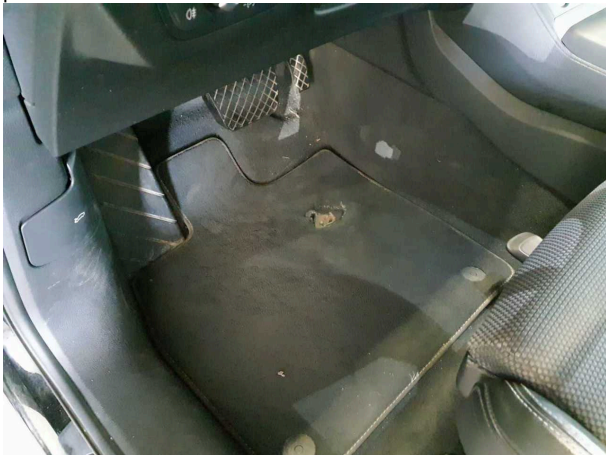
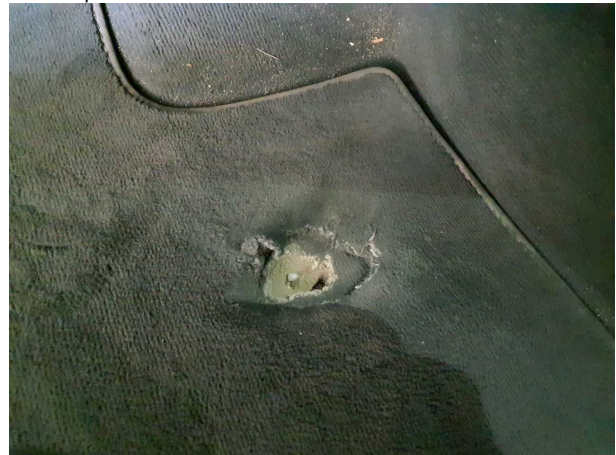
| No. | Component group | Description |
|---|---|---|
| 2 | Trim / covers | Floor mats - Damaged - Replace |

**Damage #2:** Trim / covers: Floor mats - Damaged - Replace

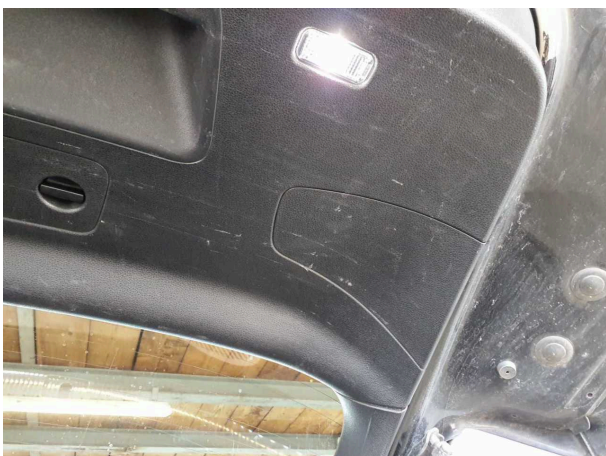
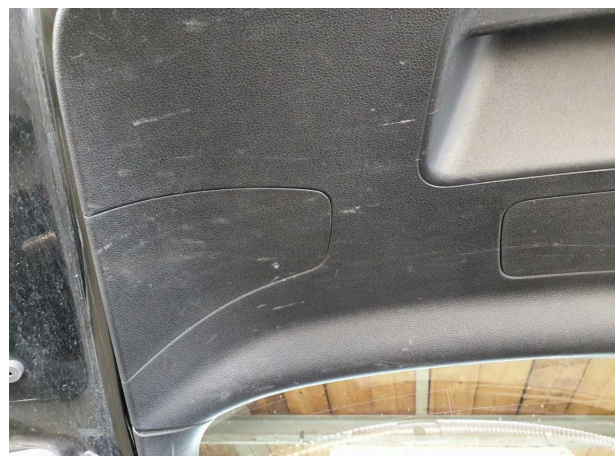
| No. | Component group | Description |
|---|---|---|
| 3 | Trim / covers | Boot lid - interior trim - Scratched - Loss in value |

**Damage #3:** Trim / covers: Boot lid - interior trim - Scratched - Loss in value

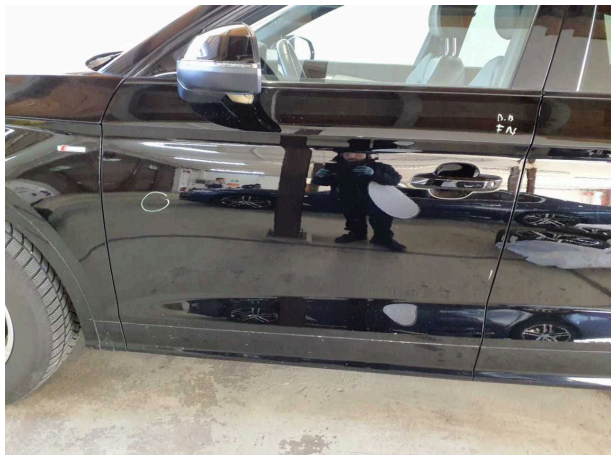
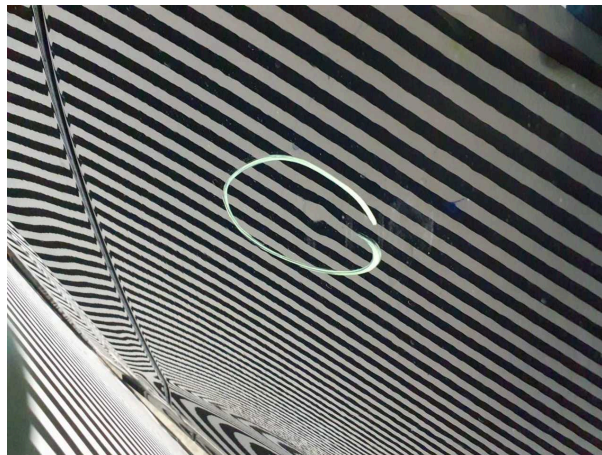
| No. | Component group | Description |
|---|---|---|
| 4 | Door - front left side | Door - dent(s) - Smooth repair work |

**Damage #4:** Door - front left side: Door - dent(s) - Smooth repair work

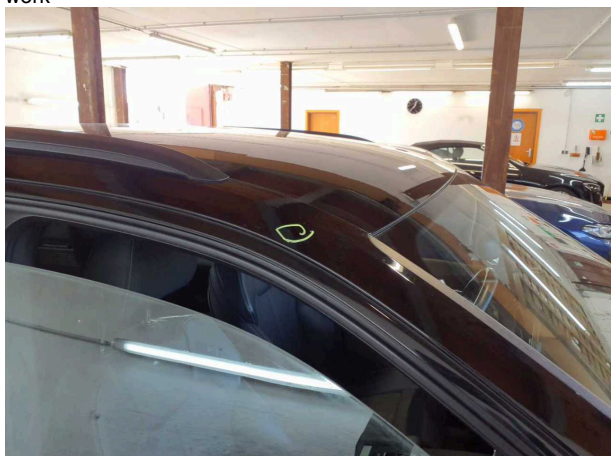
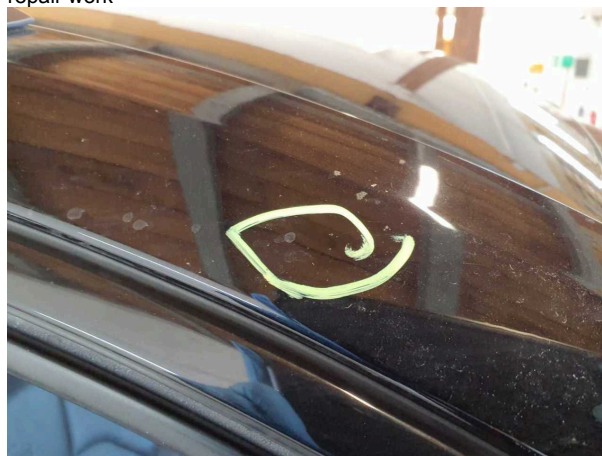
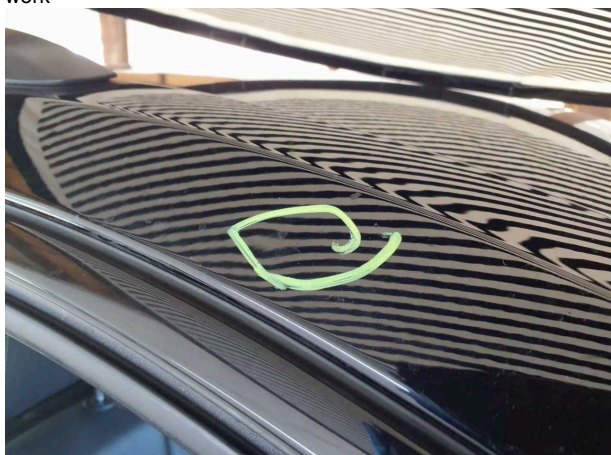
| No. | Component group | Description |
|---|---|---|
| 5 | Roof | Roof rail - right side - dent(s) - Smooth repair work |

**Damage #5:** Roof: Roof rail - right side - dent(s) - Smooth repair work

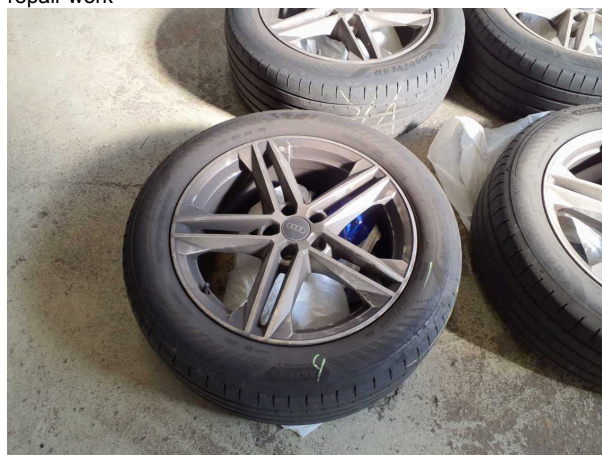
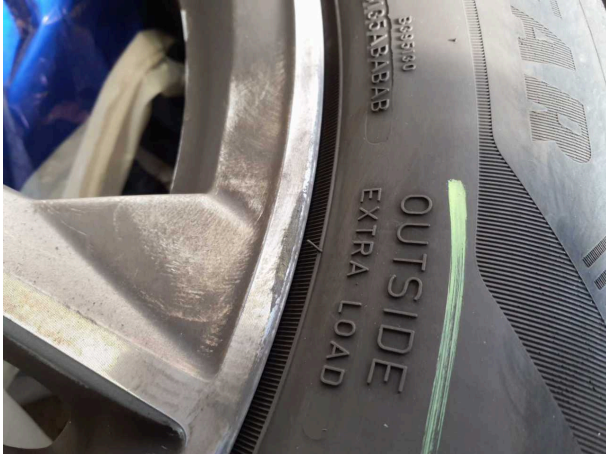
| No. | Component group | Description |
|---|---|---|
| 6 | 2nd wheel set | 1 alloy rim - Scratched - Loss in value |

**Damage #6:** 2nd wheel set: 1 alloy rim - Scratched - Loss in value

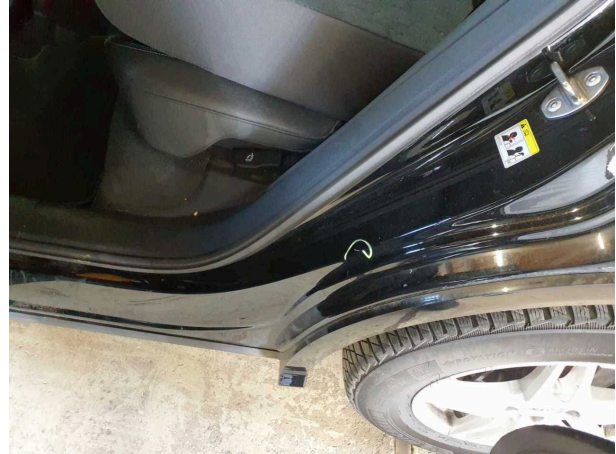
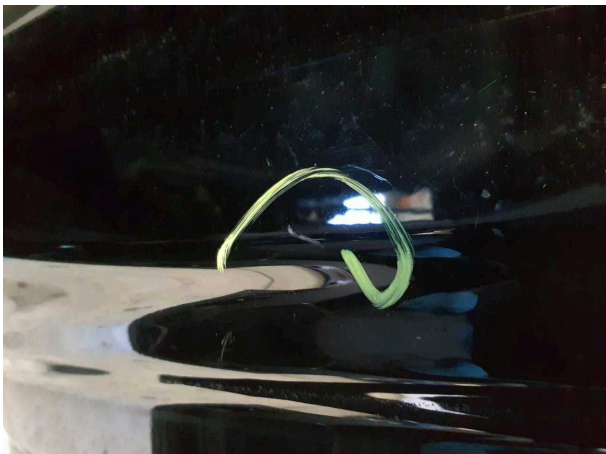
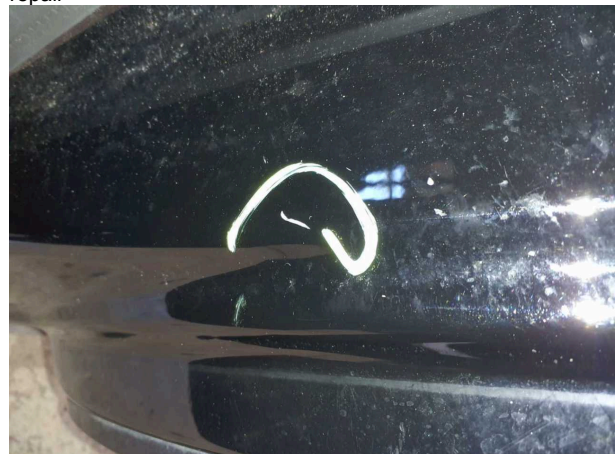
| No. | Component group | Description |
|---|---|---|
| 7 | Side panel - rear left side | Sill - Scratched - Smart repair |

**Damage #7:** Side panel - rear left side: Sill - Scratched - Smart repair

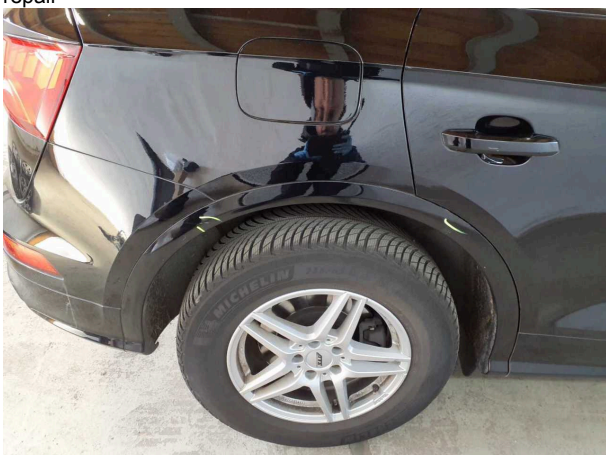
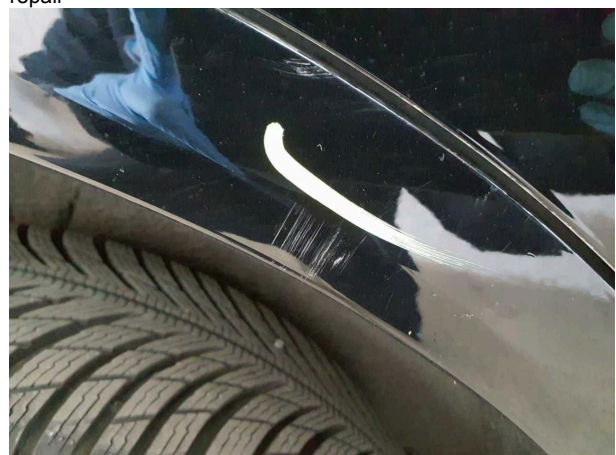
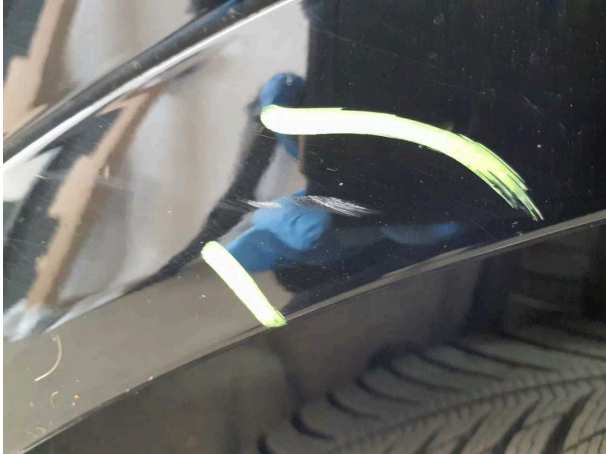
| No. | Component group | Description |
|---|---|---|
| 8 | Side panel - rear right side | Wheel well extension - Scratched - Smart repair |

**Damage #8:** Side panel - rear right side: Wheel well extension - Scratched - Smart repair

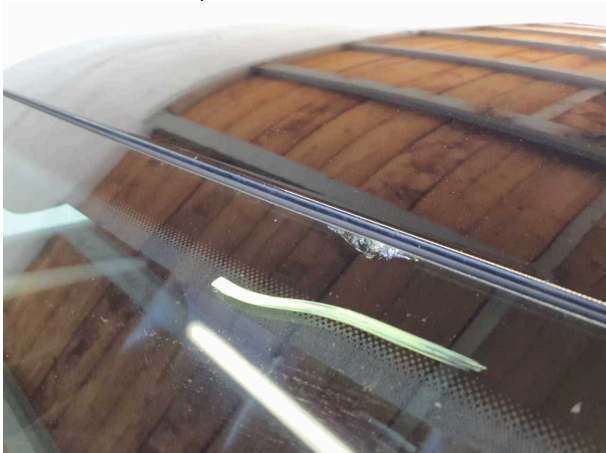
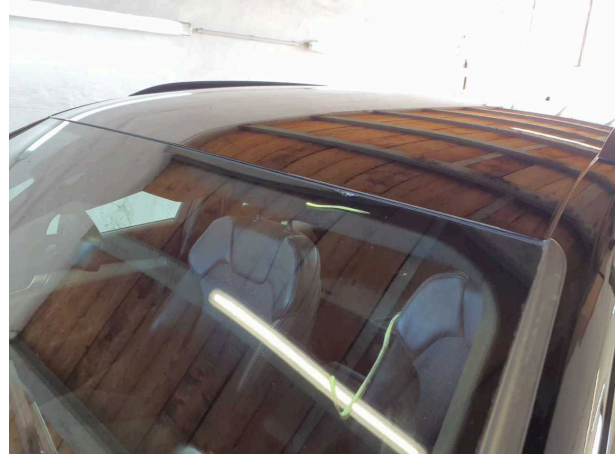
| No. | Component group | Description |
|---|---|---|
| 9 | Vehicle glazing | Windscreen with rain sensor - Damaged - Replace |

**Damage #9:** Vehicle glazing: Windscreen with rain sensor - Damaged - Replace

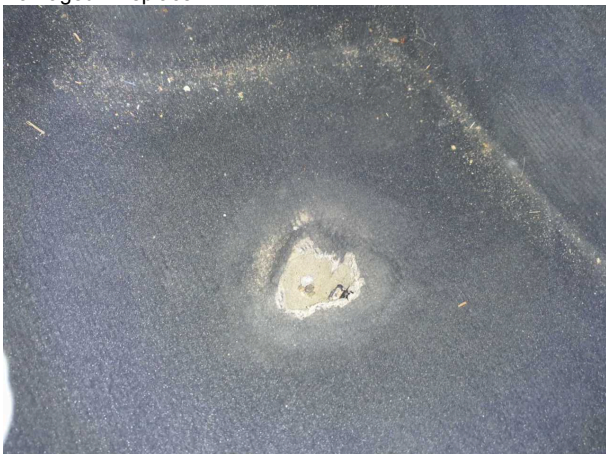
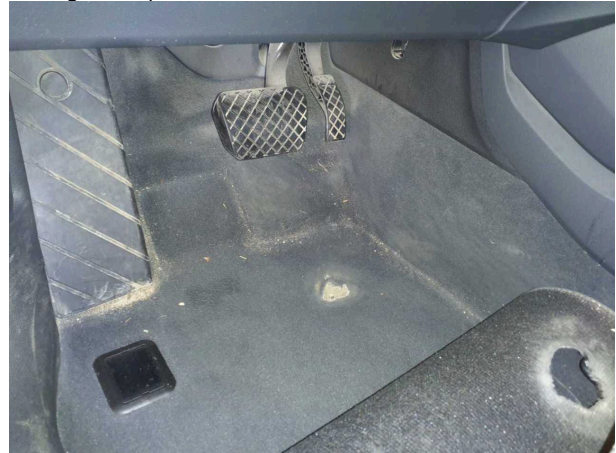
| No. | Component group | Description |
|---|---|---|
| 10 | Trim / covers | Carpet - front left side - Damaged - Replace |

**Damage #10:** Trim / covers: Carpet - front left side - Damaged - Replace

**Damage #10:** Trim / covers: Carpet - front left side - Damage... Replace

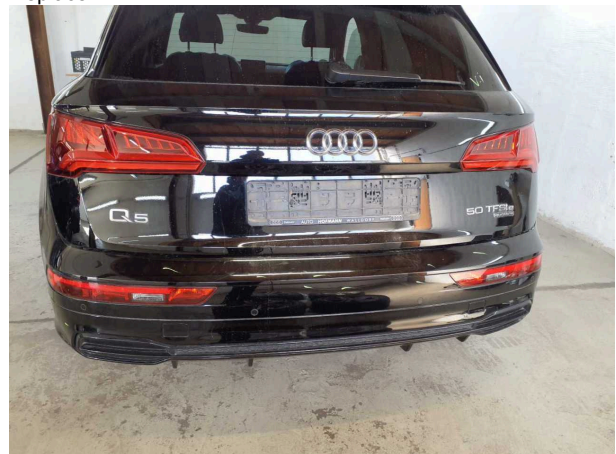
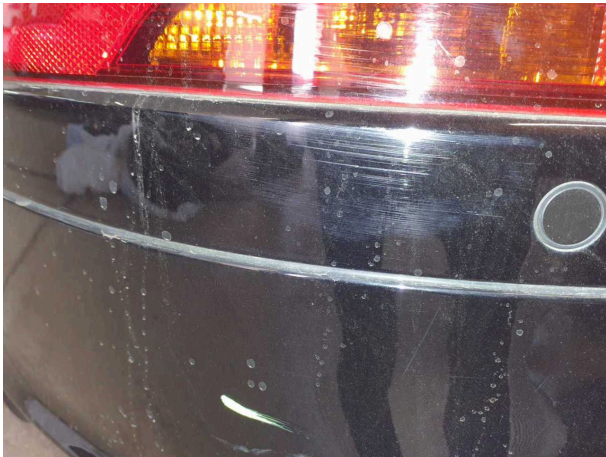
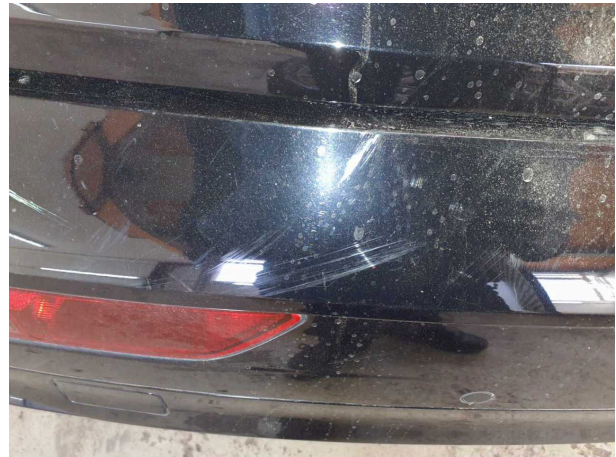
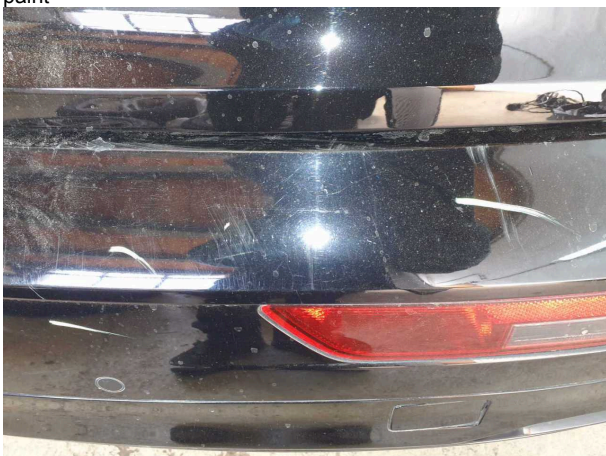
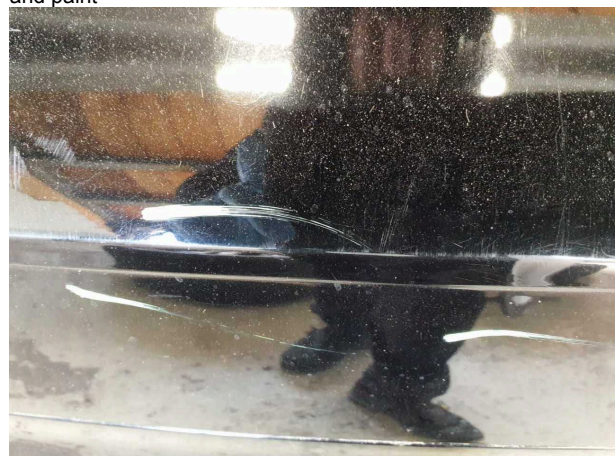
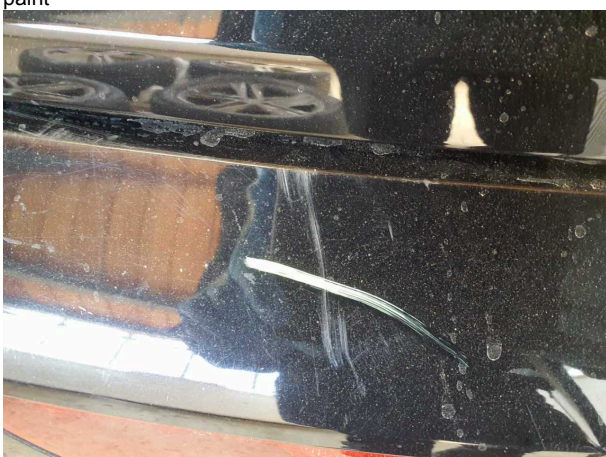
| No. | Component group | Description |
|---|---|---|
| 11 | Rear bumper | Rear bumper - Scratched - Repair and paint |

**Damage #11:** Rear bumper: Rear bumper - Scratched - Repair and paint
