WAUZZZFY8L2117894

## Zustandsbericht

Inspection date: 20 Mar 2025  
**Protocol number: 38947585**  
Delivery date: 20 Mar 2025

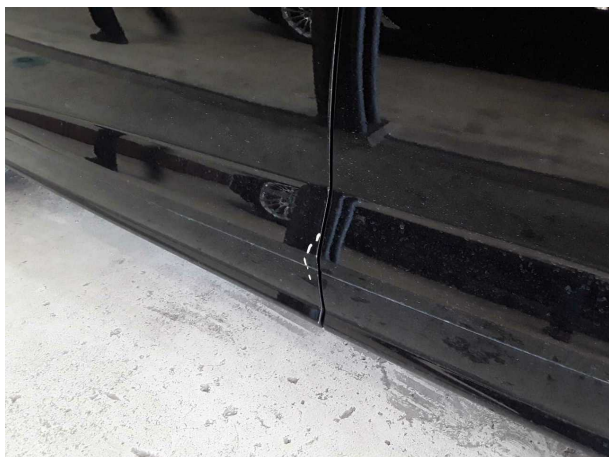
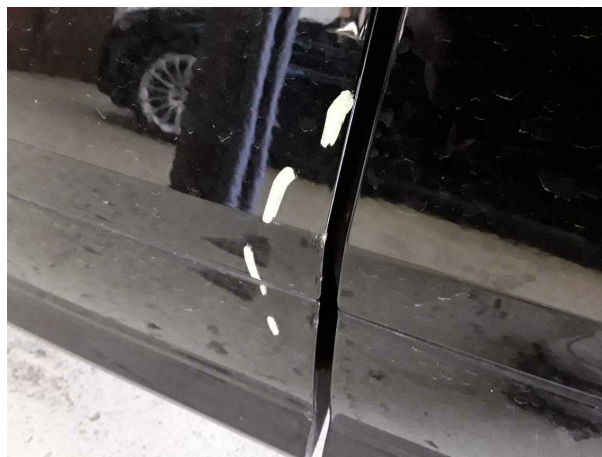
**Damage #2:** Door - front left side: Door edge - Scratch(es) - Cover / polish

| No. | Component group | Description |
|---|---|---|
| 2 | Door - front left side | Door edge - Scratch(es) - Cover / polish |

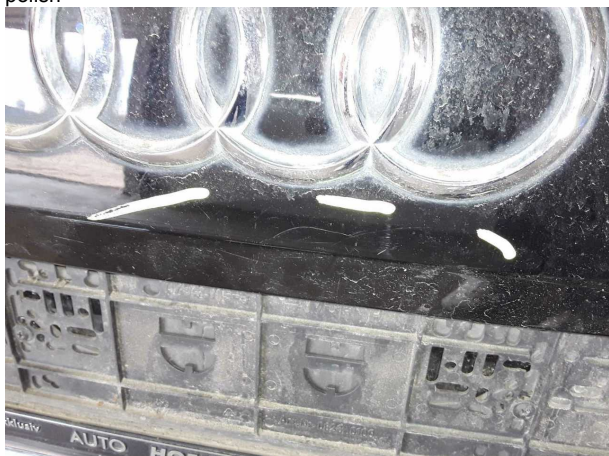
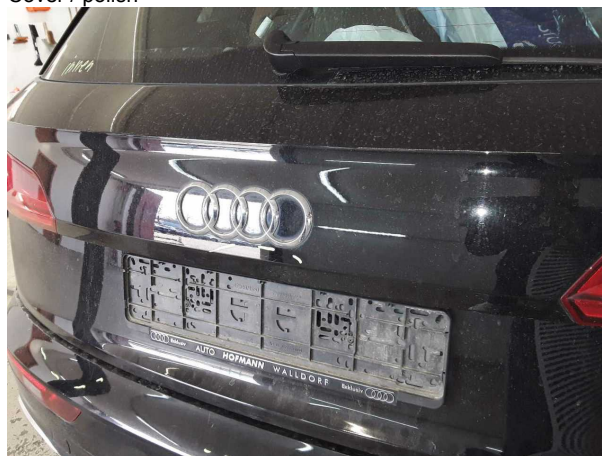
**Damage #3:** Boot lid / rear door: Boot lid - Scratch(es) - Cover / polish

| No. | Component group | Description |
|---|---|---|
| 3 | Boot lid / rear door | Boot lid - Scratch(es) - Cover / polish |

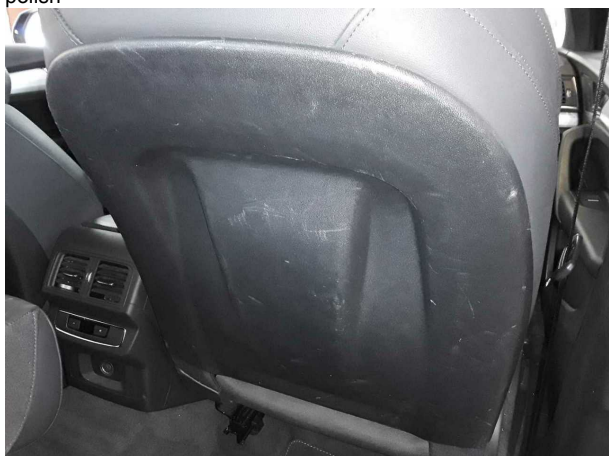
**Damage #5:** Seat - front: Seat base trim - right side - Scratched - Loss in value

| No. | Component group | Description |
|---|---|---|
| 5 | Seat - front | Seat base trim - right side - Scratched - Loss in value |

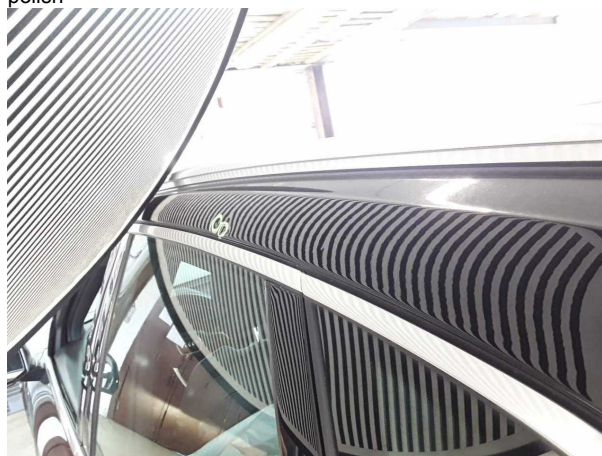
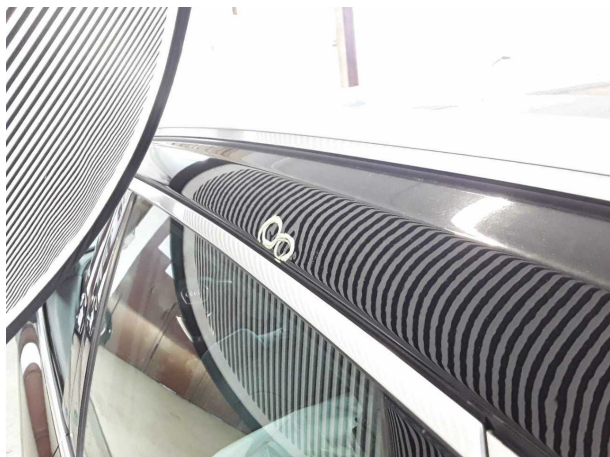
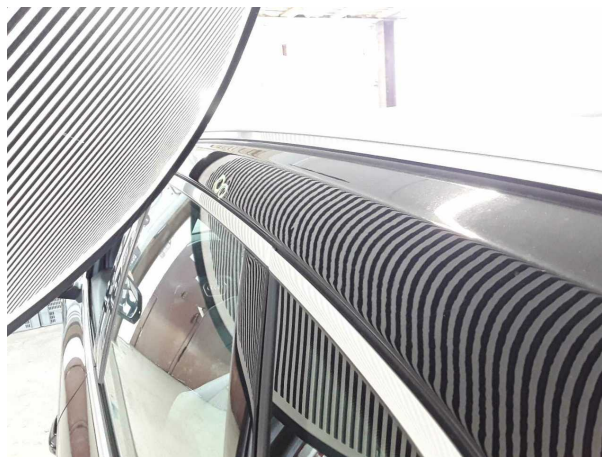
**Damage #6:** Roof: Roof rail - left side - dent(s) - Smooth repair work

| No. | Component group | Description |
|---|---|---|
| 6 | Roof | Roof rail - left side - dent(s) - Smooth repair work |

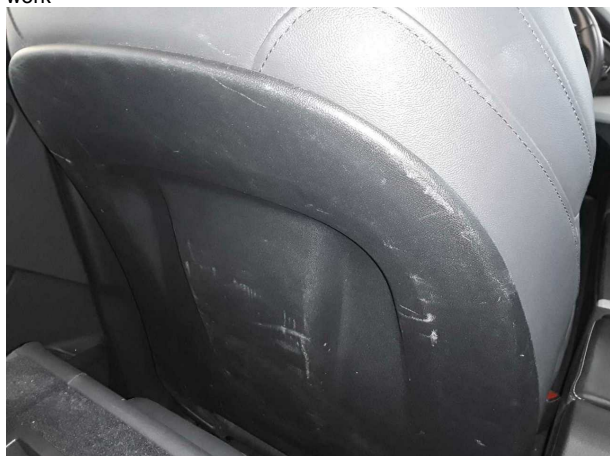
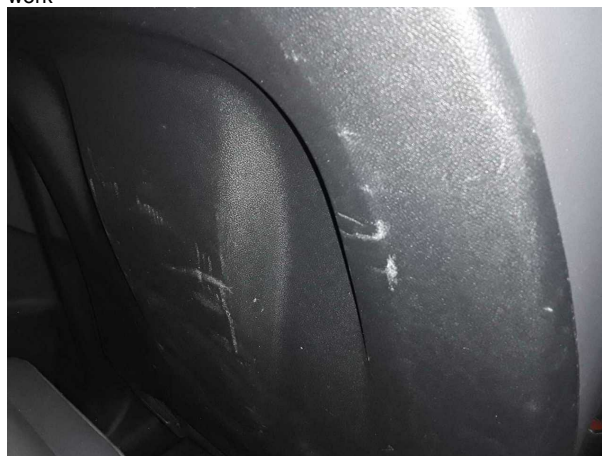
**Damage #7:** Seat - front: Seat base trim - left side - Scratched - Loss in value

**Damage #7:** Seat - front: Seat base trim - left side - Scratched... Loss in value

| No. | Component group | Description |
|---|---|---|
| 7 | Seat - front | Seat base trim - left side - Scratched - Loss in value |

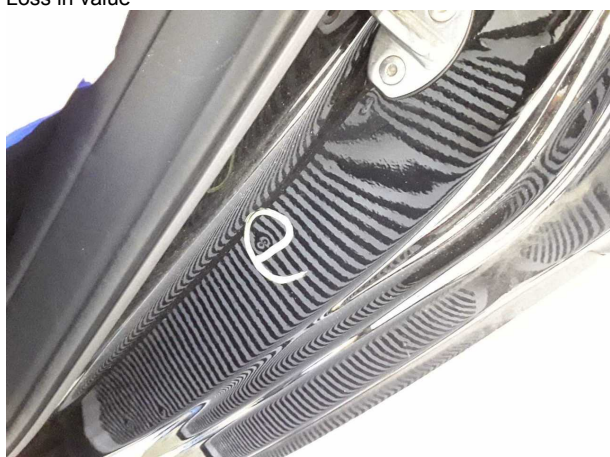
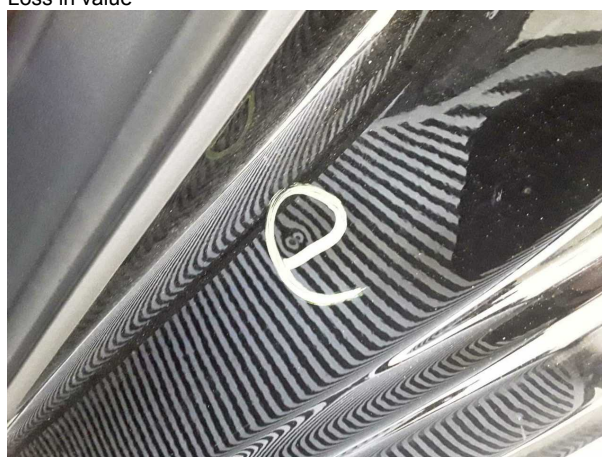
**Damage #8:** Side panel - rear left side: Sill - dent(s) - Smart repair

| No. | Component group | Description |
|---|---|---|
| 8 | Side panel - rear left side | Sill - dent(s) - Smart repair |

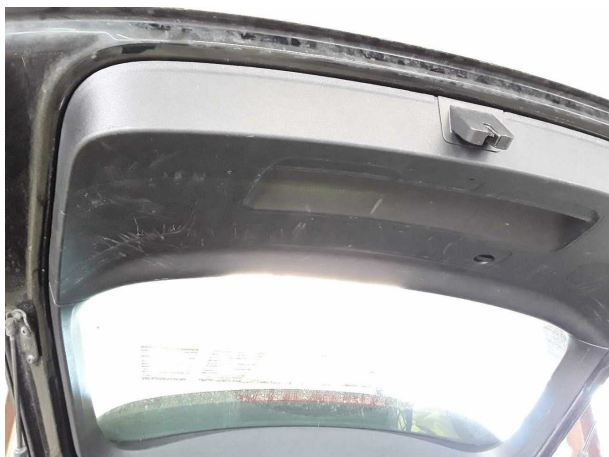
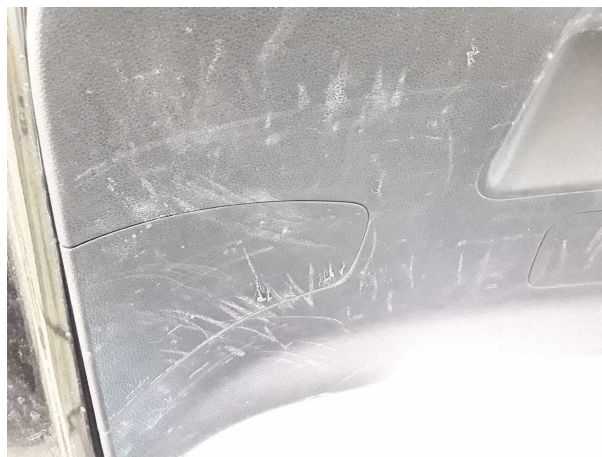
**Damage #9:** Trim / covers: Boot lid - interior trim - Scratched - Replace

| No. | Component group | Description |
|---|---|---|
| 9 | Trim / covers | Boot lid - interior trim - Scratched - Replace |

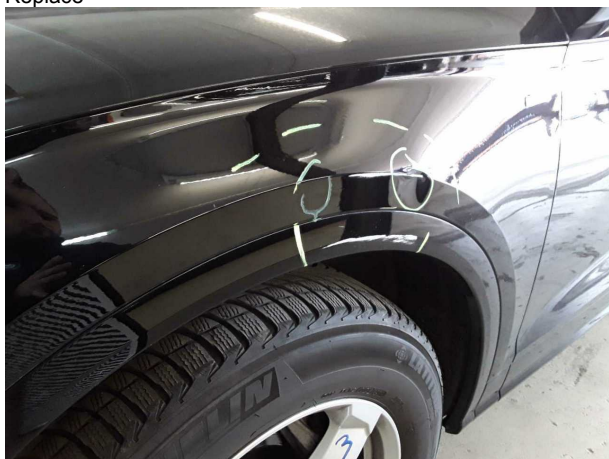
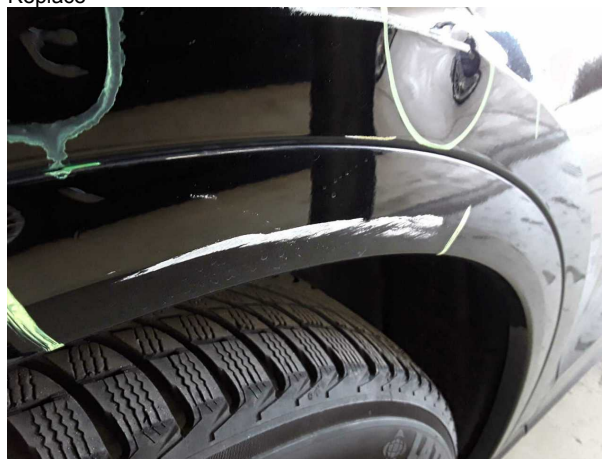
**Damage #10:** Mudguard - left side: Wheel arch - Scratched - Paint

| No. | Component group | Description |
|---|---|---|
| 10 | Mudguard - left side | Wheel arch - Scratched - Paint |

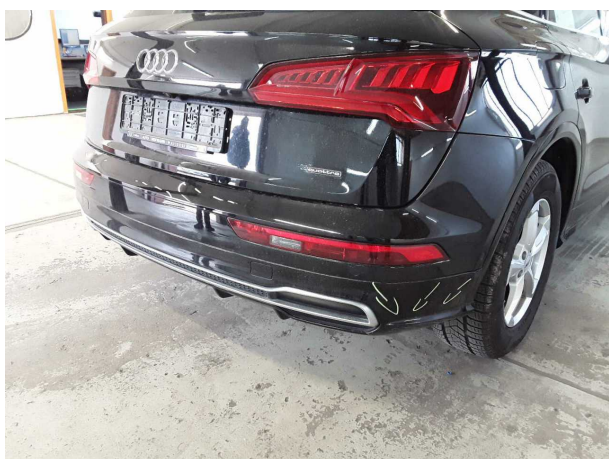
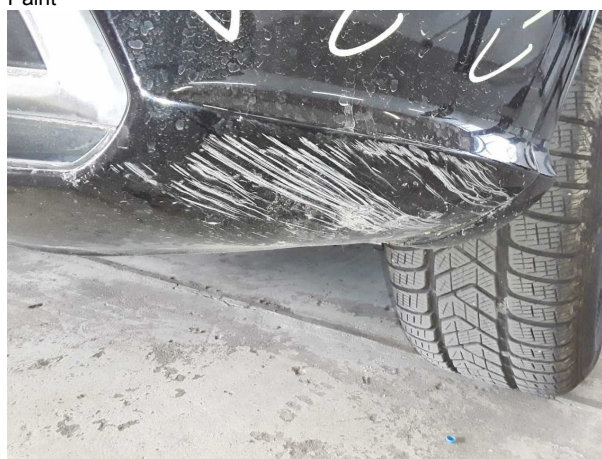
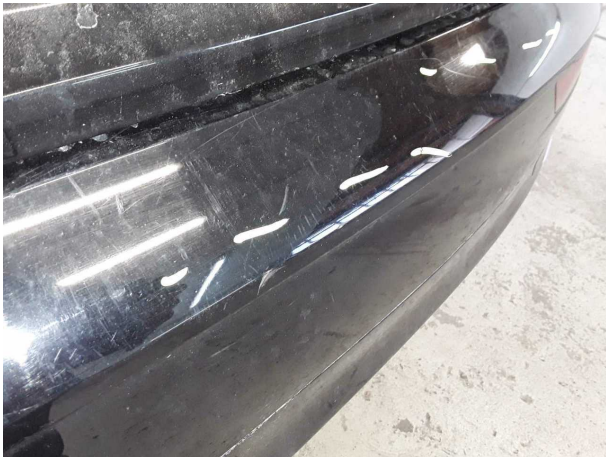
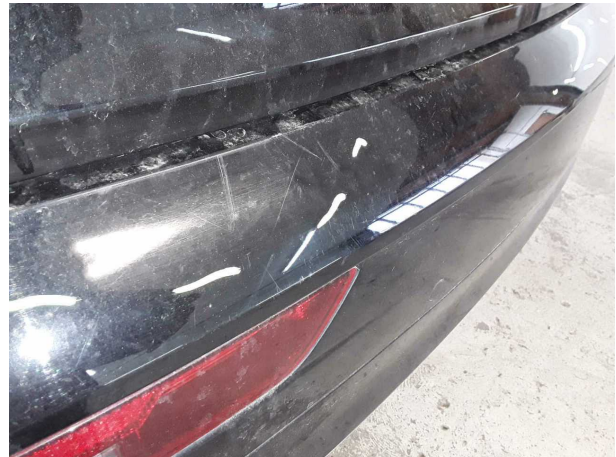
**Damage #11:** Rear bumper: Rear bumper - Scratched - Paint

| No. | Component group | Description |
|---|---|---|
| 11 | Rear bumper | Rear bumper - Scratched - Paint |

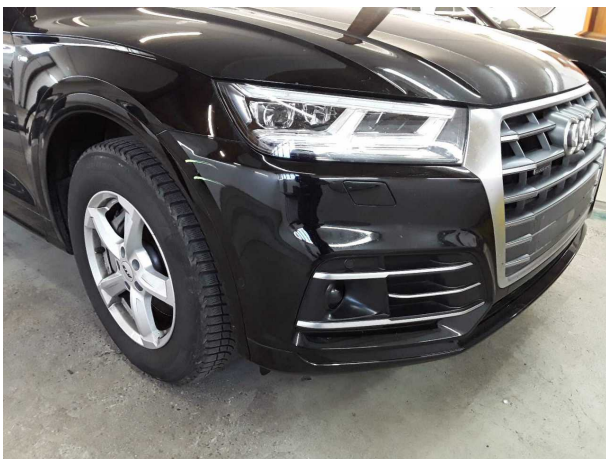
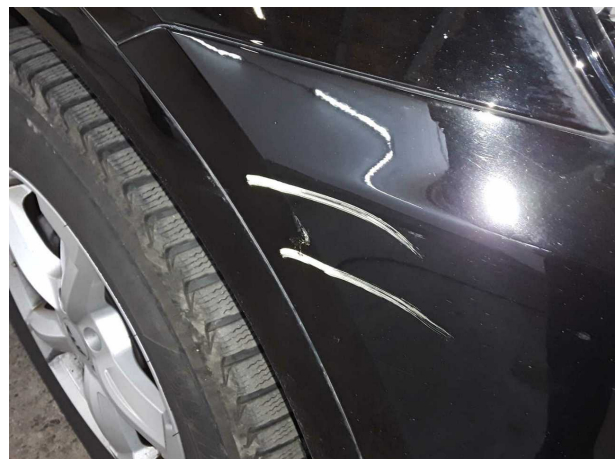
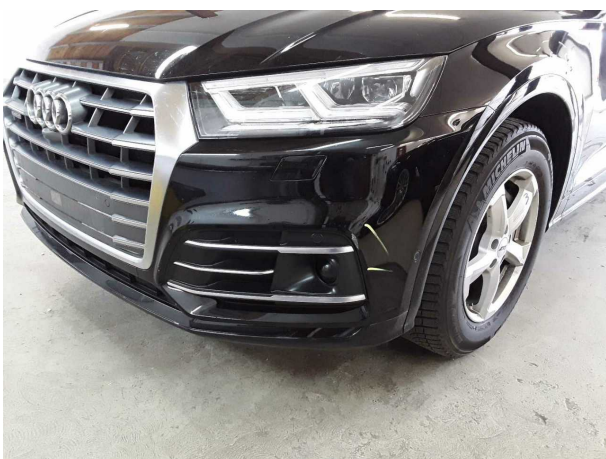
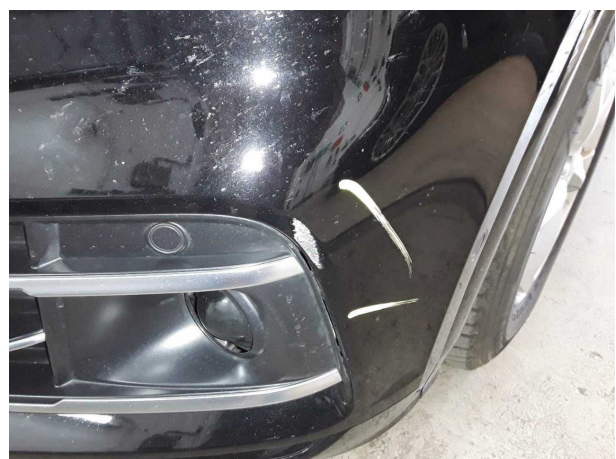
**Damage #12:** Front bumper: Front bumper - Scratched - Paint

| No. | Component group | Description |
|---|---|---|
| 12 | Front bumper | Front bumper - Scratched - Paint |

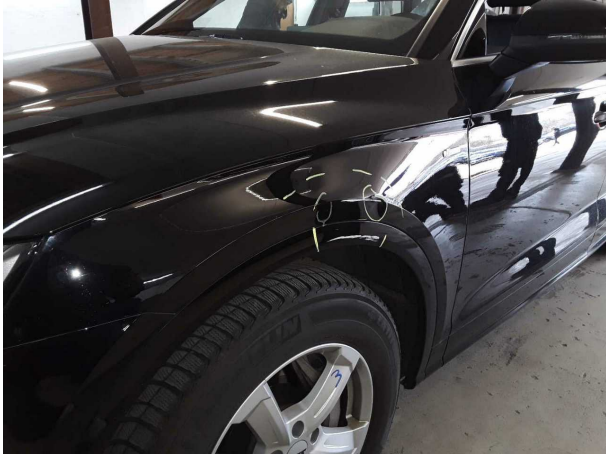
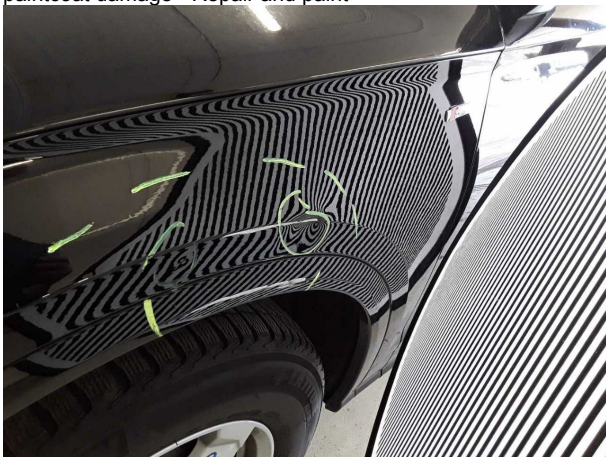
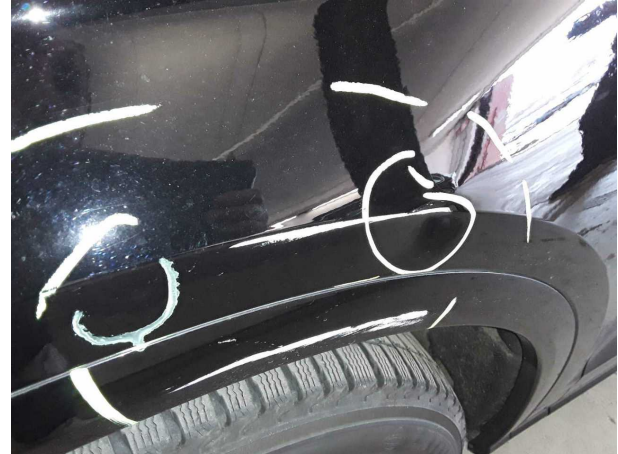
**Damage #13:** Mudguard - left side: Mudguard - left side - Dent / paintcoat damage - Repair and paint

**Damage #13:** Mudguard - left side: Mudguard - left side - De... paintcoat damage - Repair and paint

| No. | Component group | Description |
|---|---|---|
| 13 | Mudguard - left side | Mudguard - left side - Dent / paintcoat damage - Repair and paint |
