**WBA5P51050FK86760**

## Zustandsbericht

Inspection date: 11 Mar 2025

**Protocol number: 38790550**

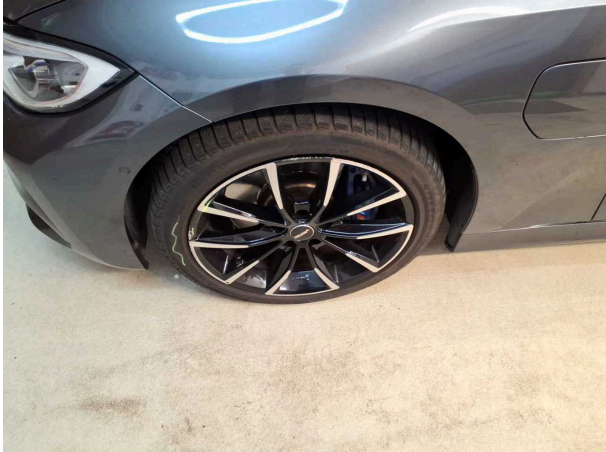
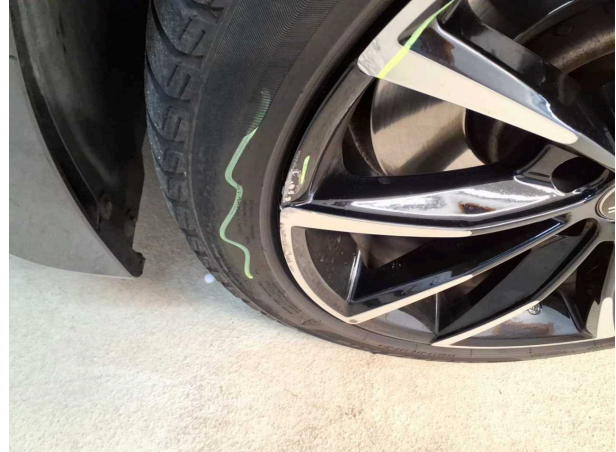
| No. | Component group | Description |
|---|---|---|
| 2 | Wheel / tyres | Alloy rim - front left side - Scratched - No deduction |

**Damage #2:** Wheel / tyres: Alloy rim - front left side - Scratched - No deduction

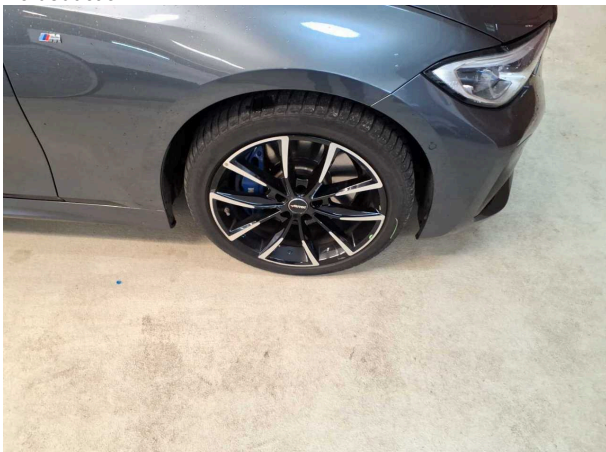
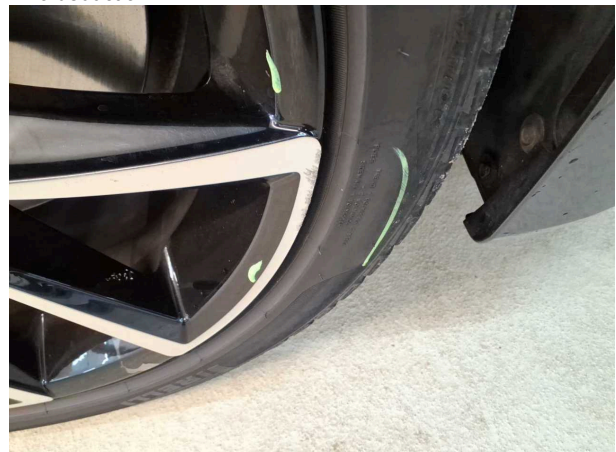
| No. | Component group | Description |
|---|---|---|
| 3 | Wheel / tyres | Alloy rim - front right side - Scratched - No deduction |

**Damage #3:** Wheel / tyres: Alloy rim - front right side - Scratched - No deduction

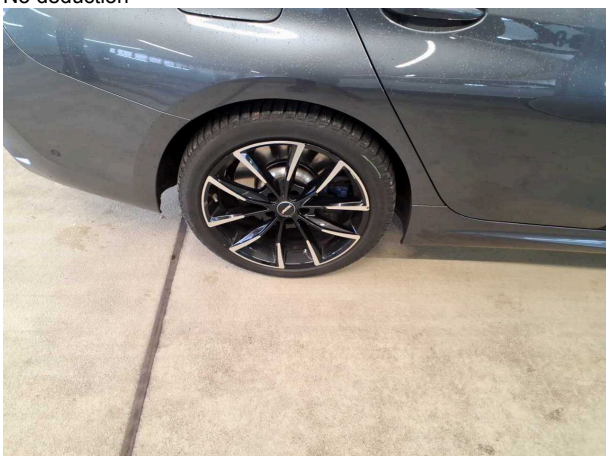
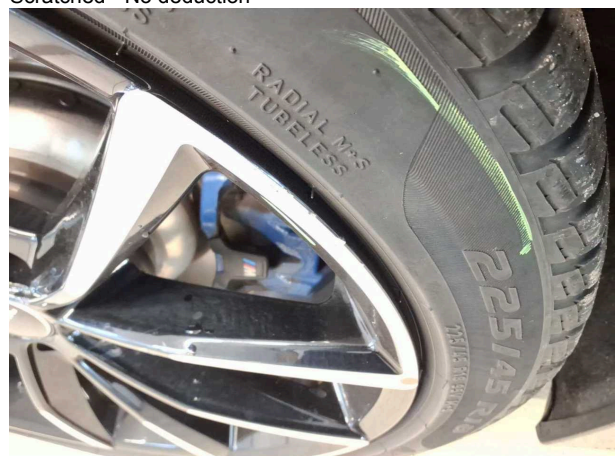
| No. | Component group | Description |
|---|---|---|
| 4 | Wheel / tyres | Alloy rim - rear right side - Scratched - No deduction |

**Damage #4:** Wheel / tyres: Alloy rim - rear right side - Scratched - No deduction

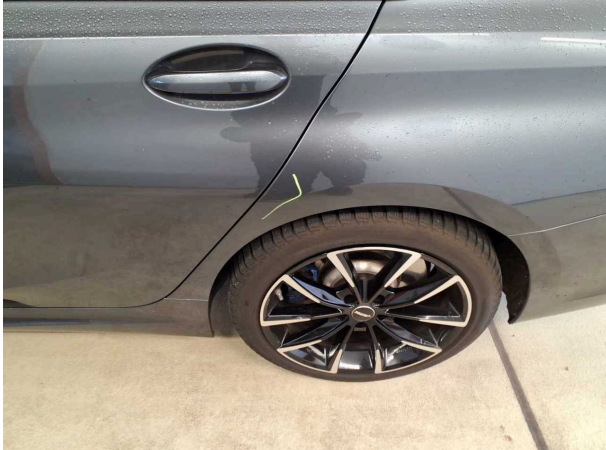
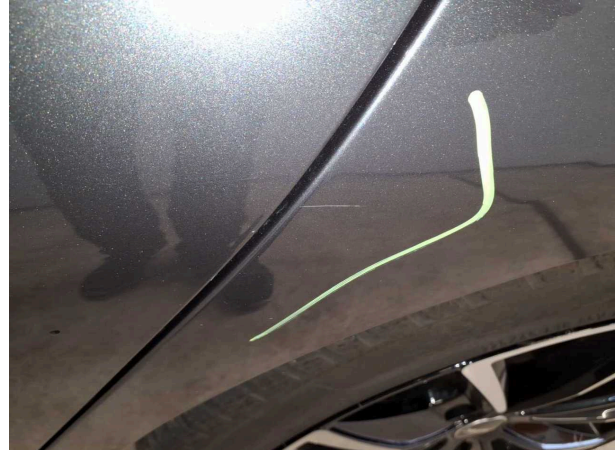
| No. | Component group | Description |
|---|---|---|
| 5 | Side panel - rear left side | Side panel - Scratch(es) - Cover / polish |

**Damage #5:** Side panel - rear left side: Side panel - Scratch(es) - Cover / polish

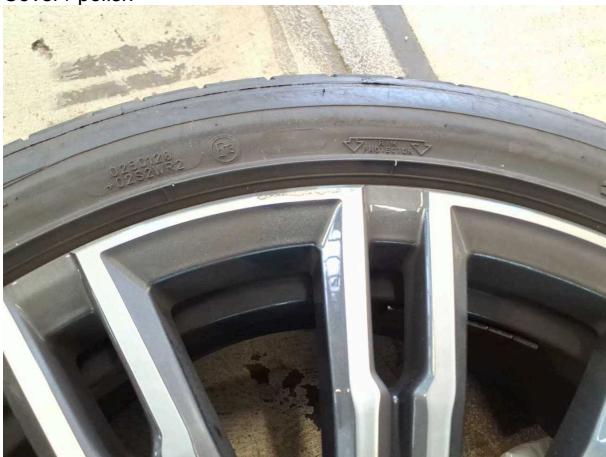
| No. | Component group | Description |
|---|---|---|
| 6 | 2nd wheel set | 1 alloy rim - Scratched - Loss in value |

**Damage #6:** 2nd wheel set: 1 alloy rim - Scratched - Loss in value

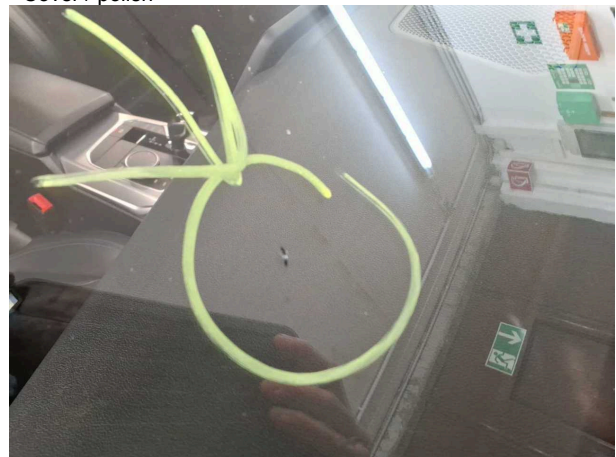
| No. | Component group | Description |
|---|---|---|
| 8 | Vehicle glazing | Windscreen - Stone chips - Replace |

**Damage #8:** Vehicle glazing: Windscreen - Stone chips - Replace
