WBA11AJ000CG78249

## Zustandsbericht

Inspection date: 20 Mar 2025  
**Protocol number:** 38932711  
Delivery date: 20 Mar 2025

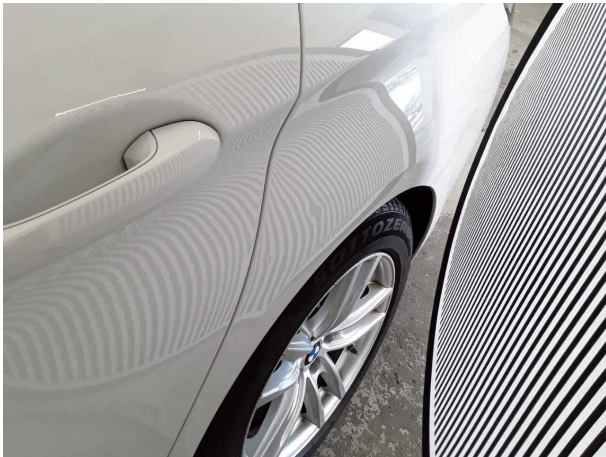
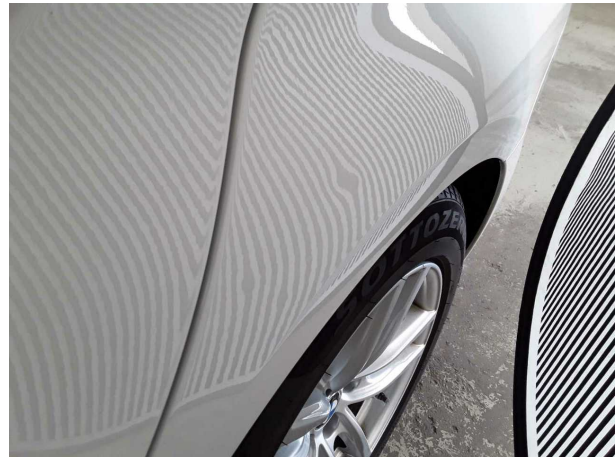
| No. | Component group | Description |
|---|---|---|
| 1 | Side panel - rear left side | Side panel - dent(s) - Smooth repair work |

**Damage #1:** Side panel - rear left side: Side panel - dent(s) - Smooth repair work

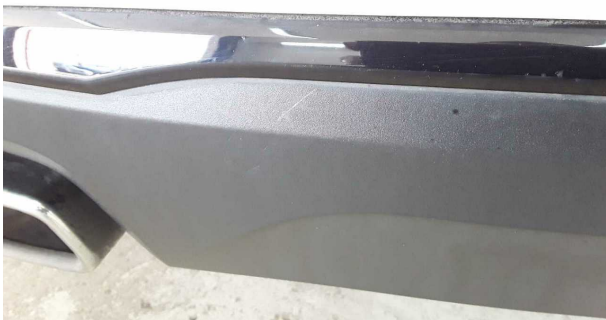
| No. | Component group | Description |
|---|---|---|
| 2 | Rear bumper | Spoiler - Scratch(es) - Loss in value |

**Damage #2:** Rear bumper: Spoiler - Scratch(es) - Loss in value

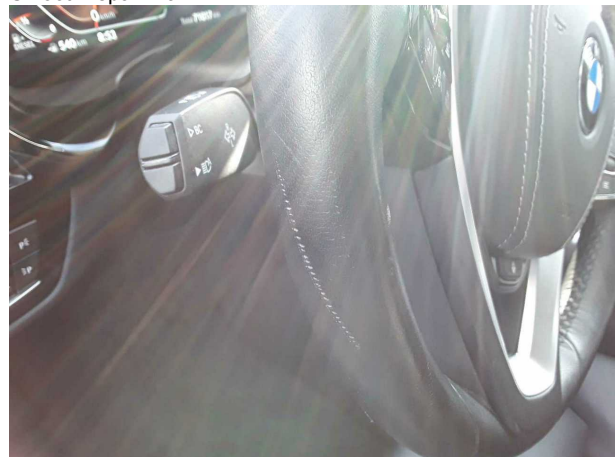
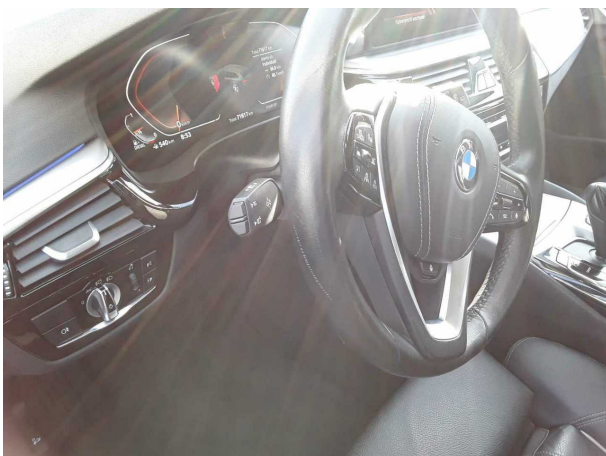
| No. | Component group | Description |
|---|---|---|
| 3 | Steering system | Steering wheel - Scratch(es) - Loss in value |

**Damage #3:** Steering system: Steering wheel - Scratch(es) - Loss in value

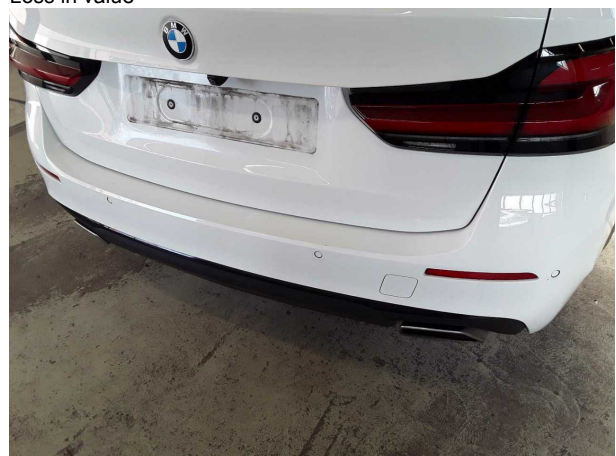
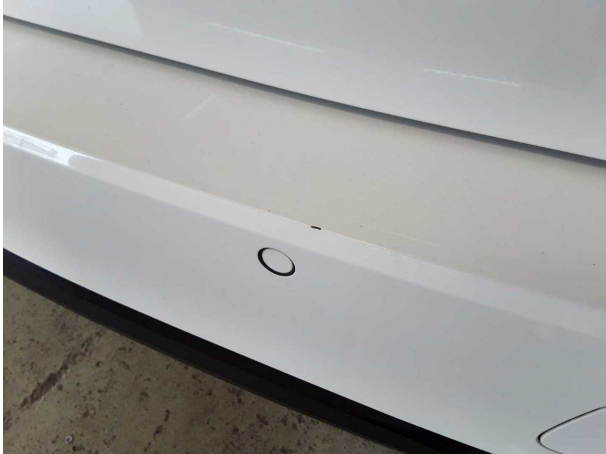
| No. | Component group | Description |
|---|---|---|
| 4 | Rear bumper | Rear bumper - Scratch(es) - Smart repair |

**Damage #4:** Rear bumper: Rear bumper - Scratch(es) - Smart repair

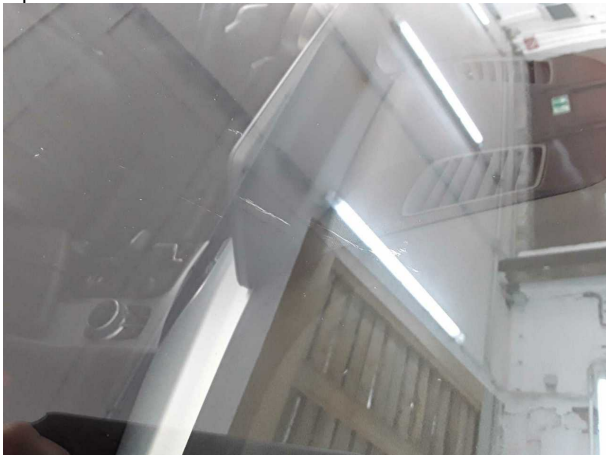
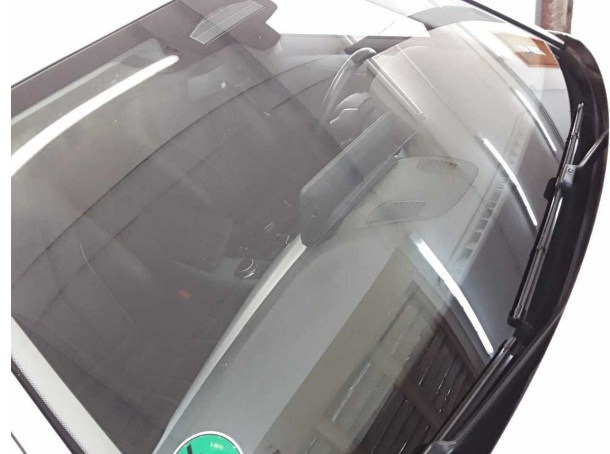
| No. | Component group | Description |
|---|---|---|
| 5 | Vehicle glazing | Windscreen - Scratch(es) - Replace |

**Damage #5:** Vehicle glazing: Windscreen - Scratch(es) - Replace
